Highway Accident Report

**Collision Between Truck-Tractor  
Semitrailer and School Bus  
Near Mountainburg, Arkansas  
on May 31, 2001**

NTSB/HAR-02/03  
PB2002-916203  
Notation 7490  
Adopted September 4, 2002

The major safety issues discussed in this report are the poor condition of the tractor semitrailer brakes, inadequate motor carrier inspections and oversight, the use of propane tanks on school buses, and occupant protection within school buses.

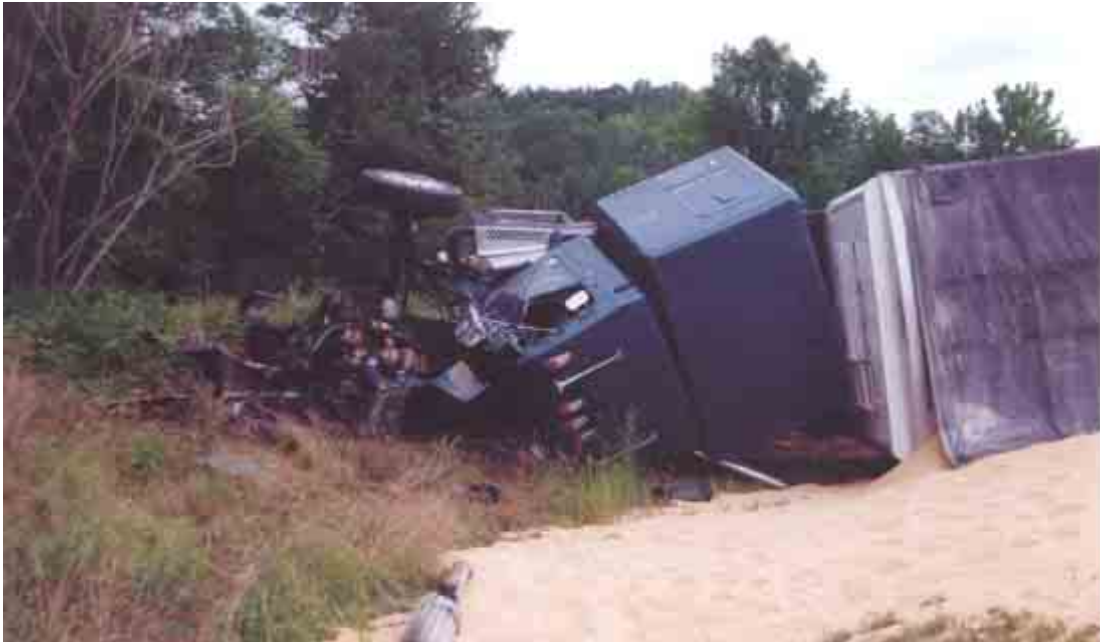
**Figure 3.** Tractor semitrailer, postaccident.

**Damage.** The tractor sustained damage to the front part of the frame, which was bent to the right about 10 degrees; the entire cab was shifted rearward, the windshield and right door window were broken, and both doors were damaged. The engine was dislodged from its mount, and parts within the engine compartment, as well as the front engine support, were broken;<sup>17</sup> the left fuel tank was dislodged and the right fuel tank was punctured; and the muffler stack was broken off. Due to accident damage, the tractor lights could not be tested to determine whether they were operational. The hopper trailer's front left upper clearance lights were damaged, the left side of the trailer was scraped, both outside left trailer wheels were bent, and the tires were flat.

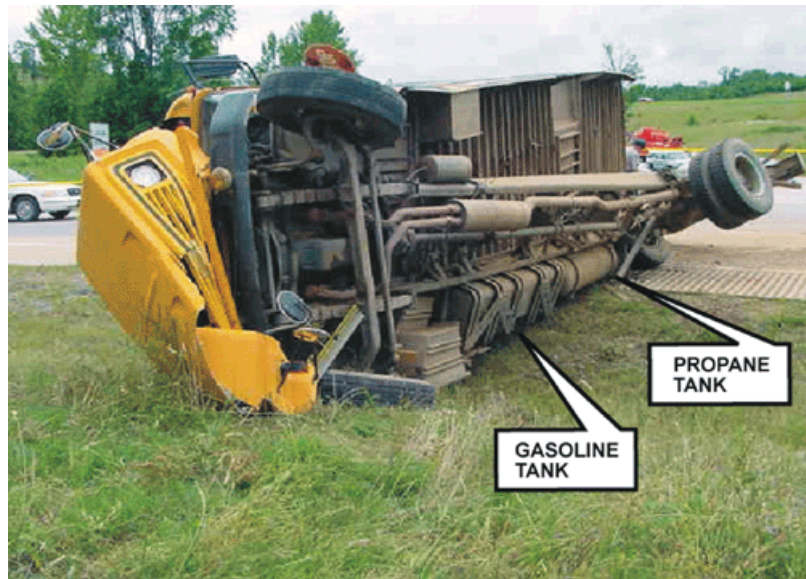
**Figure 8.** School bus propane tank.

Mountainburg Public Schools began converting school buses to propane fuel in the mid-1980s because propane was about 75 cents cheaper per gallon than regular gasoline. When the price of propane rose in the mid-1990s, the school district stopped converting the school buses because the savings were minimal; at the time of the accident, the school district had two propane-fueled buses on regular routes and two spares.

Neither the *National School Transportation Specifications and Procedures* nor the NFPA standards require cages surrounding propane tanks on school buses or crash tests for propane tanks installed on school buses. The *Federal Motor Vehicle Safety Standards* (FMVSSs) issued by NHTSA require that all fuel tanks installed by the original equipment manufacturer meet crash test standards; manufacturers comply with this requirement by placing cages around fuel tanks. NHTSA generally can only regulate equipment placed on vehicles when originally manufactured; the FMVSSs do not apply to aftermarket equipment, such as the retrofitted propane tank on the accident bus.<sup>21</sup>

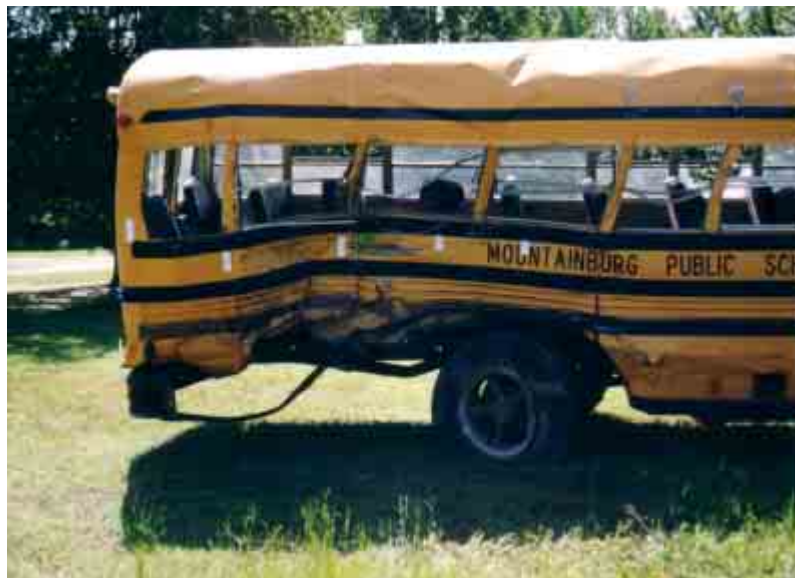
**Figure 9.** School bus damage.

Exterior damage to the school bus was limited to the right side and right roof area, extending 7 feet 2 inches from a point 2 feet forward of the right rear corner (see figure 9). The primary point of impact was in the area of the rear axle on the right side. After impact, the body partially separated from the chassis, which remained attached to the body below the driver's section. The propane tank, located underneath the floor on the right side of the bus about 4 feet forward of the impact area, was not damaged. The emergency exit door, located at the rear of the bus, was operable after the accident. The boarding door, which was underneath the bus when it came to rest, could not be opened.

Inside the bus, intrusion occurred between rows 5 through 11; the area of greatest intrusion, approximately 25 inches, was between rows 7 and 8. The seats on the right in rows 6, 7, 8, and 9 shifted to the left, blocking the center aisle. The inboard seat legs and horizontal seat supports were fractured in rows 7 through 11 on the right side. The floor joints separated behind the busdriver's seat and at rows 5, 7, and 9; the linoleum flooring remained intact, so no openings were created. On the left side windows, glazing remained intact, except for the window adjacent to row 9; the glazing was broken on all right side windows, except for the top window adjacent to row 7.
