Truck-Tractor Semitrailer Rollover and
Motorcoach Collision With Overturned Truck
Interstate Highway 94
Near Osseo, Wisconsin
October 16, 2005

ACCIDENT REPORT

NTSB/HAR-08/02
PB2008-916202

Highway Accident Report

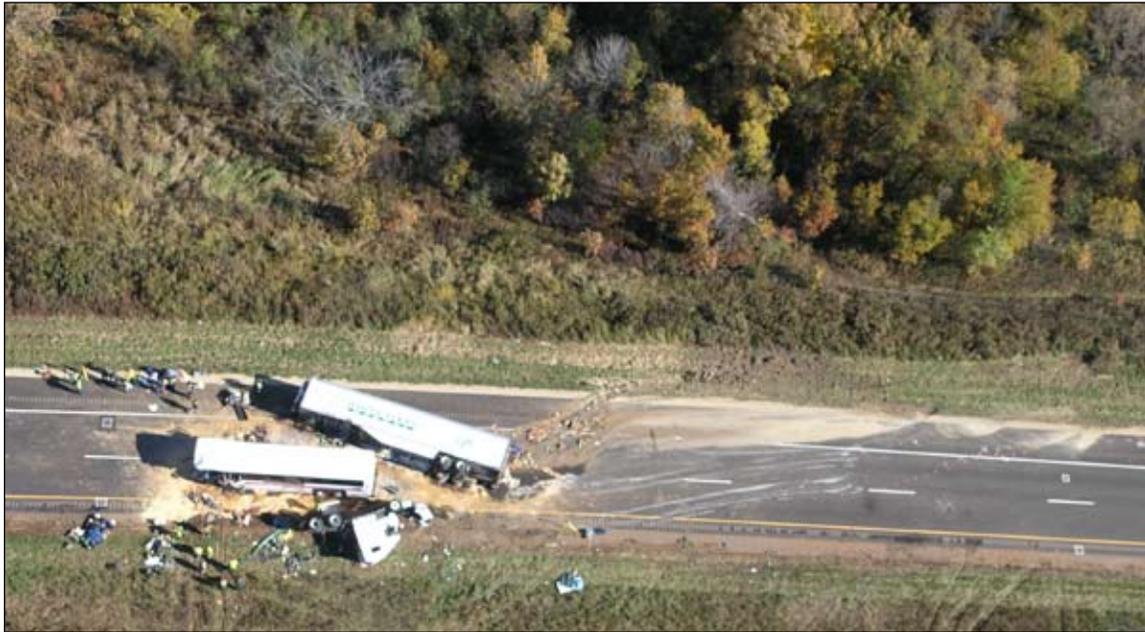
Figure 2. Accident scene from the air. (Courtesy of the Minnesota State Patrol)

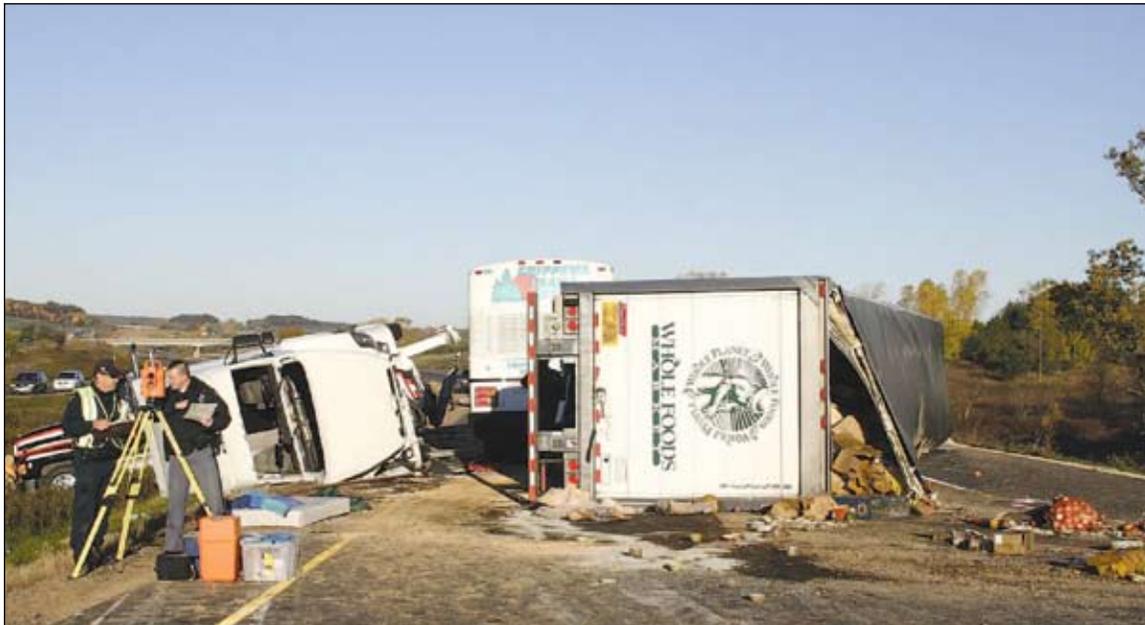
Figure 3. Accident wreckage, looking west. (Courtesy of the Wisconsin State Patrol)

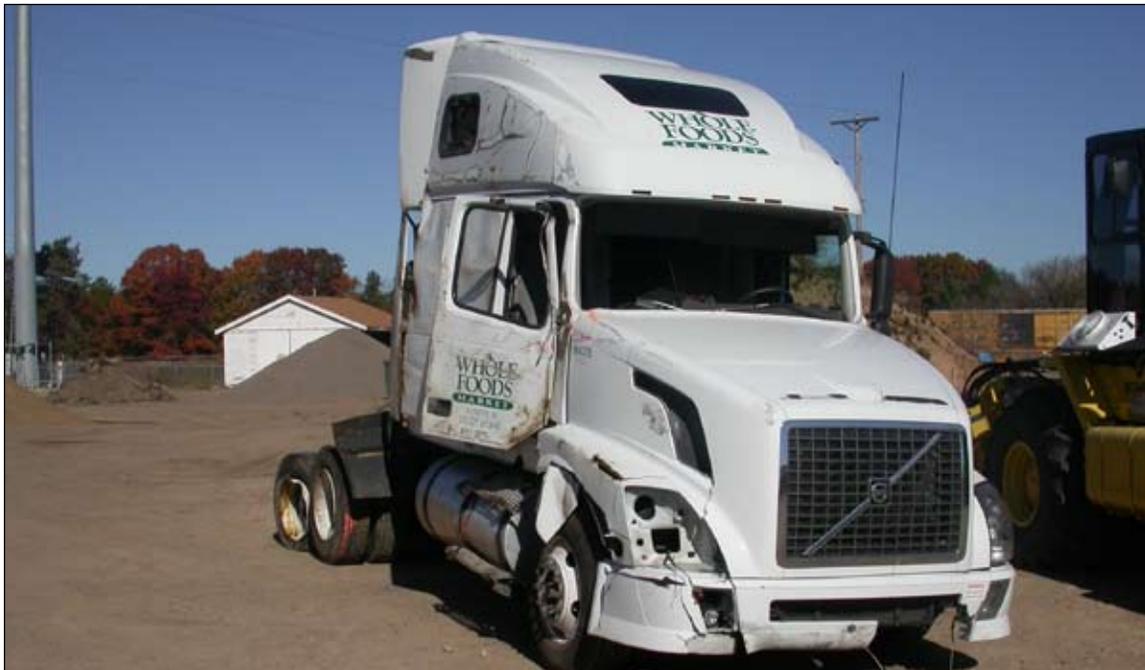
Figure 5. Accident tractor.

The tractor sustained most of its damage to the right side and underside in the area of the third axle. The right side of the tractor cab was scraped and dented. The sidewalls of the right side tires on both axles were scraped and both wheel rims were bent inward. The left side of the diesel fuel tank was punctured at its aft end. The right side headlight assembly was broken. The windshield and right side window were broken out from the tractor cab. The left side headlight assembly and the left side window remained intact. The tractor frame was bent downward behind the tractor cab and forward of the second axle. (See figure 5.)

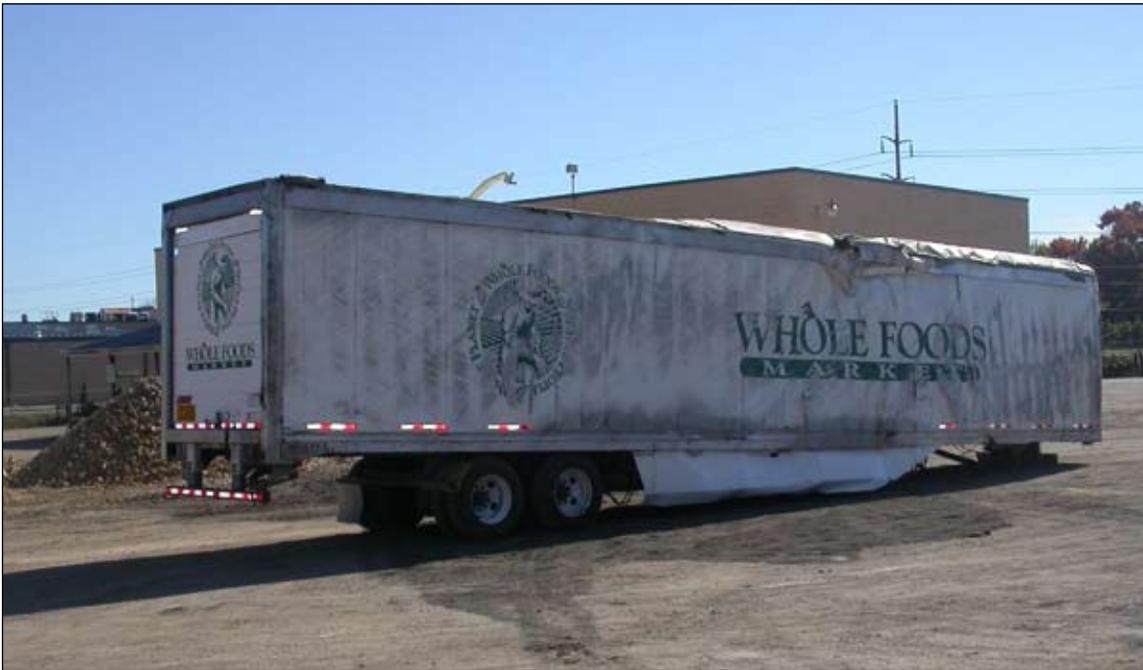
Figure 6. Accident semitrailer (right side).

The trailer sustained the majority of its damage to its right side and underside in the area of the landing gear and fuel tank mountings. The landing gear was detached from the bottom of the trailer. The fuel tank for the refrigerator trailer was also detached and had numerous cracks and punctures. The fifth wheel plate, which was detached from its mounting on the tractor, remained attached to

the trailer kingpin. The right side and the roof of the trailer were deformed. (See figure 6.) The left side of the trailer was mostly undamaged, with the exception of the area near the fuel tank mounting, where there was some outward bending to the bottom of the trailer.

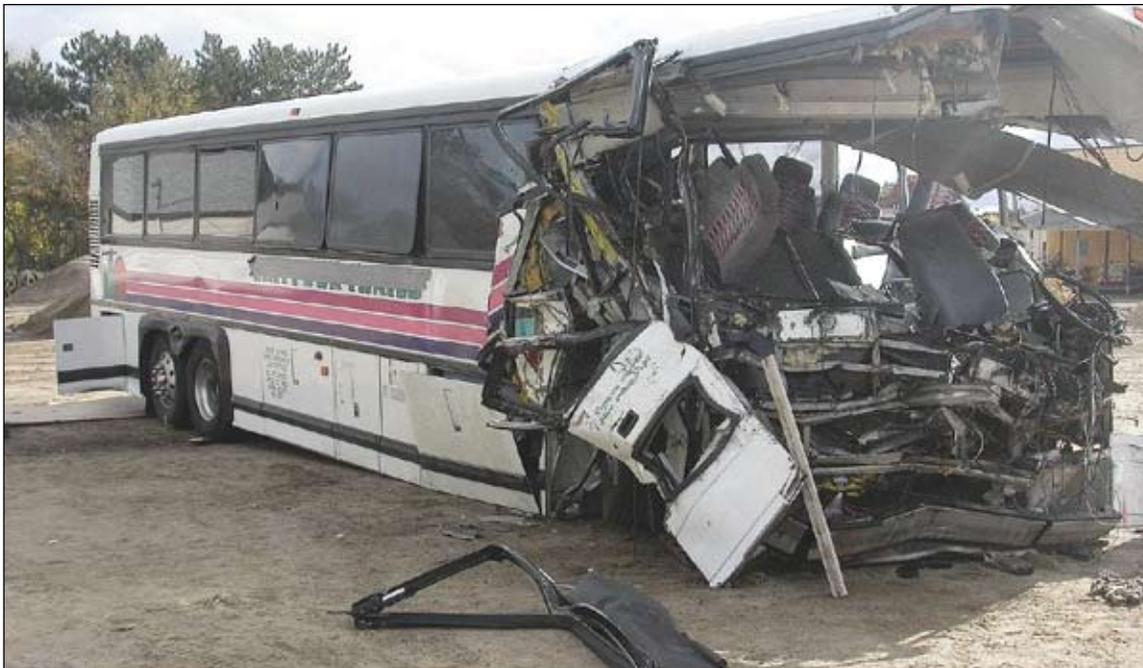
Figure 7. Motorcoach accident damage.

As shown in figure 7, the motorcoach sustained extensive damage to its front end. The front of the motorcoach was pushed rearward to about the third row of passenger seats. The front axle was pushed back and upward such that the front tires were not in full contact with the ground. The floor of the motorcoach adjacent to the front axle wheel wells was buckled upward. The seats on the right side, in the area of the front axle wheel wells, were pushed upward and out the right side of the windows.

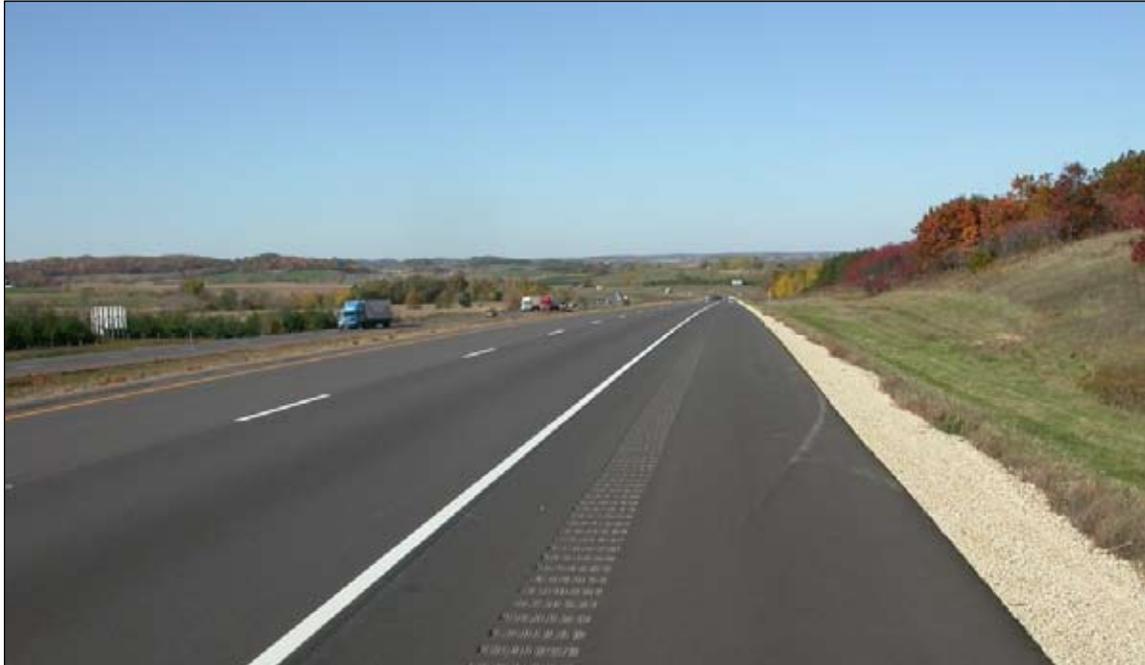
Figure 11. Rumble strips along the right shoulder of westbound I-94.

I-94 has rumble strips²⁵ on the right and left shoulders of its westbound lanes. Each rumble strip is 16 inches long and 7 inches wide. The rumble strips are spaced 5 inches apart. The depression depth of the rumble strips into the asphalt shoulder is approximately 0.5 inch. The rumble strips on the right shoulder are

offset from the solid white line by 2 feet 6 inches (see figure 11). The rumble strips on the left shoulder (adjacent to the median) are offset from the solid yellow lines by 6 inches.

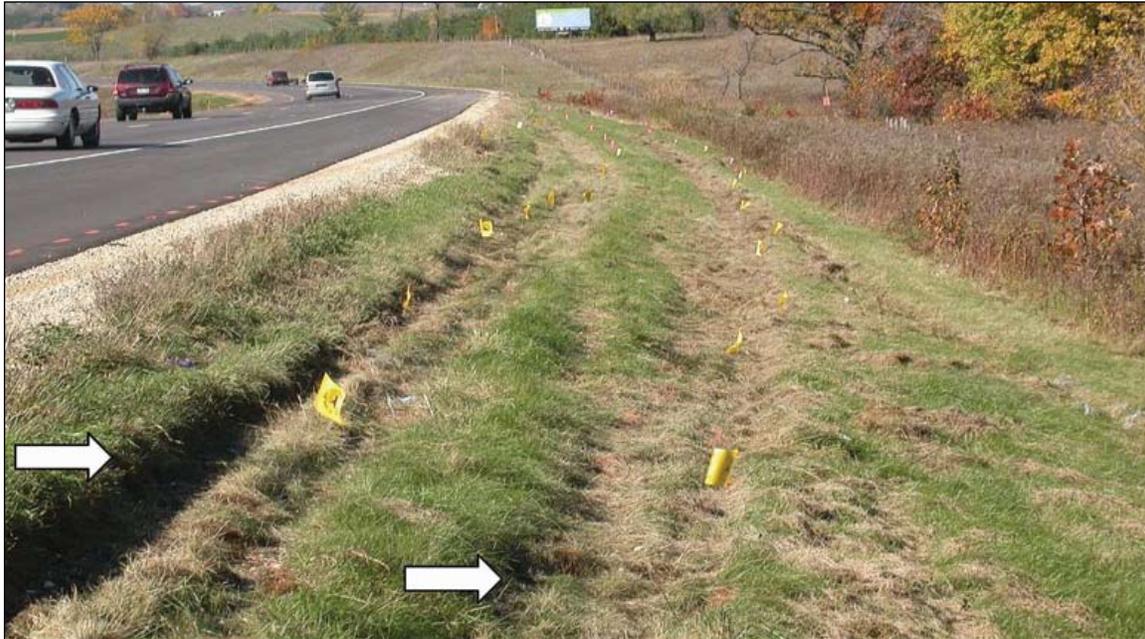
Figure 12. Osseo truck tire furrow marks.

Measurements of the tire furrow marks, shown in figure 12, were taken from where the truck departed and returned to the roadway. It is 340 feet from the first visible tire furrow mark on the earthen shoulder, adjacent to the rumble strip, to the point at which the tire began to curve back toward the pavement. The second furrow mark, which began to curve back to the pavement and was farthest from the edge of the pavement, was about 368 feet from the first visible tire furrow mark observed on the earthen shoulder adjacent to the rumble strip.

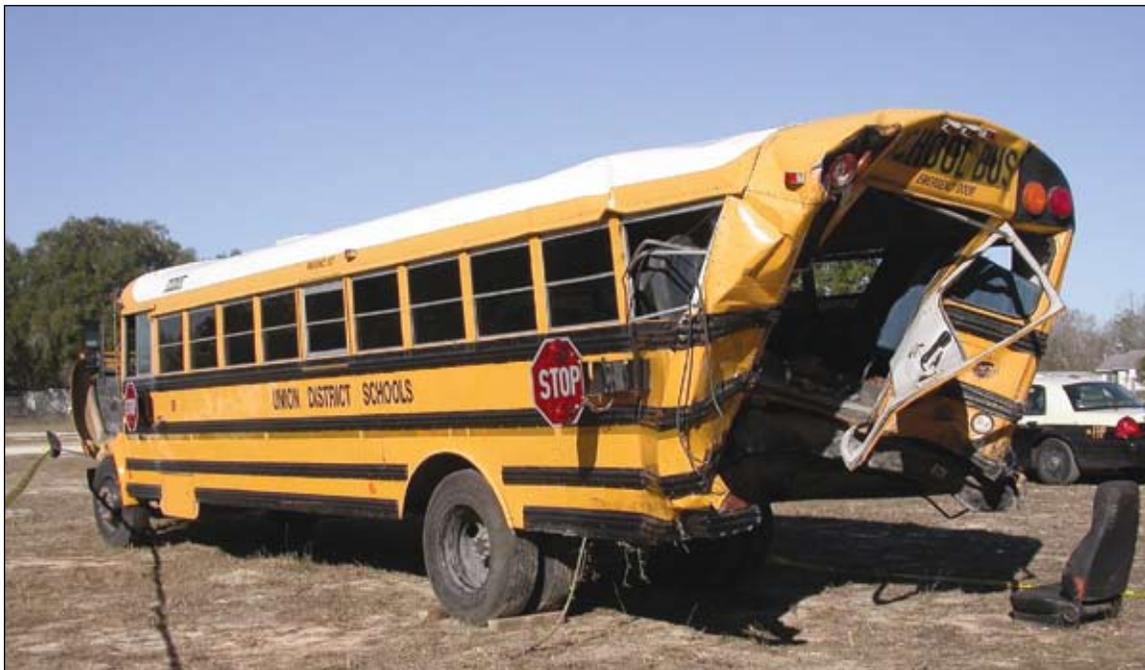
Figure 3. Accident school bus.

The tires on the bus met recommended manufacturer specifications and were in good condition. The steering and the suspension systems appeared to be normal. The brake on the left front axle was found to be out of adjustment and would have resulted in the bus being out of service according to the Commercial Vehicle Safety Alliance North American Standard Out-of-Service Criteria. However, the bus was nearly stopped at the time of the accident, and the braking system was not causal to the accident.

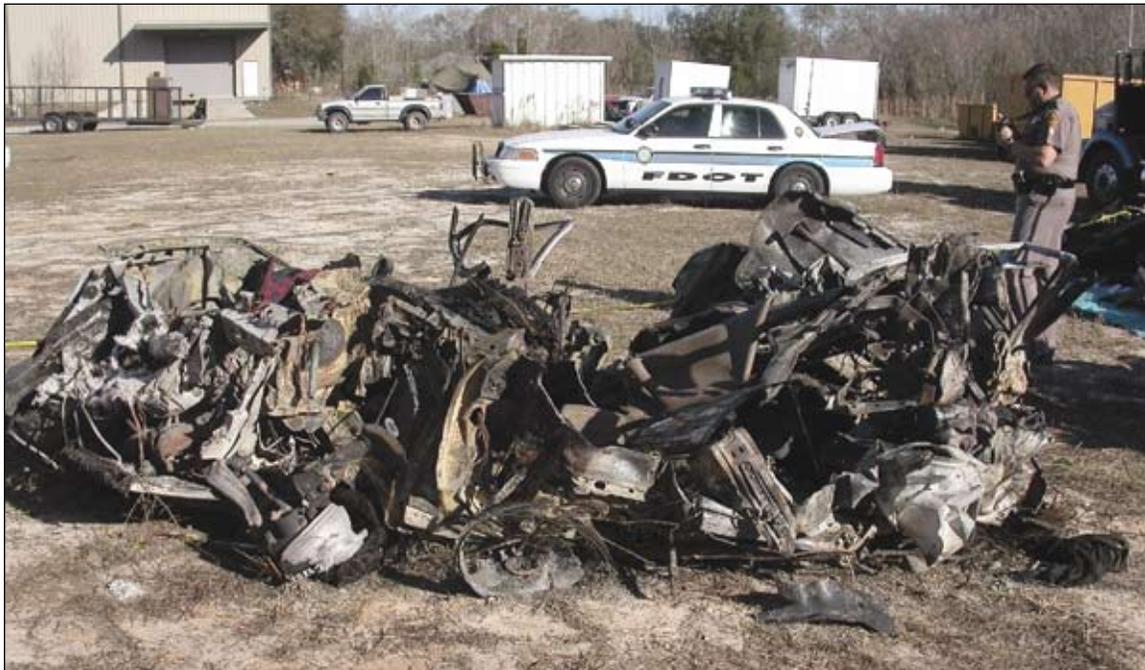
Figure 4. Remains of accident passenger car.

The vehicle was extensively damaged by the impact of the Freightliner and the postcrash fire, which consumed most of its nonmetal components. (See figure 4.) The Florida State Fire Marshal determined that the origin of the fire was the fuel tank located at the rear of the vehicle; the tank was found to have been breached as a result of the crash and to have come into contact with the pavement, introducing an ignition source. The fuel tank had a small tear from being ground into the pavement.

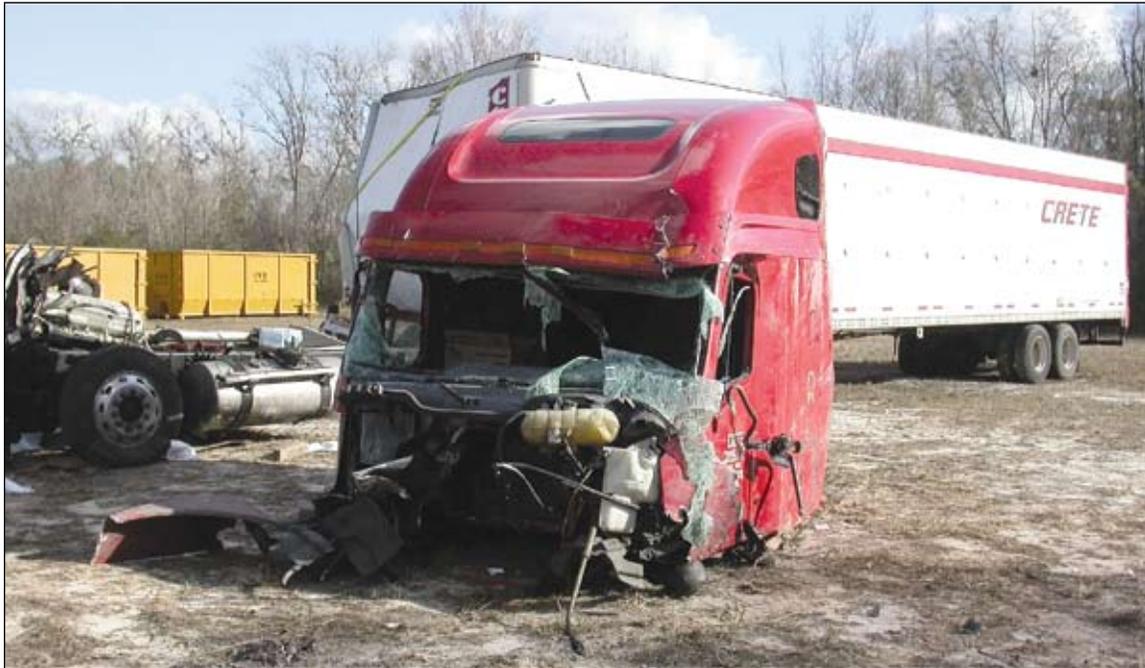
Figure 5. Cab portion of accident tractor.

The tractor and the front of the trailer, shown in figures 5 and 6, sustained the majority of the damage. The cab portion of the tractor was completely detached and separated from the tractor chassis.

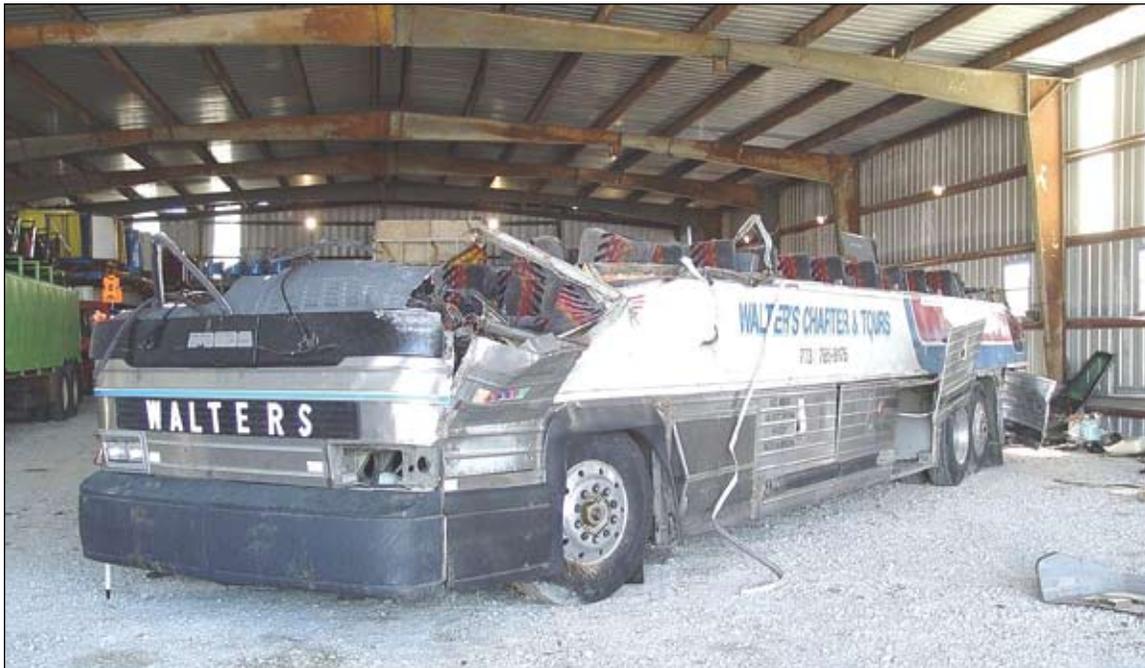
Figure 2. Motorcoach postaccident, with roof detached.

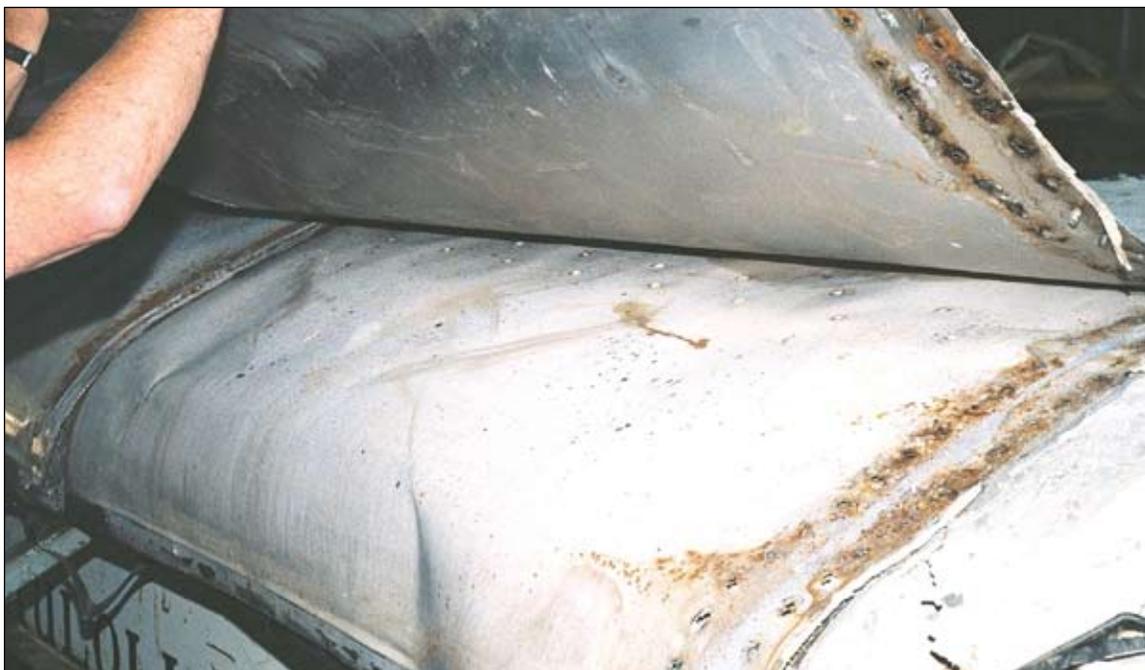
Figure 3. Roof of motorcoach, postaccident.

⁴ A Safety Board metallurgist, along with the MCI director of engineering, inspected the motorcoach roof at the Safety Board's materials laboratory on October 19–20, 2004.

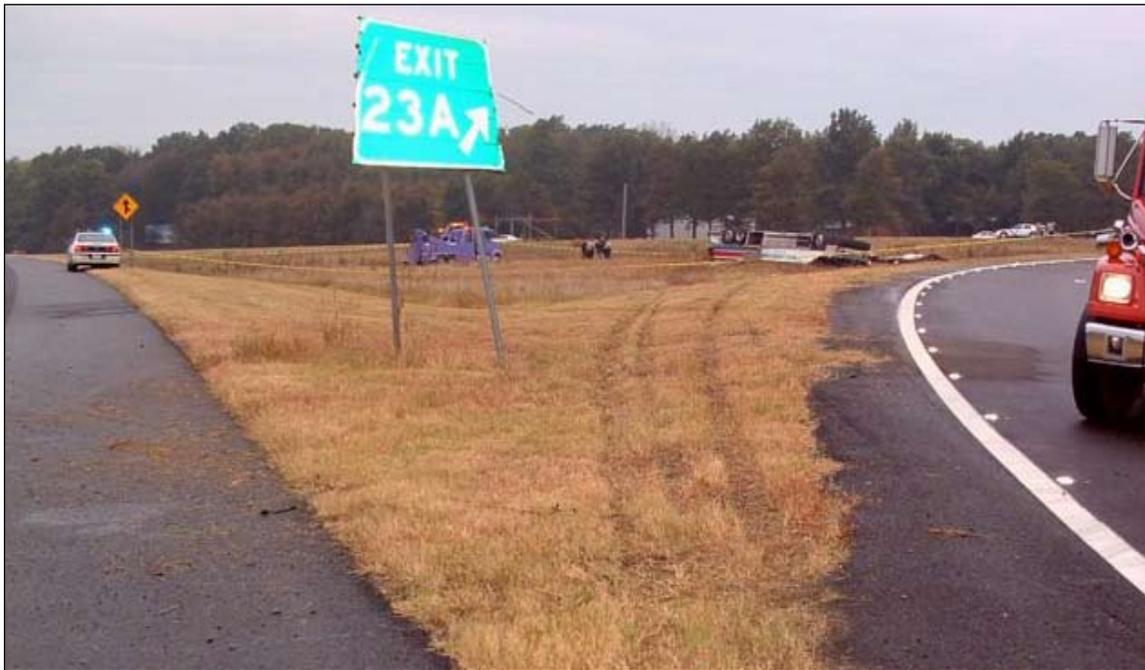
Four tire marks about 71 feet long were located along the southbound shoulder adjacent to the right traffic lane. These marks ended at the edge of the pavement, where furrow marks continued for a distance of 55 feet to the exit 23A sign. Contact damage was observed along the right edge of the exit sign panel, 9 feet above the ground. (See figure 5.) Another tire mark – beginning about 41 feet south of the origin of the four tire marks – was observed along the left side of the exit ramp.

Figure 5. Gore area with furrow marks.
