Collision Between Freight Train and Charter Motorcoach at
High-Profile Highway–Railroad Grade Crossing
Biloxi, Mississippi
March 7, 2017

Accident Report

NTSB/HAR-18/01
PB2018-101328

National
Transportation
Safety Board

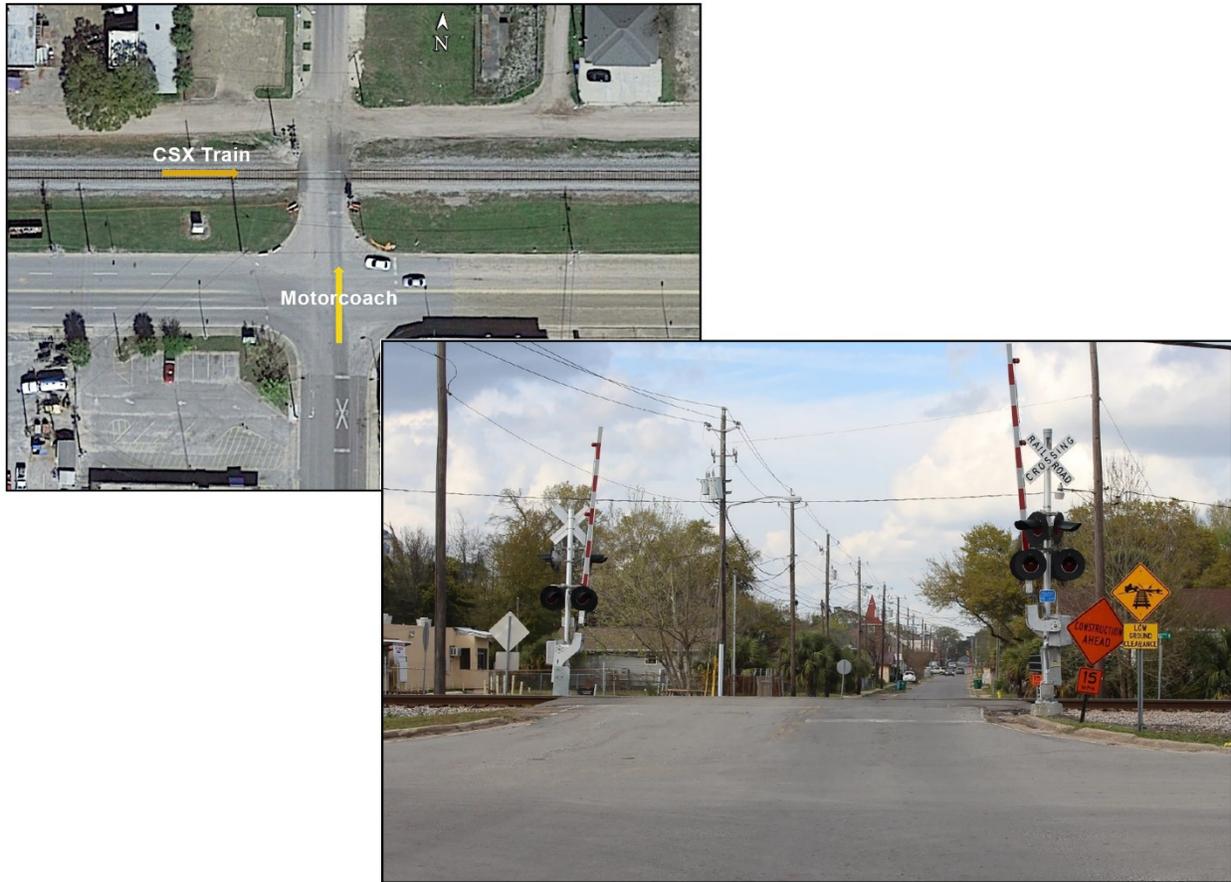
Figure 1. Overhead view of crash location (top) and forward view of northbound approach to Main Street grade crossing (bottom).

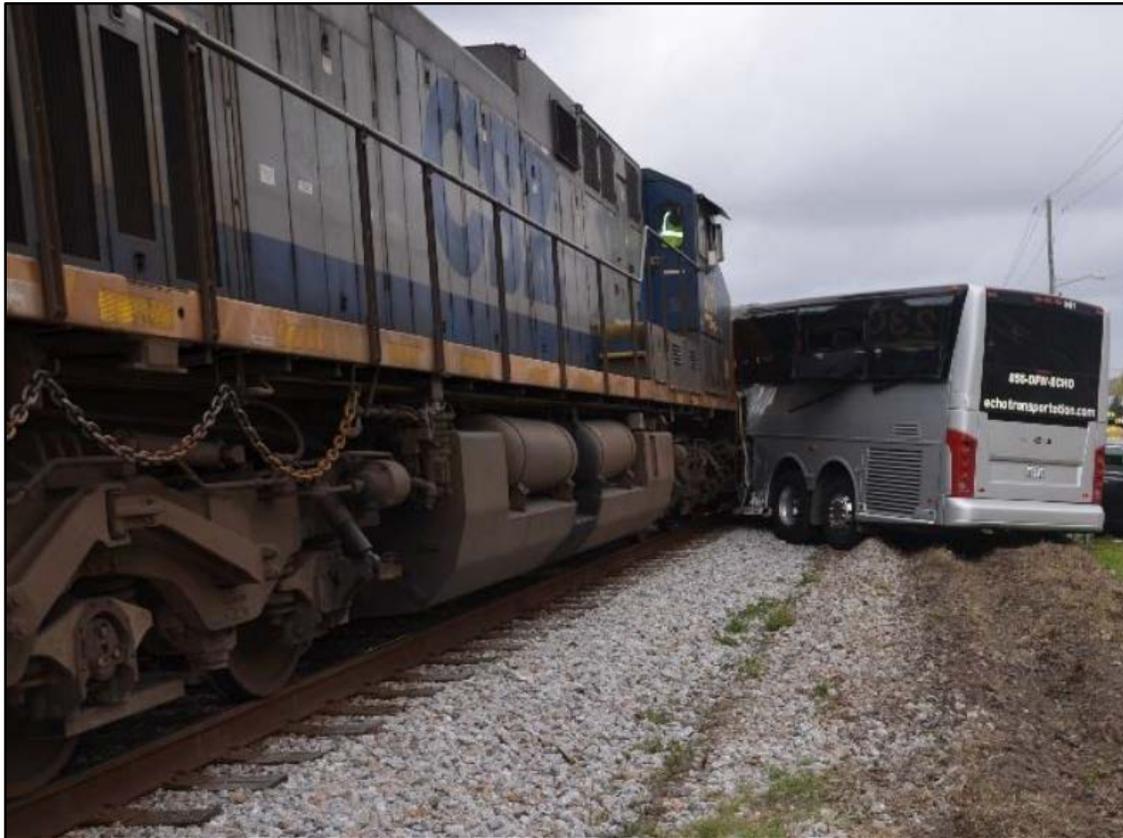
The train engineer later said that he had noticed the motorcoach on the tracks, but he expected it to clear the crossing before the train arrived there. As soon as the engineer realized that the motorcoach was not clearing the tracks, when the train was about 502 feet west of the crossing, he put the train into emergency braking. About 14 seconds later, by which time it had decelerated to about 19 mph, the train struck the left side of the motorcoach, pushing it 259 feet down the tracks before coming to a stop, with the motorcoach still in contact with the lead locomotive (see figure 2).⁷

Figure 2. Motorcoach and train final rest positions. (Source: Biloxi Police Department)

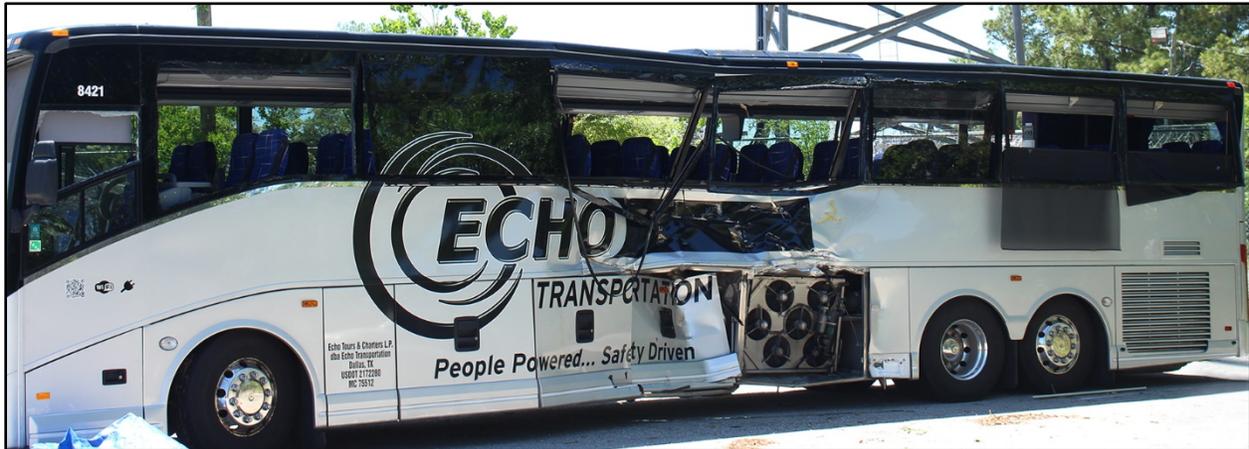
1.4.1.1 External. The motorcoach sustained significant contact damage on the left side, which began about 16.3 feet from the rear and extended forward about 9.3 feet (see figure 4). The maximum lateral displacement occurred about 22.7 feet from the rear, where the left sidewall intruded 27 inches. This maximum intrusion was in the region of rows 5 through 7. The luggage compartment door just forward of the rear axle was displaced and the compartment door to its left was folded toward the front of the motorcoach. The location of the impact damage on the left side indicated that the front of the motorcoach was about 20.4 feet past the north side of the rail tracks when the locomotive struck it. The front end sustained no crash damage.

Figure 4. Motorcoach postcrash, showing contact damage to the left side.

On the motorcoach's right side, the sidewall was bowed out in the area corresponding to the impact on the left side. The maximum lateral displacement occurred about 25.7 feet from the rear of the motorcoach, where the right sidewall bowed outward about 18 inches.

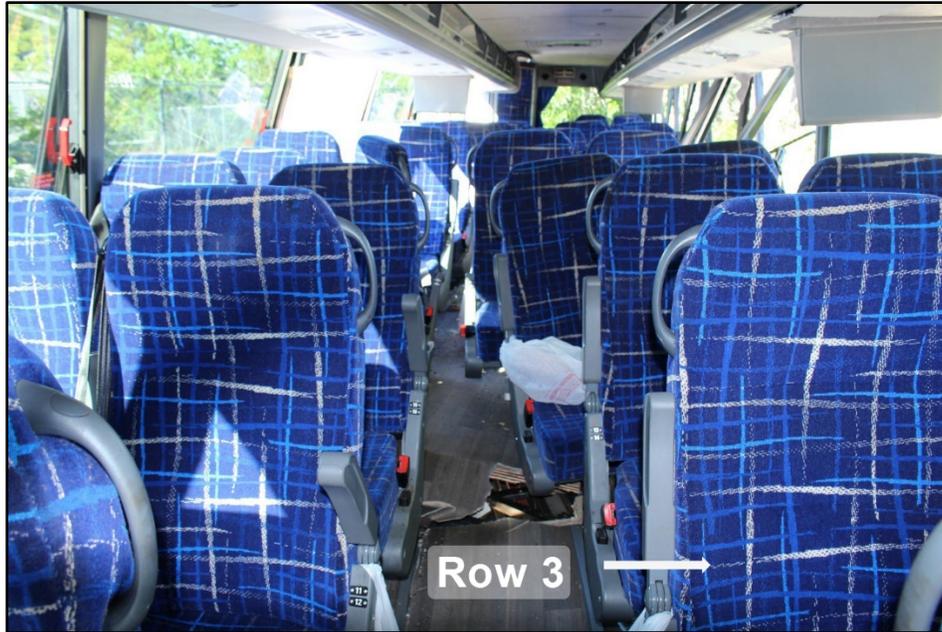
1.4.1.2 Interior. The driver seat was intact, and the steering wheel was undamaged. The front interior of the motorcoach, up to about row 4, was largely undamaged, and the aisleway in this area retained its original width of 17 inches. Extensive interior damage began at row 5 on the left side and extended to slightly beyond row 8 (see figure 5). The area of these four rows showed evidence of intrusion that reduced the overall interior width of the motorcoach, sidewall to sidewall, by 16 inches. The aisle in this area decreased in width from 17 inches to 8 inches. As a result of the impact, the motorcoach floor buckled, starting in the aisleway at row 4. The floor in front of the seats in row 5 on the right side had buckled and partially collapsed, creating an opening in the floor that extended into the row 6 seats on the right side. As a result of this floor collapse, the aisle seat in row 5 on the right side had dropped about 2 inches below the floor level, intruding into the luggage compartment. The upward buckling of the floor in row 5 raised the floor level at this location by about 12 inches.

Figure 5. Motorcoach interior, showing the buckling of the floor and the lateral displacement of the seats.

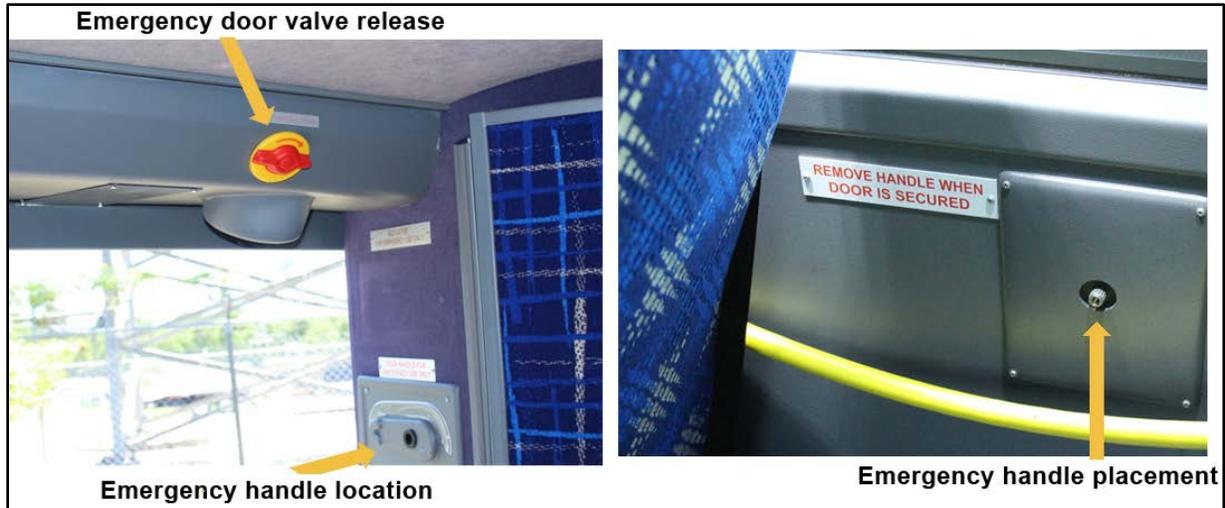
Figure 6. Interior of the motorcoach, showing the three assemblies necessary to open the rear door.

According to a passerby who entered the motorcoach after the crash but before the arrival of emergency responders, he attempted to open the rear door from inside the vehicle. He reported taking the handle that he saw mounted on the wall of the lavatory and placing it on the door in an attempt to open it, but he was unsuccessful.¹⁷

If the rear door is locked, it cannot be opened from outside the motorcoach. When the first responders attempted to open the rear door from the outside, they found it locked. Once inside the motorcoach, they were unable to locate the emergency door handle and could not open the door.¹⁸

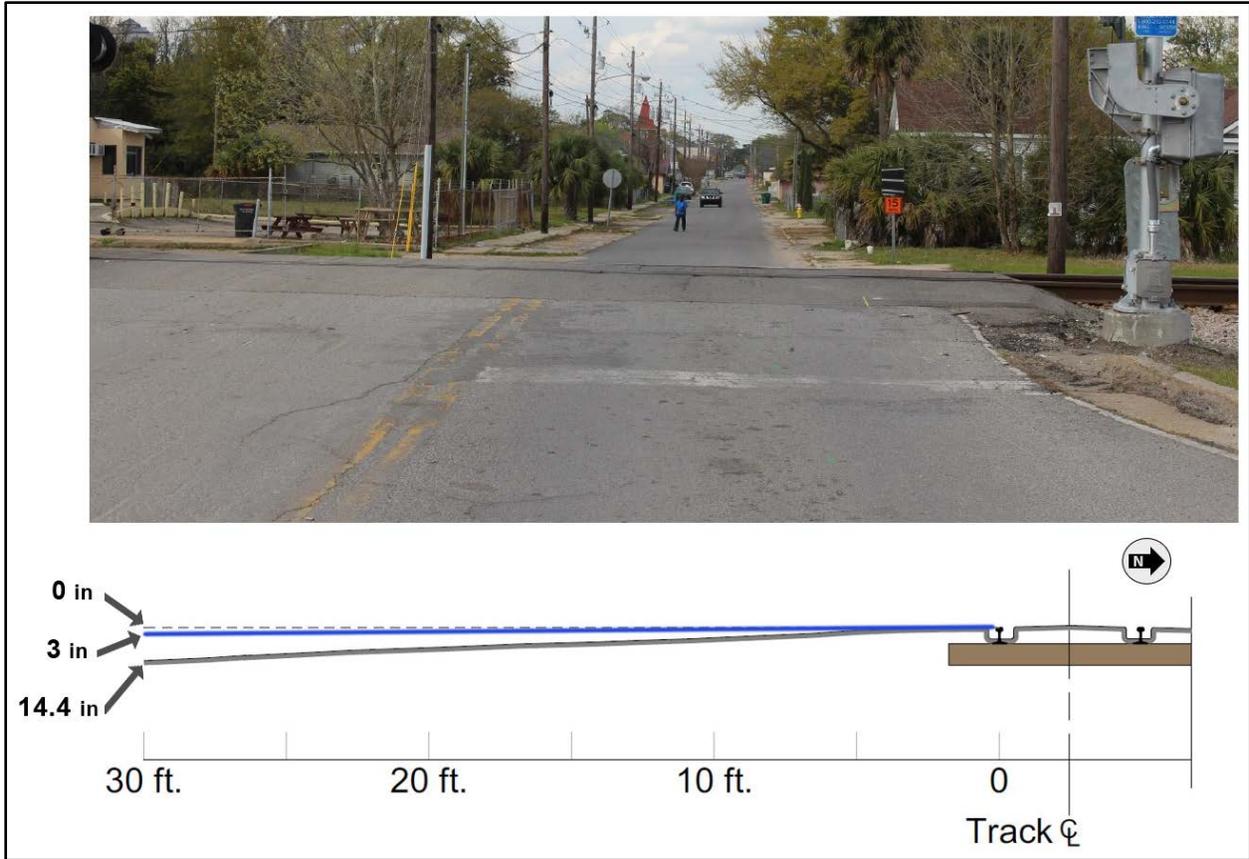
Figure 8. Photograph showing the northbound approach to the grade crossing (top)—what the driver would have seen—and cross-section diagram of the measured vertical profile of the approach’s slope (bottom). The blue line in the diagram represents the maximum elevation difference between the crossing and the approach as recommended by the FHWA and AASHTO, and the gray line represents the actual elevation difference at the grade crossing.

guidance; at 30 feet north of the rail tracks, Main Street was 45.4 inches below the track level, corresponding to a 13.3-degree slope. The Main Street grade crossing was not unique in this respect; in an area spanning 2.6 miles in Biloxi, there were 22 grade crossings, all of which had vertical profiles beyond the recommended limit.

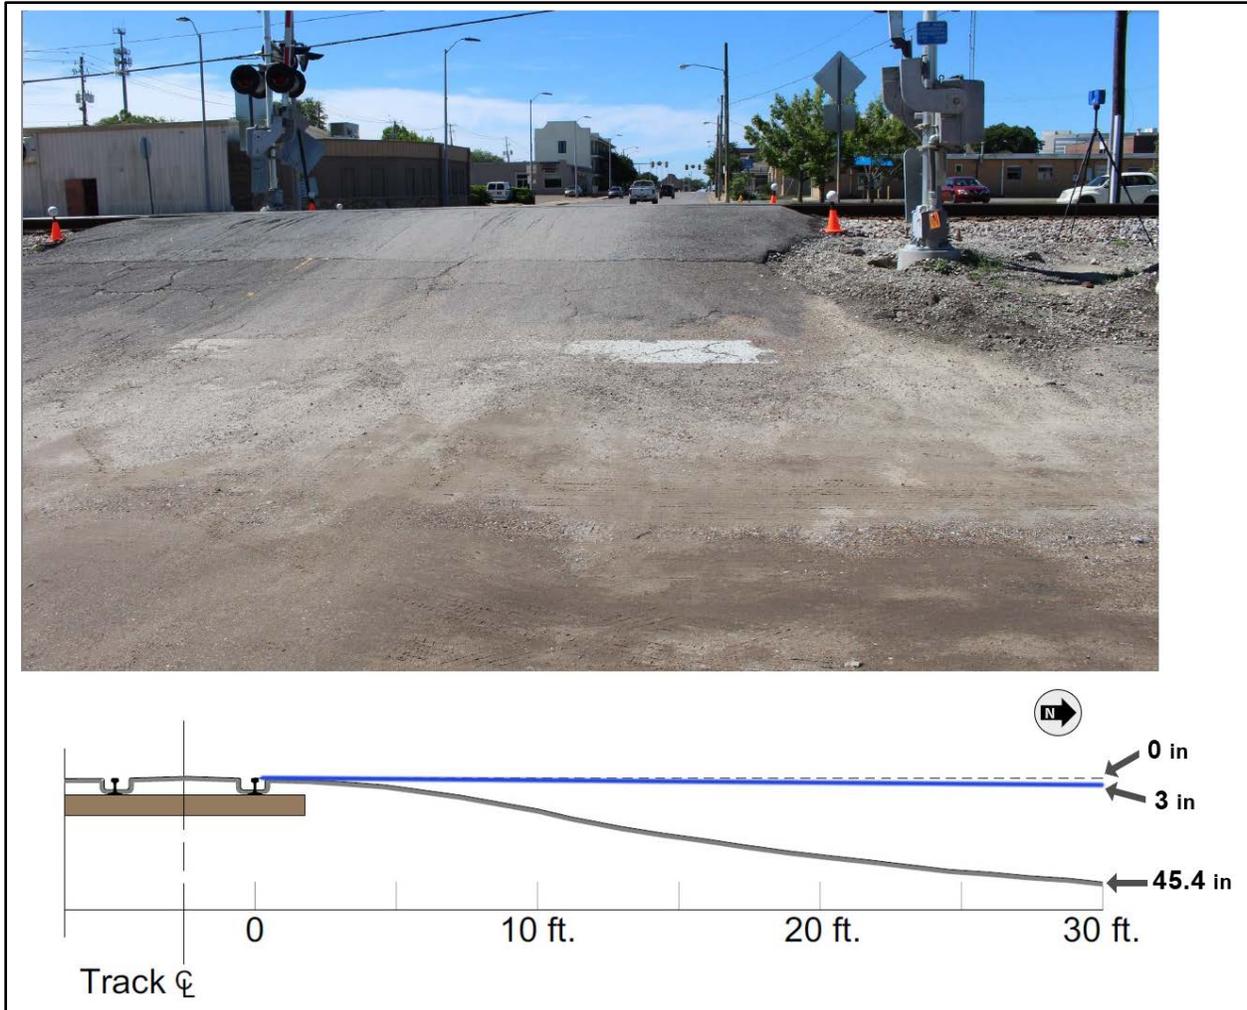
Figure 9. Photograph showing the southbound approach to the grade crossing (top) and cross-section diagram of the measured vertical profile of the approach's slope (bottom). The blue line in the diagram represents the maximum elevation difference between the crossing and the approach as recommended by the FHWA and AASHTO, and the gray line represents the actual elevation difference at the grade crossing.

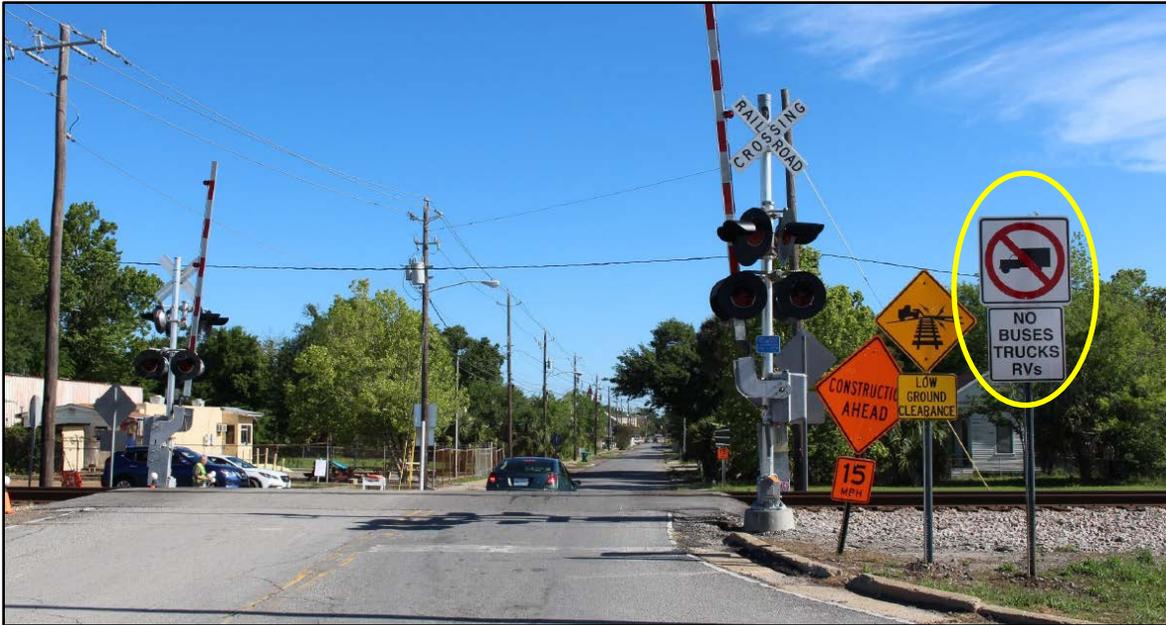
Figure 10. Postcrash view of the northbound approach to the Main Street crossing, showing the new vehicle exclusion sign and plaque (circled in yellow) posted by the City of Biloxi after the crash.

As a result of this crash, the MDOT Rails Division initiated a safety program in April 2017. As part of this program, MDOT met with local municipalities along the 74 miles of CSXT track in Mississippi and identified all grade crossings with vertical profiles exceeding the slope limits recommended in the FHWA/AASHTO design guidance. MDOT offered the local municipalities free access to LGCGC warning signs and accompanying “LOW GROUND CLEARANCE” plaques for installation at those crossings not meeting the design guidelines. As of July 2018, of the 12 entities eligible to receive the signs, 6 had requested them.
