# HIGHWAY ACCIDENT REPORT

CHARTERED BUS CRASH

REPORT NUMBER: NTSB-HAR-71-8

CHARTERED BUS CRASH  
ON  
U.S. ROUTE 22 (INTERSTATE 78), NEAR  
NEW SMITHVILLE, PENNSYLVANIA  
JULY 15, 1970

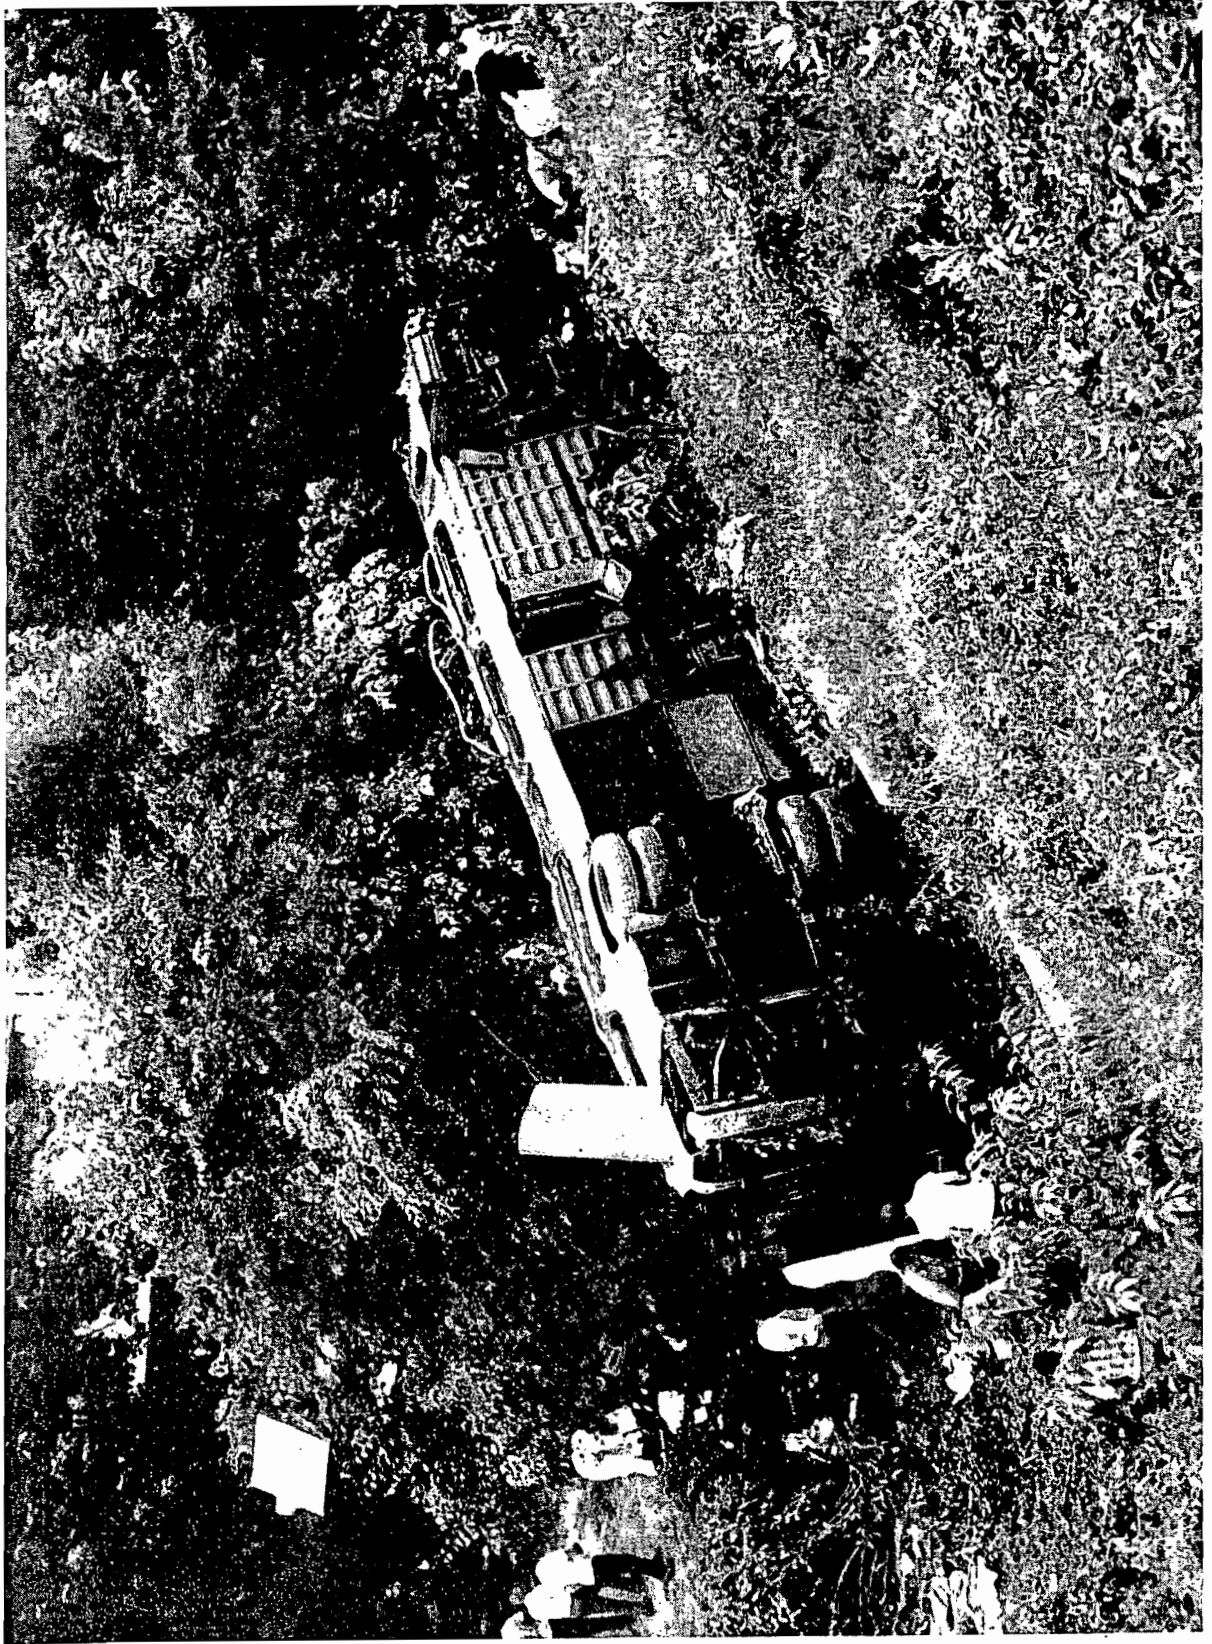
Figure 1: Final position of bus at bottom of embankment, off U.S. 22.

The glass was missing from all windows except the triangular one just aft of the driver's seat; it was cracked. Some side-window frames were missing. Those remaining were still attached at the hinges, but were badly distorted in an outward position (see Figures 1 and 6).

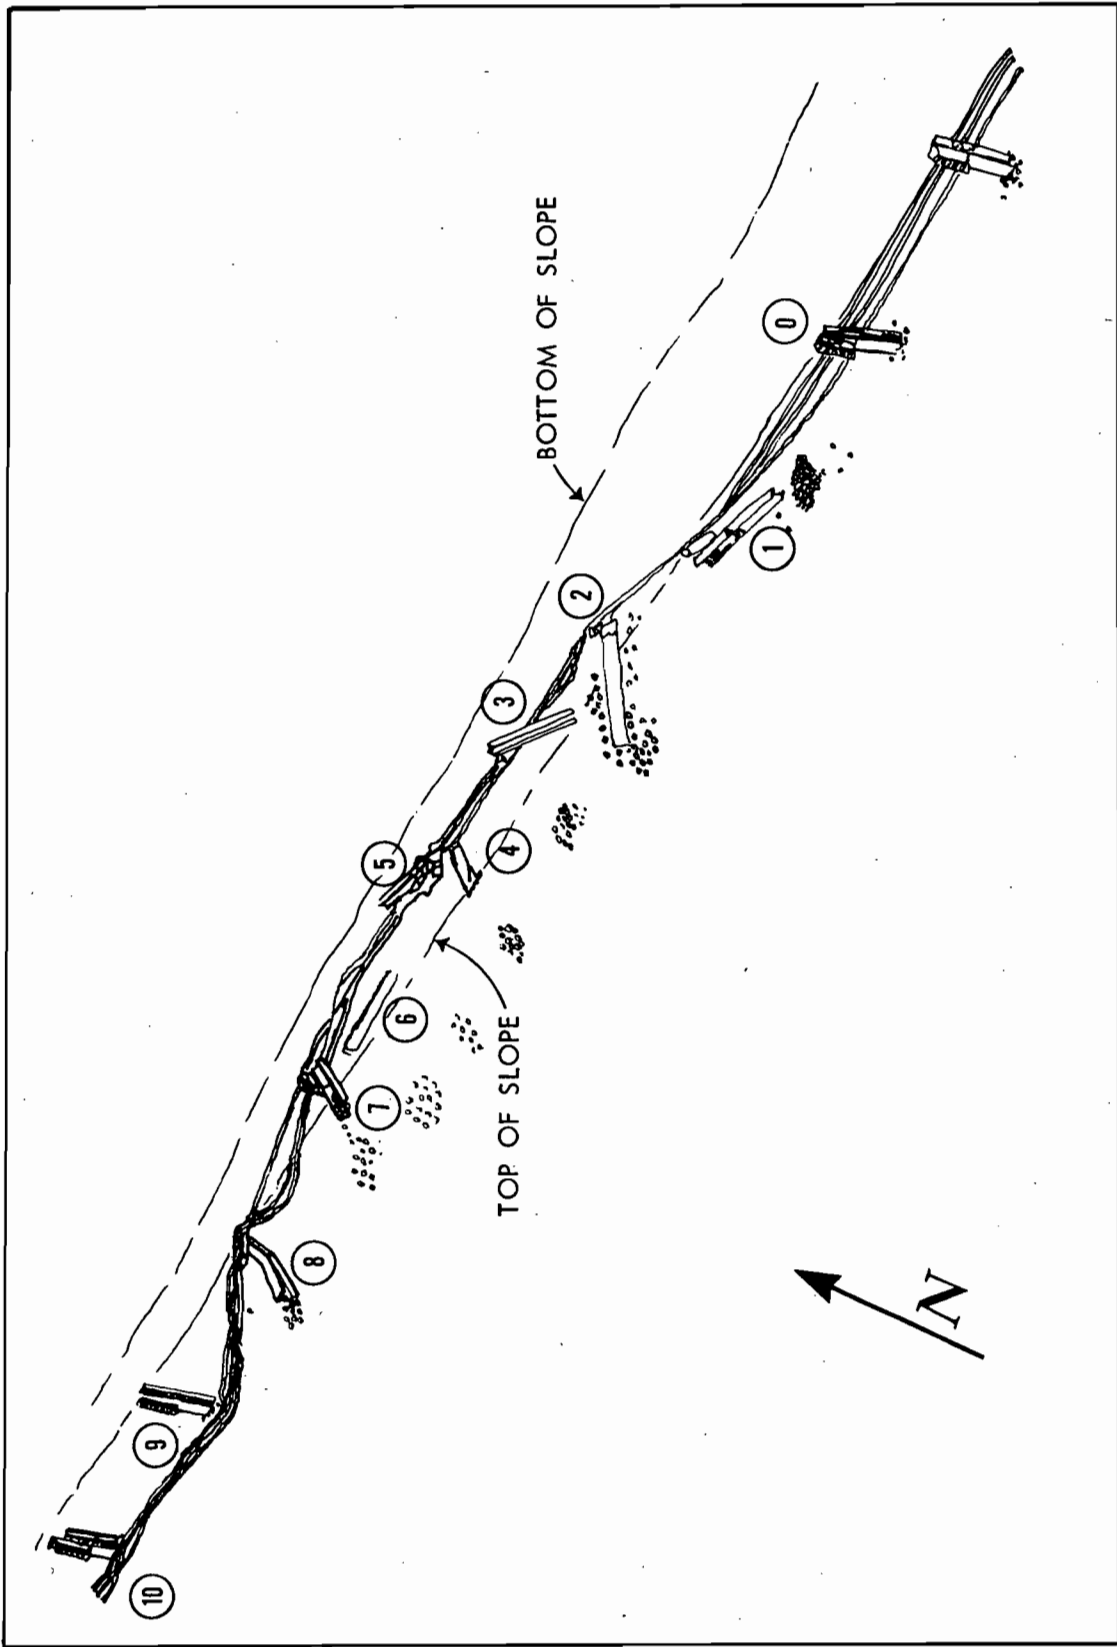
Figure 2-A Approximate position of guardrail posts after impact.

Witness testimony at the hearing revealed that an unreported accident had occurred between July 9 and July 15, 1970, resulting in the uprooting of two guardrail posts and the bending of a third, adjacent to the point where the bus crashed through. These posts had not been replaced prior to the July 15, 1971, bus accident.

- 1) Grooving of 1,150 feet of highway in the westbound lanes and 1,320 feet in the eastbound lanes (grooves were 1/8 inch deep, 1/8 inch wide, 3/4-inch centers);
- 2) Replacement of 3,000 feet of cable guardrail with W-beam type;
- 3) Paving of 2,000 feet of shoulder on both sides of the highway, and re-grading and paving the median area.

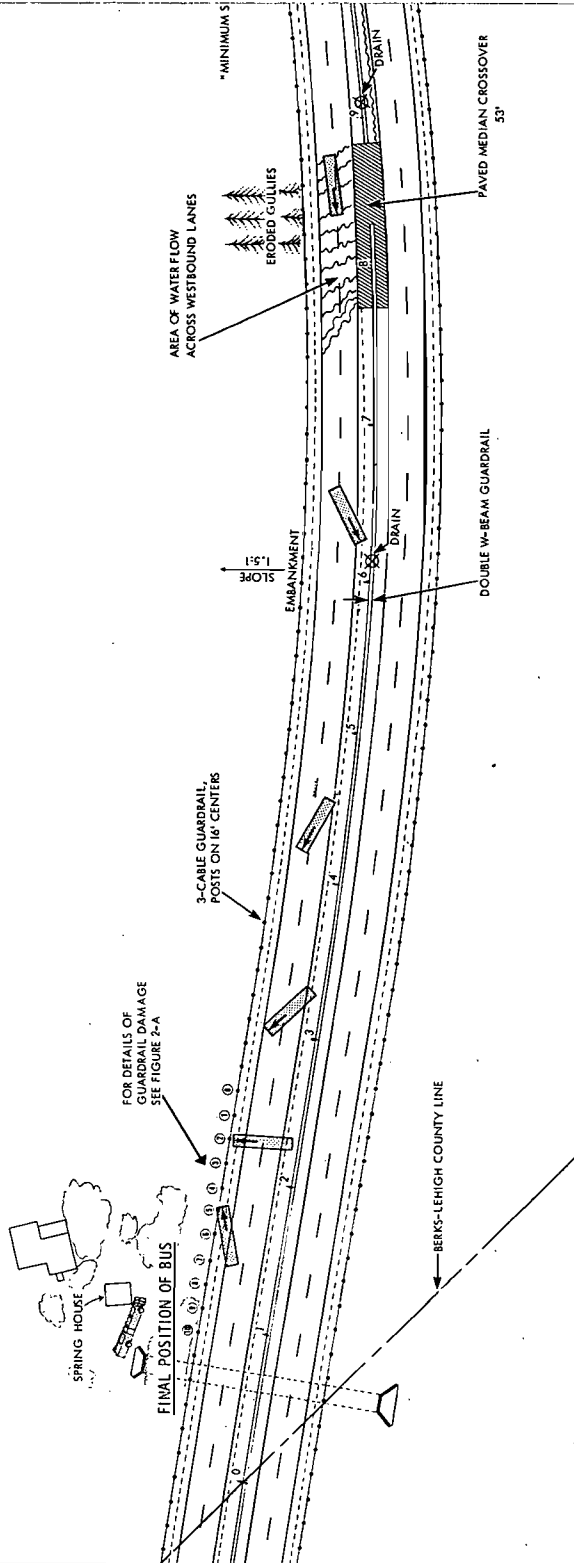
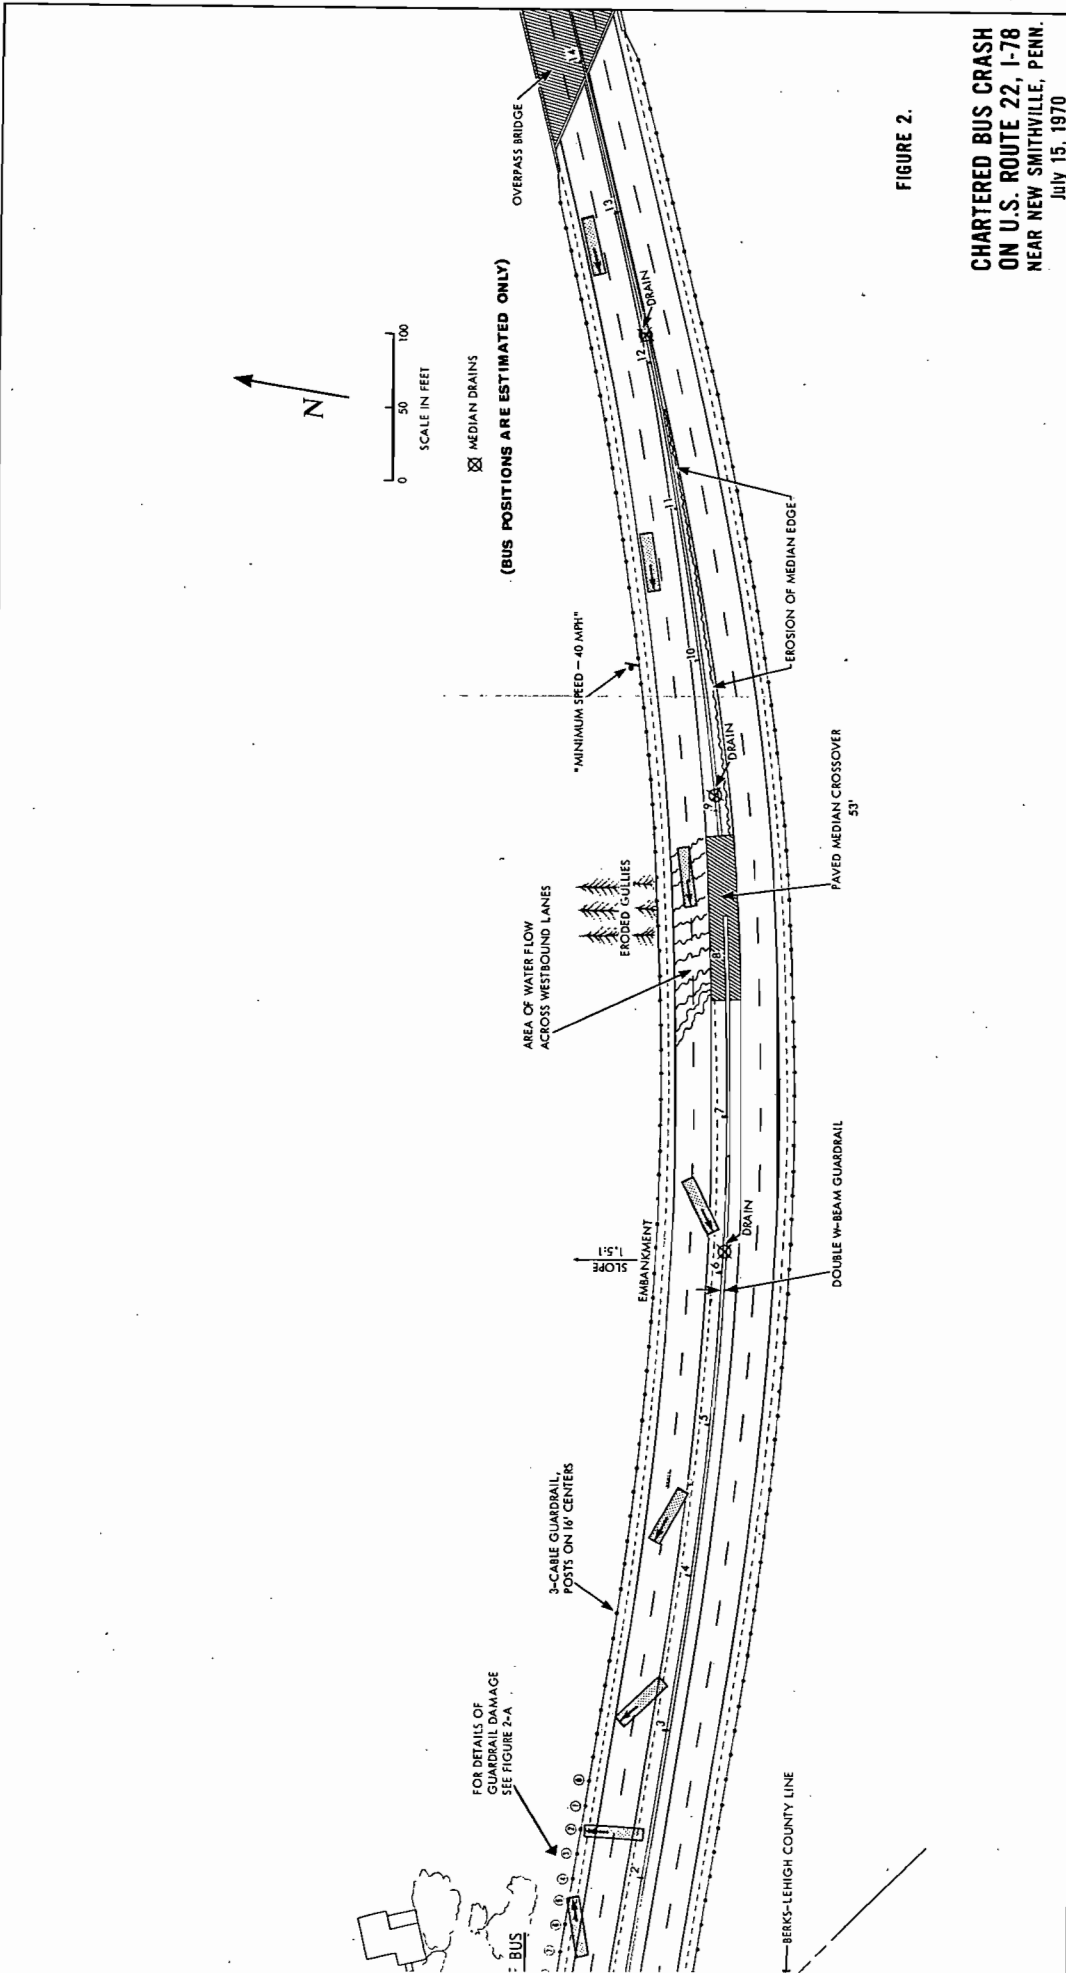
FIGURE 2.

On July 22, 1970, after the accident and before improvements had been effected on the highway, water-flow tests were conducted at the site. Photographs were taken of the tests and of conditions along the median strip and at the paved median crossover point (see Appendix D and Figure 2).

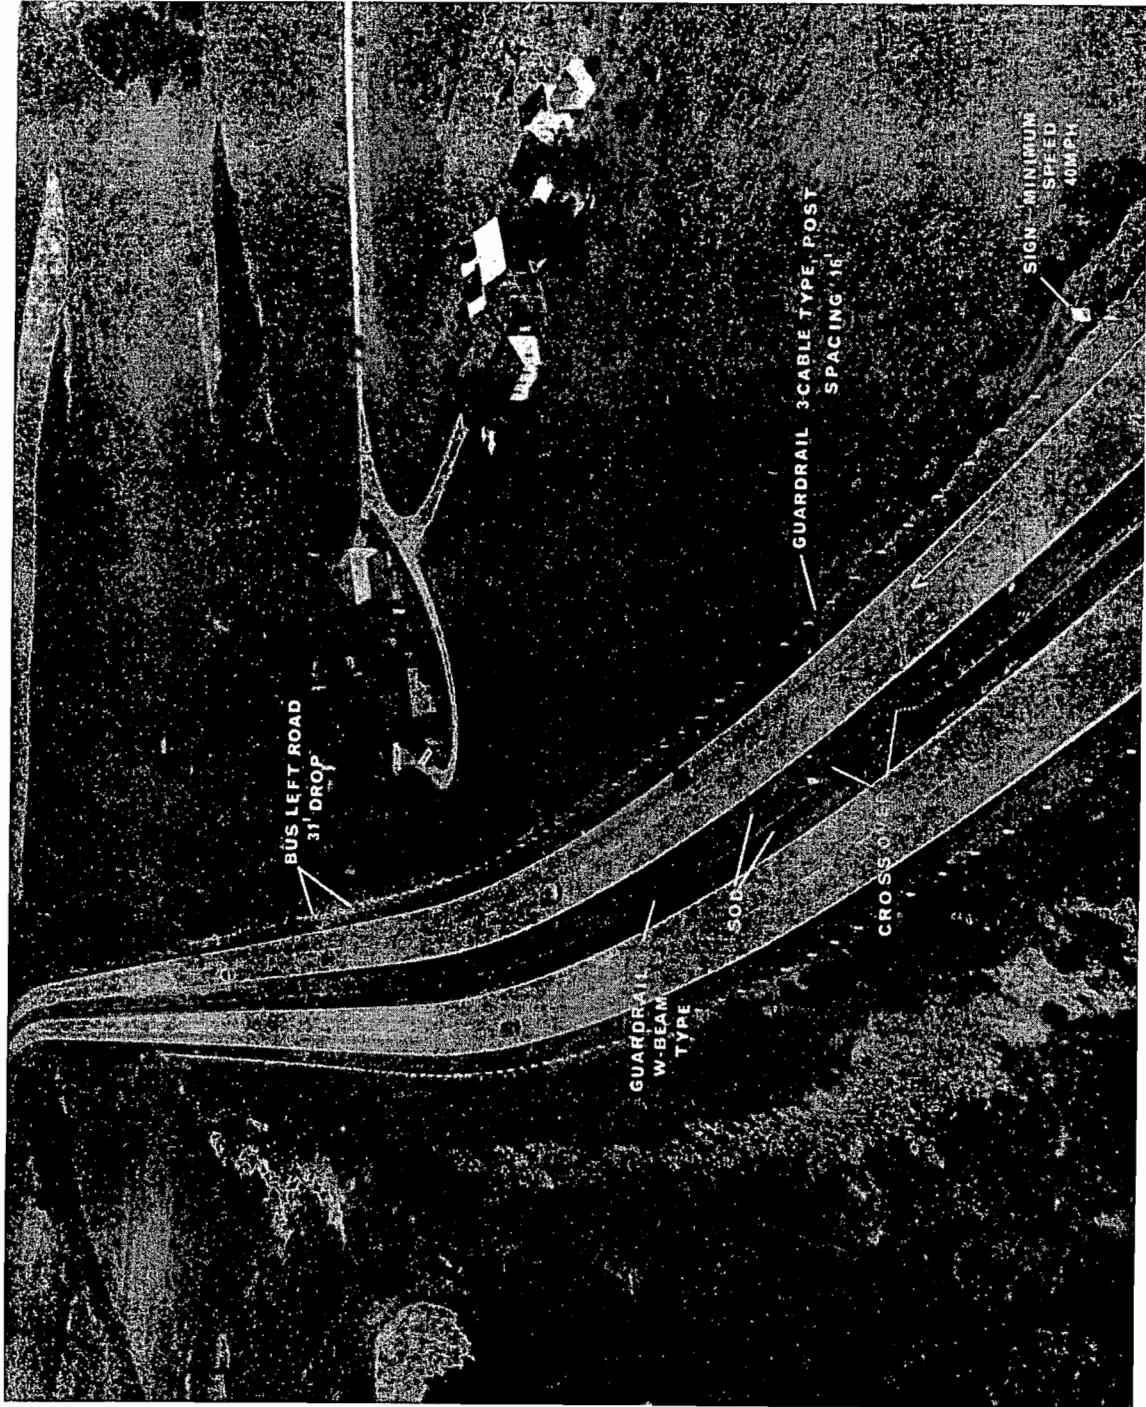
Figure 3: Accident site, westbound lanes of U.S. 22, looking west.

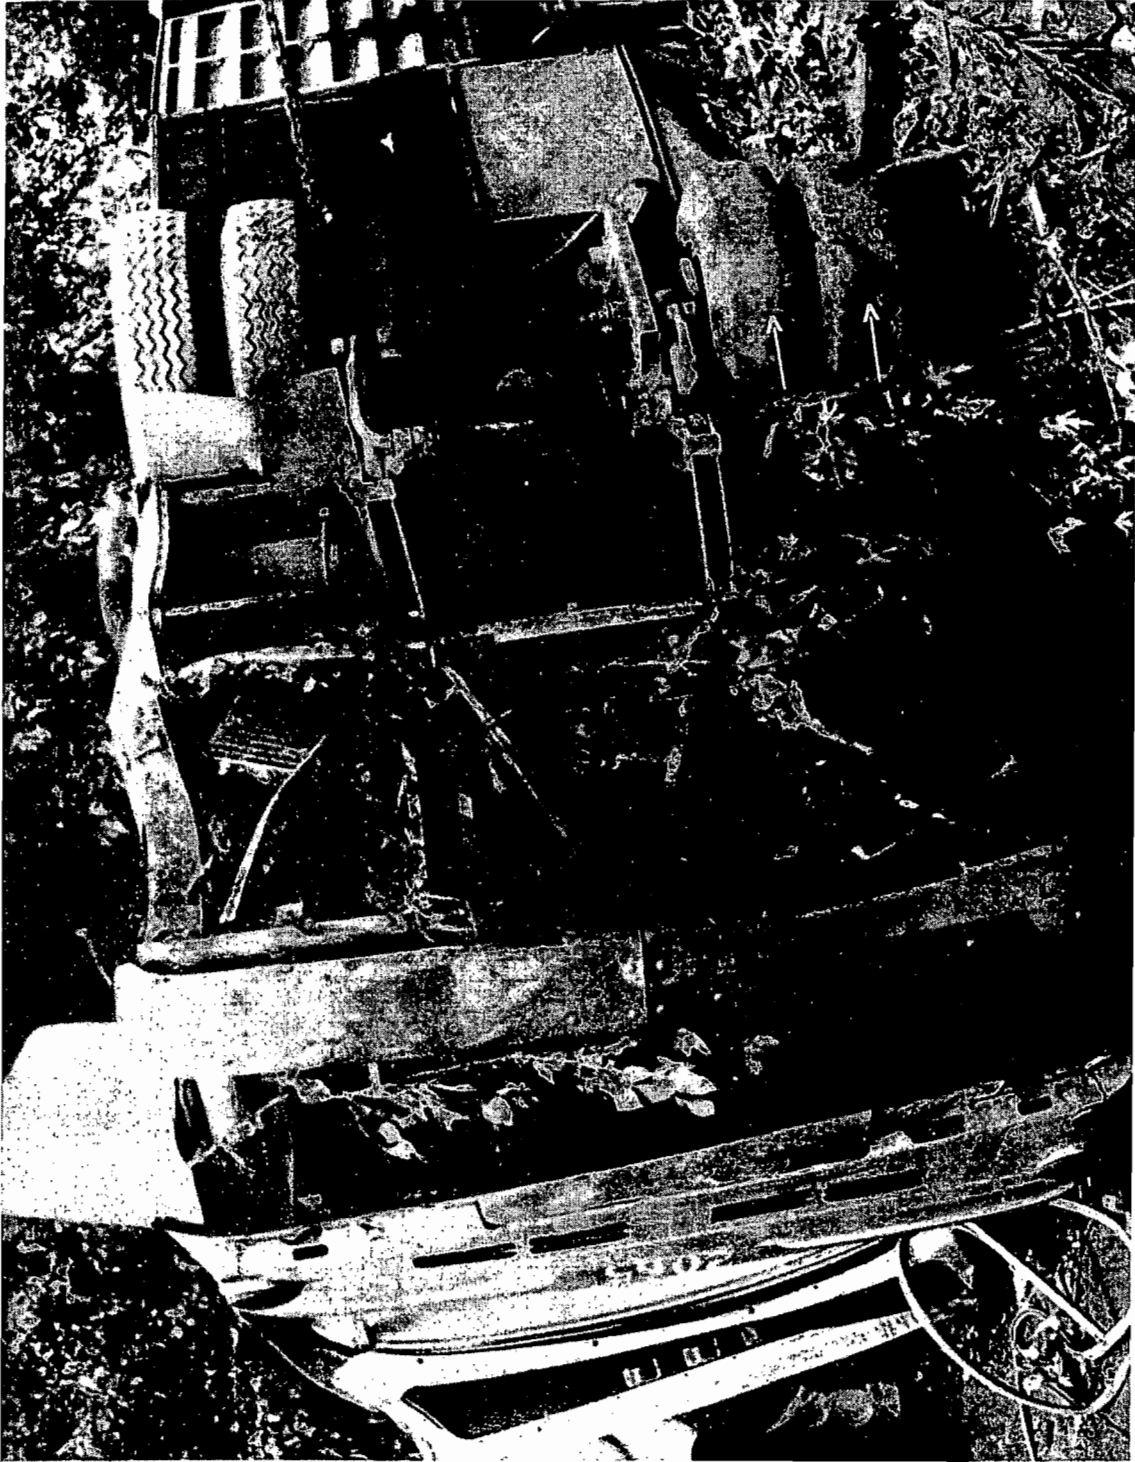
The two left-rear tires of the bus were smooth; all others had adequate tread. Steering-system damage, found after the crash, could not be positively established as being pre-crash, in-crash, or post-crash induced.

Figure 4: Post-crash view of rear underside of bus, showing condition of tread on rear tires. Arrows indicate left rear tires.

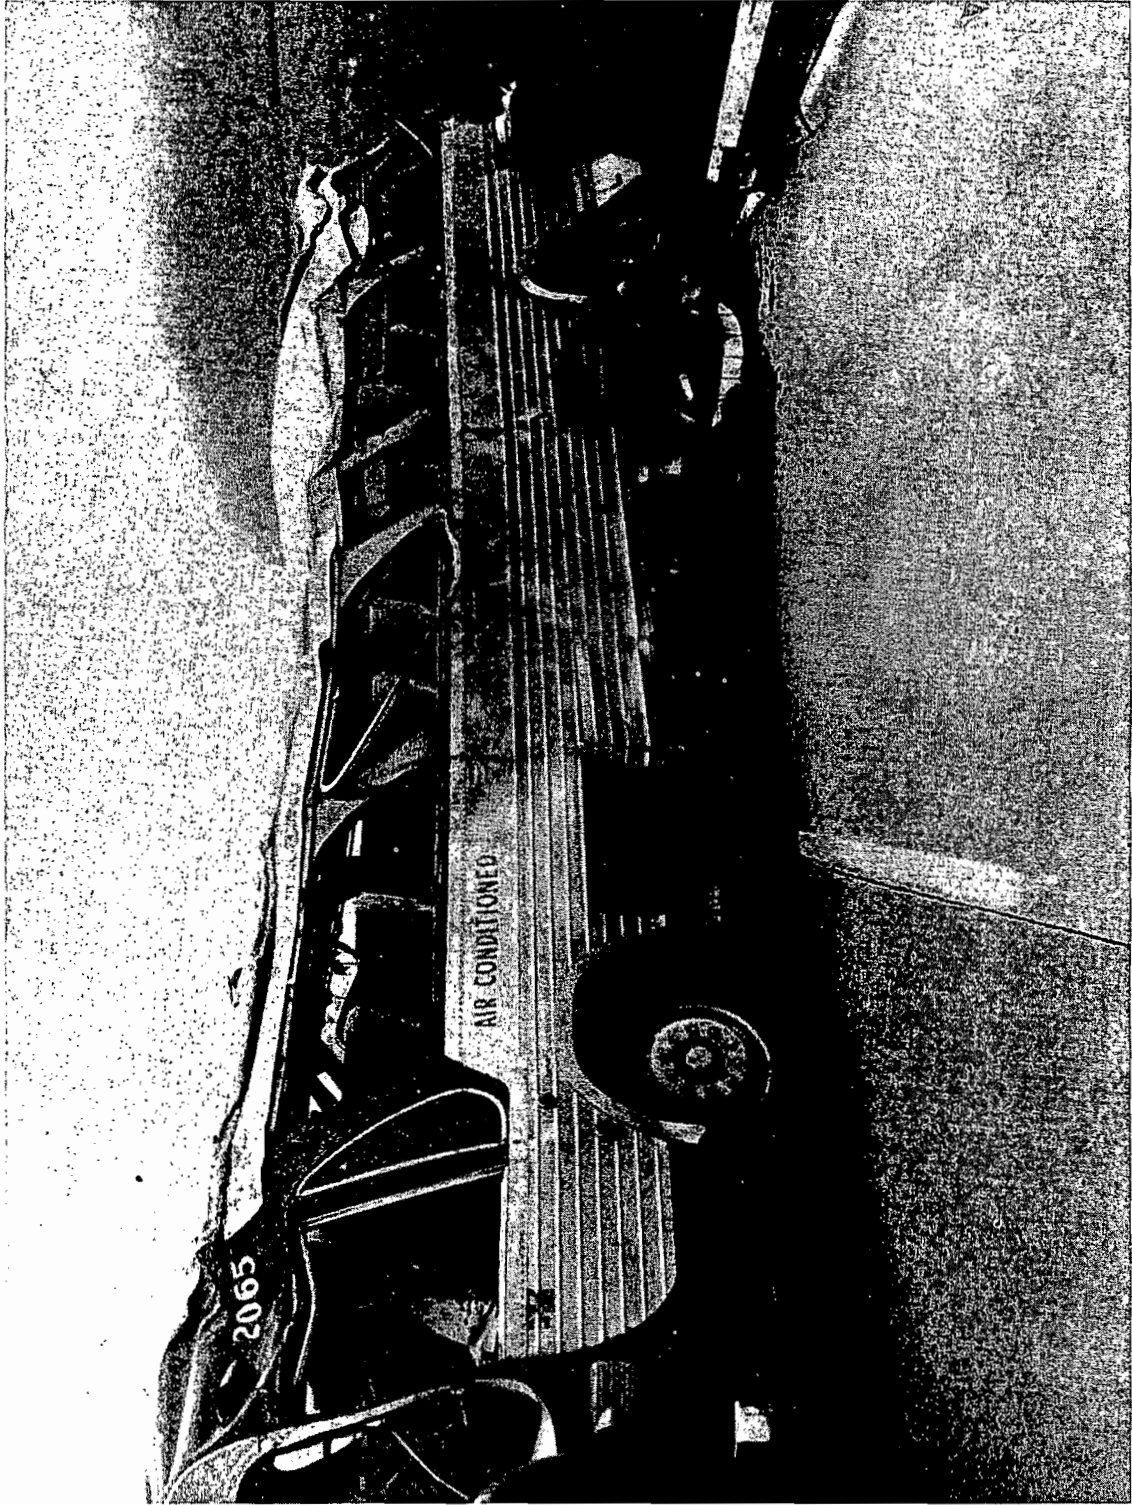
Figure 6: Left side of bus after removal from bottom of embankment. Some of the damage just ahead of the rear wheel was incurred during retrieval operations.

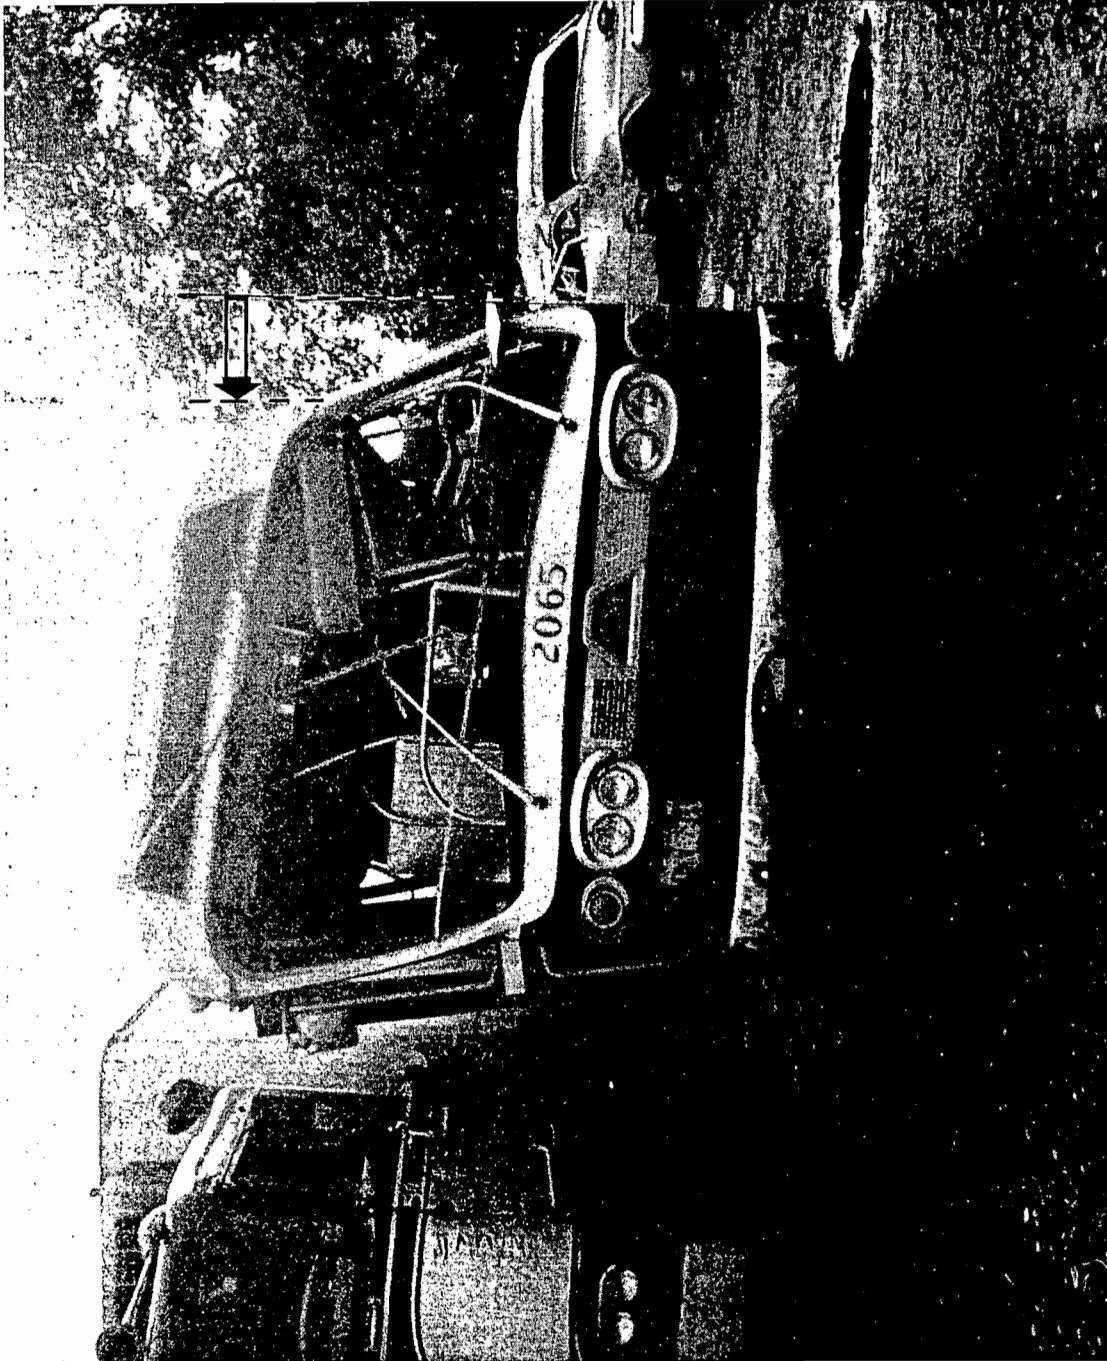
Figure 7: Deformation of bus roof from left to right. Note lack of impact damage to front of bus.

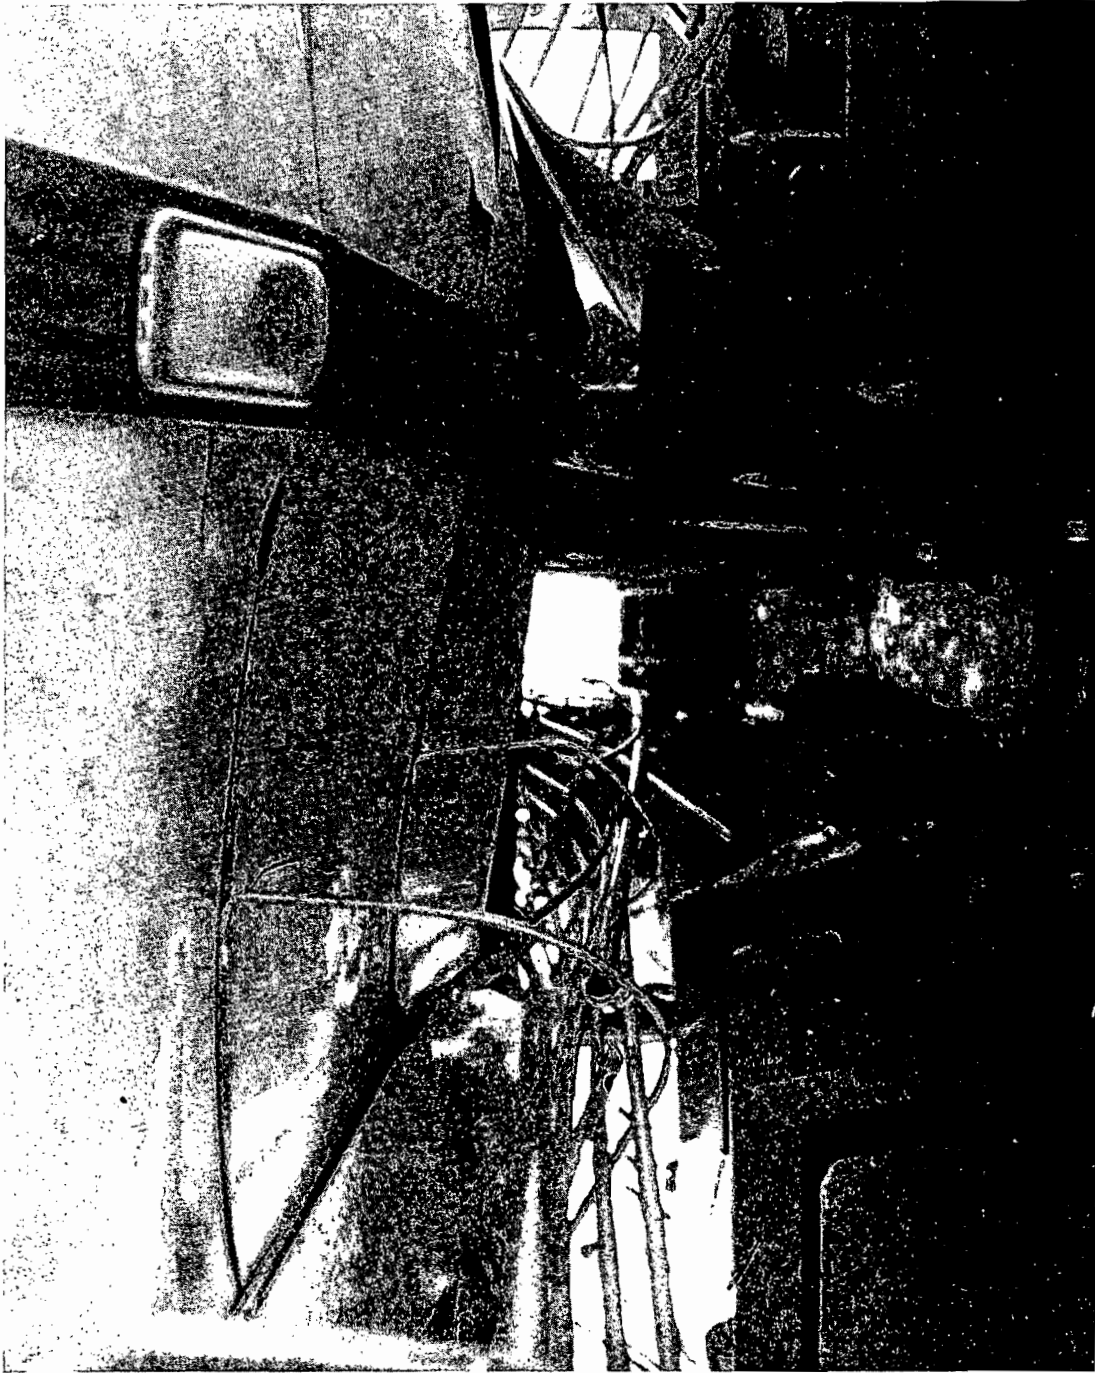
The ceiling panels of melamine were deflected downward to the right, paralleling the roof distortion. Several panels had broken loose and split in areas of extreme roof deflection, particularly in the front, middle, and rear areas, and where occupant impacts had occurred during the accident sequence. The broken edges of this paneling were sharp and jagged.

Figure 8: Interior of accident bus, looking forward. Note sideward and downward deformation of roof.  
(Compare with Figure 5.)

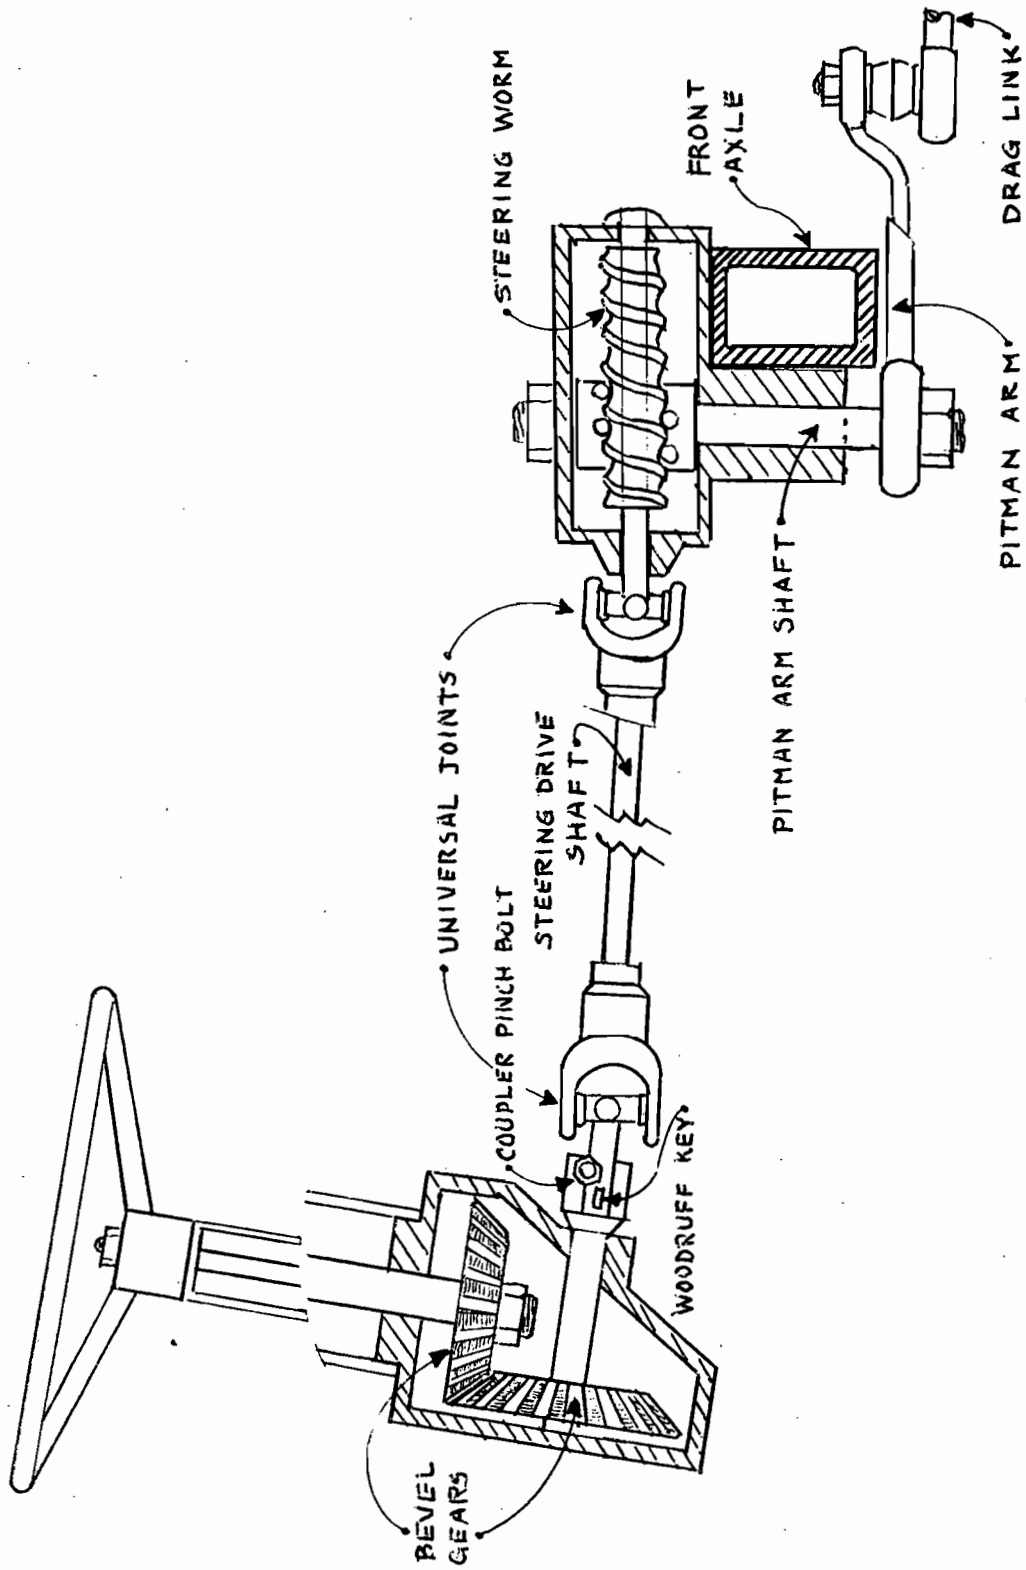
FIGURE A. SCHEMATIC OF STEERING SYSTEM COMPONENTS

While reinstalling the steering gear on the front axle, Penn-DOT personnel found that the output Woodruff drive key was broken off flush with the outer circumference of the bevel gear output shaft. The coupler pinch bolt was found to be loose on disassembly. It bore marks of severe denting and "coining"<sup>7</sup> at the points where the bolt would engage the bevel gear output shaft, and appeared to be bent.

- a. The steering gear worm-and-ball nut was distorted; the ball tracks were cracked and burnelled; the edges of the cracks in the ball tracks revealed no evidence of the balls having rolled across the cracks after they were formed;
- b. A force of (about) 450 foot-pounds of torque and a rotation of some 7° to 10° on the shaft were required to shear a tested Woodruff key;
- c. It could not be determined just when the Woodruff key had been sheared, other than that there had been some steering input after the shear occurred;
- d. Bending and coining of the coupler pinch bolt indicated some steering input after the Woodruff key failed. In a series of tests, GM found it could duplicate the coining marks (found on the accident pinch bolt) by applying three successive

- e. The amount of looseness in the steering which may have existed immediately prior to the accident could not be determined;
- f. The steering shaft worm and pitman arm were distorted by a severe external lateral force applied at the front wheels while the wheels were in a left-turn position.

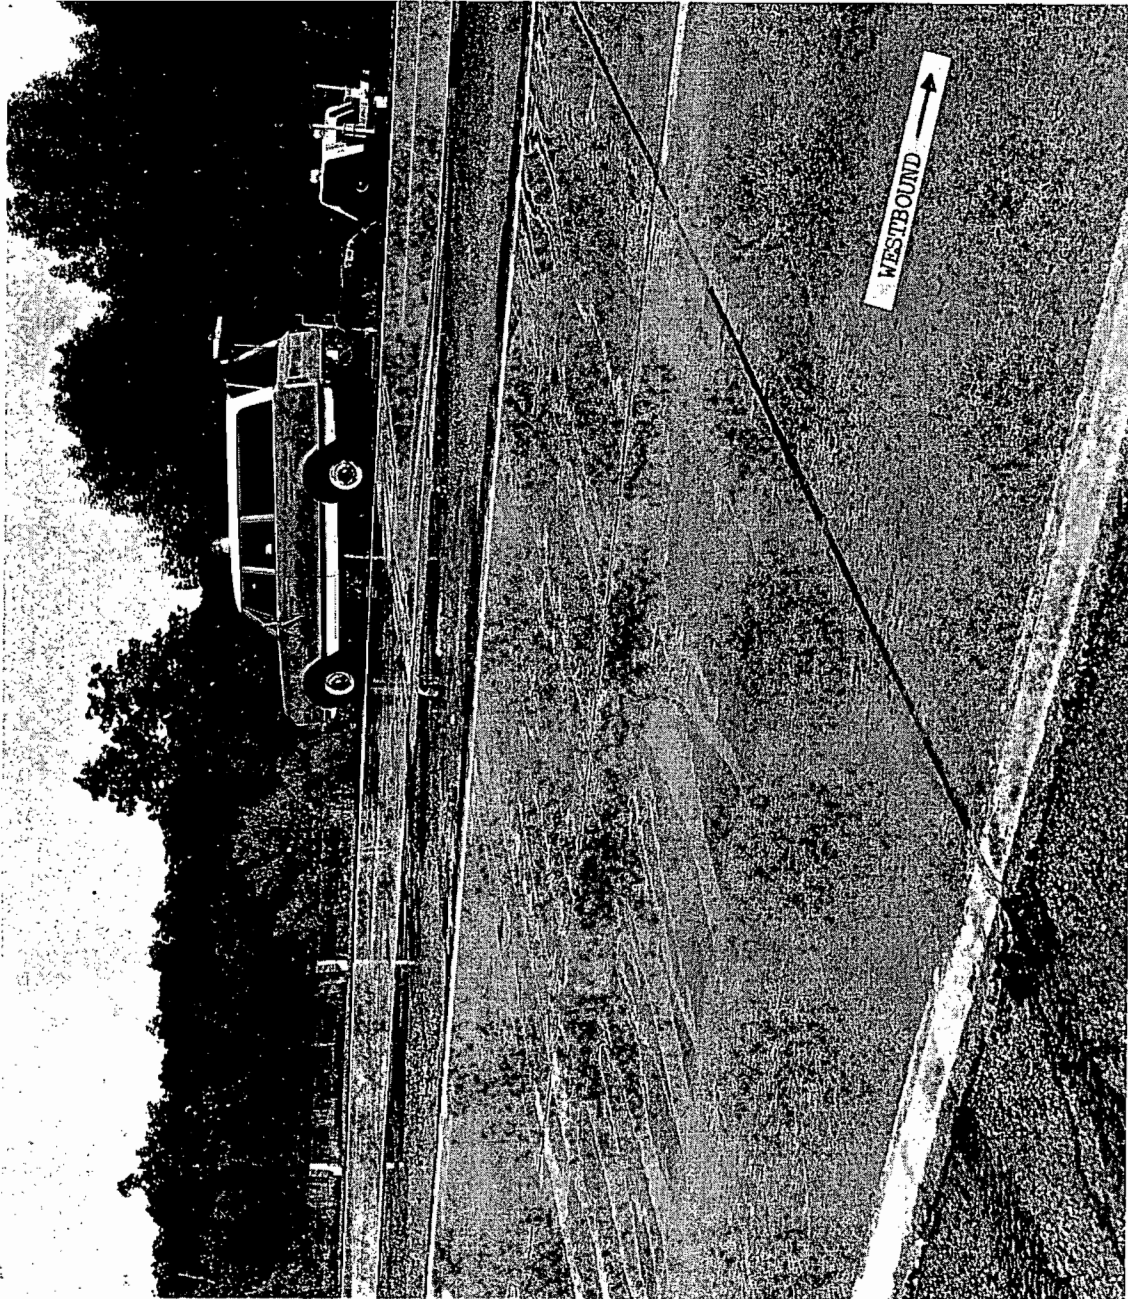
Figure A. Course of water released on eastbound shoulder, collecting and crossing to westbound lanes at the paved crossover point.

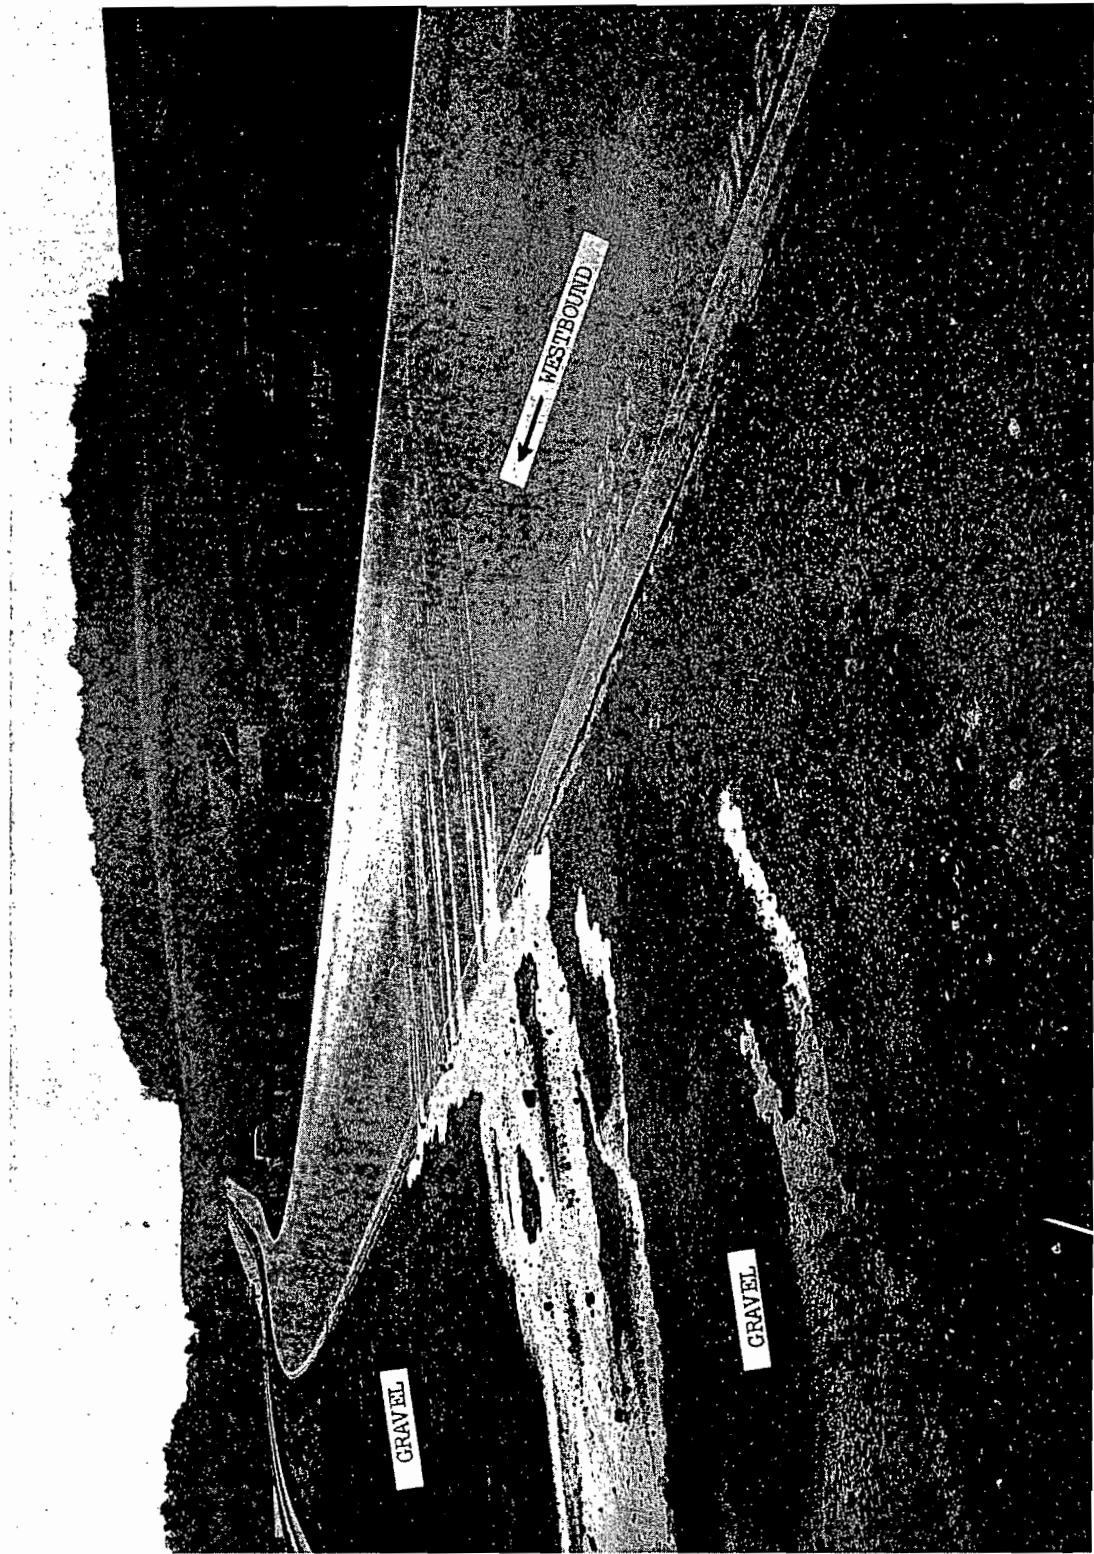
- 5) Considerable quantities of loose gravel (or crushed stone, 1/4- to 1/2-inch diameter), which littered the paved median crossover, had the appearance of eroded paving material which could have washed from the median east of the paved crossover point (Figure B, Appendix D).

Figure B. Course of water released on eastbound shoulder, crossing to westbound lanes at the paved crossover point. Coarse gravel deposits appear to be crushed stone washed from the eastbound median, resulting from water flow several hundred feet eastward of the crossover point.

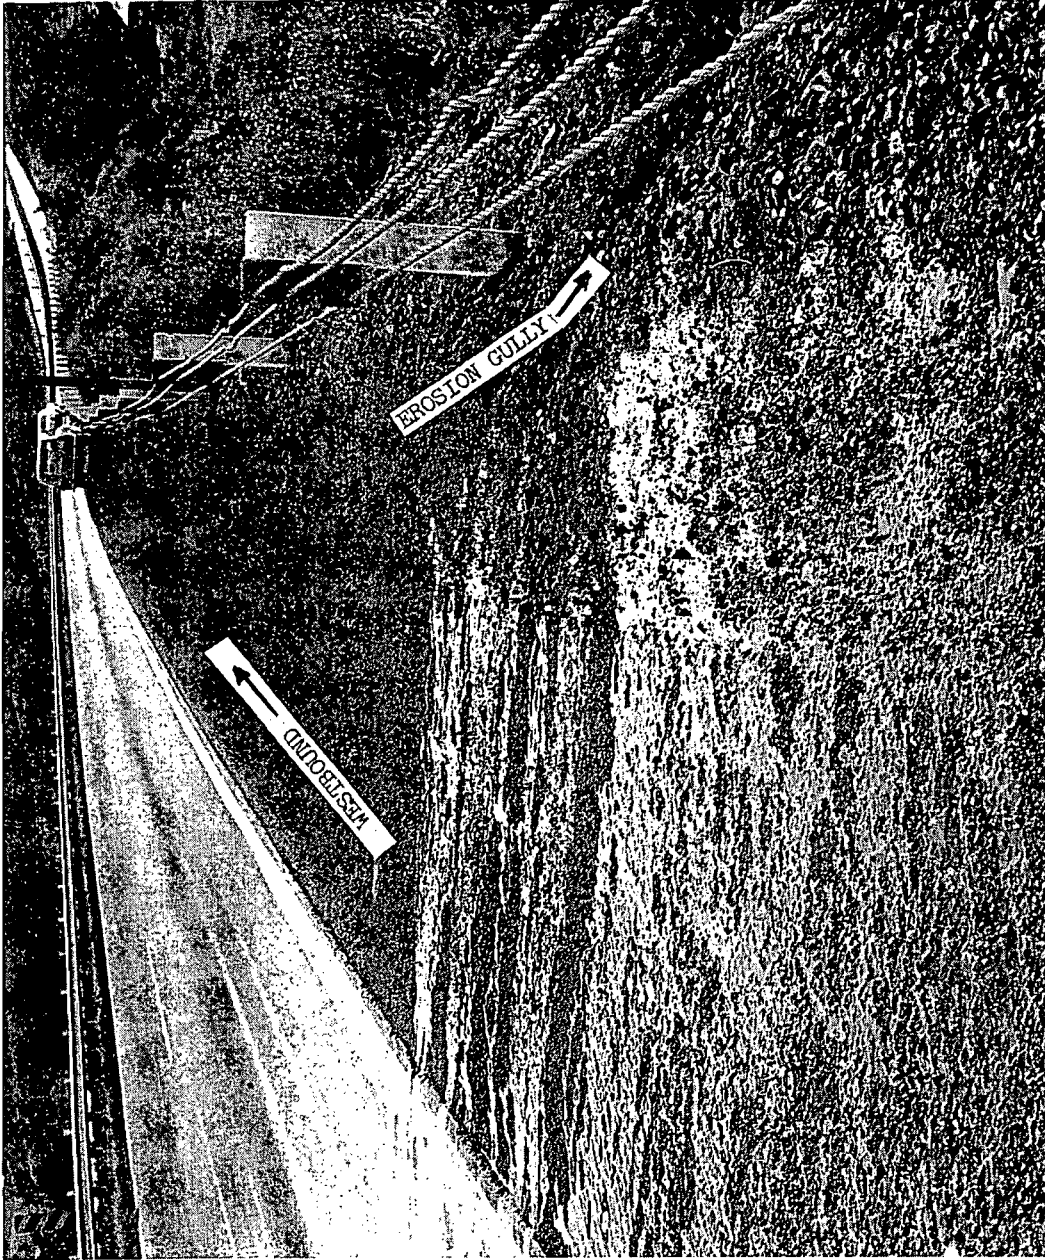
Figure C. Course of water released on eastbound shoulder, as it left the westbound lanes via the westbound shoulder. Erosion of westbound shoulder appears to be caused by excessive runoff at the area opposite the paved median crossover point.
