# HIGHWAY ACCIDENT REPORT

CHARTERED BUS CRASH

REPORT NUMBER: NTSB-HAR-71-8

CHARTERED BUS CRASH  
ON  
U.S. ROUTE 22 (INTERSTATE 78), NEAR  
NEW SMITHVILLE, PENNSYLVANIA  
JULY 15, 1970

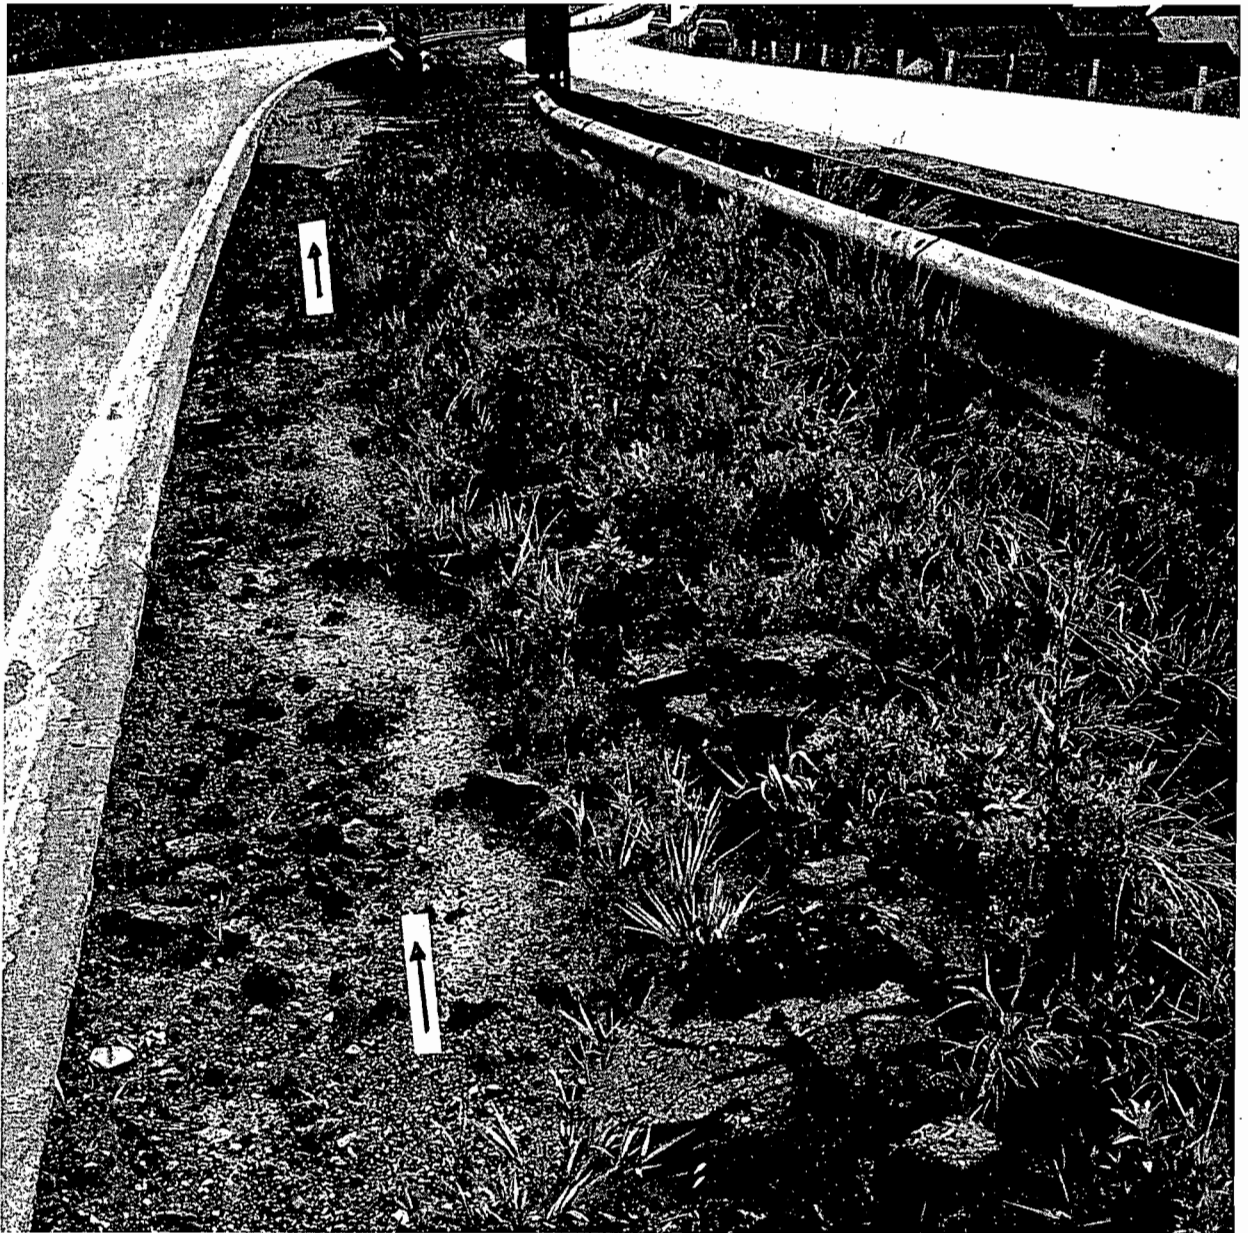
Looking west along the eastbound median . . . .

Figure D. Looking west along the westbound median. Erosion of the median edge denotes the course of water runoff (arrows) which had bypassed the median drain outlets and crossed the median at the paved crossover point.

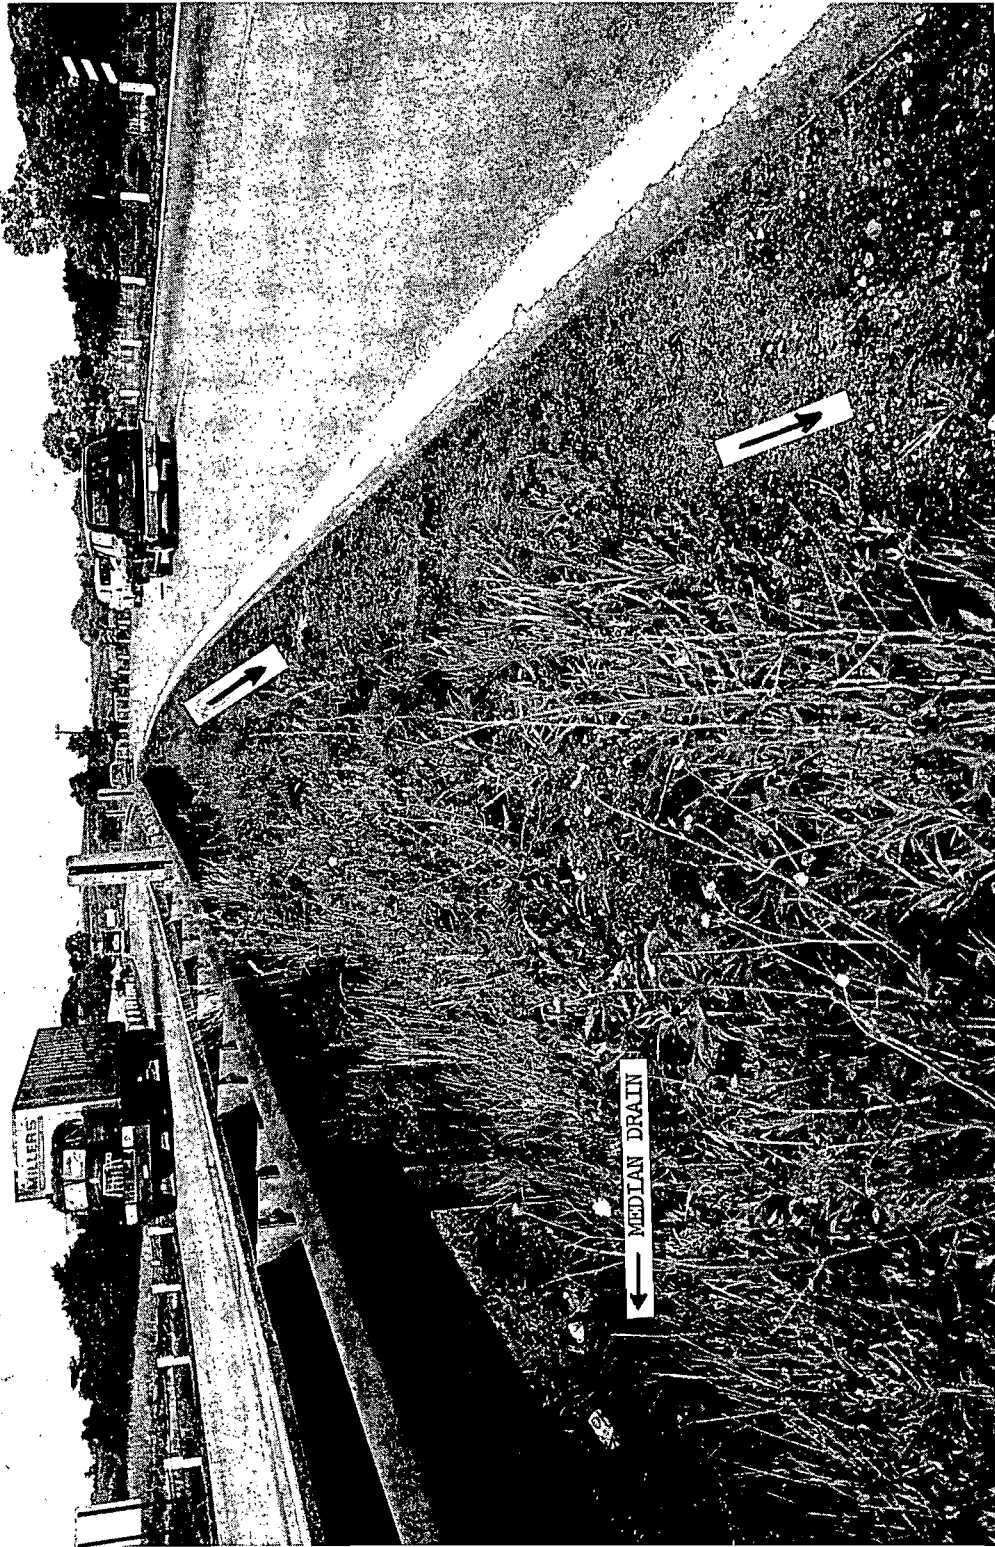
- 4) Water released along the eastbound lanes, for several hundred feet east of the crossover point, would have been unable to reach the drains in the median area because of accumulated road-material debris and matted vegetation which would have blocked the flow and caused it to flow along the median paralleling the eastbound pavement edge (Figure D, Appendix D). Debris and matted vegetation had also accumulated to form dams around the edges of the drains.

Figure E. Looking east along the eastbound median. Erosion of the median edge denotes the course of water runoff (arrows) which had bypassed the median drain outlets and run westward to the paved median crossover point. Erosion extended for several hundred feet to the east.
