NATIONAL TRANSPORTATION SAFETY BOARD

HIGHWAY ACCIDENT REPORT

COLLISION OF HUBERT ROTEN TRUCKING COMPANY TRUCK AND SKINNER CORPORATION BUS

NEAR HAMILTON, GEORGIA

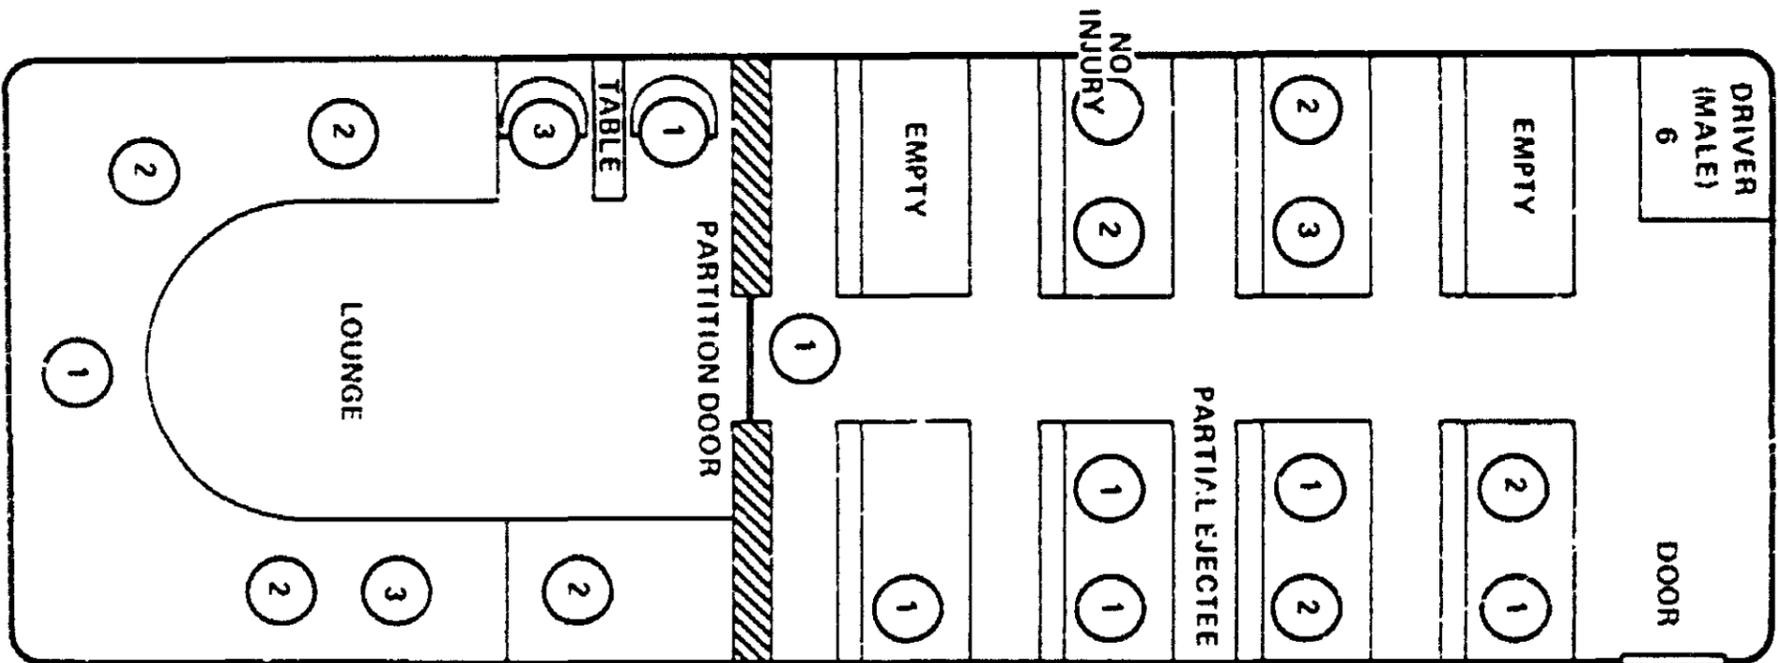
The bus -- The bus was a 1969 GMC 41-passenger Land Cruiser, Model PD 4107, which had been purchased stripped and modified. (See Figure 2.) The bus was owned and operated by the Skinner Corporation of West Point, Georgia.

Figure 2. Injury severity by seating position.

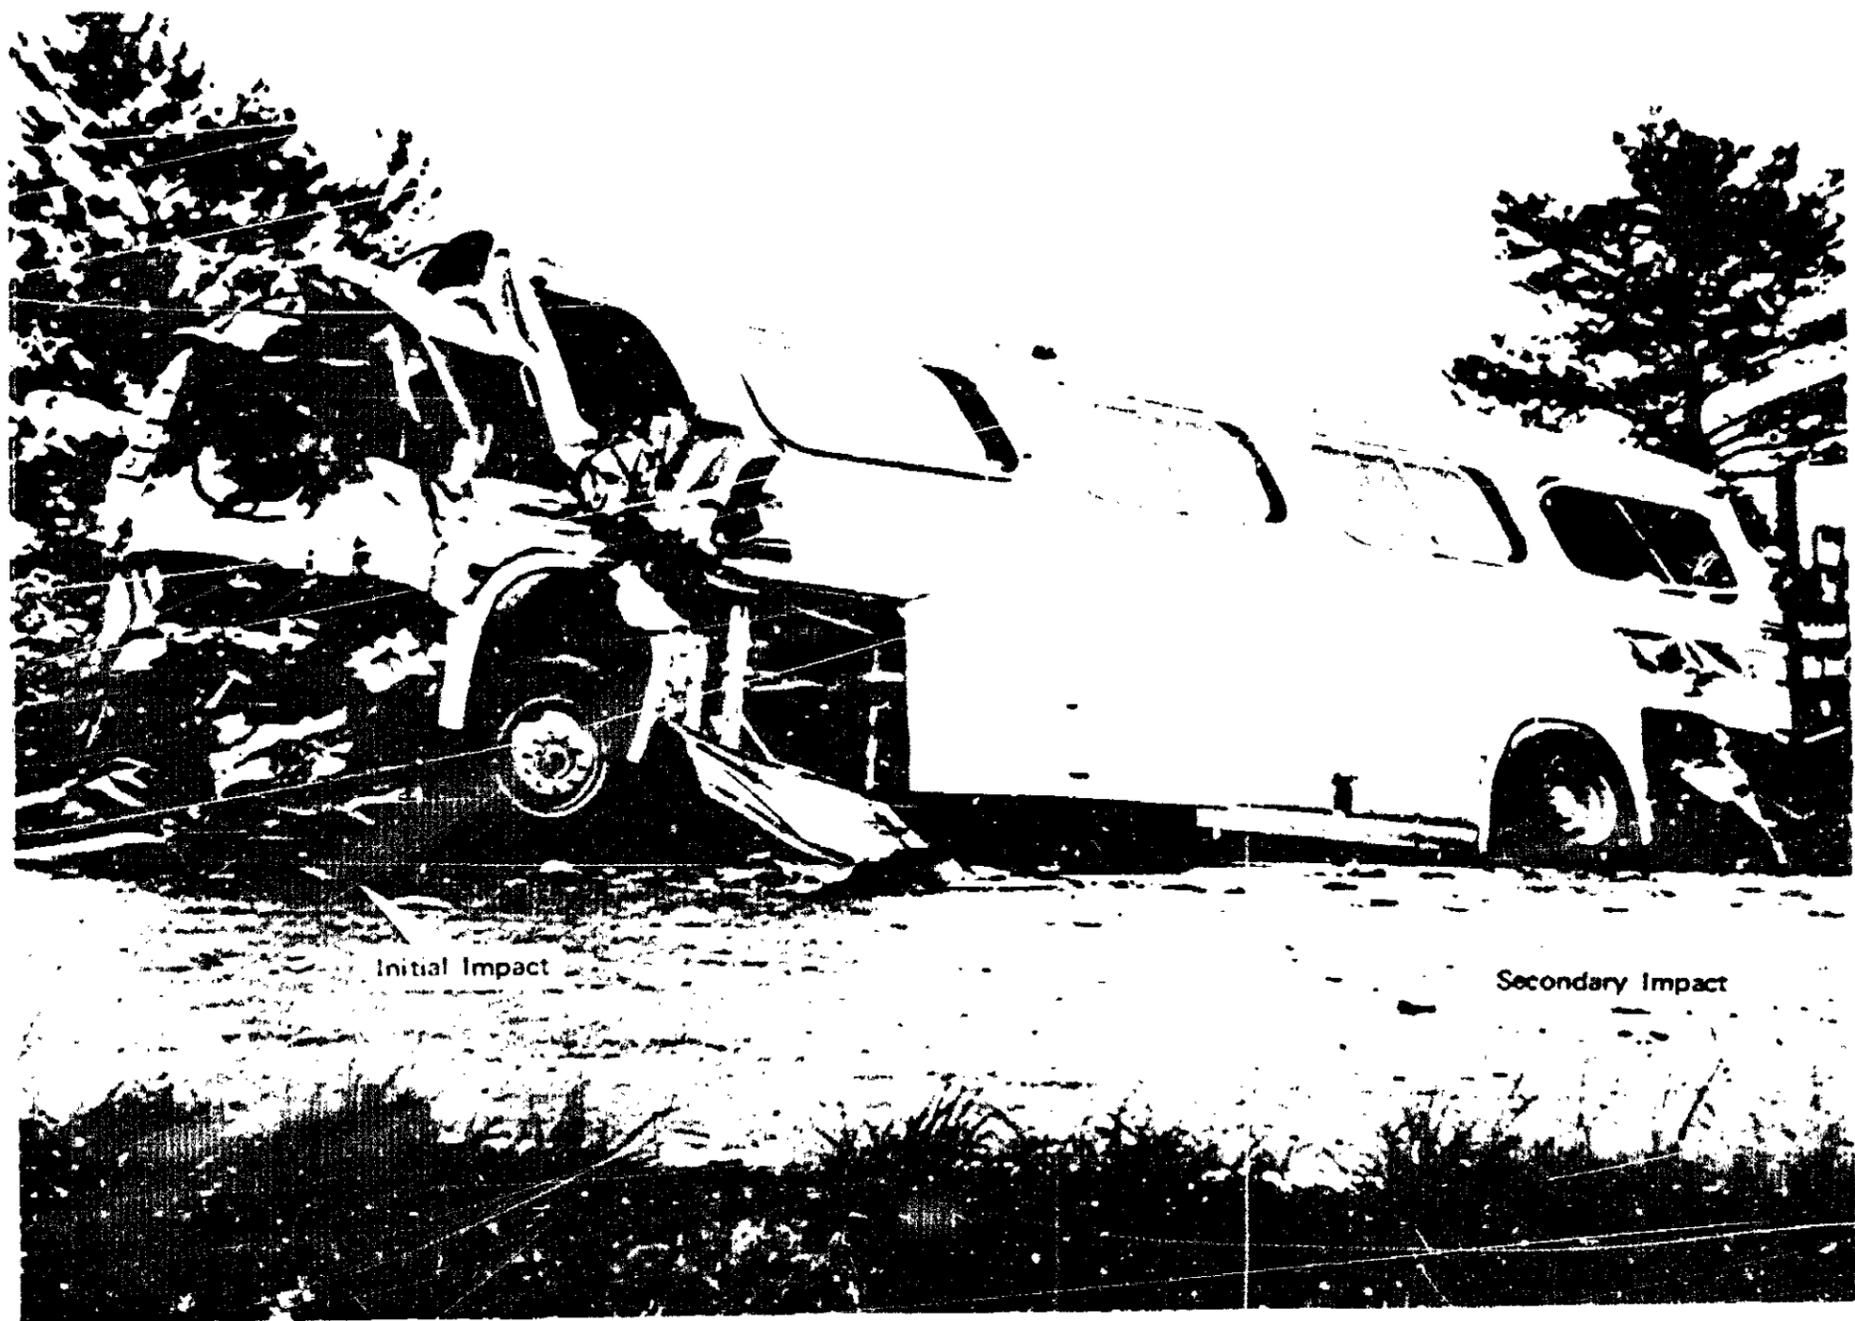
At impact, all seats in the front of the bus failed at their floor anchorage points. All but one seat support at the right rear of the front half of the bus failed at their wall anchorage points. The seat anchorage system consisted of fixed stainless steel clips mounted on threaded bolts which were attached to the aisle leg and to the wall side of each seat. Each clip was inserted into slotted tracks that were mounted on the floor and on the wall of the bus. A nut and a lock washer on the threaded bolt were tightened against the outside of the track to lock the seat to the track. During the collision, the clips bent and the slots in the track widened to permit failure of each anchorage system.

The bus' exterior was damaged extensively on the left front and on the left side near the driver's seat. The underframe buckled to the second bulkhead behind the front wheels. (See Figure 3.) The exterior also was damaged on the left rear side. The bus windows released at impact.

Figure 3. Crash damage which was sustained by the bus.
