# **NATIONAL TRANSPORTATION SAFETY BOARD**

## **SPECIAL INVESTIGATION**

**METROPOLITAN COACH CORPORATION  
CHARTER BUS ACCIDENT  
BETHESDA, MARYLAND  
OCTOBER 11, 1975**

**REPORT NUMBER: NTSB-HAR-76-6**

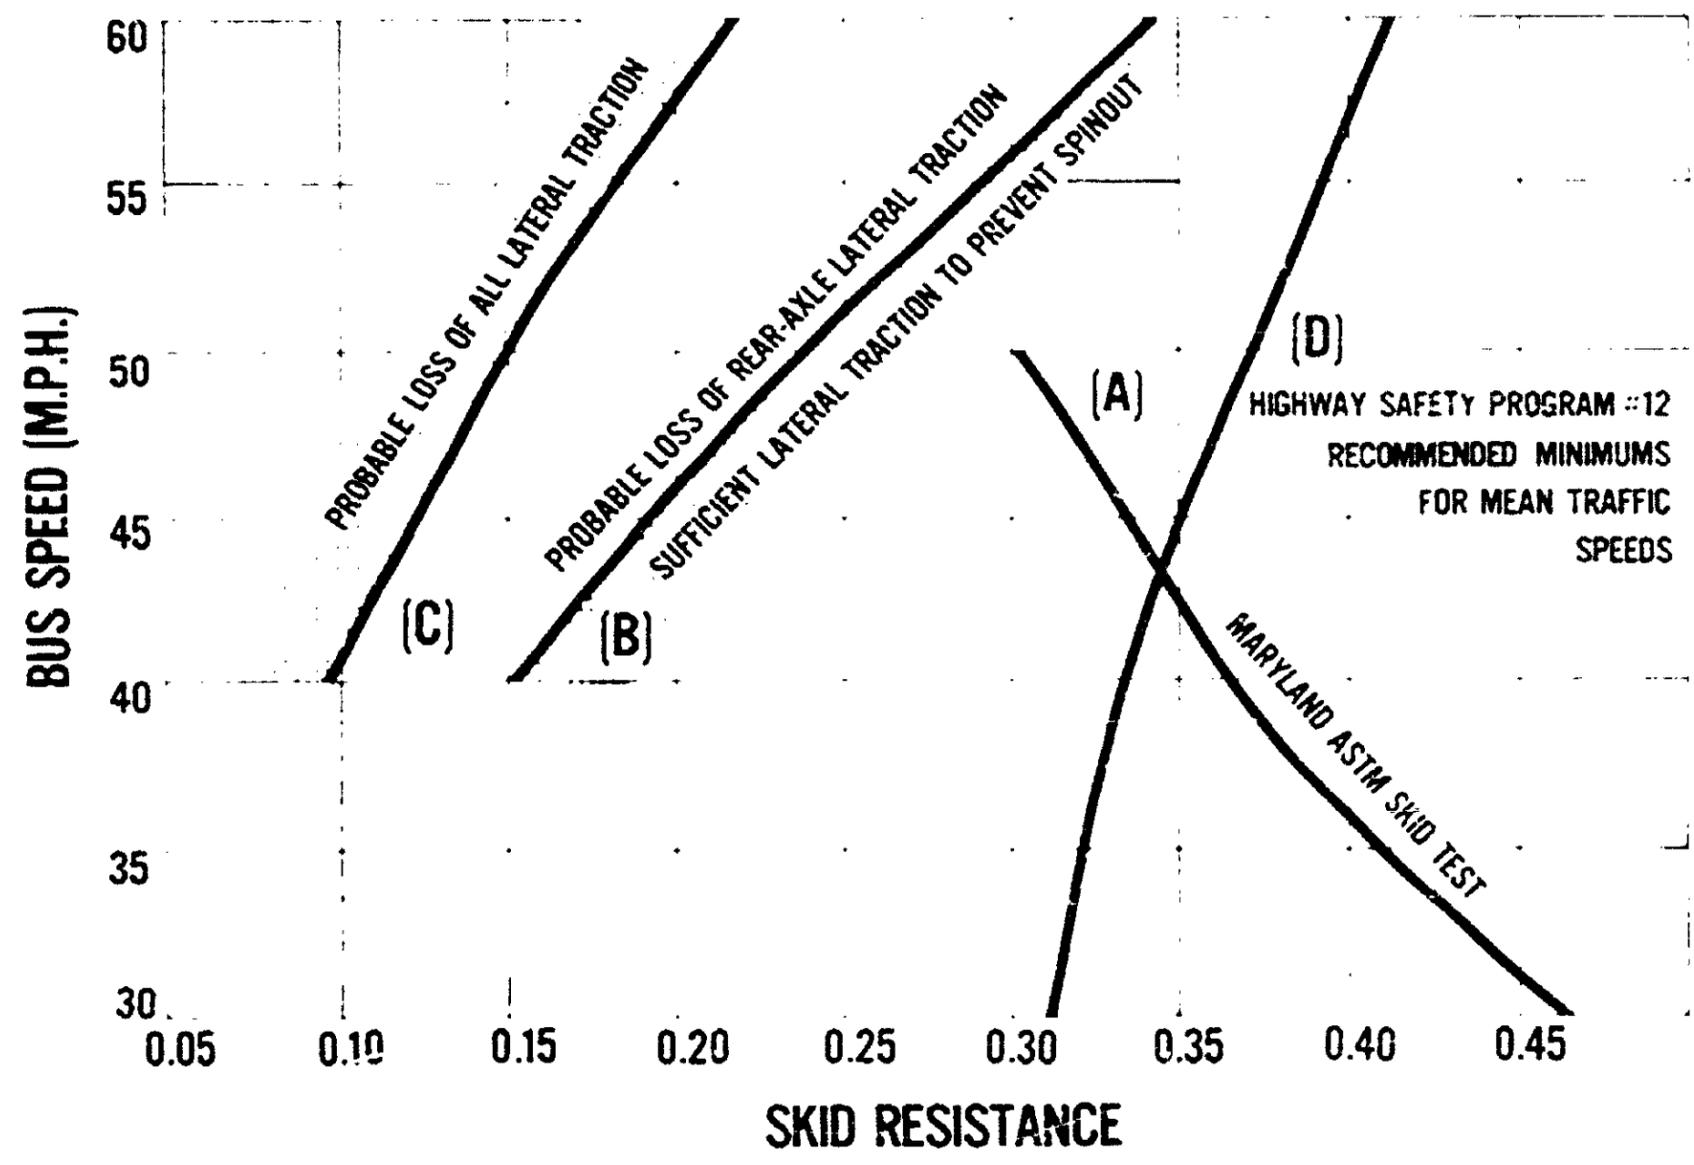
FIGURE 1

Curve A (See Figure 1.) indicates the pavement's frictional coefficient as determined by the Maryland State Highway Administration's October 29, 1975, tests. Curve B indicates the calculated tire-to-pavement frictional coefficient at which the rear axle's tires would be expected to lose lateral traction. Curve C indicates the calculated tire-to-pavement frictional coefficient at which the bus would be expected to lose lateral traction. Curve D indicates the recommended minimum frictional values for mean traffic speeds as tested at 40 mph, in the Highway Safety Program Standard Number 12.

At all frictional values to the right of curve B, the bus should be stable and under lateral control. At 50 mph, the bus should be under control with any frictional coefficient above 0.237. Curve A indicates that the frictional coefficient under American Society for Testing Materials (ASTM) test E-274 was 0.30 at 50 mph.

If the bus needed only a 0.237 frictional coefficient to resist the lateral forces which resulted from centrifugal force, and the test value was 0.30, the accident should not have occurred. Since the accident did occur, either the ASTM test values do not represent actual bus tire-to-road frictional coefficients or some other dynamic factor caused the bus to slide.

LATERAL TRACTION ANALYSIS OF BUS ON 1,091-FT RADIUS CURVE;  
 0.06 FT/FT SUPERELEVATION, GVW-20,935 LBS., REAR AXLE 13,545 LBS.
