**NATIONAL  
TRANSPORTATION  
SAFETY  
BOARD**

**HIGHWAY ACCIDENT REPORT**

**CATES TRUCKING, INC.,  
TRACTOR-SEMITRAILER/MULTIPLE-VEHICLE  
COLLISION AND OVERRIDE, I-285  
ATLANTA, GEORGIA  
JUNE 20, 1977**

**REPORT NUMBER: NTSB-NAR-78-5**

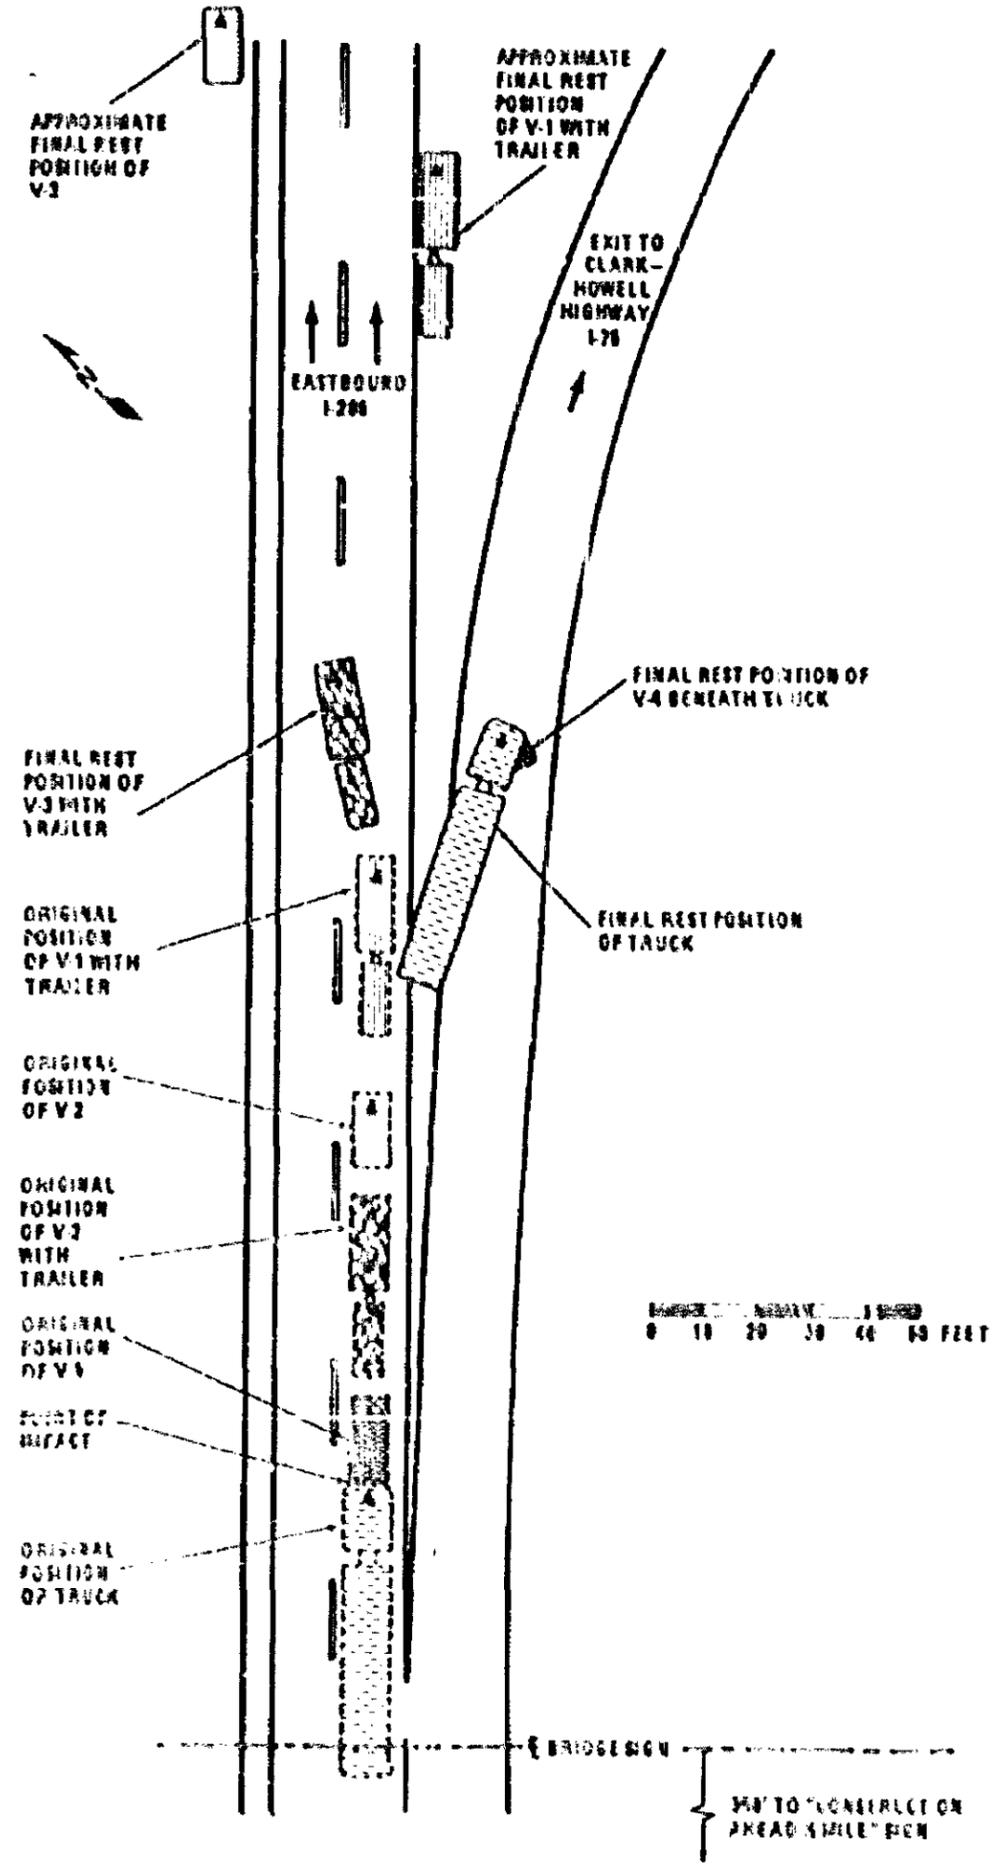
Figure 2. Plan view of accident site.

The truck struck the rear of Vehicle 4 and completely overrode it; its front wheels came to rest on the hood of that vehicle. The momentum of the truck forced Vehicle 4 into the camper-trailer being towed by Vehicle 3. Vehicle 3 moved forward and struck Vehicle 2. Since the wheels of Vehicle 2 had been turned to the left in anticipation of a lane change, it sideswiped the left rear of the trailer being towed by Vehicle 1, crossed the passing lane, and came to rest in the median. Vehicle 3 and its trailer came to rest across the two eastbound lanes of I-285. Vehicle 4, which was lodged under the truck, came to rest in the Clark Howell Highway exit lane. (See figure 2.)

The roadway at the accident site had two 12-foot bituminous-paved through lanes in each direction. The eastbound and westbound traffic was separated by a 40-foot median, which consisted of 30 feet of grass and a 5-foot paved shoulder in each direction. In addition to the two eastbound through lanes at the point of impact, there was a parallel deceleration lane for the exit. (See figure 2.) The road surface was in good repair.
