## **HIGHWAY ACCIDENT REPORT**

**GATEWAY TRANSPORTATION CO., INC.,  
TRACTOR-SEMITRAILER PENETRATION OF  
MEDIAN BARRIER AND COLLISION WITH  
AUTOMOBILE, I-70,  
ST. LOUIS, MISSOURI  
SEPTEMBER 25, 1977**

1. Report No. NTSB-HAR-79-3		2. Government Accession No.		3. Recipient's Catalog No.	
4. Title and Subtitle Highway Accident Report - Gateway Transportation Company, Inc., Tractor-Semitrailer Penetration of Median Barrier and Collision With Automobile, I-70, St. Louis, Missouri, September 25, 1977				5. Report Date March 22, 1979

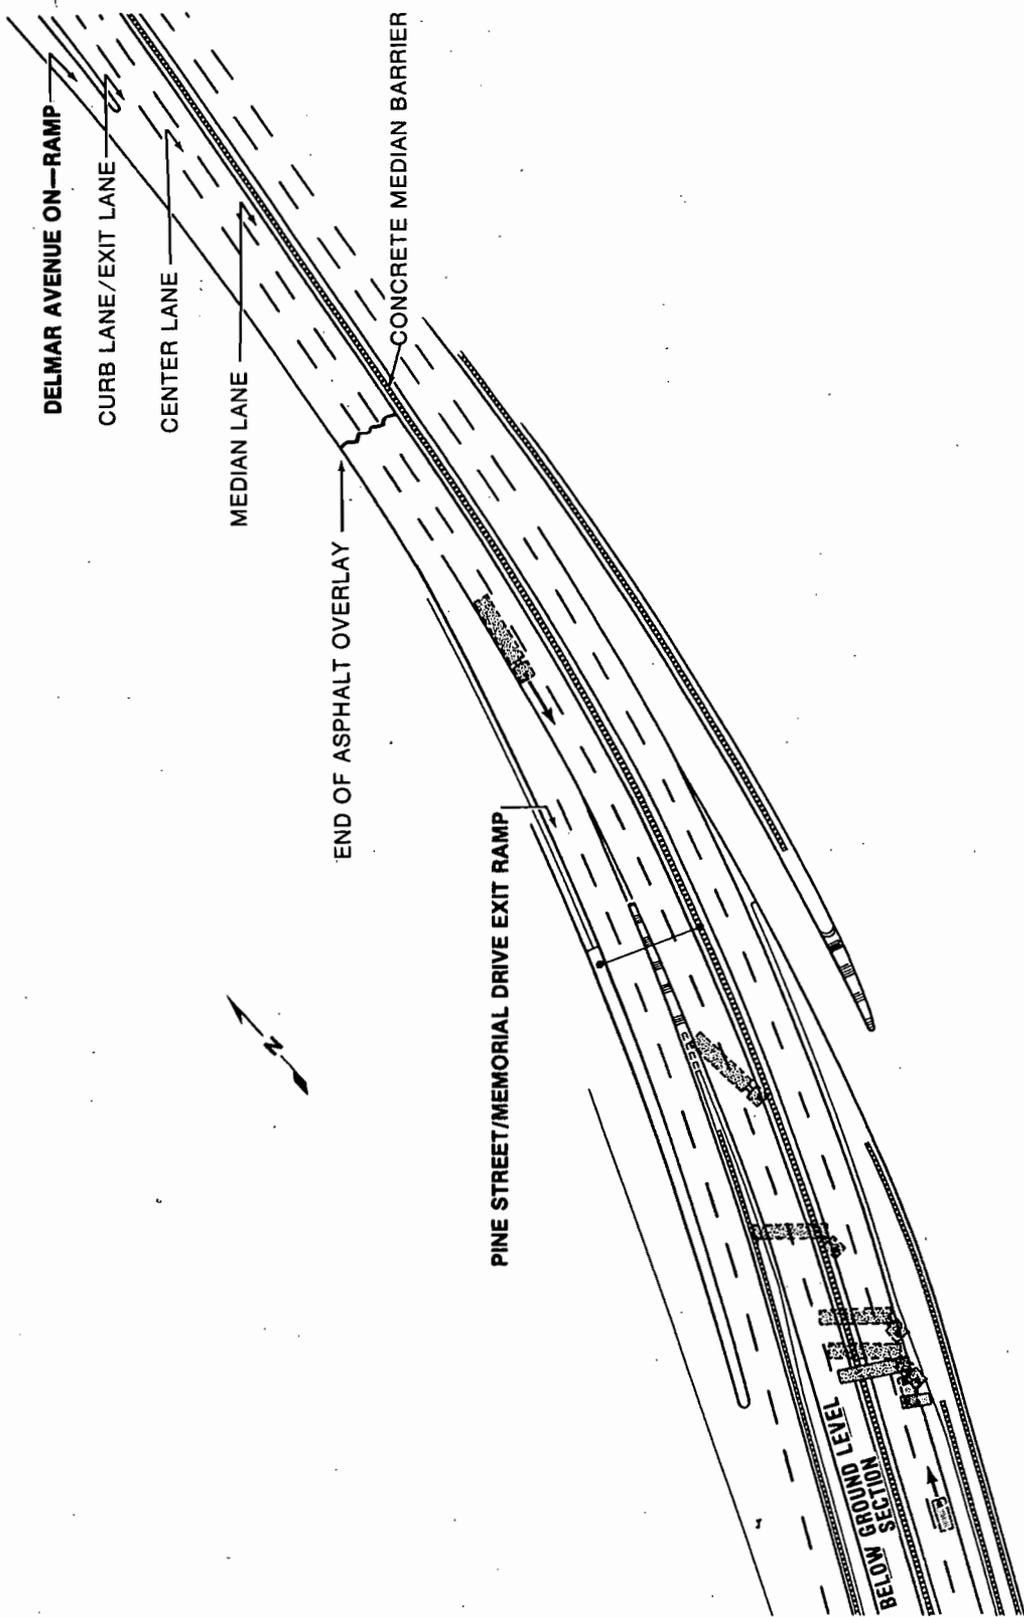
Figure 1. Accident site, on Interstate-70, St. Louis, Missouri.

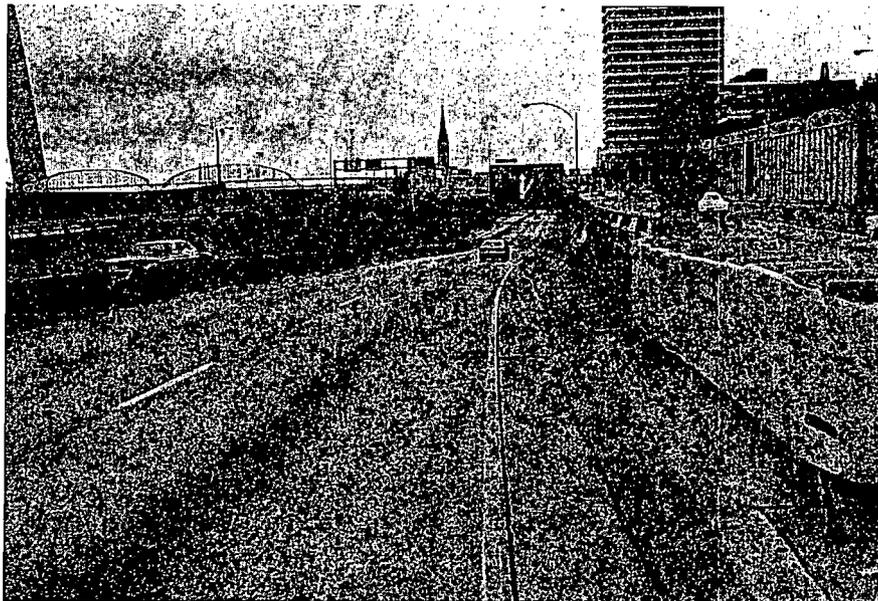
Figure 2. Damage to concrete median barrier; note tire scuffs and breaks in the barrier.

Three sections of concrete were separated from the median barrier. (See figure 2.) The concrete first broke where the tractor's left front wheel penetrated the barrier at a joint between two sections of the barrier. The second and third breaks occurred as the semitrailer's suspension and wheels hit the barrier. The barrier had not been displaced laterally or tipped, and there were no signs of inherent material weakness or deterioration of the barrier.

Calculations and physical evidence indicated that the tractor-semitrailer was traveling no faster than 55 mph when it first contacted the "New Jersey" concrete median barrier and that the attack angle between the tractor and the barrier was between 16° to 23°. <sup>11/</sup> The FHWA has crash tested the "New Jersey" barrier with tractor-semitrailers traveling at lower impact speeds and attack angles, and the barrier did contain and redirect these vehicles. However, the FHWA has not yet established the limits of speed or attack angles beyond which the barrier can no longer contain and redirect these vehicles. The impact speed and attack angle in this accident probably did exceed the design limits of the "New Jersey" barrier and, therefore, contributed to the severity of the accident. At the same time, there was some evidence that the design limits were not significantly exceeded and that minimal limitations in the "New Jersey" barrier design may have permitted the tractor-semitrailer to penetrate and vault the barrier.

The tractor's left front tire scuff along the face of the barrier indicated that the climb angle of the tire began to level off and that the vehicle was beginning to be contained and redirected when the top of the barrier broke away at a contraction joint. In tests of a more massive "Texas" barrier that: (1) had no contraction joints over a 150-foot length, (2) was continuously reinforced, and (3) was 3 inches wider at the base and 2 inches wider at the top, a 48,800-pound tractor-semitrailer was contained and redirected by the barrier at an attack angle of 15° and an impact speed of about 45 mph. <sup>12/</sup> The 30,850-pound vehicle involved in this accident had nearly the same momentum at 55 mph as the test vehicle in the "Texas" barrier tests. Therefore, a barrier only slightly stronger, particularly at the joints, and/or larger than the one in place may have prevented the truck from entering the opposing traffic lanes.

Limited data collected by the Southwest Research Institute for the FHWA <sup>13/</sup> indicated that concrete barrier failures are caused primarily by trucks. Several barriers failed at joints in a pattern similar to that observed at St. Louis. The Institute recommended that "open joints in CMB (Concrete Median Barrier) construction should be spaced at maximum intervals to take advantage of barrier mass and to minimize reinforcement required at joints to effect consistent strength. The option of using contraction joints in the barrier should take advantage of aggregate interlock and reinforcement should be continuous across these joints." <sup>14/</sup>

"Establish a program to examine the feasibility of developing design alternatives to improve the performance of concrete barrier systems already in place. (Class II, Priority Action) (H-79-19)"

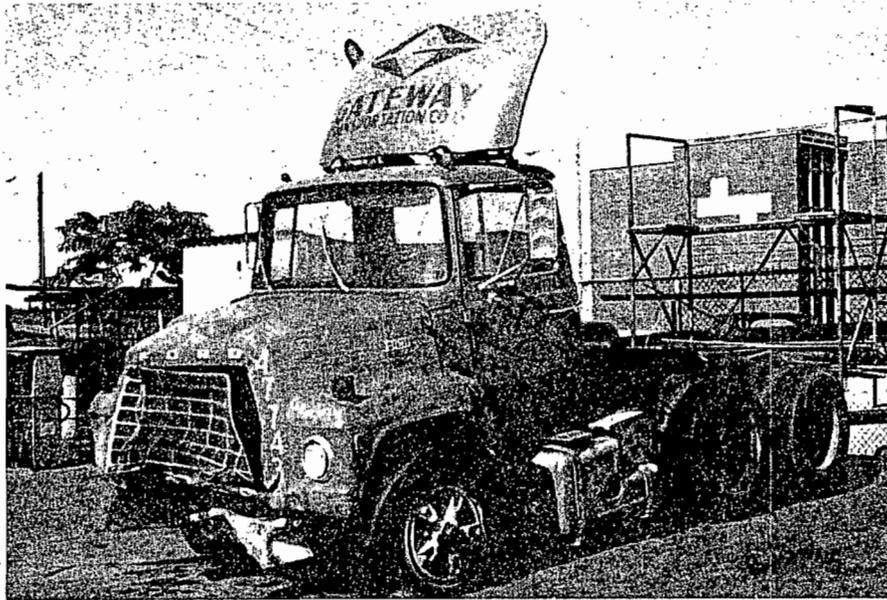
The tractor-semitrailer -- The tractor was a 1977 Ford 9000, cab-behind-engine, 3-axle truck, VIN-W91UV087404, manufactured in December 1976. (See figure 3.) The odometer indicated 96,924 miles. The tractor was owned by Gateway Transportation Company, Inc., of La Crosse, Wisconsin. It was equipped with the following: A turbocharged Cummins NTC290 engine, a Spicer 5-speed transmission, rear axles that were both powered, air-mechanical drum brakes on the front and the two rear axles, Eaton antilock brake valves and controllers on the two rear axles, a sliding fifth wheel, and 11R-22.5 steel radial tubeless tires. The front axle brake system was not equipped with an antilock system or a brake limiting valve. These items were then and are currently offered as optional equipment by the manufacturer. The tractor's cab contained only a driver's seat which was equipped with a lapbelt restraint.

Two deficiencies were noted in the tractor braking system. The left front brake linings were contaminated with wheel bearing oil over about 10 percent of the surface area and the brake linings at the forward right rear wheel were contaminated with wheel bearing oil over 75 percent of the surface area. No malfunctioning steering, antilock, or air brake system components were detected.

Figure 3. View of tractor.

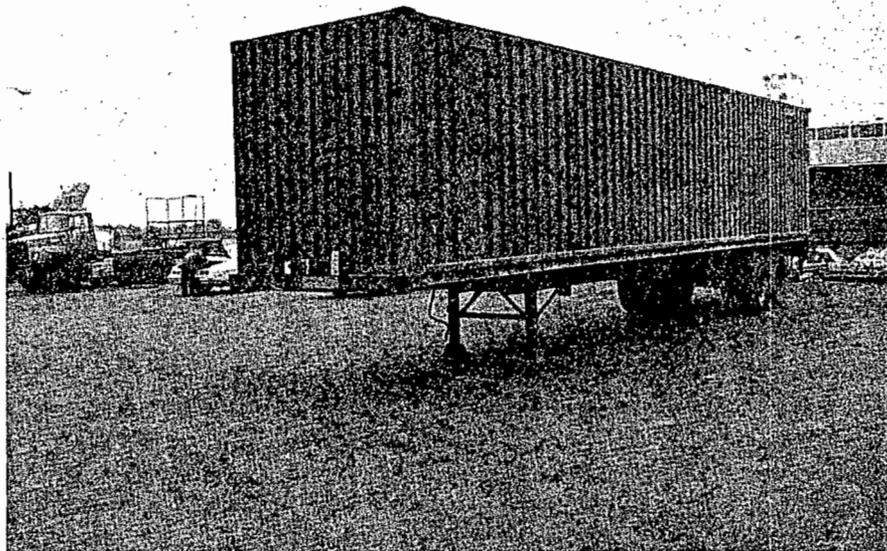
The semitrailer was a 1974 Theurer semitrailer chassis with a Tokyu detachable container; it was owned by United States Lines, Inc., of Jefferson, Maine. (See figure 4.) The semitrailer was not equipped with antilock braking systems.

Figure 4. View of trailer.

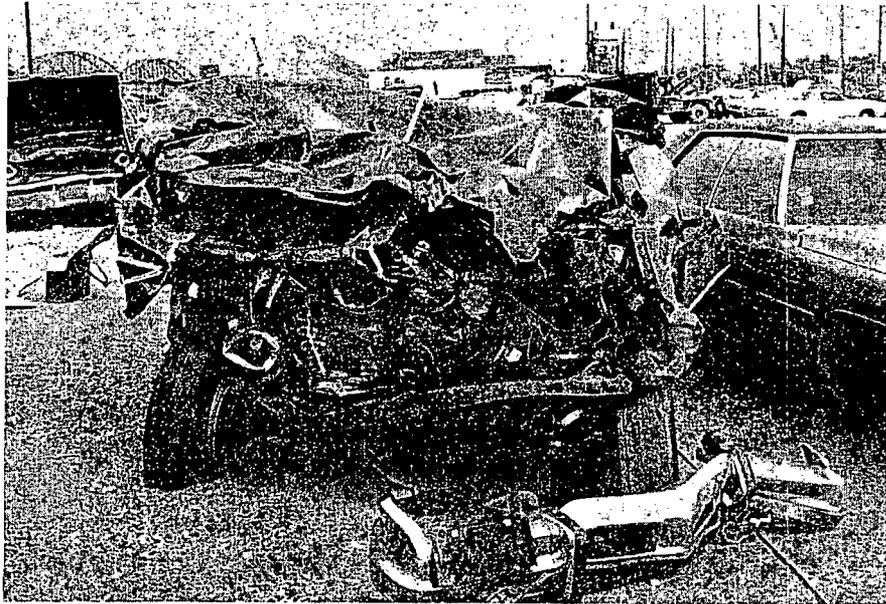
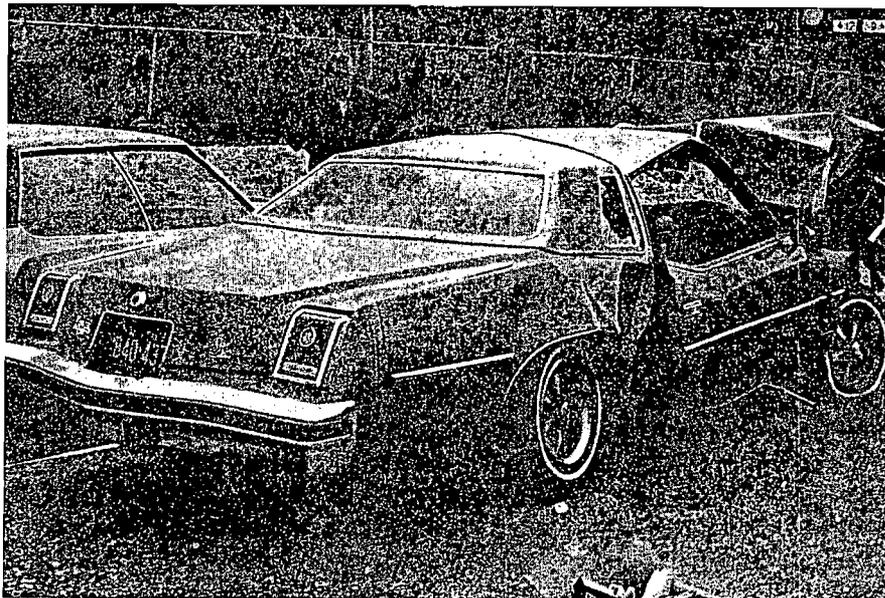
The automobile -- The automobile was a 1977 Pontiac Grand Prix, 2-door sedan, VIN 2J57Y7A253896. (See figures 5 and 6.) This vehicle was last inspected in the State of Missouri in June 1977 and had 1,800 miles registered on its odometer. Equipment included power brakes, power steering, bench seats with locking and folding seatbacks, integral lapbelt and shoulderbelt restraints that were chassis-sensitive at the outboard front seat positions, lapbelts only at all other seat positions, adjustable head restraints that were adjusted down, padded dash and sunvisors, and an energy-absorbing steering column.

There was extensive damage to the entire front half of the car. Frontal crush was produced by head-on contact (12 o'clock force direction) and was 43.5 inches on the right side and 28.5 inches on the left, with roughly a straight line between the two points. The front bumper was scratched on the top about 19 inches to the right of center, and a small portion of rubber trim was torn from the face of the bumper. The bumper did not engage any substantial parts of the truck tractor in the collision, but was torn loose during disengagement and postcrash movement. This evidence indicated the tractor was airborne at the point of impact with the automobile. The hood was buckled upward and pushed rearward; the trailing edge of the hood did not penetrate the windshield. The roof and both A-pillars were buckled by longitudinal compression of the upper portions of the body. The engine block was fractured in several places and the drive shaft was buckled in compression. The steering column energy-absorbing device inside the car had collapsed to the maximum limit permitted by other crash damage and the steering column energy-absorbing device in the engine compartment was compressed to within 1 1/4 inches of its minimum length. The universal joint of the steering shaft was torn but was not disengaged. The forward frame was buckled at the base of the firewall and the toeboard was almost vertical. Undercarriage, motor, and exhaust system components had contacted the pavement at several points.

Figure 5. Front view of automobile.

Figure 6. Rear view of automobile.
