Highway Accident Report - Multiple Vehicle
Median Barrier Crossover and Collision, Grand
Central Parkway, New York, New York, June 8, 1979

(U.S.) National Transportation Safety Board, Washington, DC

21 Nov 79

MULTIPLE VEHICLE MEDIAN BARRIER CROSSOVER
AND COLLISION
GRAND CENTRAL PARKWAY
NEW YORK, NEW YORK
JUNE 8, 1979

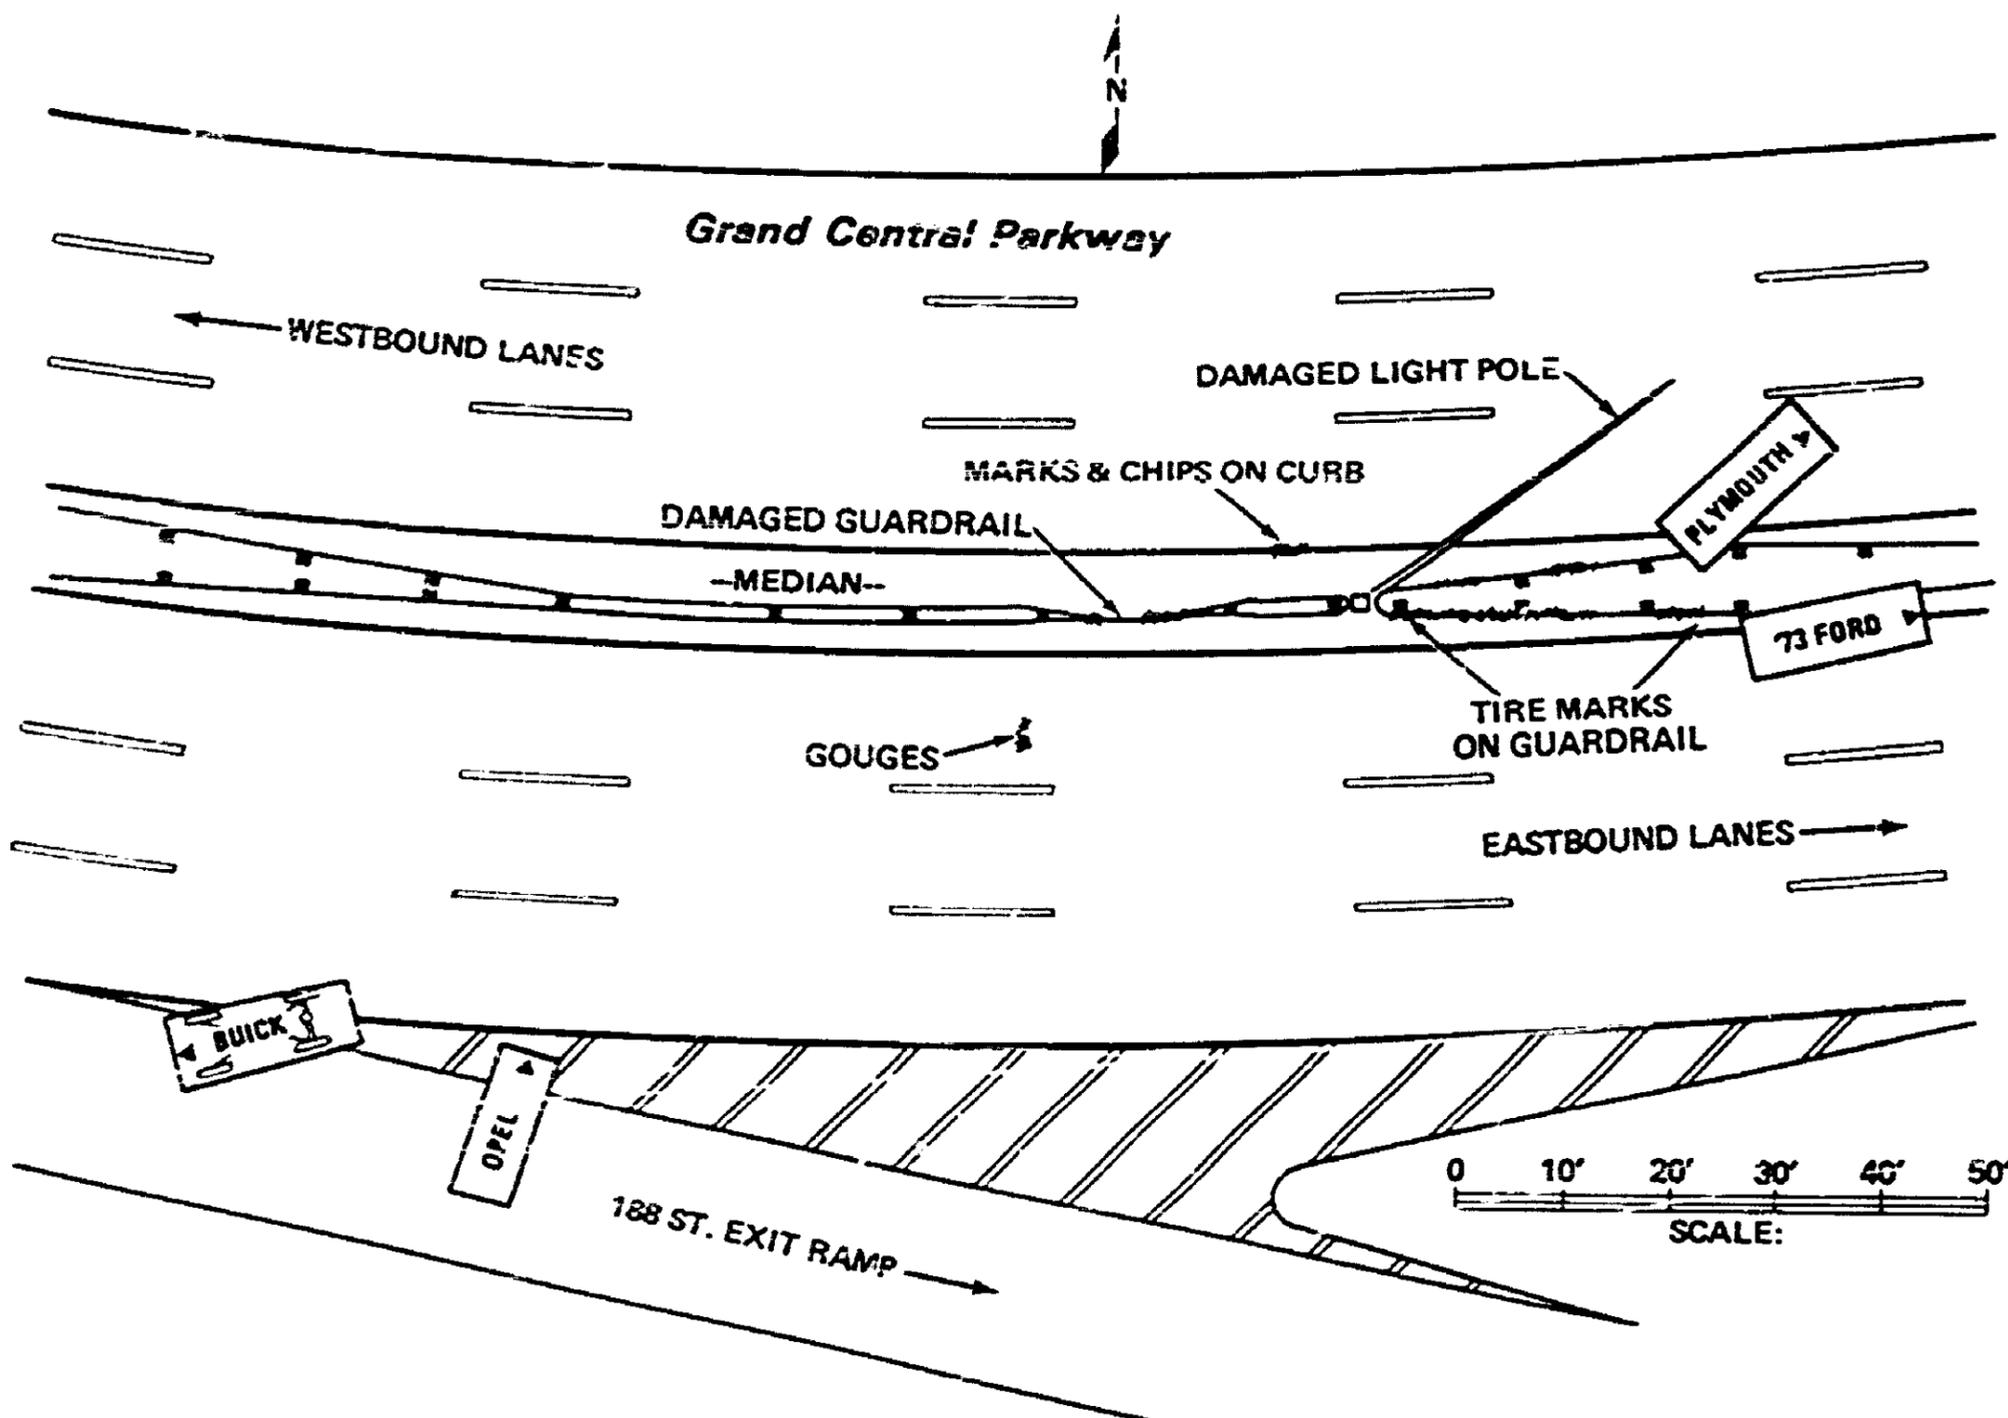
Figure 1. Accident site diagram.

Physical evidence found at the crash site included two chipped areas and a tire scuff mark on the concrete median curb adjacent to the westbound lanes. A 30-foot section of guardrail, starting opposite the tire scuff mark, was deformed laterally toward the south. There were tire scuff marks on the north face of the guardrail. The guardrail was deflected 14 1/2 inches at the point of maximum deformation. Numerous tire scuff marks were found on the south face of the guardrail, opposite the eastbound lanes, beginning shortly before the flared section of guardrail and continuing intermittently onto the flared section for a distance of 48 feet. (See figure 1.)

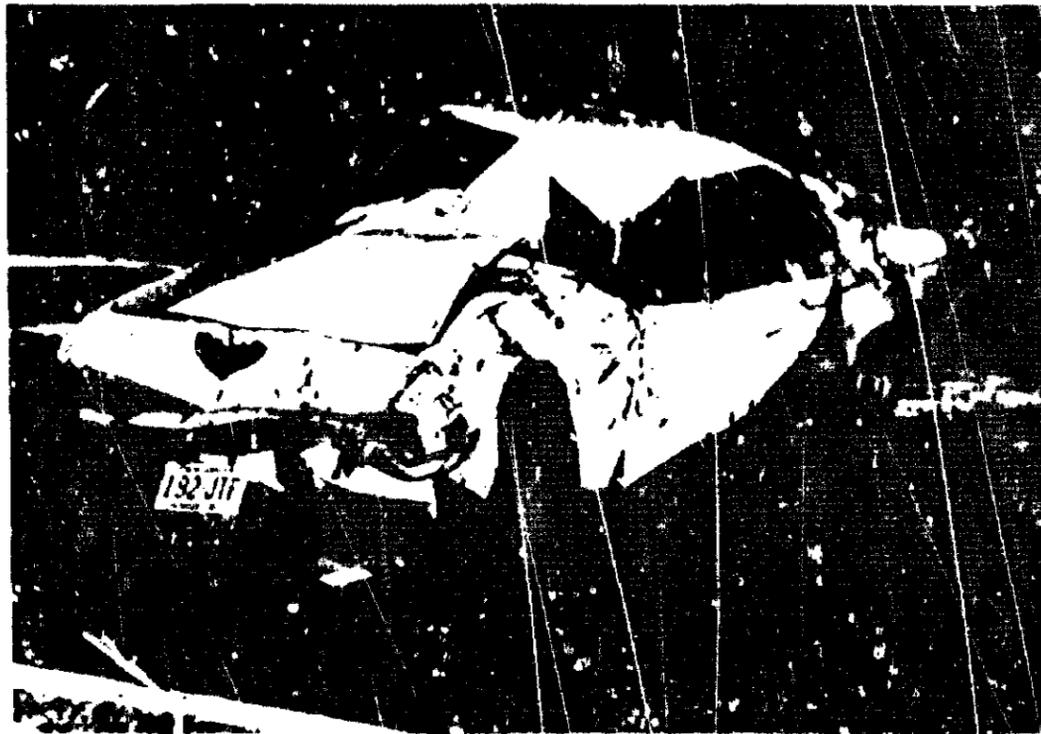
The Opel, a 1972 "Manta," two-door sedan, was white, and its curb weight was 1,877 lbs. Its left side was heavily damaged. (See figure 6.) The left front fender and left side of the front bumper were pushed back. The side and top of the left front fender, cowling, hood, left door, and left rear quarter panel were dented and buckled. The left "A" pillar was pushed back and to the left, and all window glass was broken. Traces of gold paint and black smudges were found on the front bumper, cowling, hood, roof, left front fender, and "A" pillar. Glass was imbedded in the side of the left front fender, and pieces of fiberboard from the Buick's rear window shelf panel were wedged between the front of the left front fender and the bumper. Human hair was found wedged between the left front tire and wheel rim.

Figure 6. Front and left views of Opel.

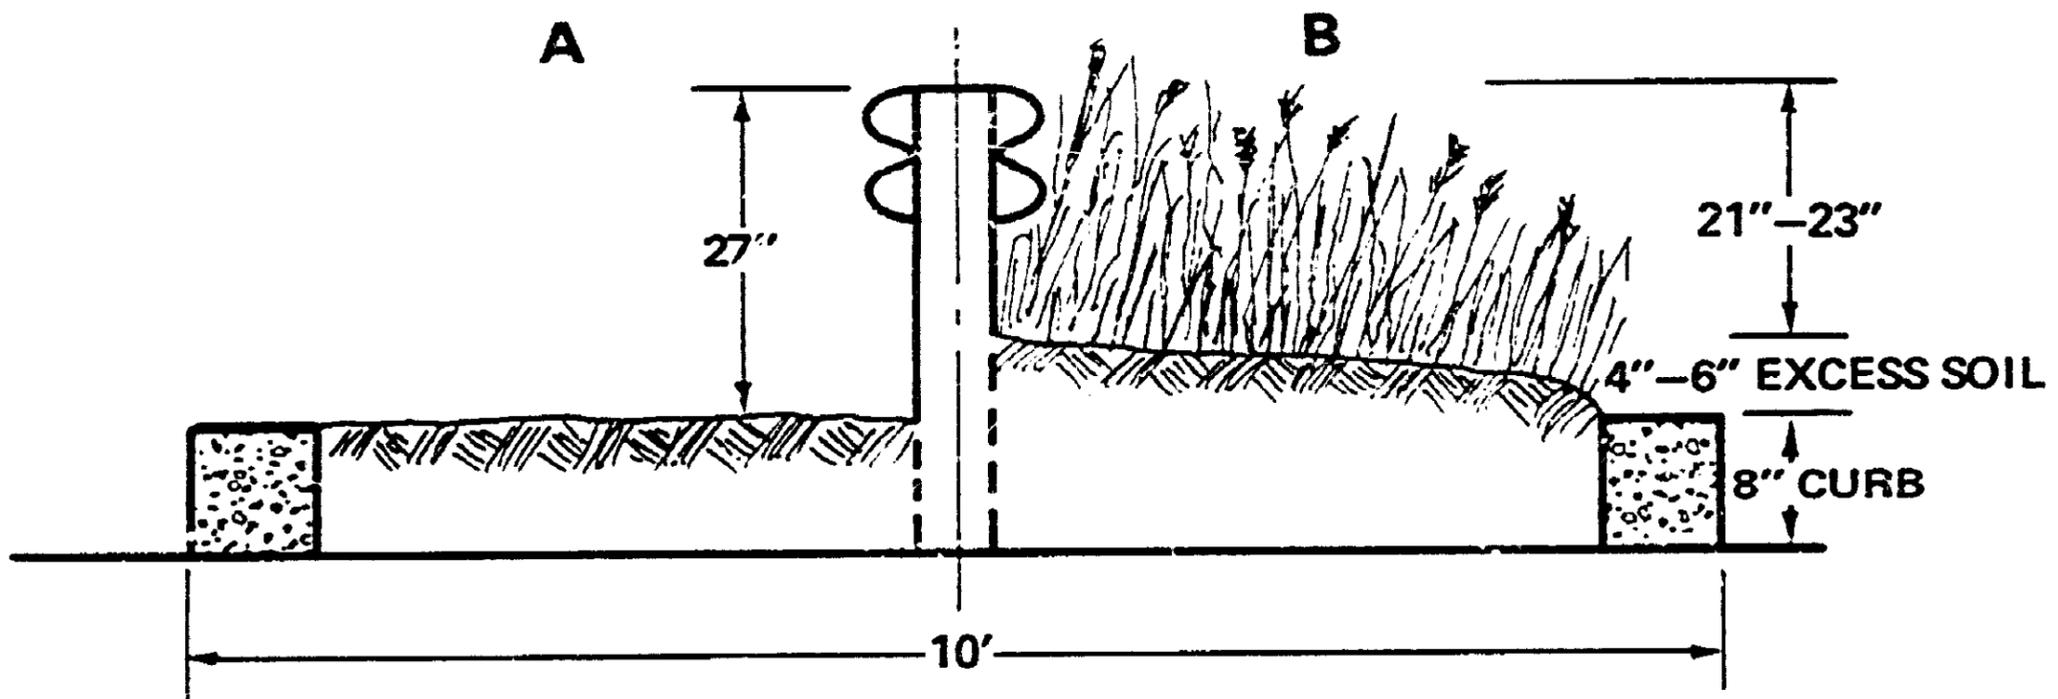
The opposing lanes were separated by a 10-foot raised grass median that was bordered by an 8-inch barrier-type concrete curbing. A median barrier system 5/ of weak post, W-beam guardrail was installed on top and in the center of the median. At the time of the accident, the median was heavily overgrown with vegetation that exceeded the height of the guardrail; the vegetation has since been cut down. The design height of the guardrail was 27 inches, but because of a 4- to 6-inch excess accumulation of soil on the median, the height of the guardrail was reduced to 21 to 23 inches. (See figure 7.)

Figure 7. Cross section of median. A - Plan design and
B - Condition at time of crash

Although the median and median barrier met established design standards when it was constructed, it does not conform with current design standards published in the AASHTO "Guide for Selecting, Locating and Designing Traffic Barriers." Improper placement of barrier guardrail in relation to curbing, insufficient barrier guardrail height, gaps in the barrier guardrail to accommodate breakaway light poles, and excessive vegetation and dirt accumulation on the median were substandard conditions that facilitated rather than deterred errant vehicles from vaulting the median into the opposing lanes. The AASHTO guide suggests that where a barrier system is judged to be substandard, the barrier should be modified or replaced.

- to the New York State Department of Transportation:
"Replace substandard median barrier on the Grand Central Parkway with an operational system that conforms to current standards. (Class II, Priority Action) (H-79-48)"

- to the New York City Department of Transportation:
"As an interim measure, remove soil buildup from the median on the Grand Central Parkway and from similar locations in the City where an accumulation of soil has reduced the effective height of the guardrail. (Class II, Priority Action) (H-79-49)"

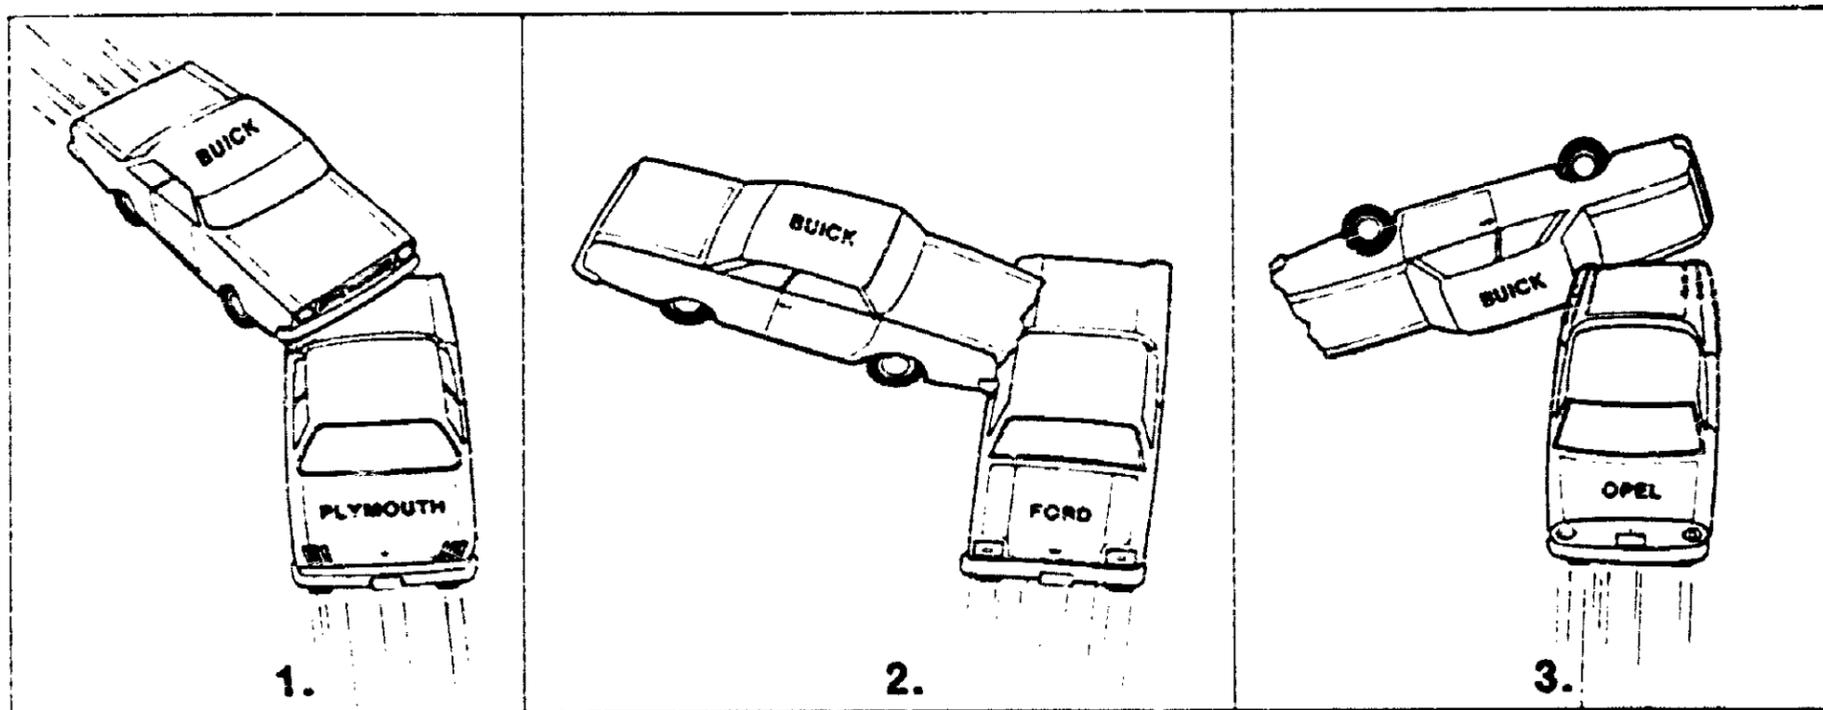
Damage to the vehicles indicates that the crash sequence with the eastbound cars began when the airborne Buick crashed through the windshield of the Plymouth, struck the driver, tore across the top of the car diagonally, and pushed the roof back onto the trunk lid. The Buick then collided with the Ford, striking it at the left side and left corner of the windshield. Since the Buick was descending, it penetrated deeply into the passenger compartment of the Ford and tore away the roof, back seat, trunk compartment, left rear door, and left rear quarter panel. As the Buick separated from the Ford, it rotated and rolled; when it collided with the Opel, it was probably overturned and moving backward. As the Opel and Buick crashed, the left front of the Opel apparently penetrated the rear window of the Buick and came in contact with one or more of the Buick's passengers, as evidenced by the hair found on the Opel's left front wheel. (See figure 8.)

Figure 8. Crash sequence and approximate vehicle attitudes.

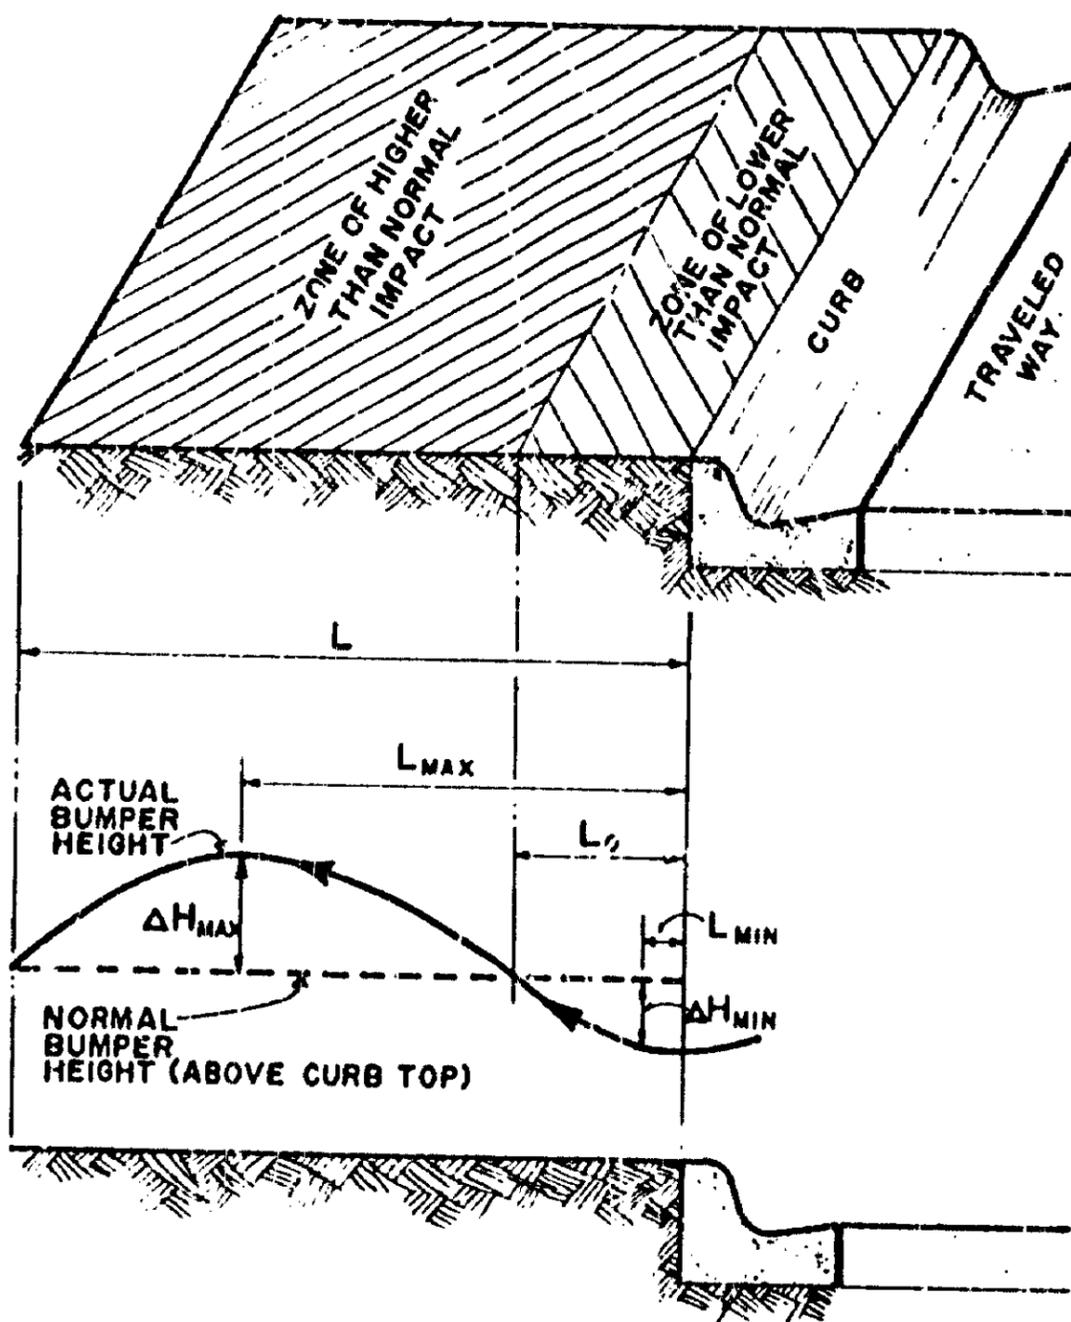
FIGURE F-14. DESIGN PARAMETERS FOR VEHICLE ENCROACHMENTS ON CURBS.

the acceleration lane to the crash site, his intoxicated condition may have precluded any chance for a successful recovery. As a result of striking the 8-inch median curb, the Buick bounced upward and continued across the median at a shallow angle. The upward trajectory of the vehicle was such that as it vaulted the median only the wheels struck the top of the guardrail and the Buick became an uncontrollable airborne missile that ultimately was halted by a series of crashes with passenger cars going in the opposite direction. See appendix A for AASHTO barrier guide data on bumper trajectory.
