Highway Accident Report - Van/Slow-Moving
Farm Vehicle Collision, U. S. Route 6/50
Near Delta, Utah, September 12, 1979

(U.S.) National Transportation Safety Board
Washington, DC

20 Mar 80

1. Report No. NTSB-HAR-80-2		2. Government Accession No.		3. Recipient's Catalog No. PB80 183031	
4. Title and Subtitle Highway Accident Report-- Van/Slow-Moving Farm Vehicle Collision, U.S. Route 6/50, Near Delta, Utah, September 12, 1979				5. Report Date March 20, 1980

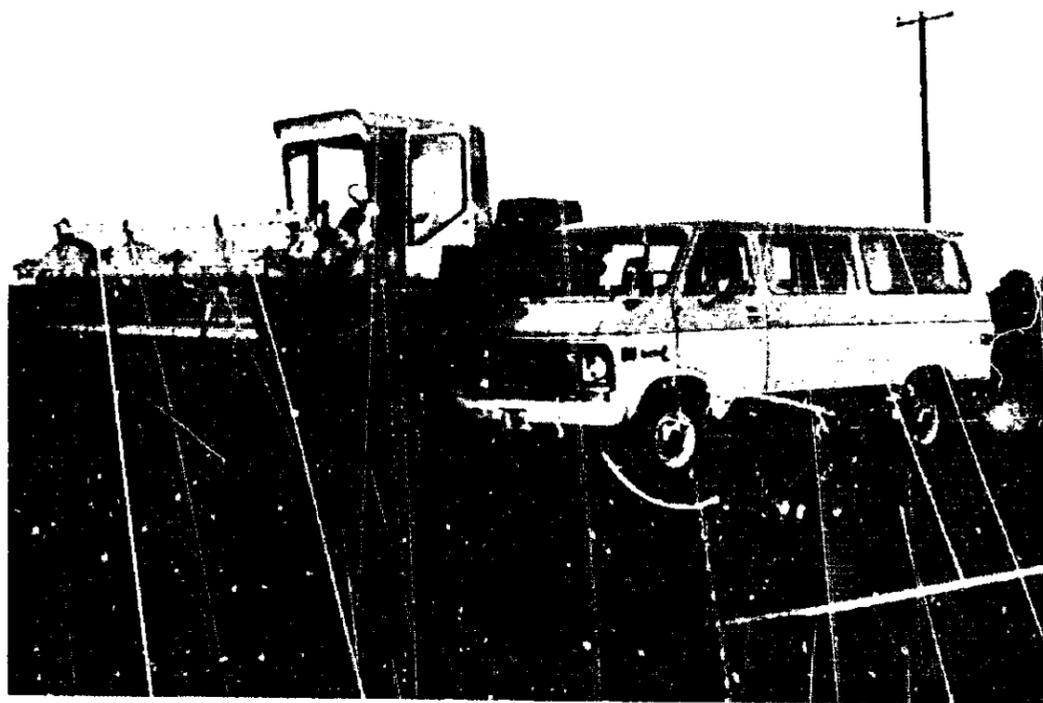
The overtaking vehicle, a 1976 Dodge van occupied by 14 senior citizens en route to the Utah State Fair in Salt Lake City, overtook and collided with the windrower. (See figure 3.) The right front corner of the van struck the left rear edge of the cutting attachment. (See figure 4.) The van was traveling about 55 mph as it approached the windrower.

Figure 3.—Impact simulation using two vehicles similar to those involved in the accident.

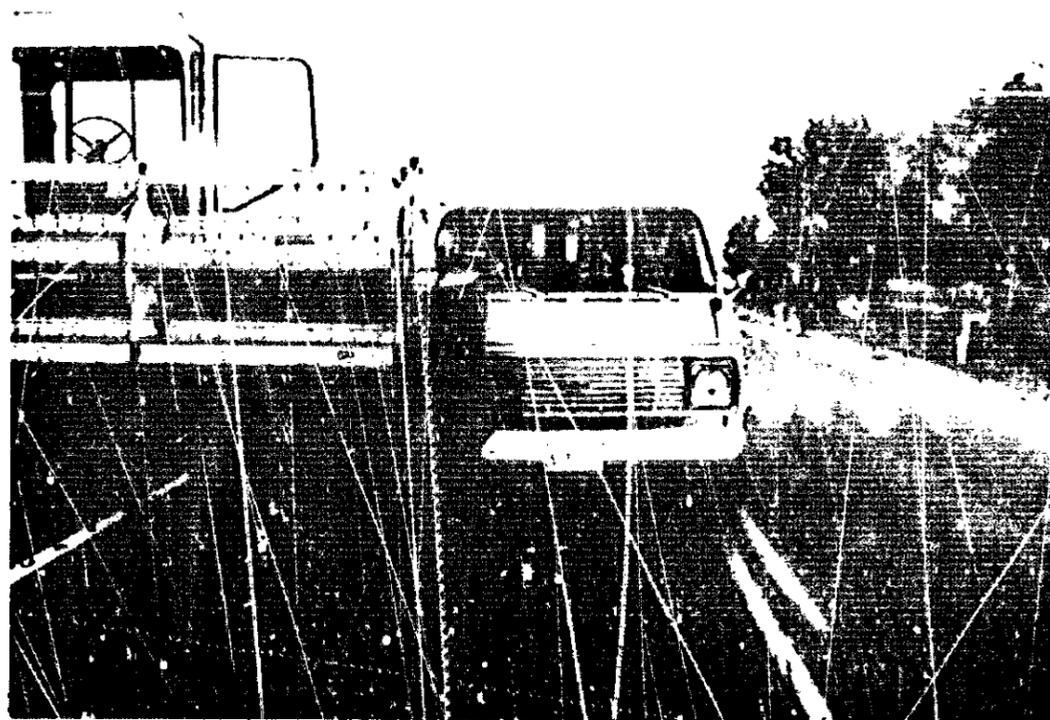
Figure 4.—Impact simulation. Note (1) extent of engagement between van and windrower, (2) left tire of van on road centerline, and (3) tire marks from van after initial impact.

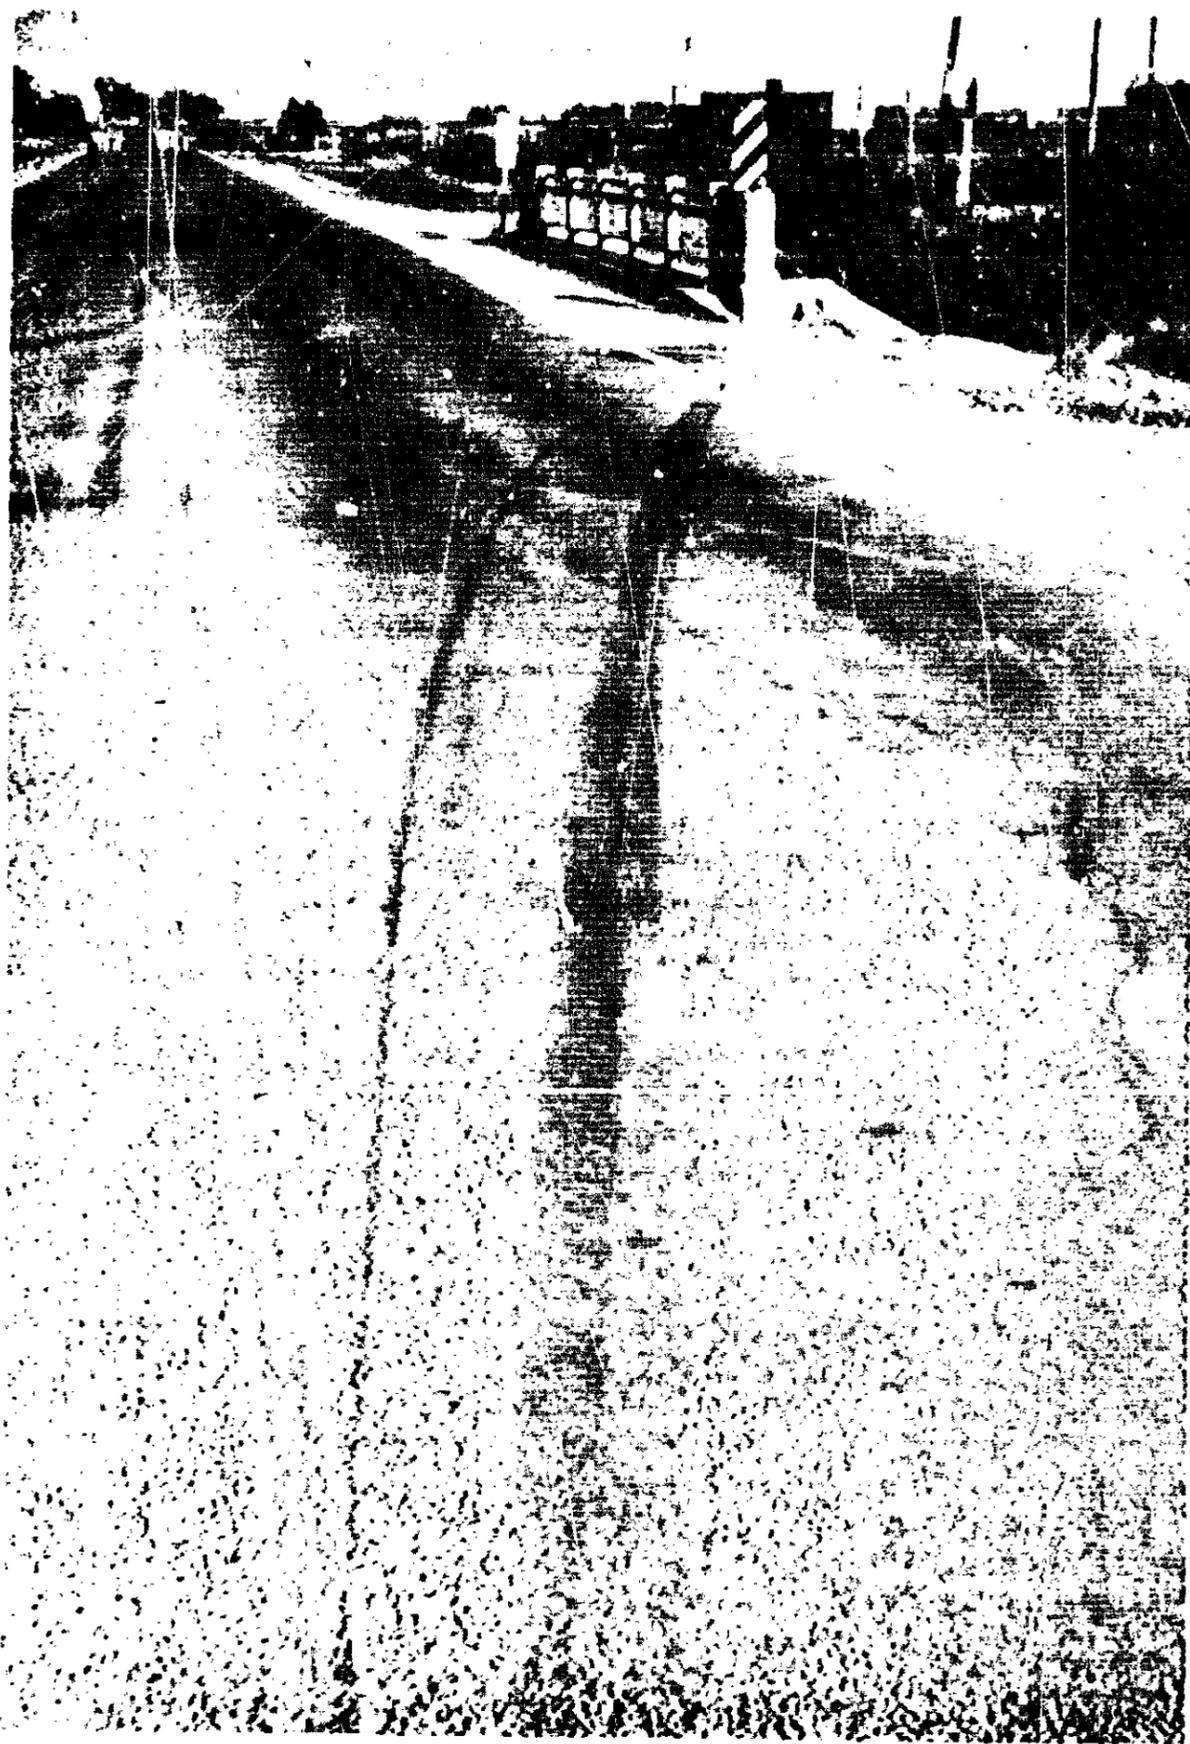
At impact, the tires on the left side of the van were on the roadway centerline. (See figure 5.) The van rolled onto its left wheels and traveled off the right side of the road. The left side of the van then struck the front of the concrete bridge parapet that was located about 4 1/2 ft beyond the edge of the pavement. The right front passenger and a passenger seated on the right side of the first bench seat were ejected through the windshield and into the irrigation canal. The van came to rest on its left side; the front of the van rested on top of the bridge wing wall, below and beside the parapet. The windrower came to rest facing the right shoulder of the road, and the cutting attachment had separated from the front of the machine.

Figure 5.--View of roadway beyond point of impact. Note the left-side tire scuff marks of the van leading to the bridge parapet, and the diagonal object marker in front of the parapet.

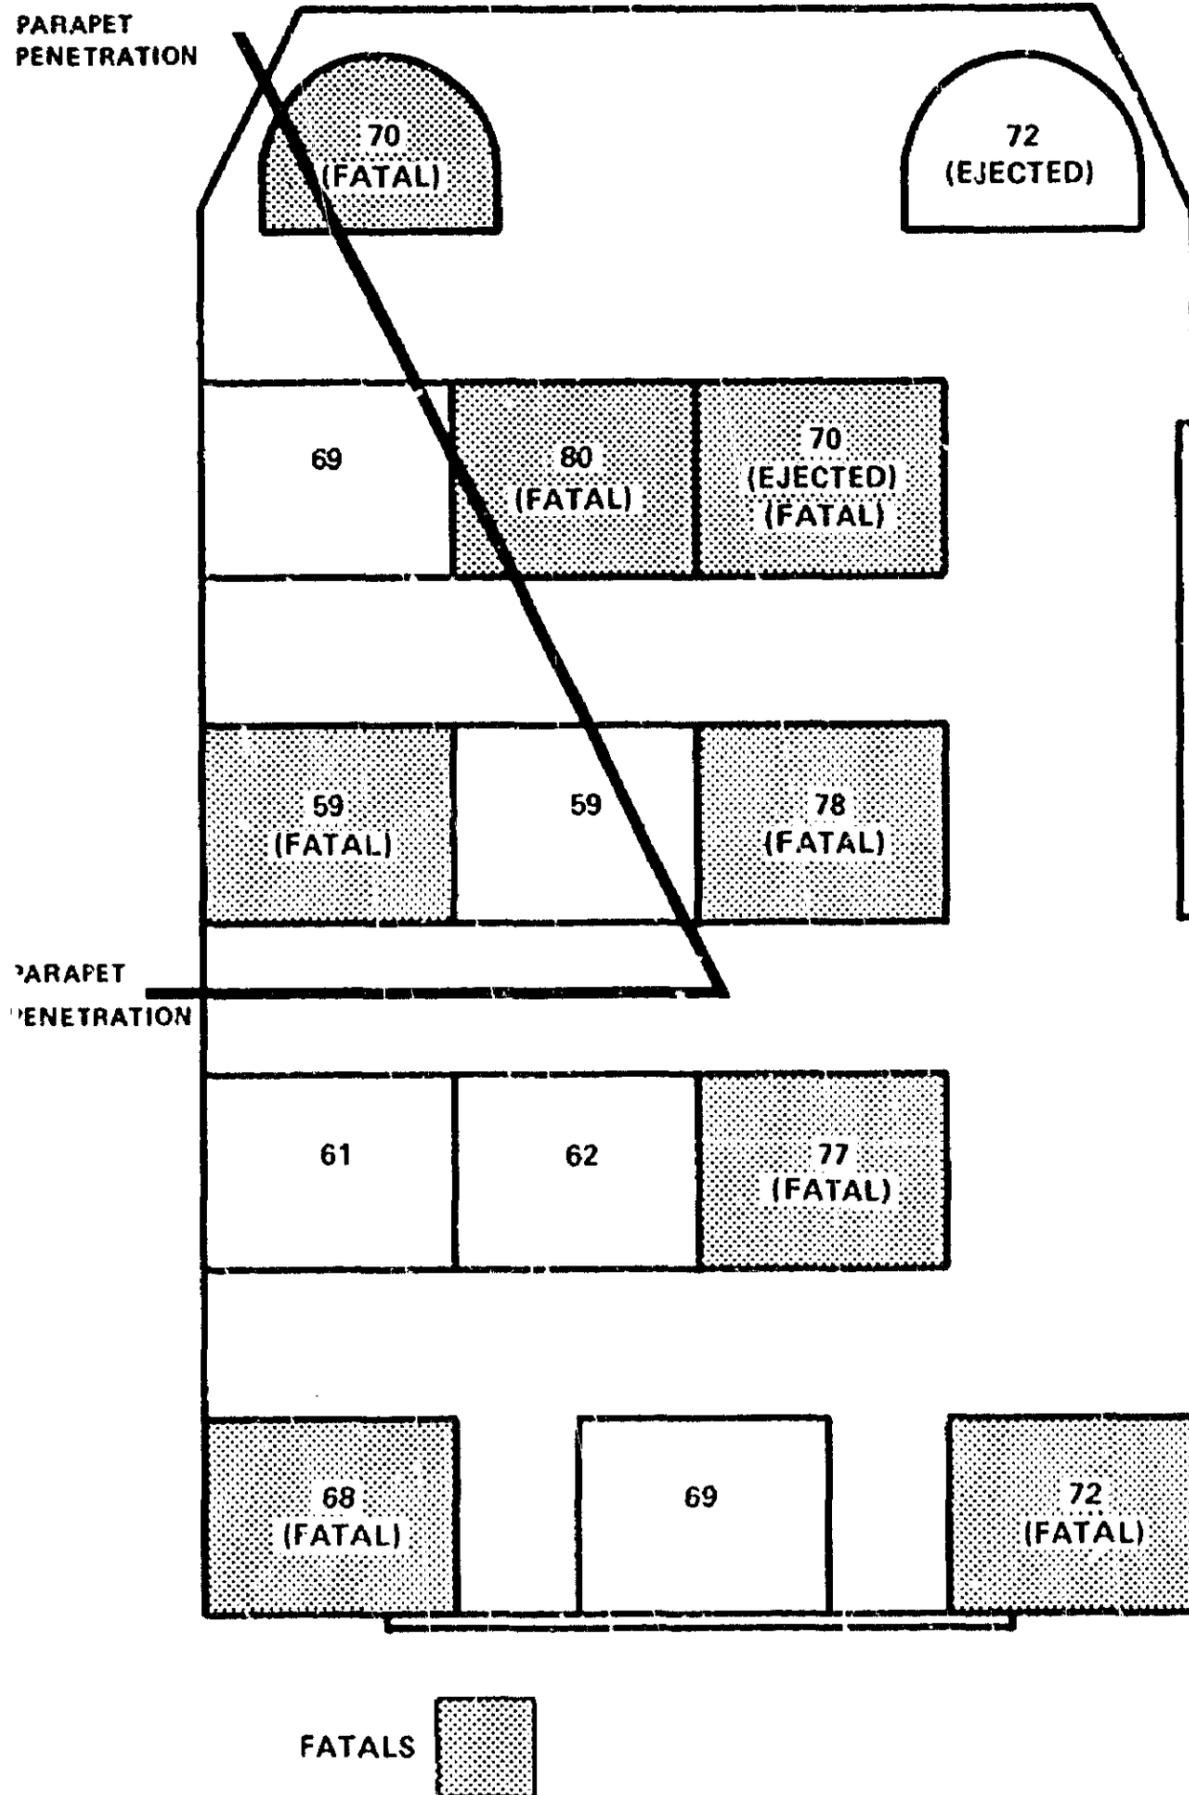
The ages of the van occupants ranged from 59 to 80 years. (See figure 6 for the age, seating position, and the degree of injury to van occupants.) The ejected right front passenger was hindered by a shoulder injury but managed to swim to and crawl up the embankment. The other ejected occupant was found several hundred feet downstream. No autopsies of the passengers were performed; the examining doctor noted that the deceased ejected occupant had incurred severe traumatic injuries during ejection and drowning was not the probable cause of death.

Figure 6.—Van seating chart showing occupant ages and injuries.

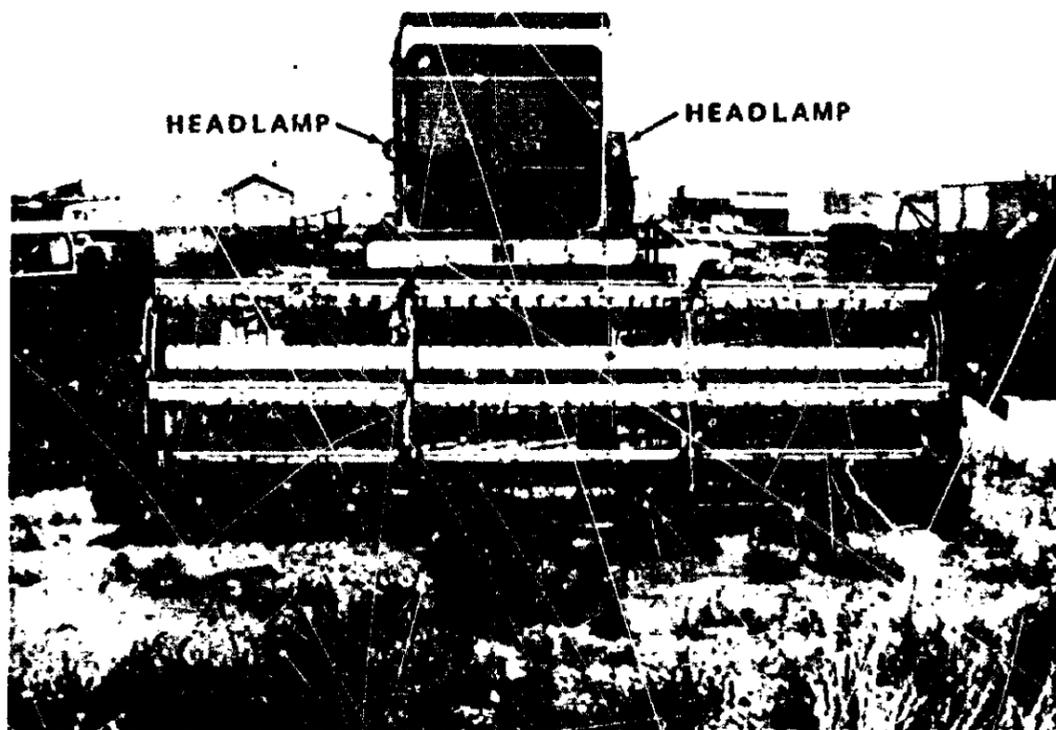
Figure 9.—Front view of windrower. Note two white head lamps, one on each side and at the front of the cab.

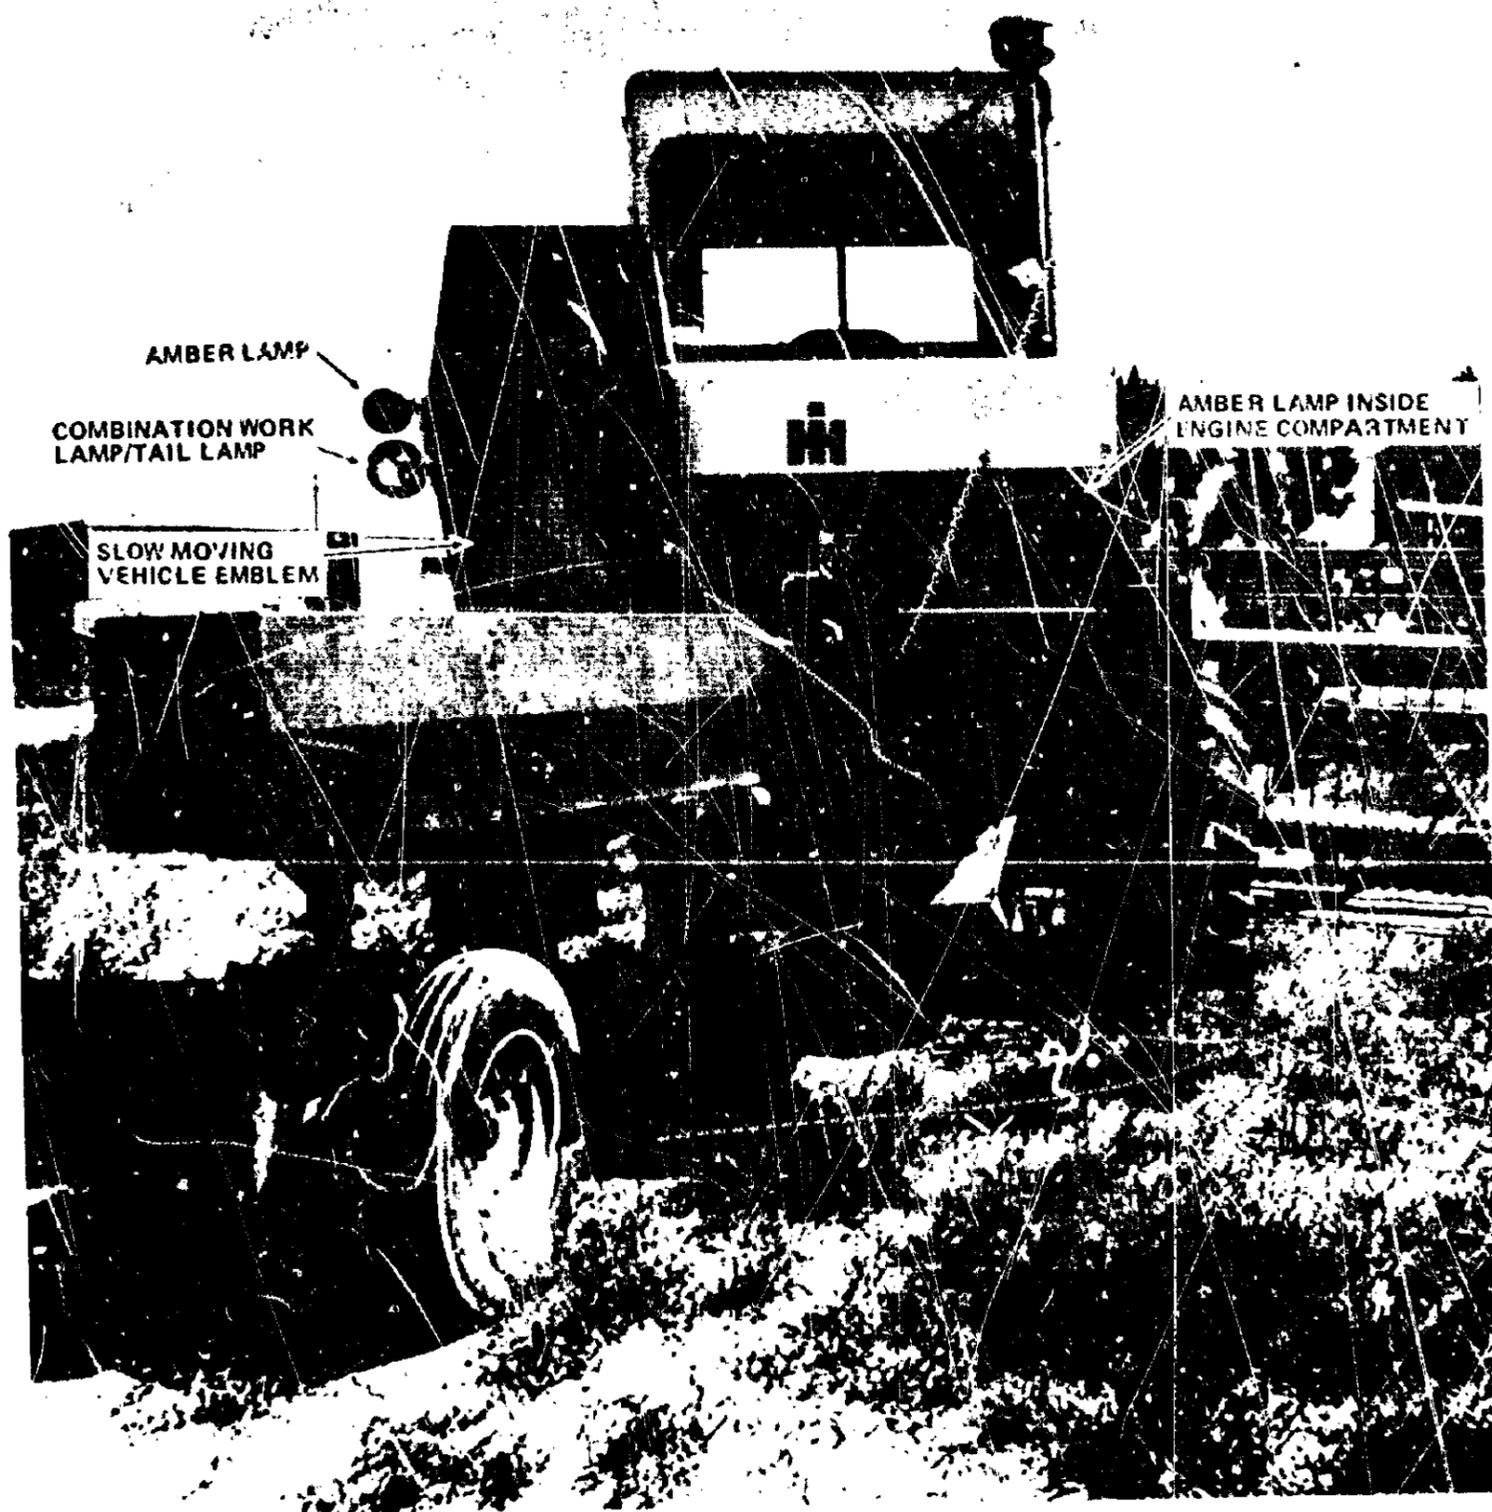
Figure 10.—Rear view of windrower. Note combination work lamp/tail lamp on left side, amber lamp above, slow-moving vehicle emblem, and amber lamp inside the engine compartment.

A single switch in the cab was designed to activate all of the lamps on the vehicle. The amber flashing lamps were not operable when tested by the Utah Highway Patrol shortly after the accident, and the driver reported that they were not operable at the time of the accident. Investigation revealed that the flasher unit was corroded, that the right side light bulb filament was broken, and that the left lamp appeared to have a poor ground connection.

The slow-moving vehicle emblem was not visible at distances beyond 300 ft when any form of windrower rear lighting was in use. The emblem seemed to have been positioned too close to the left amber and red lamps, and its reflected color was too similar to the color of the lights for it to be distinguishable at greater distances. The rear white work lamp "washed out" all other features of the windrower until the van was less than 300 ft from the windrower. At more than 1,000 ft from the windrower, the rear white work lamp was somewhat similar in appearance to the "yard lights" south of and perpendicular to the highway. Individual investigators were able to begin making various judgments to distinguish the work lamp from the "yard lights" at about 1,000 ft from the windrower. These judgments consisted of: (1) the white light from the work lamp was straight ahead, was in the path of the van, and was brighter than the "yard lights," (2) the work lamp was a green-white color while the "yard lights" were a blue-white color, (3) the work lamp was at a lower elevation than the "yard lights," and (4) the work lamp appeared to be a single lamp that could have belonged to an approaching vehicle. However, it was also possible to assume that (1) the road ahead curved to the left and the light was not on the road, and (2) the light ahead was not from a vehicle because it would appear to be almost stationary on a slow-moving vehicle. Although no specific point could be established, there was general agreement that the differences between the windrower white work light and the "yard lights" and the danger of striking the windrower light became more and more obvious as the investigators moved closer to the windrower.

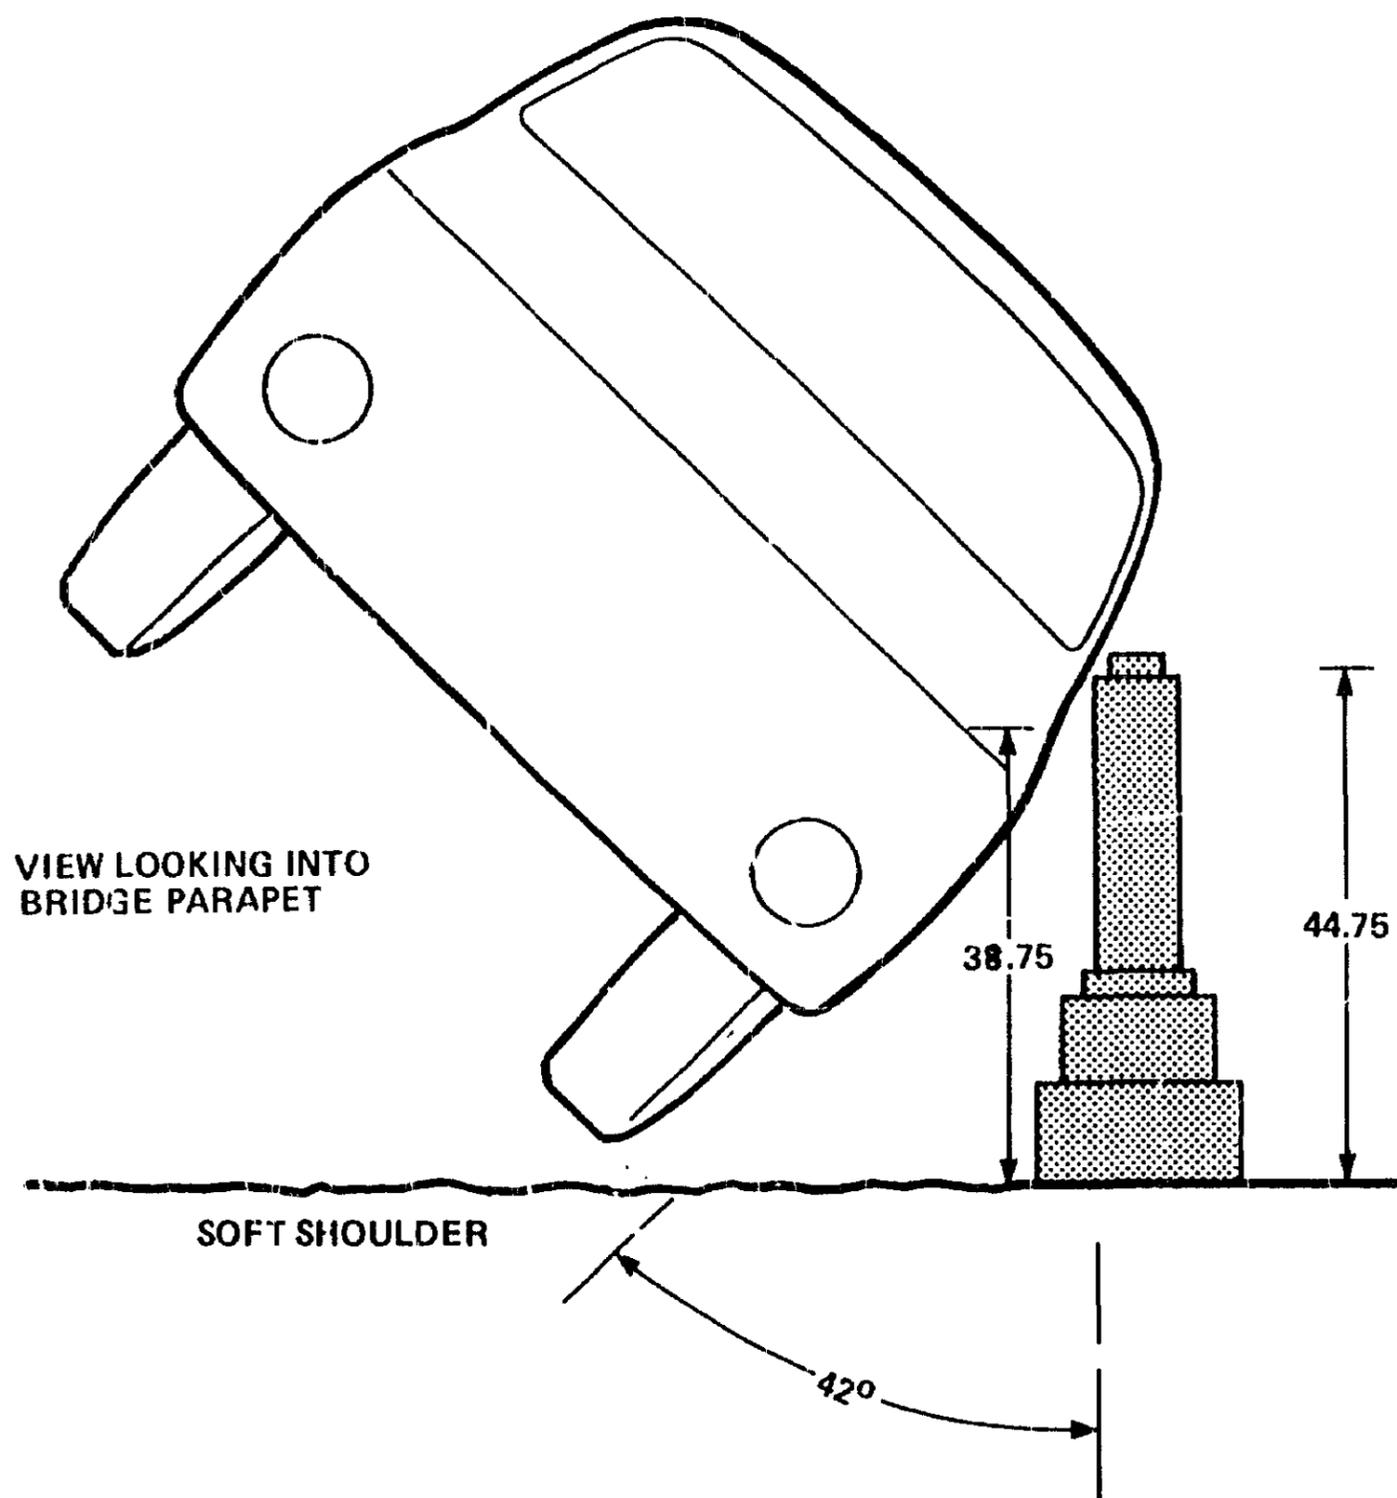
Contact with the bridge parapet was more significant than the collision between the van and windrower. The Safety Board evaluated whether there would have been any change in accident severity if a conventional impact attenuator or approach guardrail system had been installed in front of the parapet. According to the physical evidence, the van did not slide into the parapet; the parapet was directly in the van's path as it crossed the edge of the pavement at a 30° angle to the roadway. Accordingly, the right front corner of the van had the potential to first strike an impact attenuator or guardrail system about 8 ft west of the parapet.

Figure 11.—Angle of impact with bridge parapet.
