Highway Accident Report: Two-Vehicle
Collision and Fire, U.S. Route 422
Indiana, Pennsylvania, September 22, 1979

(U.S.) National Transportation Safety Board
Washington, DC

3 Apr 80

TWO-VEHICLE COLLISION AND FIRE
U.S. ROUTE 422
INDIANA, PENNSYLVANIA
SEPTEMBER 22, 1979

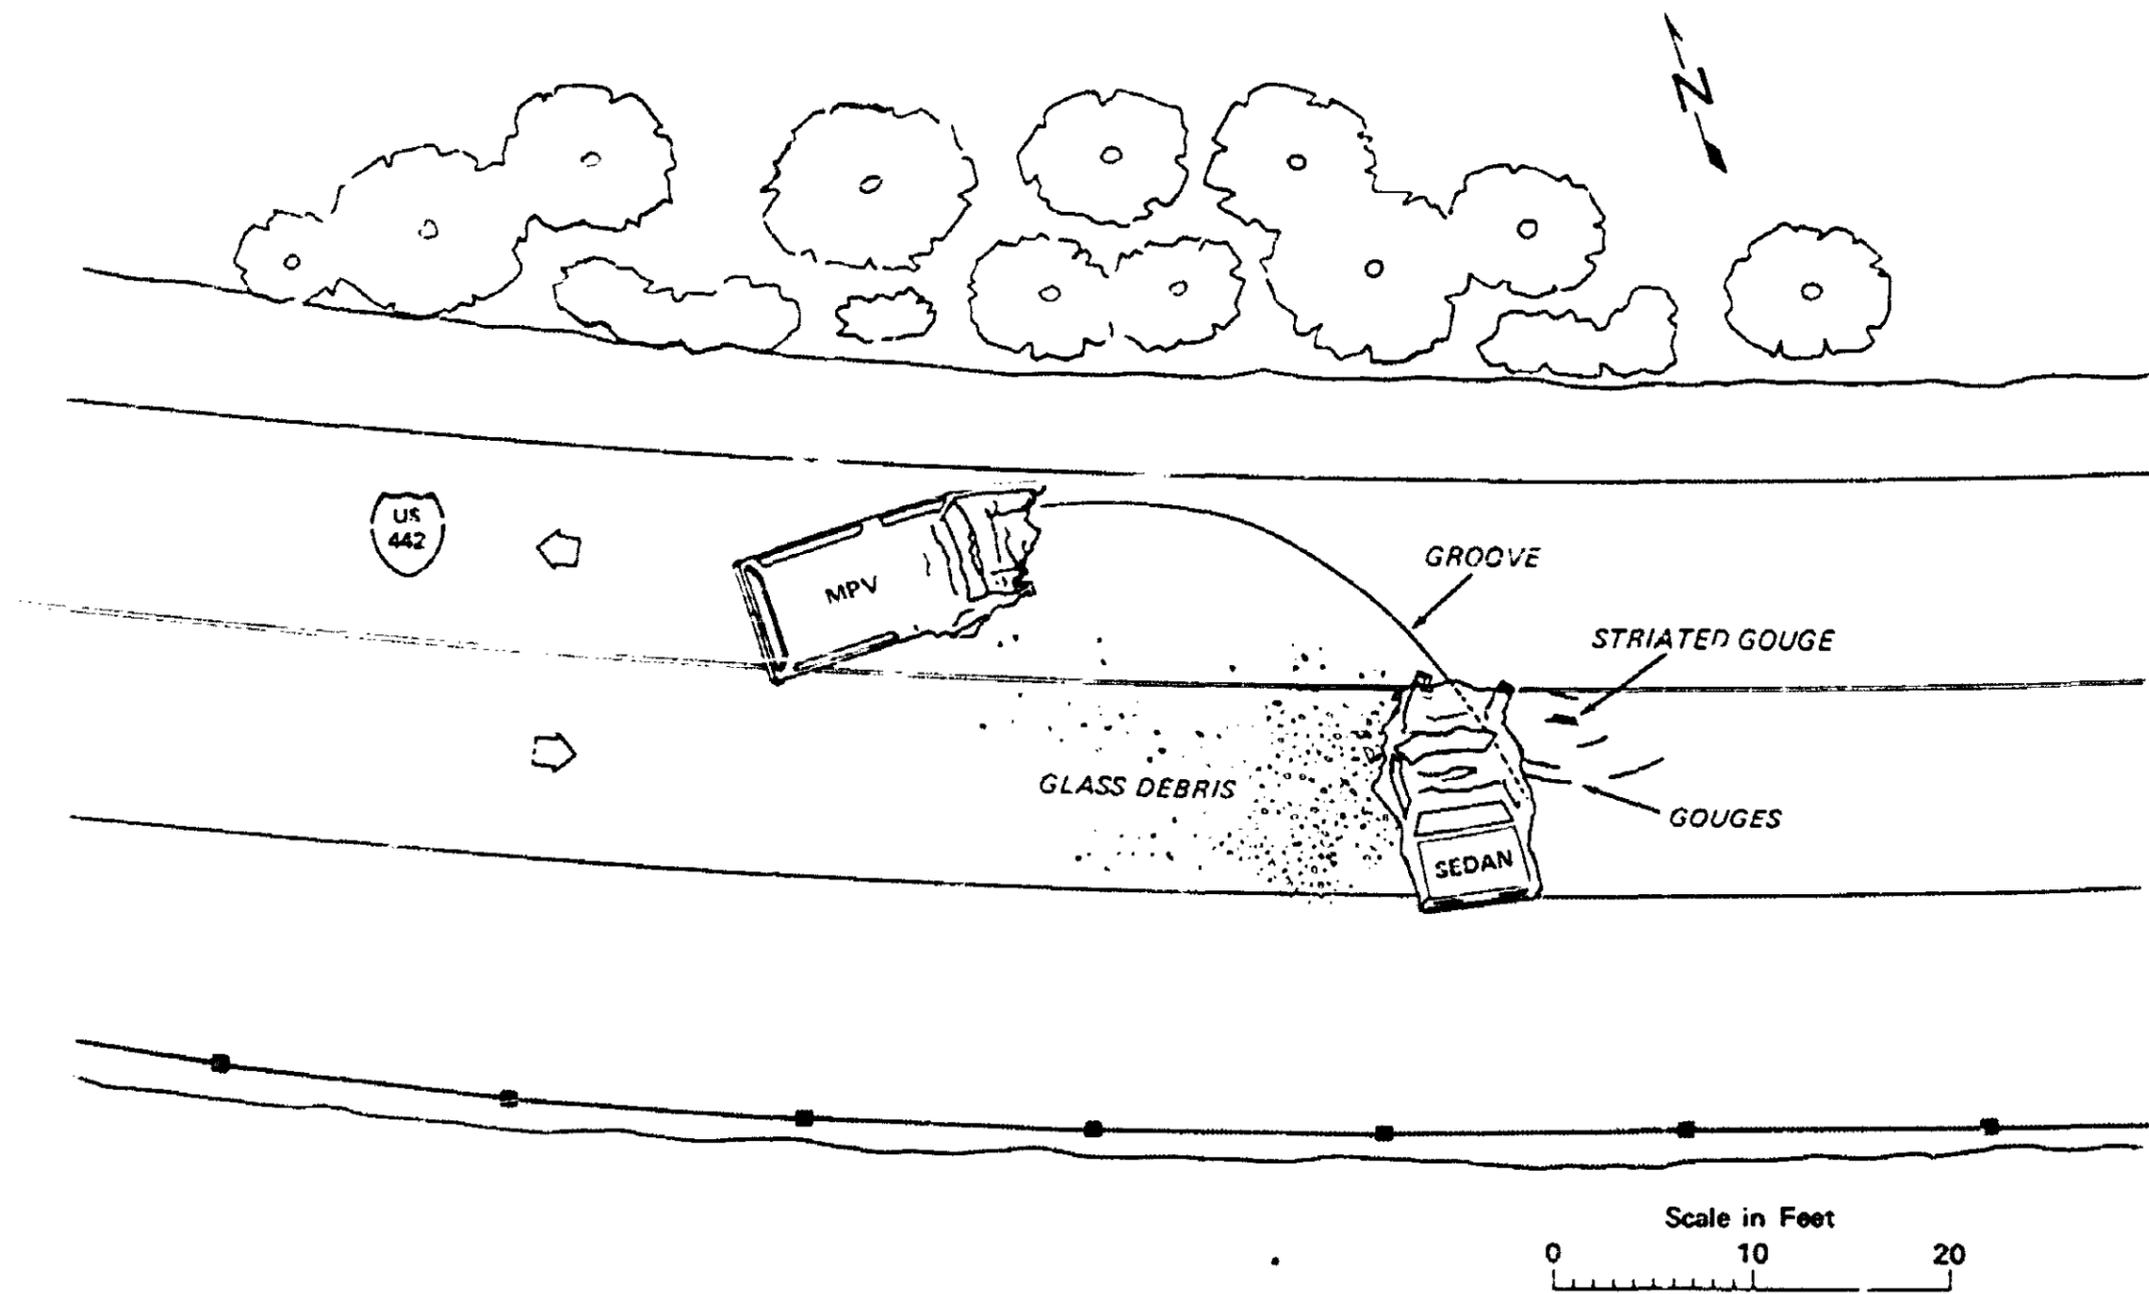
The westbound sedan and the eastbound MPV approached each other on a curved section of U.S. Route 422 where they collided virtually head-on in the eastbound lane. The sedan came to rest in the eastbound lane facing north, and the MPV came to rest in the westbound lane facing northeast. (See figure 1.) One MPV passenger was ejected and was found in the roadway next to the right side of the MPV. There were no witnesses to the crash.

Figure 1. Accident scene diagram.

One gouge mark in the eastbound lane consisted of a pattern of narrow striations that matched the gear teeth of the sedan's flywheel. These striations were 1 foot 8 inches in length. They were slightly curved to the right in a westerly direction. The eastern end of the striations was 2 feet 5 inches south of the centerline and proceeded westerly at a 14° angle toward the centerline. (See figure 9.) Another mark, a long continuous groove gouge, began in the eastbound lane and ended in the westbound lane where the MPV came to rest. This groove gouge started 5 feet 1 inch north of the eastbound lane edgeline and continued northwesterly in a curved configuration for 26 feet 8 inches. The end of this groove gouge was 2 feet south of the westbound lane edgeline. This mark stopped at the front of the MPV's point of rest. (See figures 10 and 11.) A concentration of glass debris was on the roadway in the eastbound lane west of the sedan's point of rest. (See figure 1.)

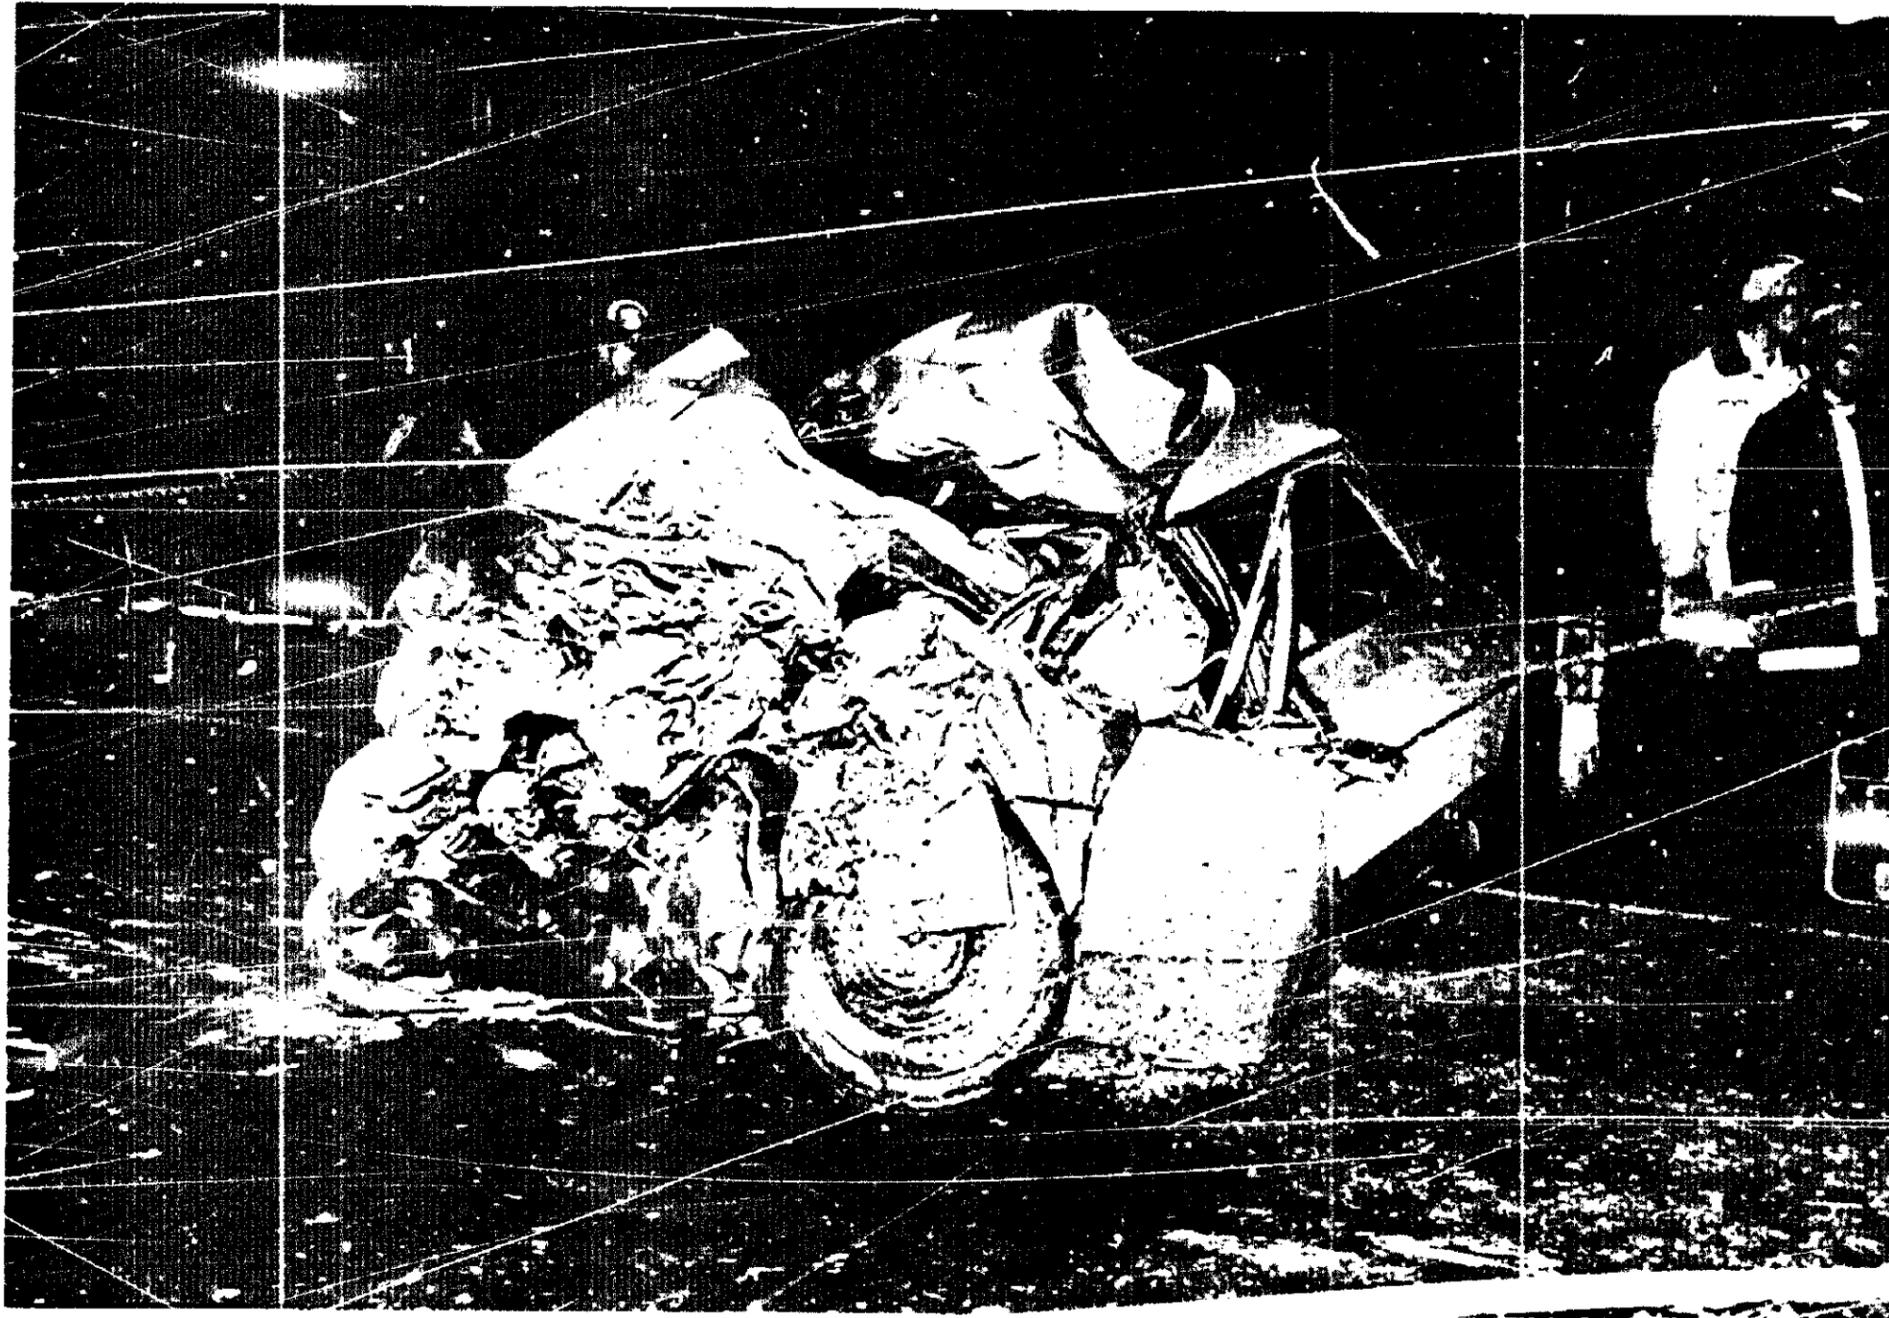
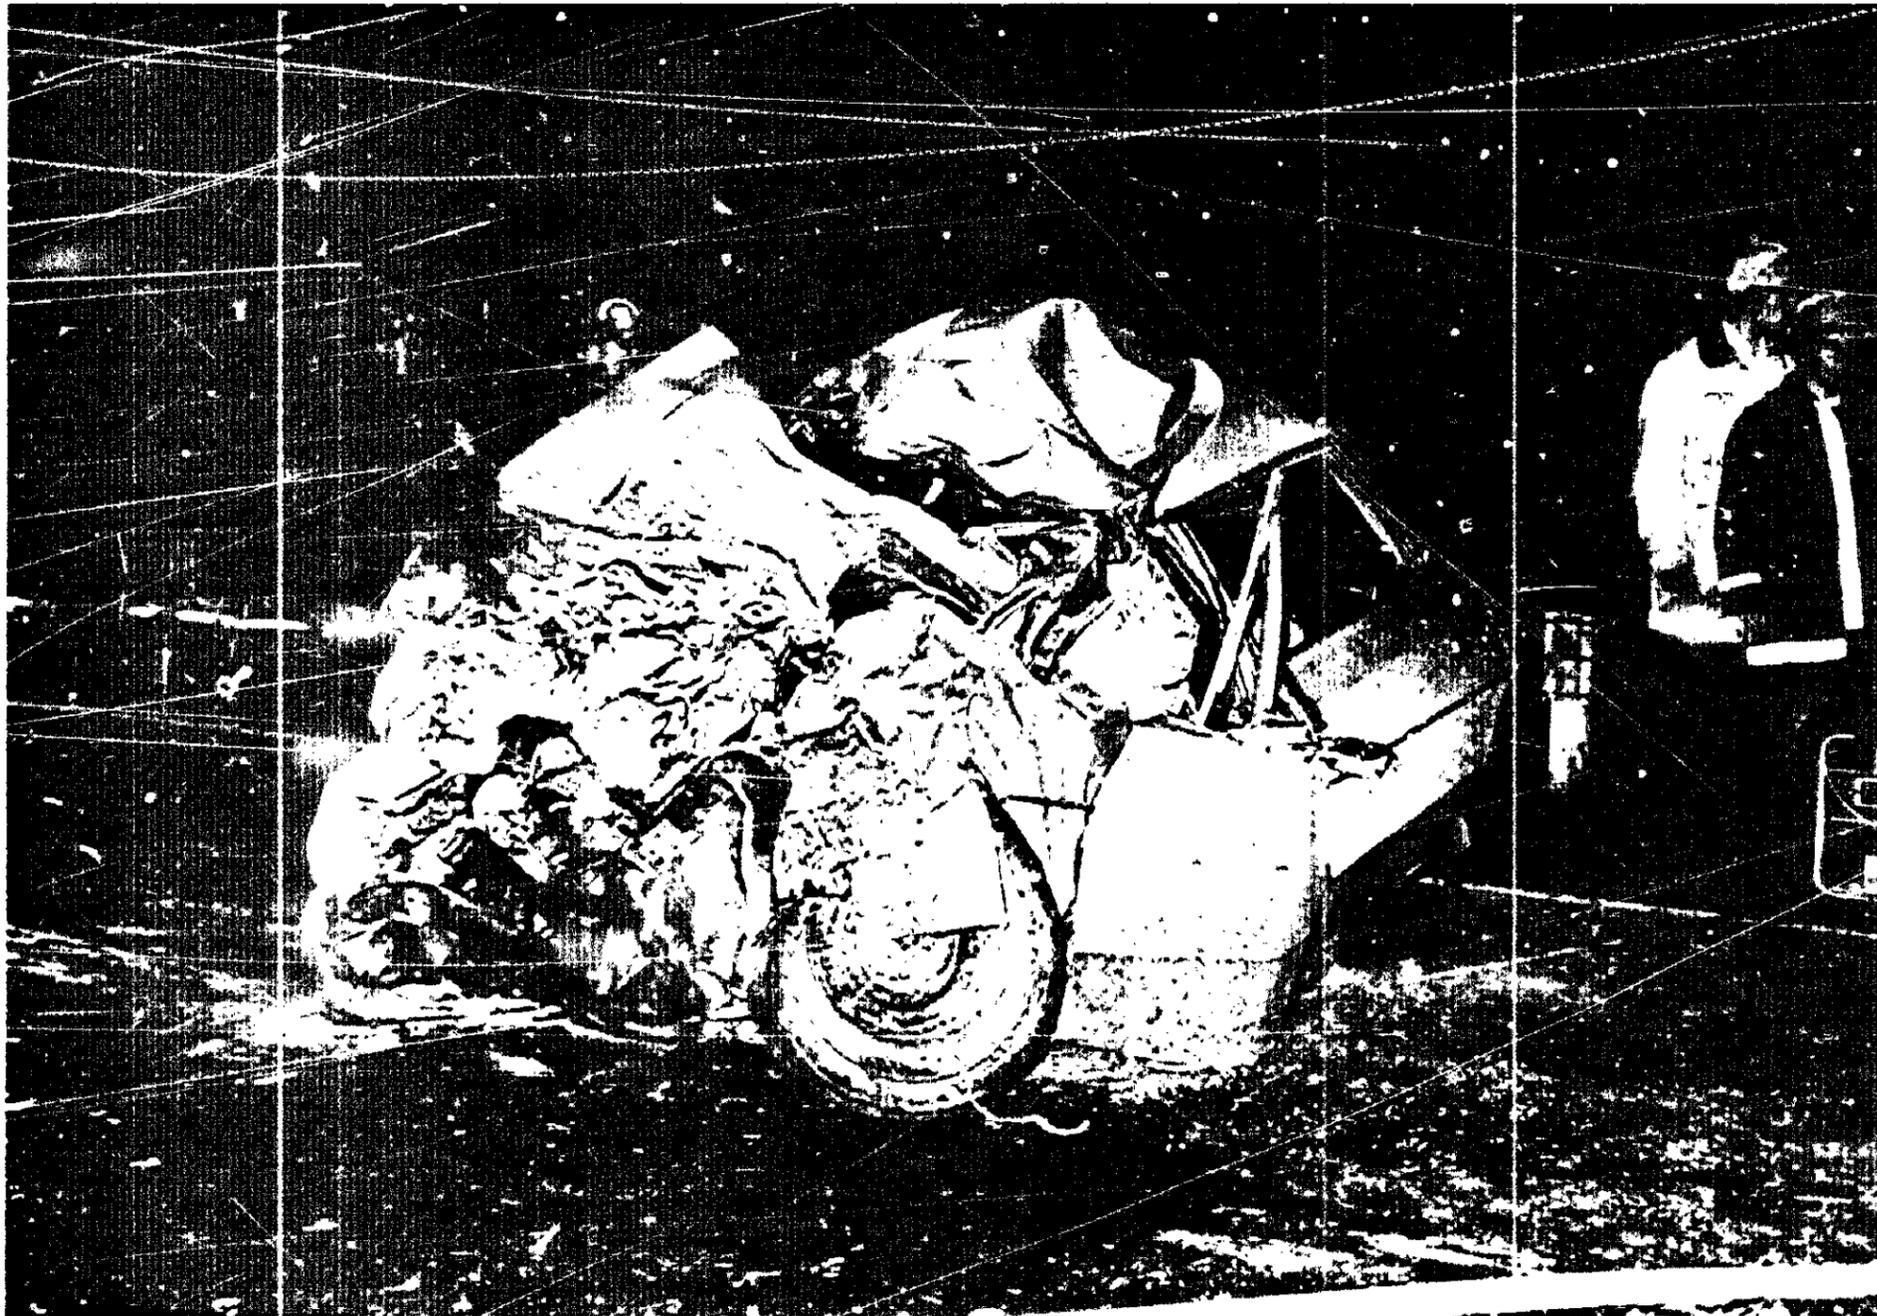
Damage to the vehicle was extensive; the complete front was crushed rearward and slightly to the right. The right front was collapsed 77 inches and the left front 58 inches. The only sections not deformed were the rear bumper, trunk lid, and rearmost portion of the rear fenders. The front fenders, bumper, grill, hood, radiator, engine, transmission, front wheels, and frame were all crushed rearward and slightly to the right. (See figure 2.) The roof was severely buckled and all window glass was broken. (See figure 3.) The flywheel housing was broken, and the bottom of the flywheel gear was bent rearward; asphalt deposits were embedded in the gear teeth. The right side of the leading edge of the crushed hood had a dent, which when placed against the front of the MPV matched the contour of the MPV's engine fan hub. To the right of this dent were honeycomb-shaped impressions that matched the design of the MPV's radiator core. (See figure 4.) An orange mark, matching the color of the shattered speedometer needle, was visible on the speedometer face between the 70 and 75 mph calibration lines.

Figure 2.—Left-front view of westbound sedan at final rest position.

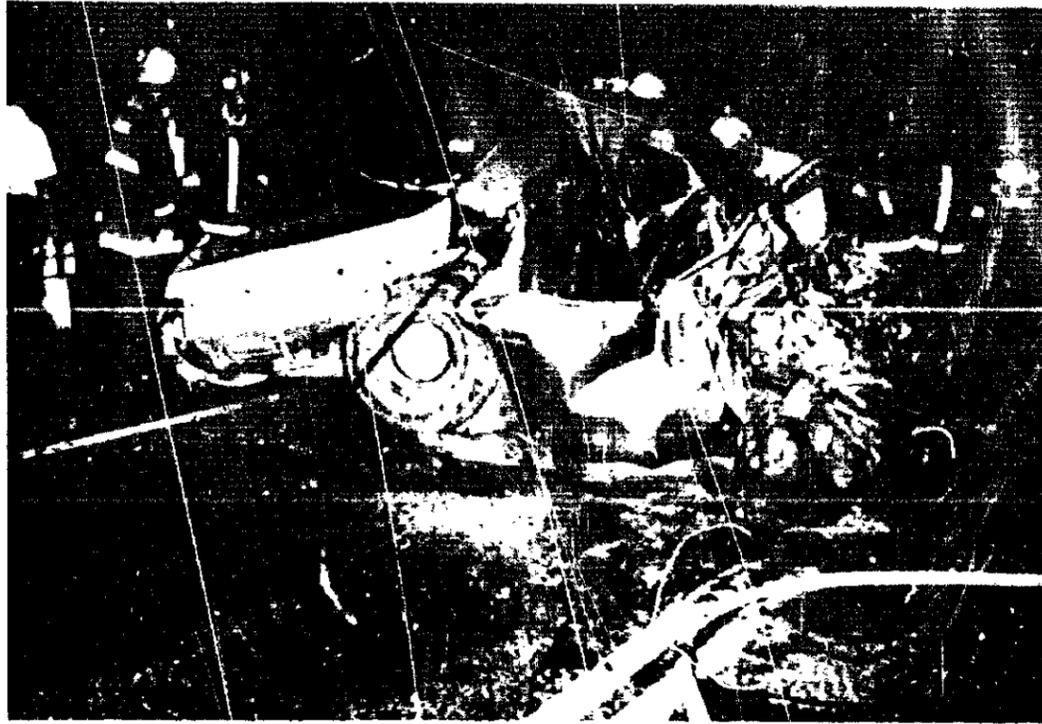
Figure 3.—Right-side view of sedan.

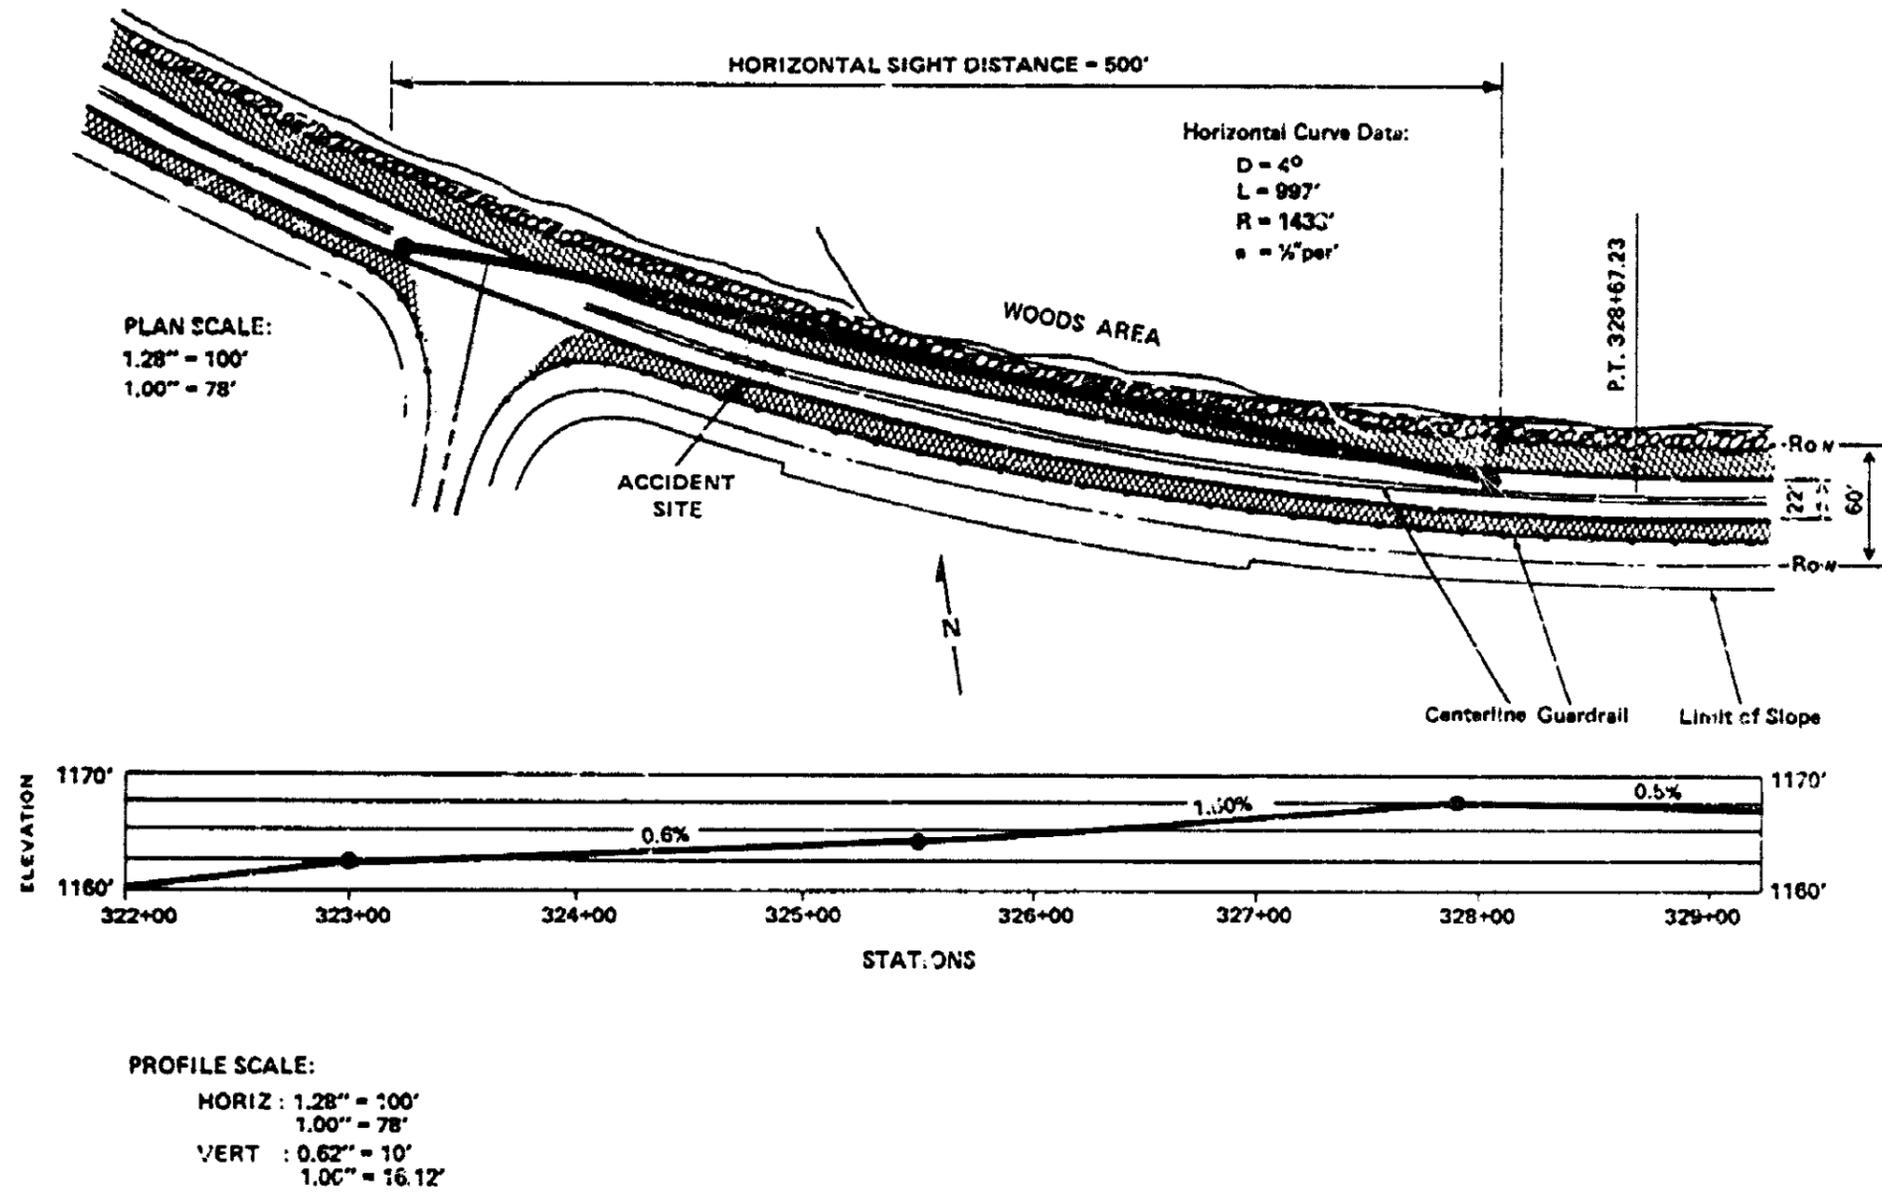
U.S. Route 422 is an east/west, State-maintained, Federal-aid primary highway through hilly terrain. At the crash site, U.S. Route 422 was an unlit, relatively level, undivided, 2-lane, 22-foot-wide highway that curved 4° (1,433-foot radius) right for westbound traffic. It had a superelevation of 1/2 inch per foot. (See figure 7.) The average daily traffic was 8,200 vehicles per day. The curved section was 997 feet long. The crash occurred in the curve about 367 feet west of the point of tangent. There was a 5-foot-wide, gravel shoulder for the westbound lane which was adjacent to a vegetation-covered, steep upward dirt slope that limited the horizontal sight distance to about 500 feet. (See figures 7, 8, and 9.) The eastbound lane was bordered by a 12-foot-wide, gravel shoulder that was adjacent to a steep downhill dirt slope. A cable guardrail was located on the outer edge of the south shoulder. The road surface, which had been fully repaved in the summer of 1975, was bituminous concrete. Segments of the road had been repaved between September 5 and September 10, 1979. Solid white edgelines delineated the roadway and a double yellow centerline separated the lanes. These lines had been repainted on September 19, 1979, 3 days before the accident. The posted speed limit on the road was 55 mph, and "no passing zone" signs were posted facing westbound traffic at 500-foot intervals, from 6,700 feet east to 2,100 feet west of the crash site.

Figure 7.—Plan and profile.

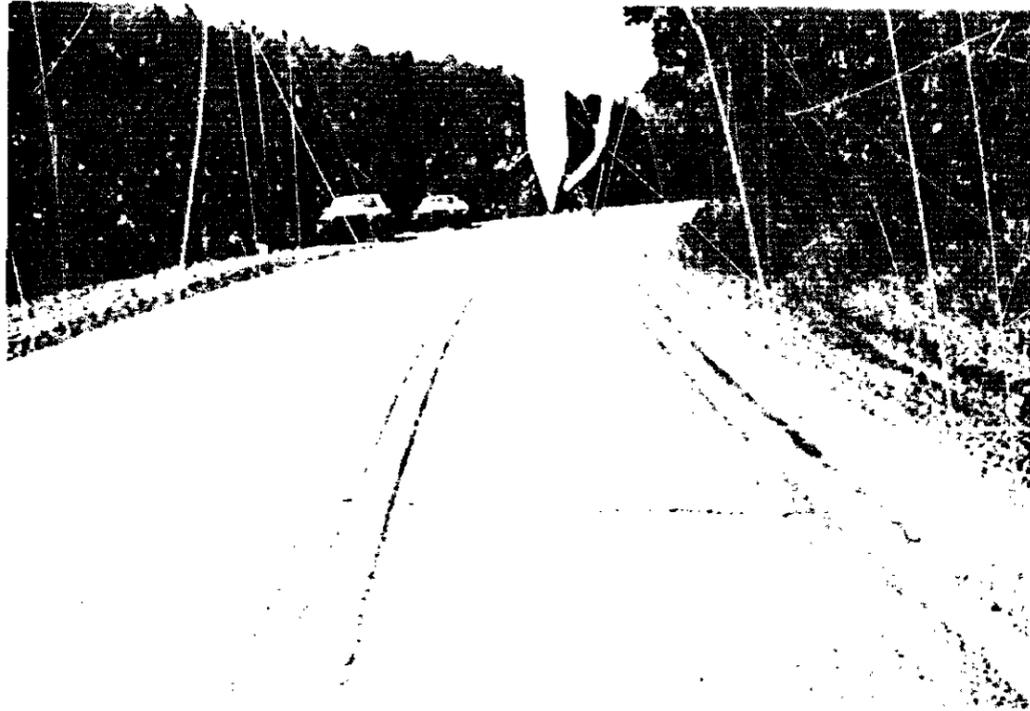
Figure 8.—Westbound view of U.S. 422.
Arrow indicates approximate point of impact.

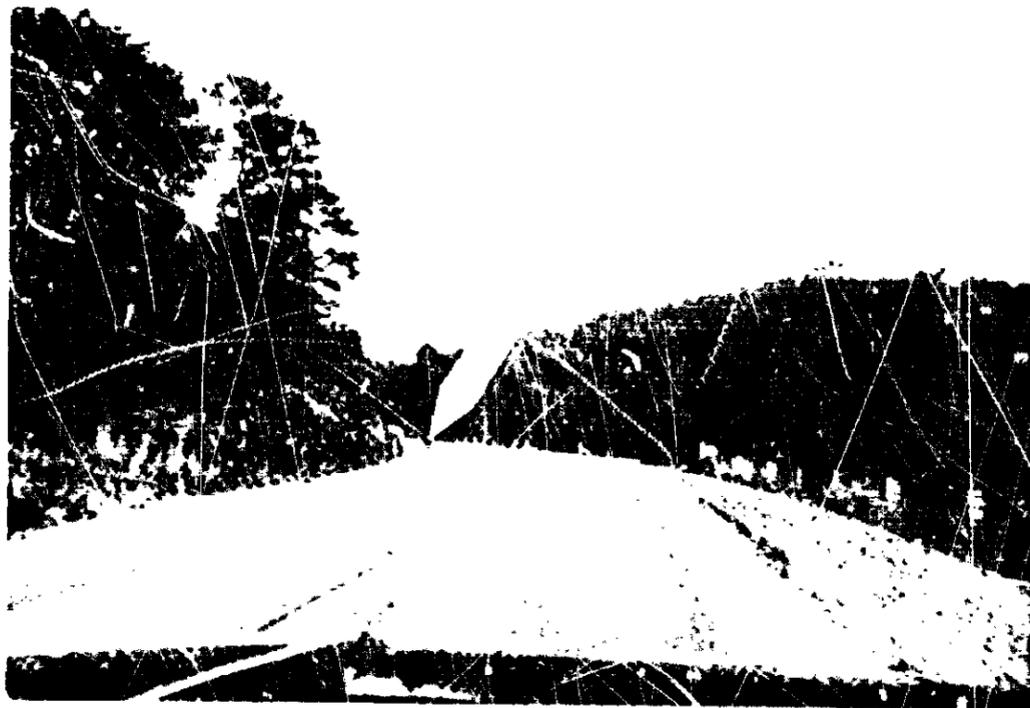
Figure 9.—Eastbound view of U.S. 422.
Arrow indicates point of impact.

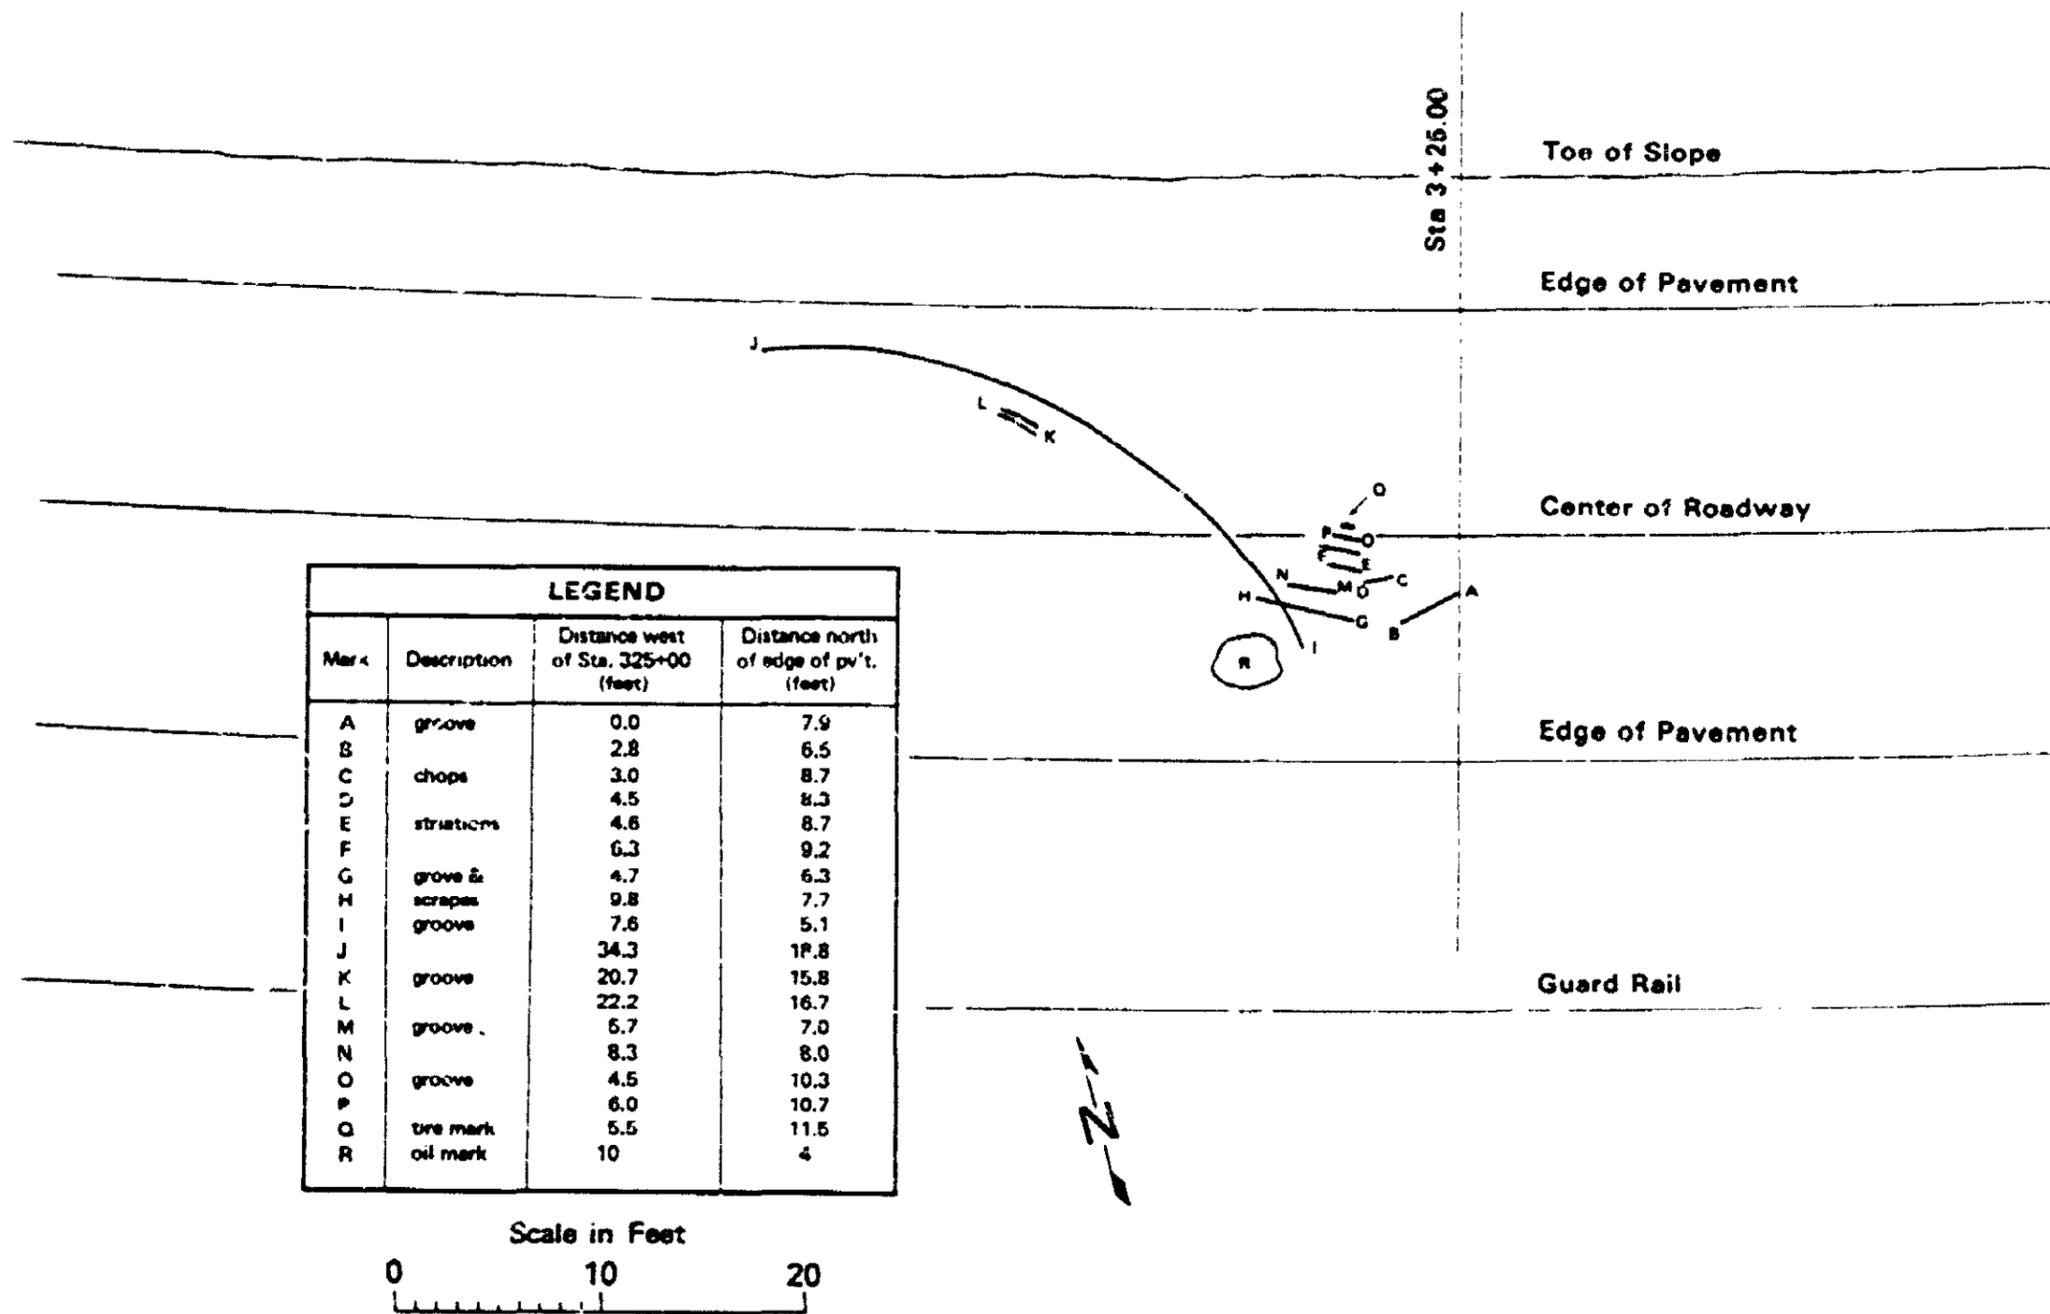
Figure 11.—Marks on roadway.
