NATIONAL TRANSPORTATION SAFETY BOARD

HIGHWAY ACCIDENT REPORT

HEAD-ON COLLISION OF
AUTOMOBILE AND PICKUP TRUCK
U.S. ROUTE 64
NEAR PERRY, OKLAHOMA
FEBRUARY 23, 1980

NTSB-HAR-80 4

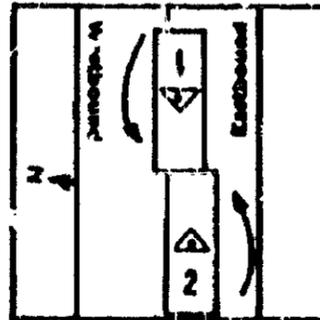
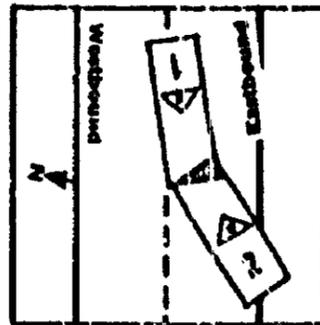
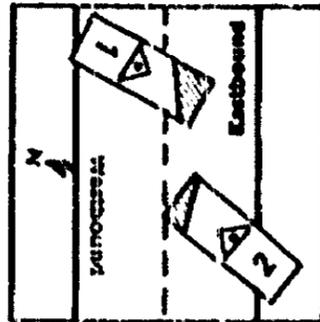
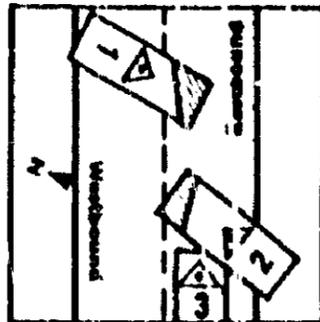
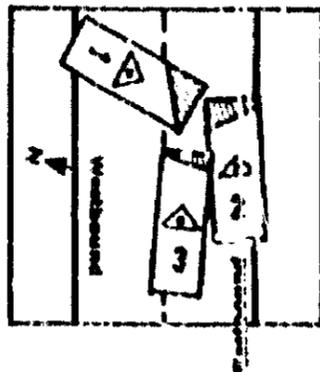
Figure 1.--Diagram of collision kinematics of two-door sedan (1), pickup truck (2), four-door sedan (3).

1. Initial impact positions and relative rotation of the two-door sedan and Pickup.

2. Maximum engagement of the two-door sedan and Pickup.

3. The distance of the two-door sedan and Pickup moved after first impact.

4. Initial impact of four-door sedan with Pickup.

5. Final rest positions of all three vehicles.

Accident reconstruction indicates that the two-door sedan and pickup truck impacted about 26 feet west of the crest of the 400-foot hill. The vehicles hit head-on, with a 12- to 18-inch offset, when 80 percent of the westbound two-door sedan was in the eastbound lane and when all of the eastbound pickup truck was in the eastbound lane with its left side on the centerline of the road.

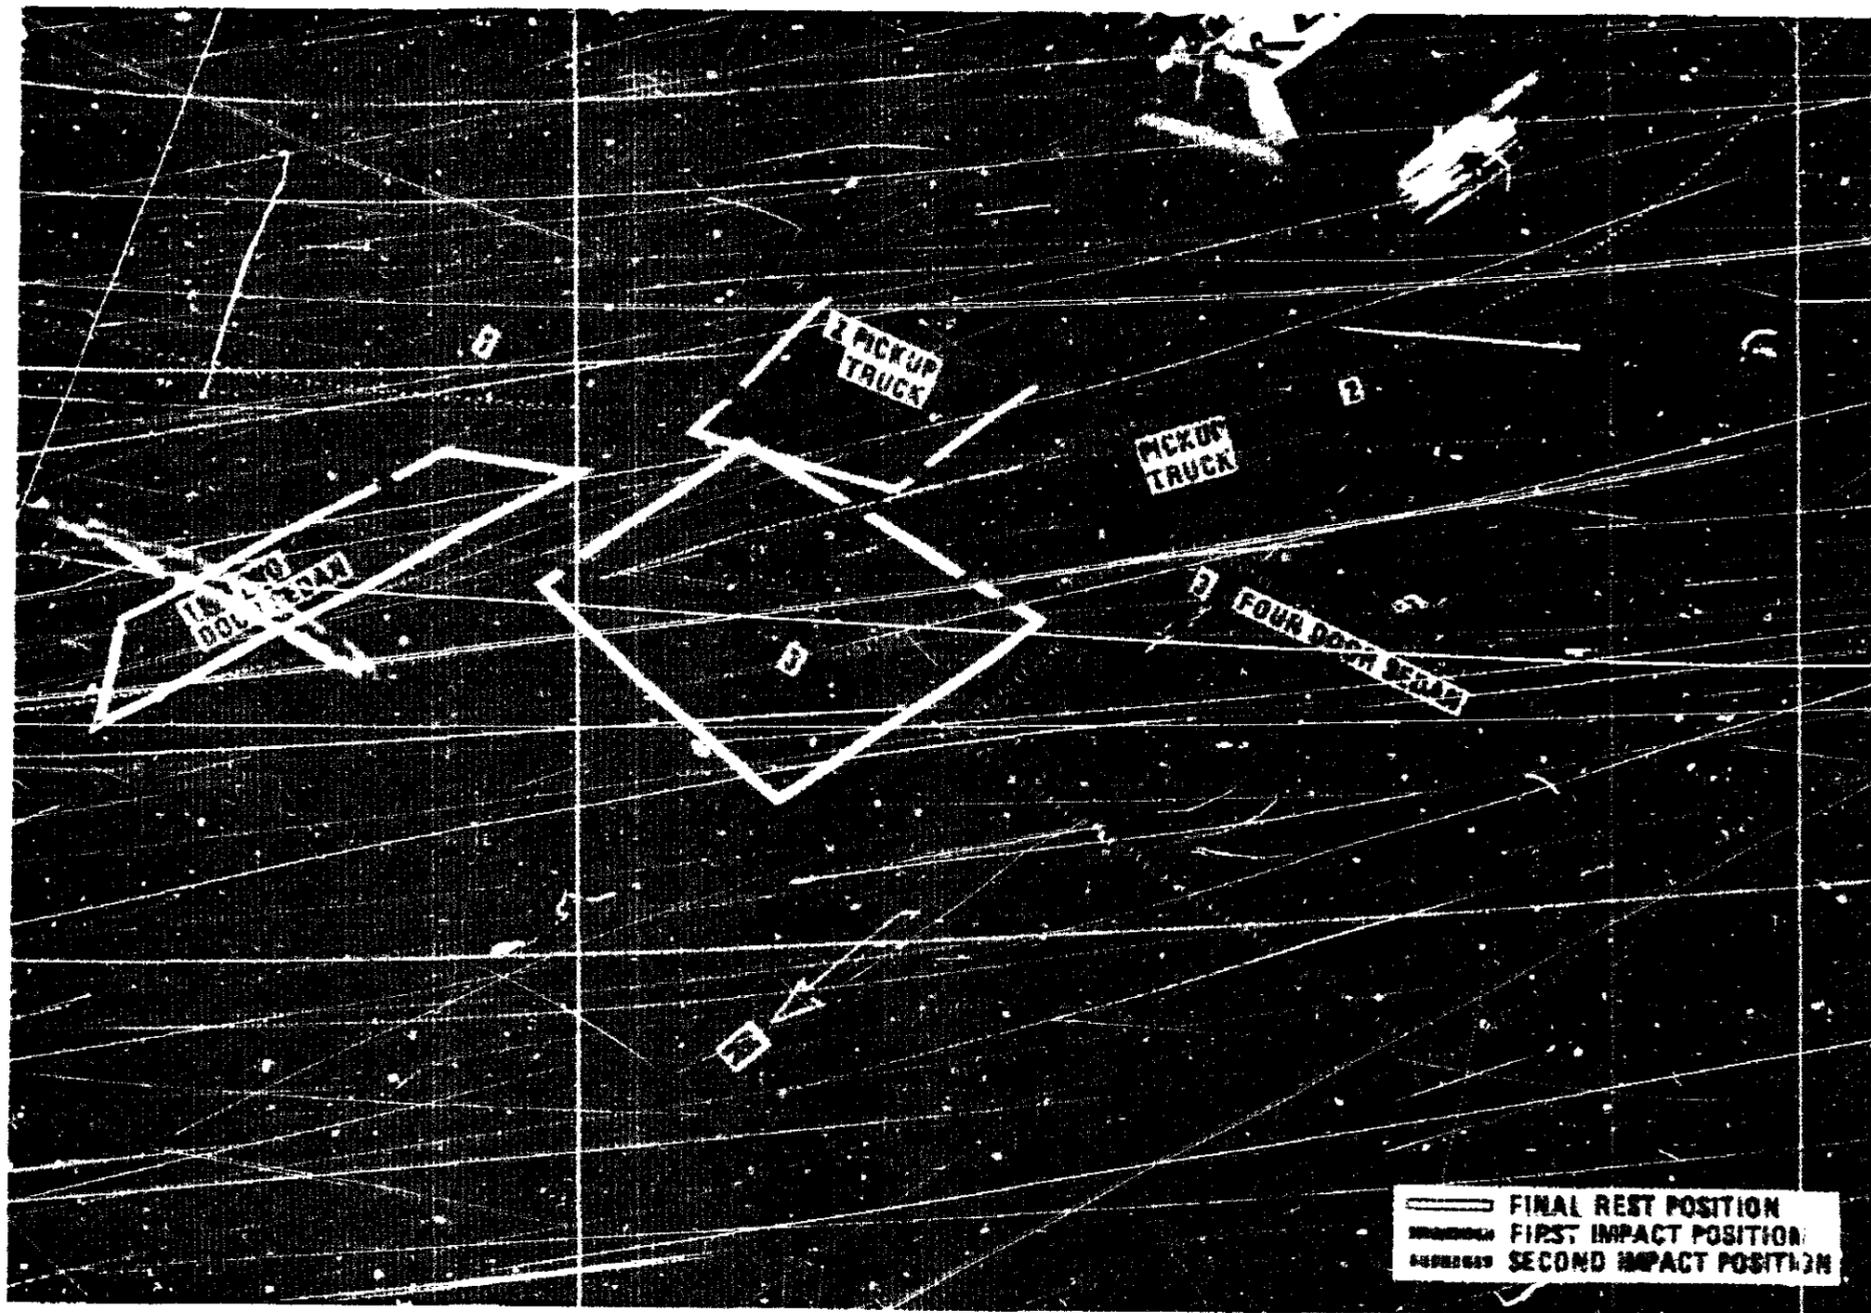
Figure 2.—Impact and final rest positions.

The positions of final rest and an approximate point of initial impact and secondary impact were determined using photographs taken by the Perry City Police Chief, physical evidence on the highway, and the vehicle damage. (See figure 2.)

After impact, the two-door sedan rotated counterclockwise about 66° while rebounding into the westbound lane and caught fire; all of the combustible materials burned. The initiating fuel source was probably gasoline draining from a broken tank-to-fuel pump line. The ignition source is unknown.

The pickup truck rotated about 45° counterclockwise while rebounding rearward in the eastbound lane and onto the shoulder. The eastbound four-door sedan collided with the left side of the pickup truck as it came to a momentary halt following its rebound from the first collision.

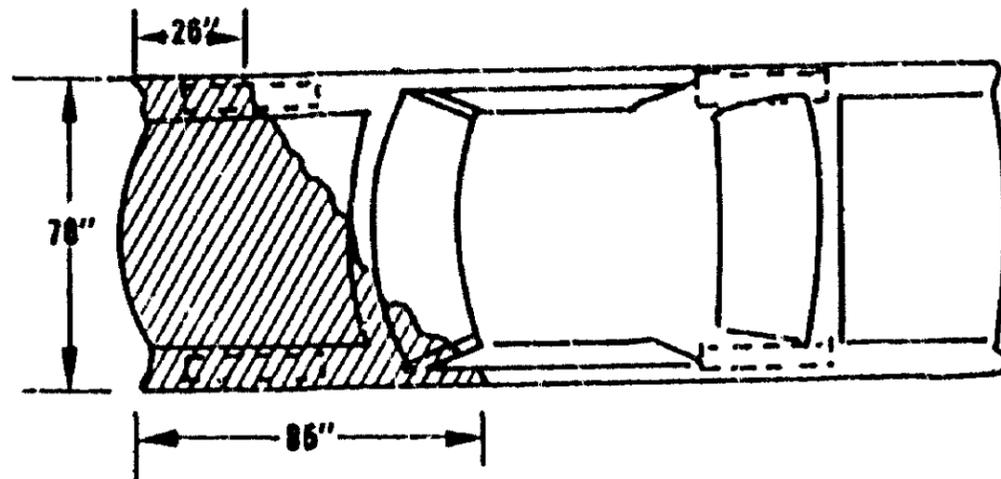
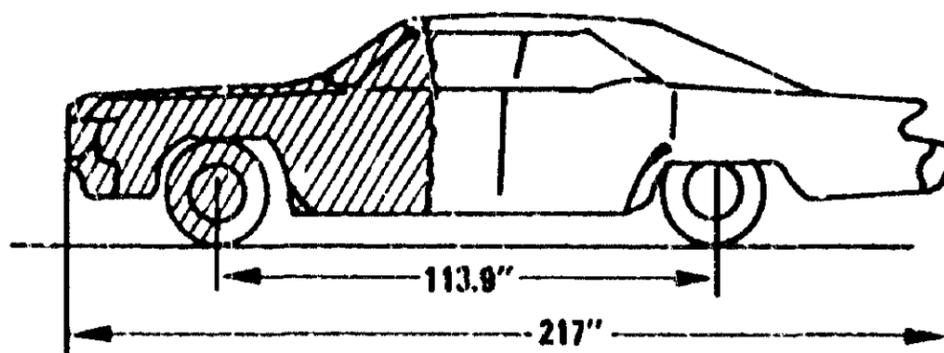
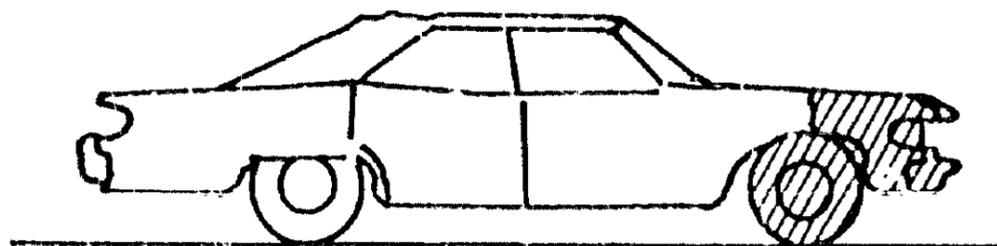
Figure 4.--Two-door sedan damage diagram.

The front end components of the two-door sedan were deformed rearward. The most significant deformation was 85 inches on the left and 26 inches on the right front. (See figures 3 and 4.)

Note: All vehicle components suffered fire damage except rear of trunk lid and right front fender.

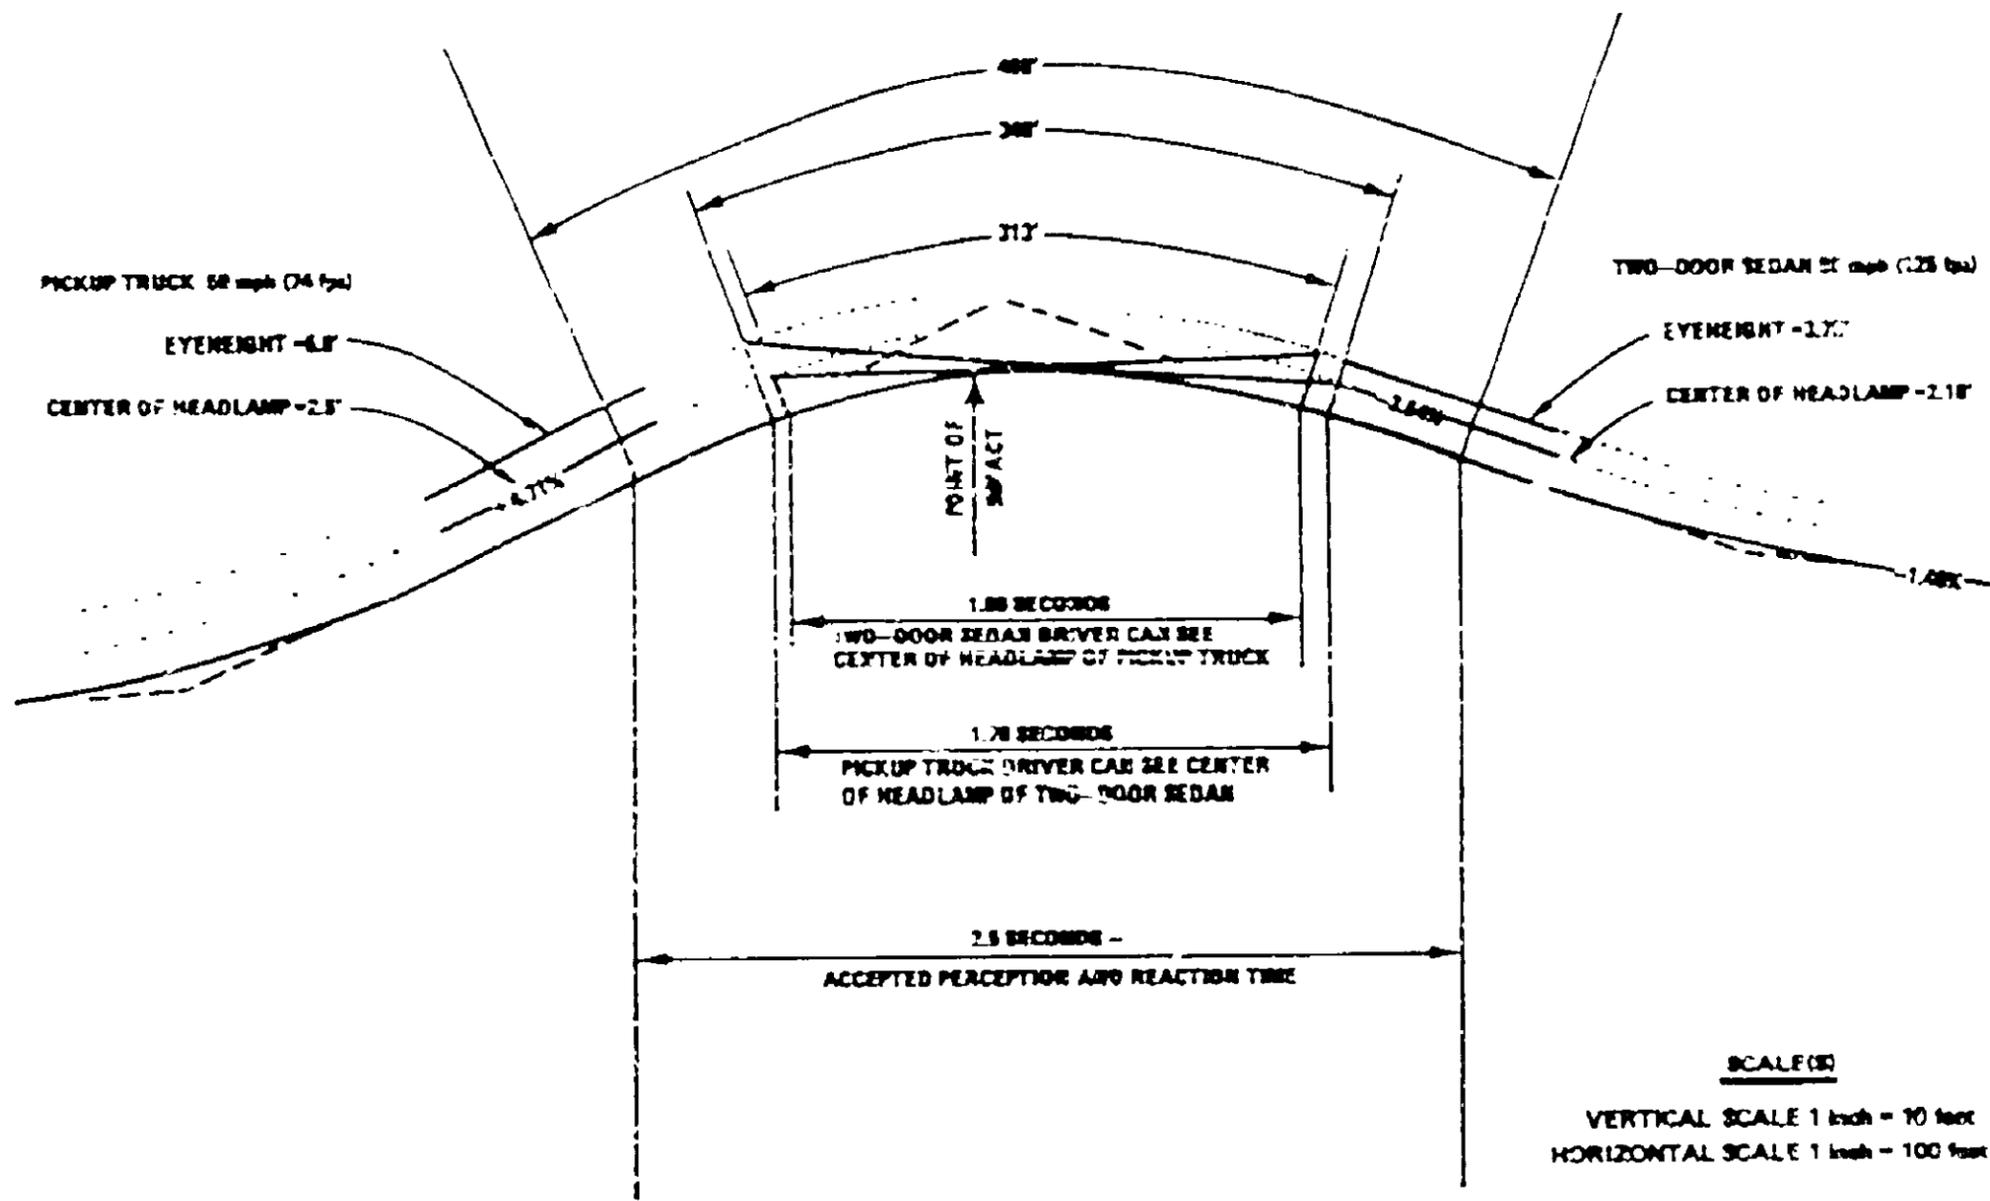
Figure 10.--Time and distance sight chart for two-door sedan and pickup truck.

The four-door sedan driver indicated that the pickup truck was traveling approximately 50 mph. Calculations indicated the speed of the two-door sedan was about 85 mph. At the relative closing speed of 135 mph (199 feet per second), both drivers only had 1.7 seconds to see the other vehicle before the collision. (See figure 10.)

The alcohol-impaired judgment and driving ability of the pickup truck driver probably was not a contributing factor in this accident. Without warning, he was suddenly confronted with an oncoming vehicle 340 feet away in his lane of traffic at a closing speed of about 135 mph (199 feet per second). He had about 1.7 seconds to recognize the hazard, decide on an evasive action, and react. Based upon the PIEV time of 2.5 seconds, the pickup truck driver did not have time to take evasive action. By the time he could have recognized the danger, made a decision, and reacted, the collision had occurred. (See figure 10.)
