Highway Accident Report - B and J Trucking
Company Truck Tractor/Coachella Valley Unified
School District Schoolbus Collision, State
Route 86, Near Coachella, CA, April 23, 1980

(U.S.) National Transportation Safety Board
Washington, DC

29 Sep 80

**B & J TRUCKING COMPANY TRUCK TRACTOR/
COACHELLA VALLEY UNIFIED SCHOOL DISTRICT SCHOOLBUS
COLLISION, STATE ROUTE 86
NEAR COACHELLA, CALIFORNIA
APRIL 23, 1980**

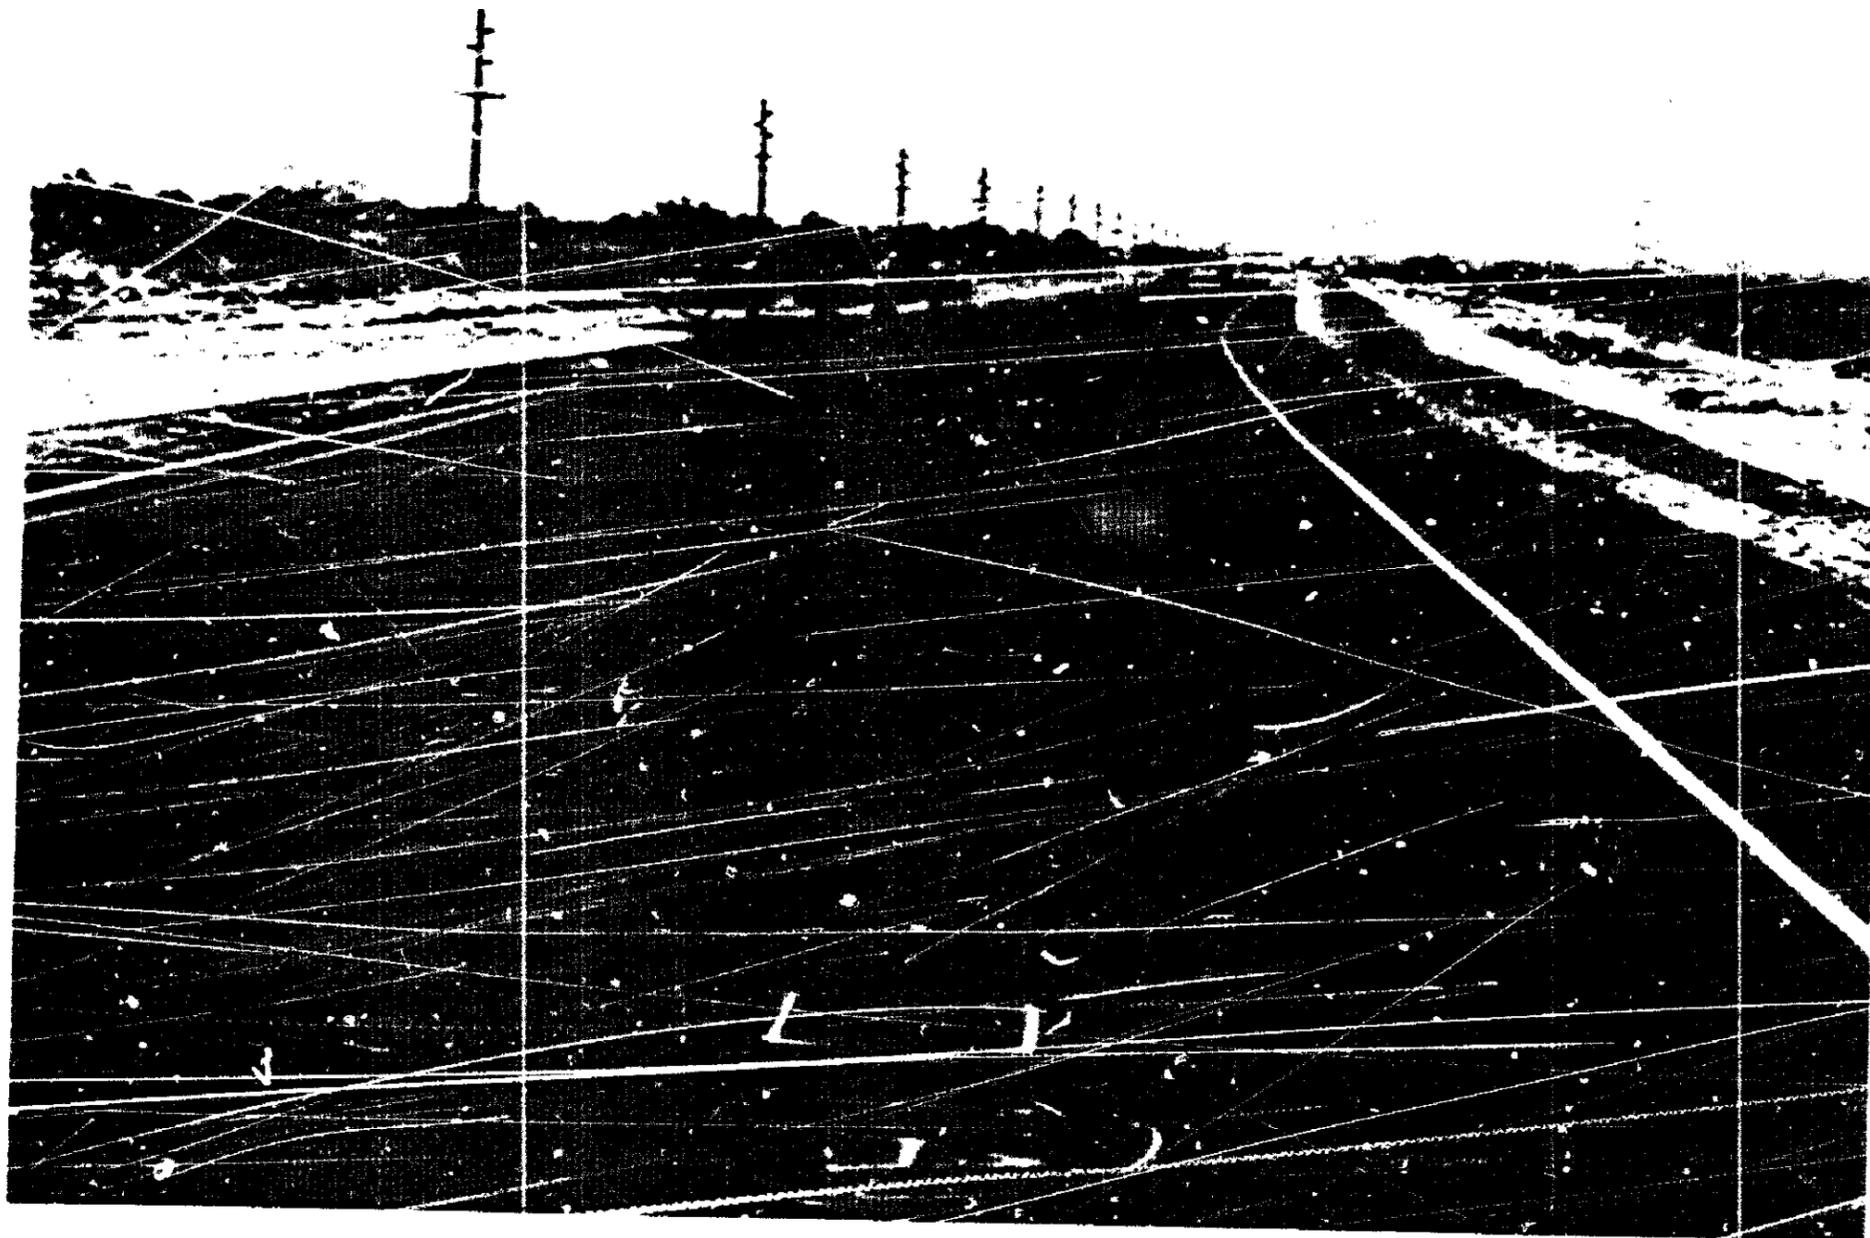
Figure 1.--Scalloped tire scuff mark.

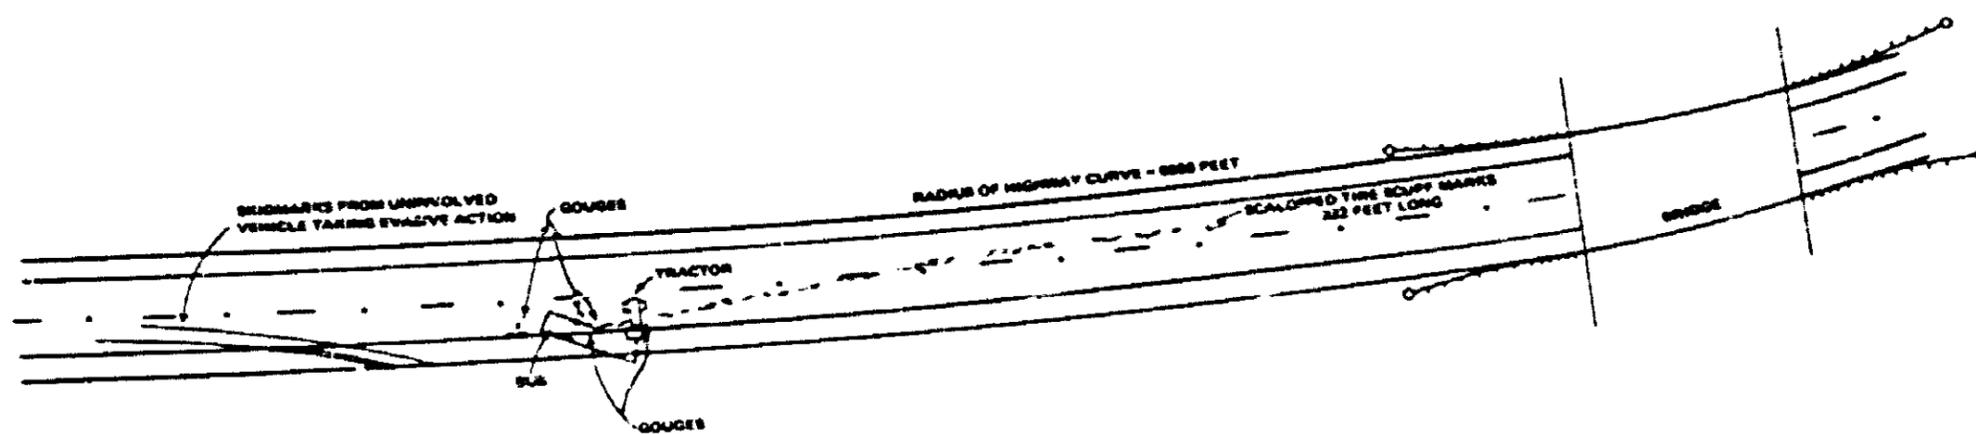
About 3:25 p.m., P.s.t., on April 23, 1980, a truck tractor was traveling north on California State Route 86, a two-lane rural highway in southern California. A schoolbus and two automobiles were traveling south. The driver of the second automobile estimated that the schoolbus was traveling between 50 to 55 mph, and he did not notice anything abnormal about the tractor's speed. The tractor had just crossed a 75-foot-long bridge and was about 400 feet from the end of a long, slight curve to the right when witnesses in the southbound vehicles saw and heard the left front tire blow out. A series of scalloped tire scuff marks, typically produced by a rolling flat tire, began at the point where the tire blew out. (See figure 1.) The tractor swerved to the left, crossed the centerline at about a 7° angle, and collided head-on with the schoolbus. (See figure 2.)

Figure 2.--Accident site.

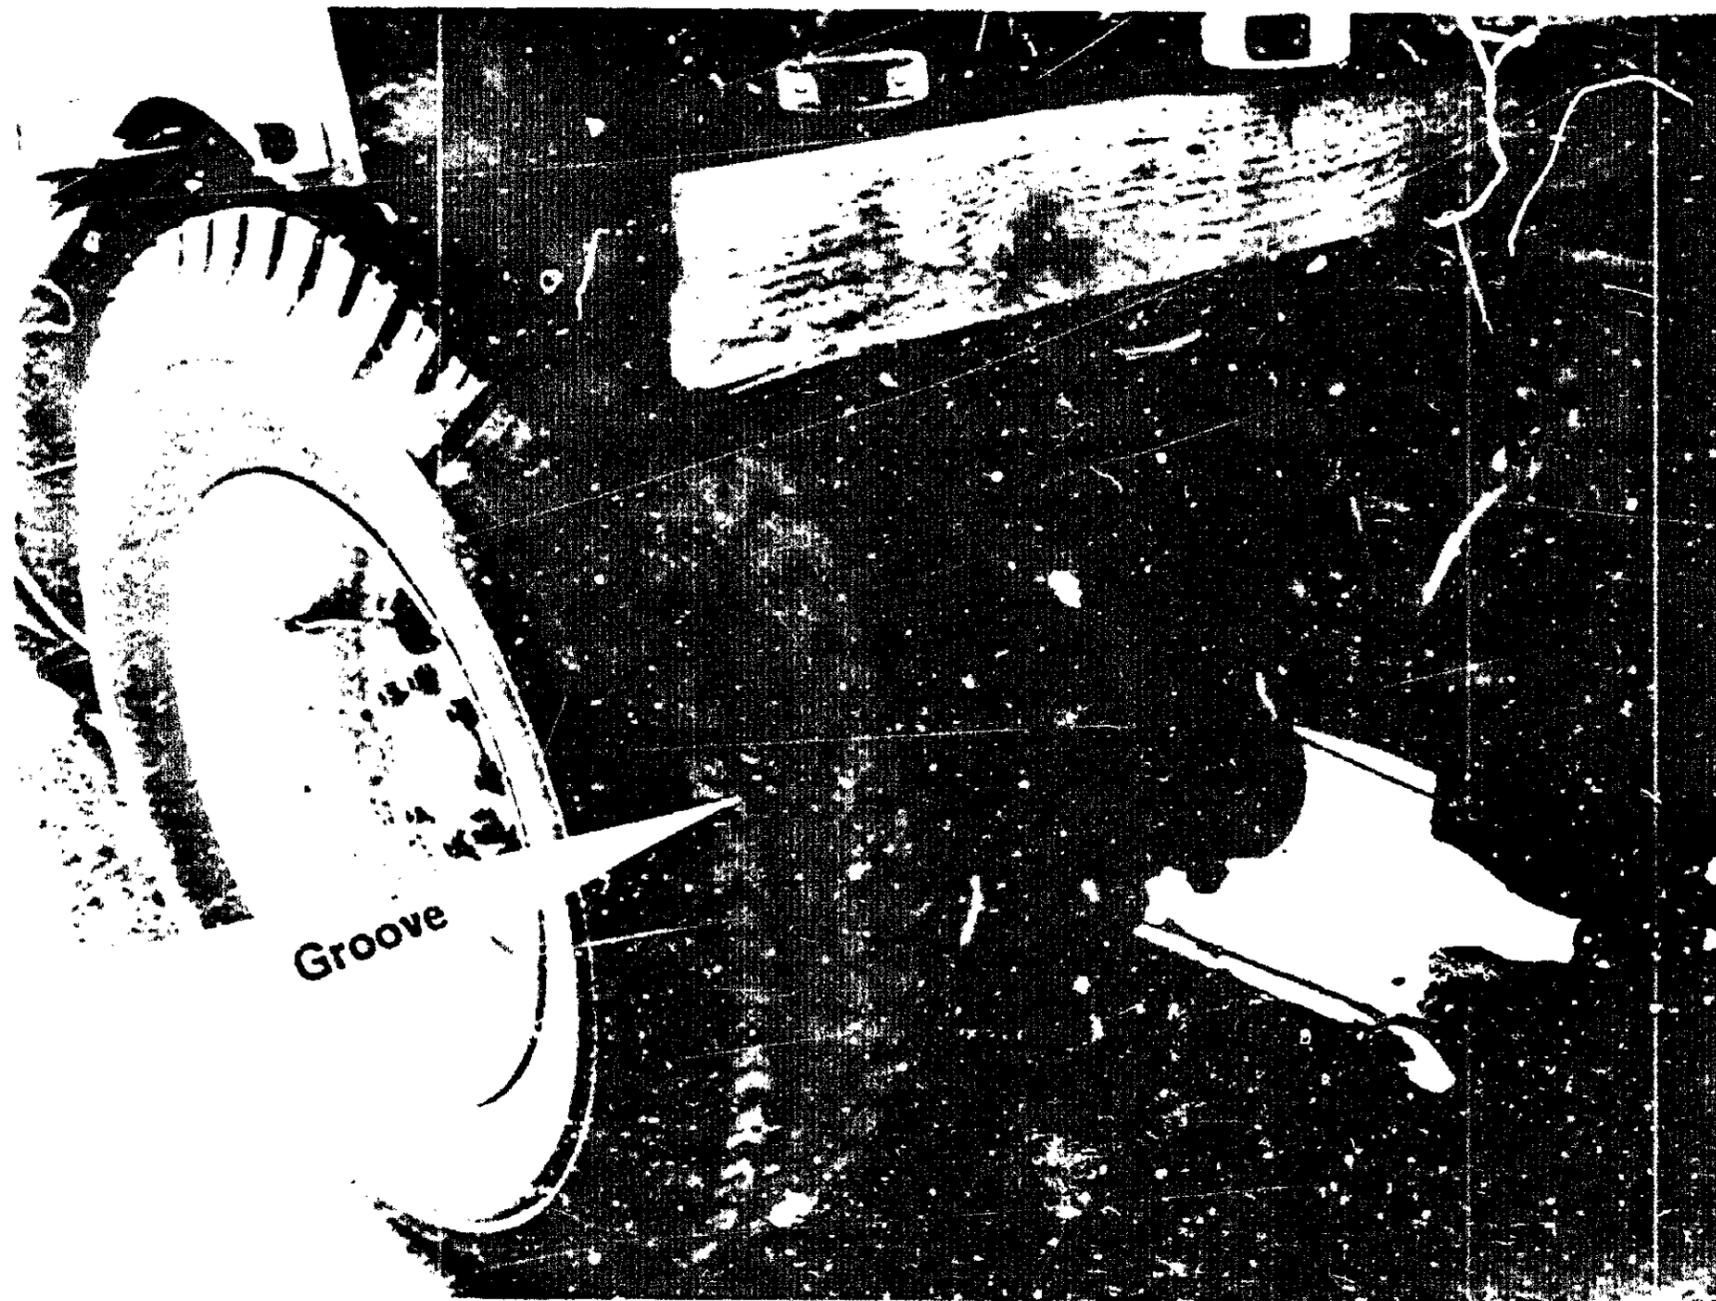
Figure 6.--Groove in left rear outside tire.

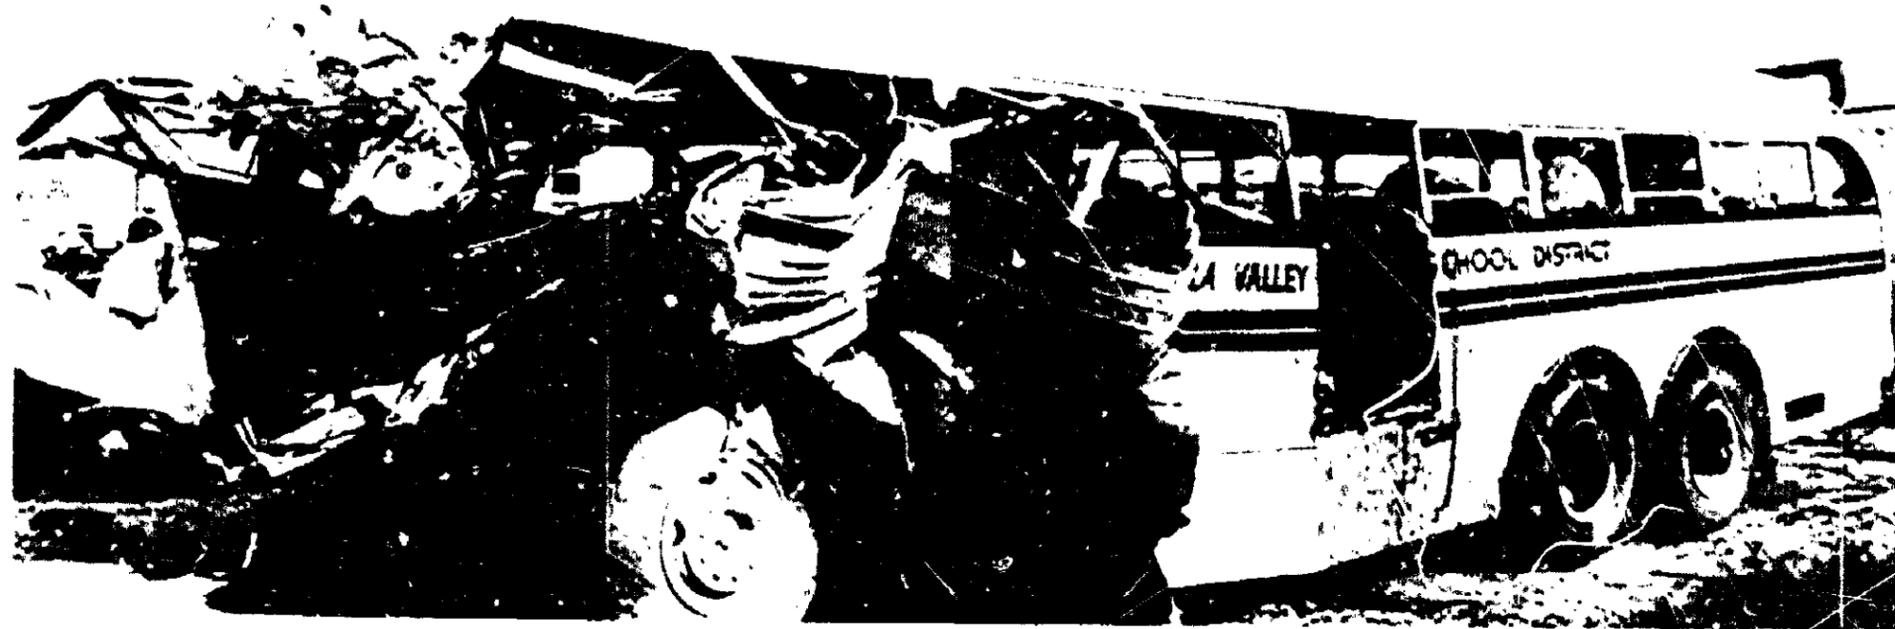
Figure 7.--Damage to schoolbus.

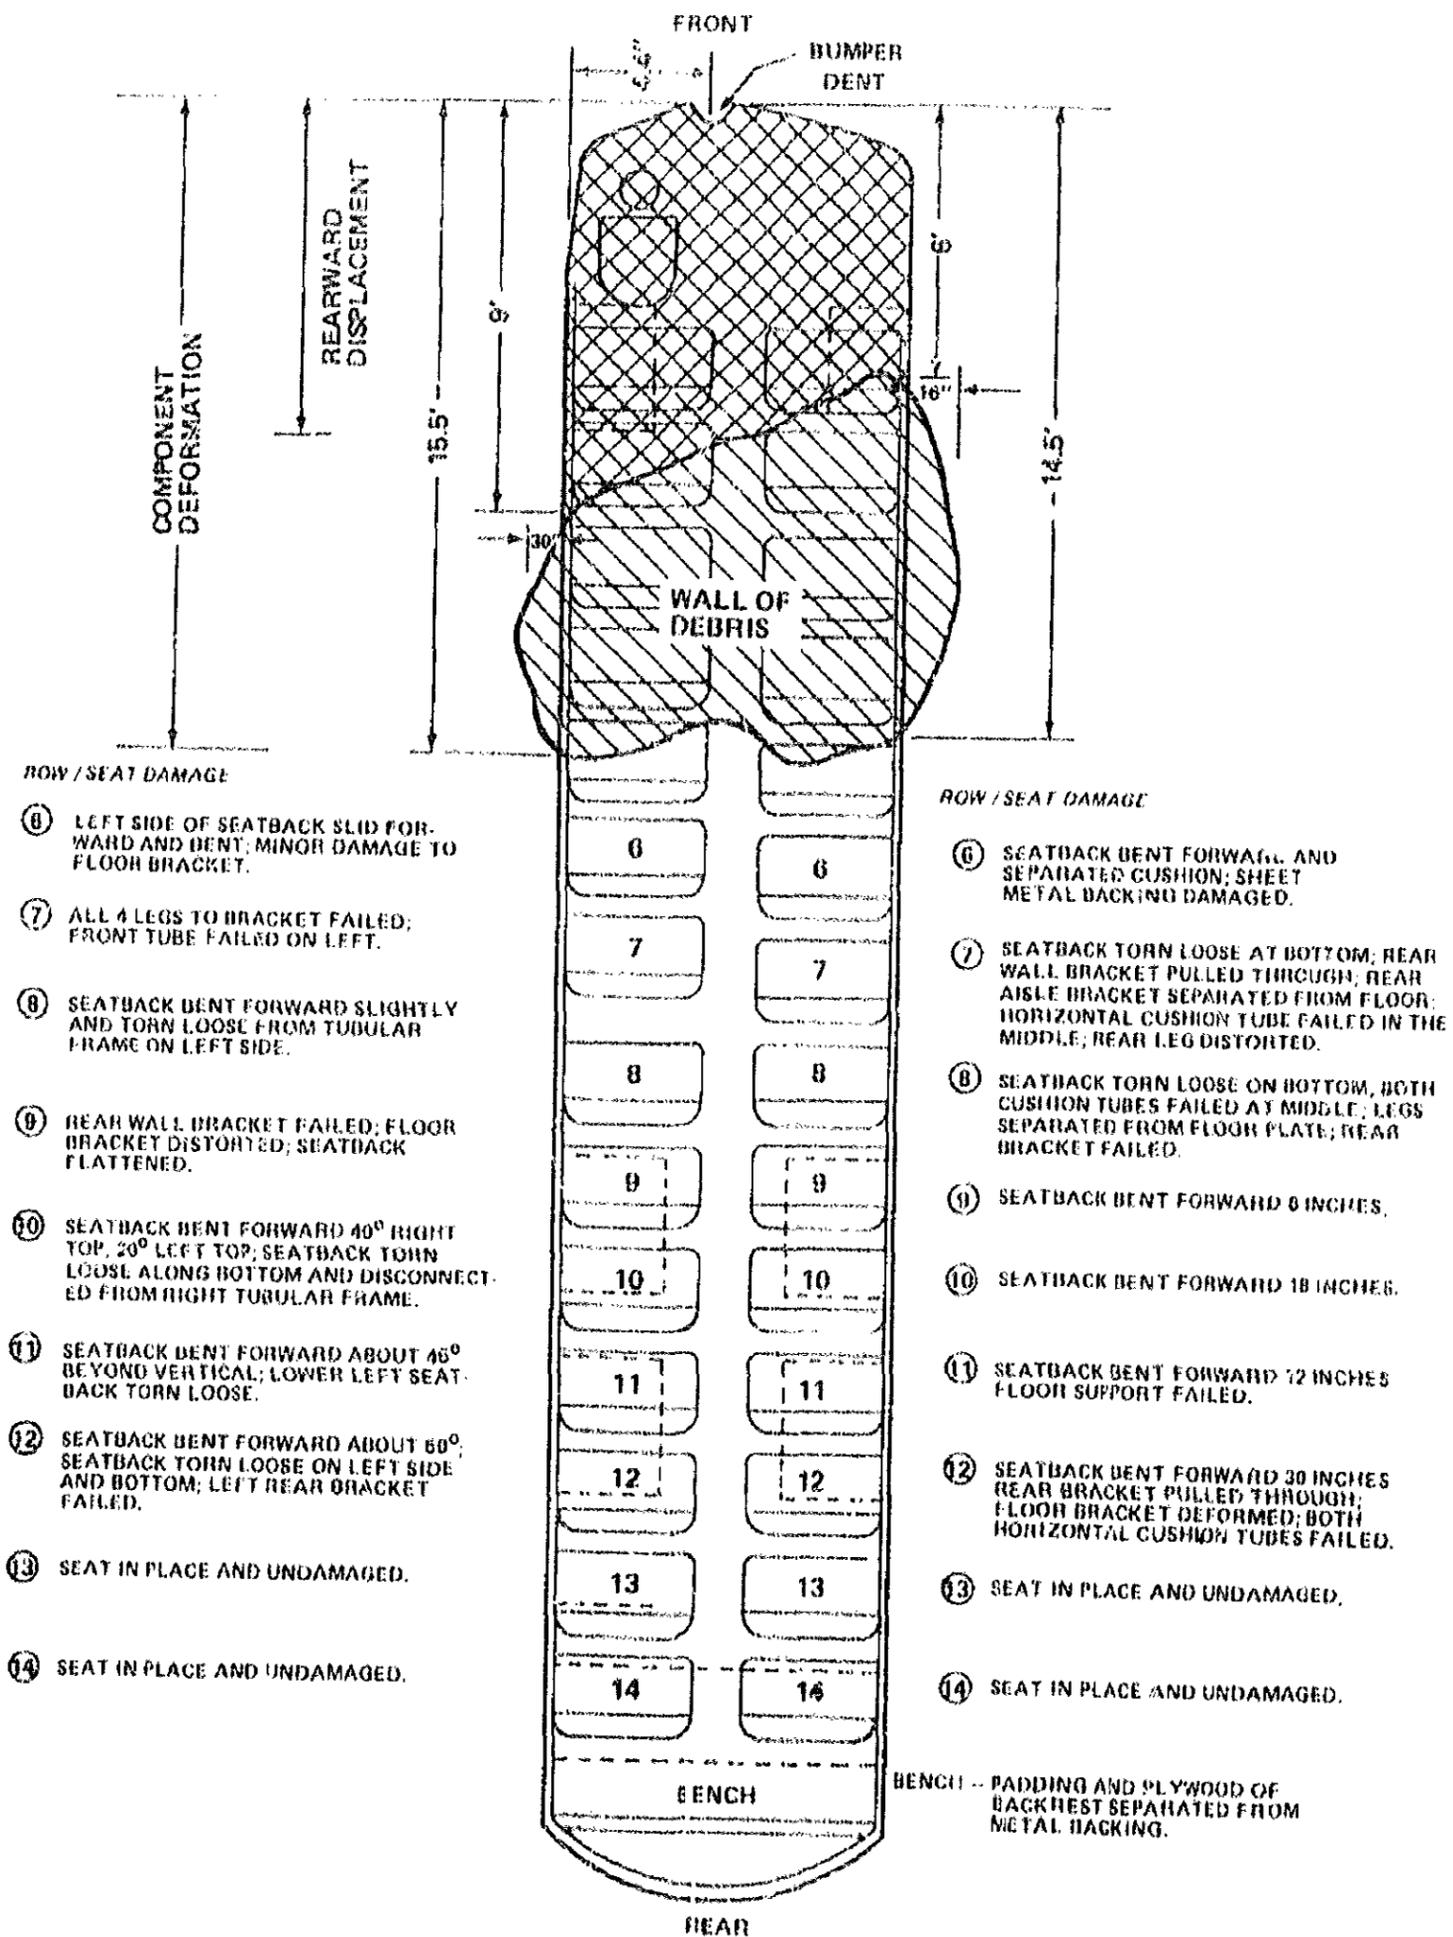
Figure 8.--Schoolbus crash damage patterns.

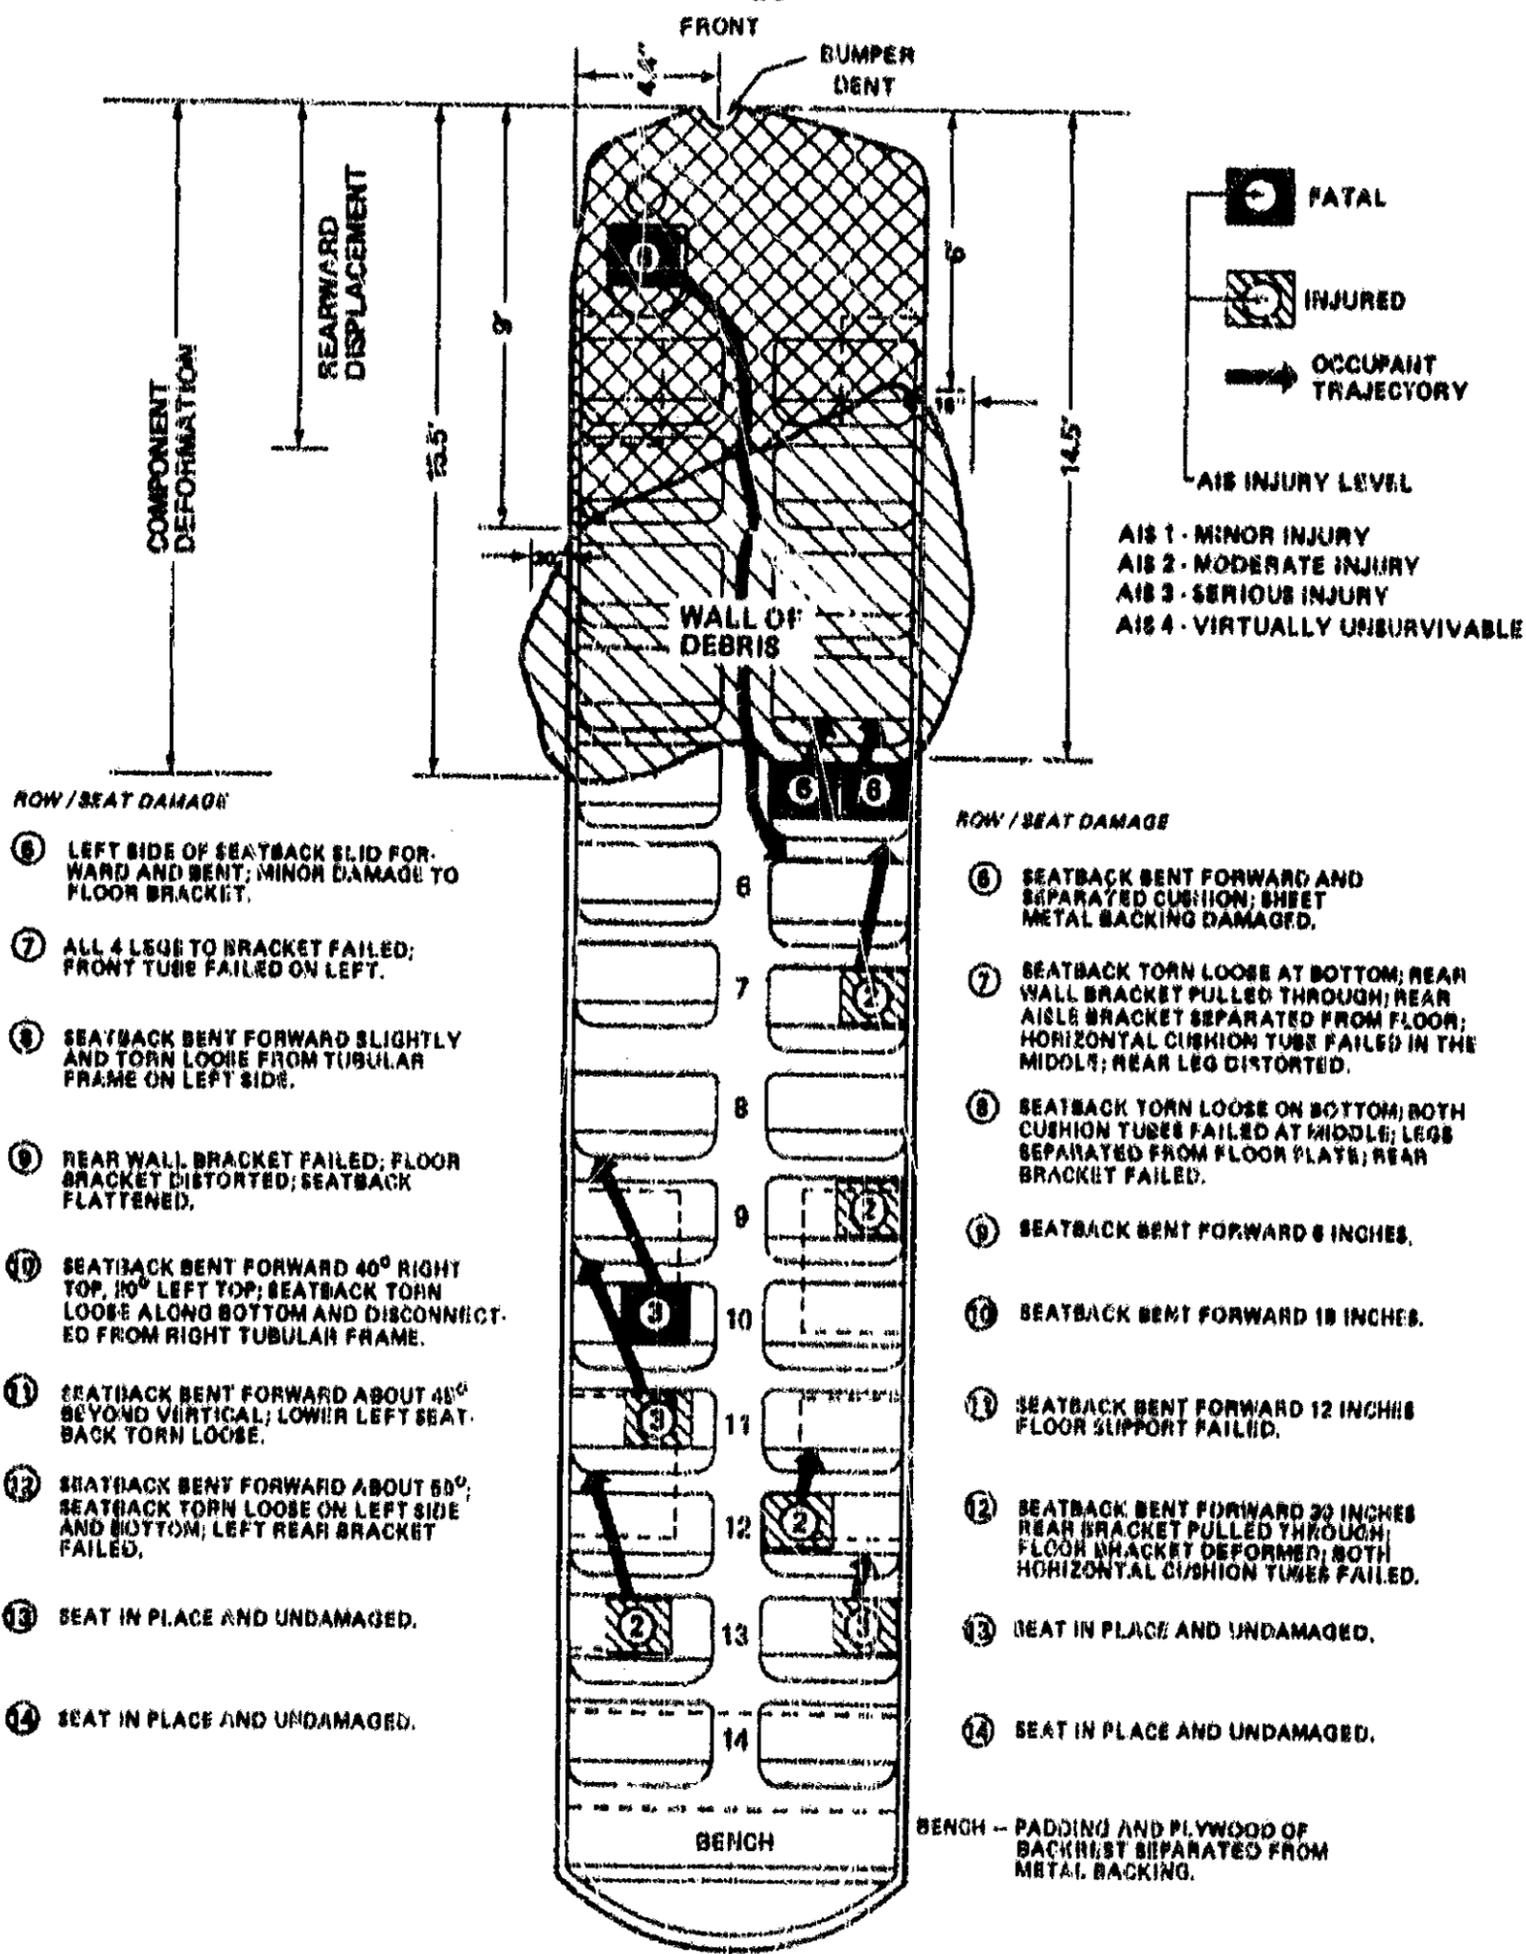
Except for the passenger in the 10th row who suffocated as a result of moderate injuries, only the driver and the two passengers who were sitting in the major damage zones near the front of the bus died. The Safety Board's seating recommendation would not have prevented the fatalities which did occur, since the two passengers who sat in the 5th row could have sat there under the Safety Board's seating recommendation. However, if more passengers had been sitting in the major damage zones, or more particularly, at the front of the bus, more serious or fatal injuries would have occurred.

Figure 17.--Schoolbus seating chart showing occupant AIS injury level, crash trajectory, and damage patterns.
