Highway Accident Report: Multiple-Vehicle
Collisions and Fire in Fog, Interstate 15, Near
San Bernardino, California, November 10, 1980

(U.S.) National Transportation Safety Board
Washington, DC

10 Jun 81

1. Report No. NTSB-HAR-81-2		2. Government Accession No. PB81-218869		3. Recipient's Catalog No.	
4. Title and Subtitle Highway Accident Report-- Multiple-Vehicle Collisions and Fire, Interstate 15, Near San Bernardino, California, November 10, 1980				5. Report Date June 10, 1981

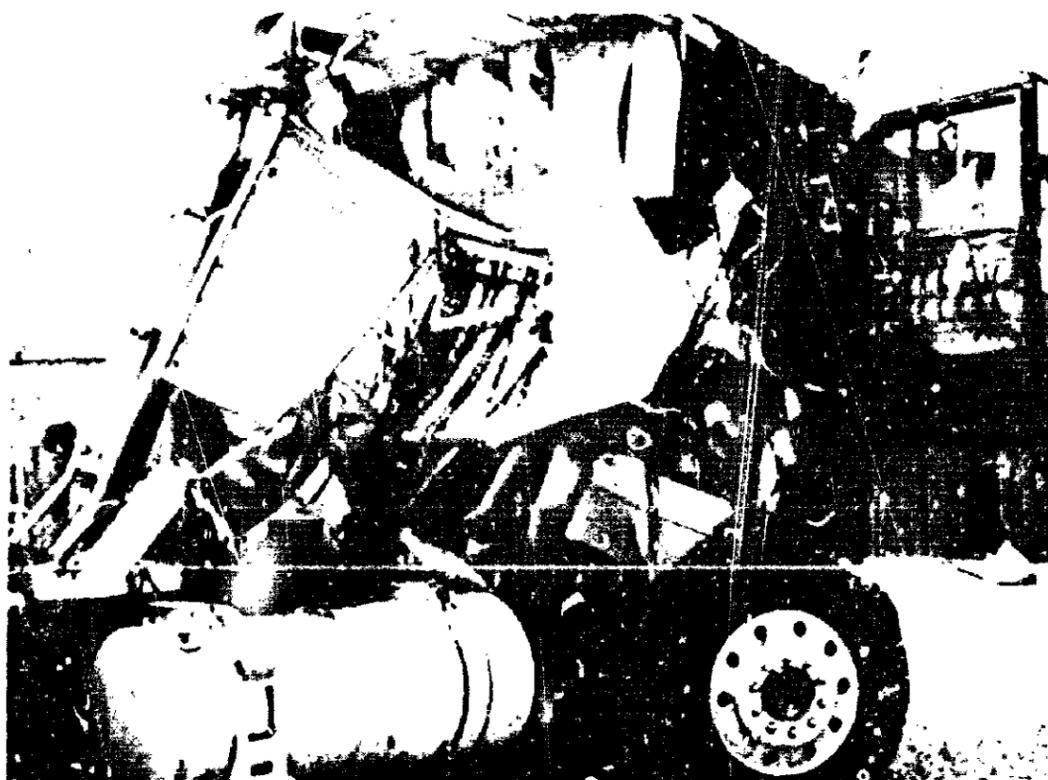
Figure 6.--Right side of Vehicle 14 showing damage to headerboard and truck cab due to cargo shift.

The shift of the cargoes of railroad ties in Vehicle 5 and sheet aluminum in Vehicle 14 was possible because the tiedown web straps on the railroad ties were inadequate to prevent their forward shift and the palletized aluminum sheets were not secured to the trailer. In both cases, the headerboards were not capable of retaining the forward surge of the cargo. FMCSR 393.106(e) requires a headerboard to retain cargo at a deceleration rate of 20 feet per second per second. This is the equivalent of the forces exerted during a locked-wheel stop. However, both vehicles, in striking the rear ends of loaded trailers, developed deceleration rates and forces that exceeded their headerboards design specifications. If the palletized sheet aluminum on Vehicle 14 had been tied down as required by FMCSR 393.100C(4), the combined strength of the tiedowns and the headerboard might have retained the cargo. The State of California should evaluate accidents involving vehicles transporting loads of aluminum and other metal products to determine if such accidents and any attendant injuries could be prevented or their severity reduced by requiring such loads to meet the securement requirements for steel products contained in Title 13, Subchapter 7 of the California Administrative Code.

Both the headerboard on the tractor and the headerboard on the semitrailer were deformed forward and downward by the palletized aluminum sheets which surged forward on impact. The front of the cab was deformed rearward about 2 feet on impact and the rear of the cab was crushed forward about 4 feet when the cargo shifted forward. (See figure 6.)
