NATIONAL TRANSPORTATION SAFETY BOARD

HIGHWAY ACCIDENT REPORT

DIRECT TRANSIT LINES INC.,
TRACTOR-SEMITRAILER/MULTIPLE-VEHICLE
COLLISION AND FIRE,
U.S. ROUTE 40,
FROSTBURG, MARYLAND
FEBRUARY 18, 1981

NTSB-HAR-81-3

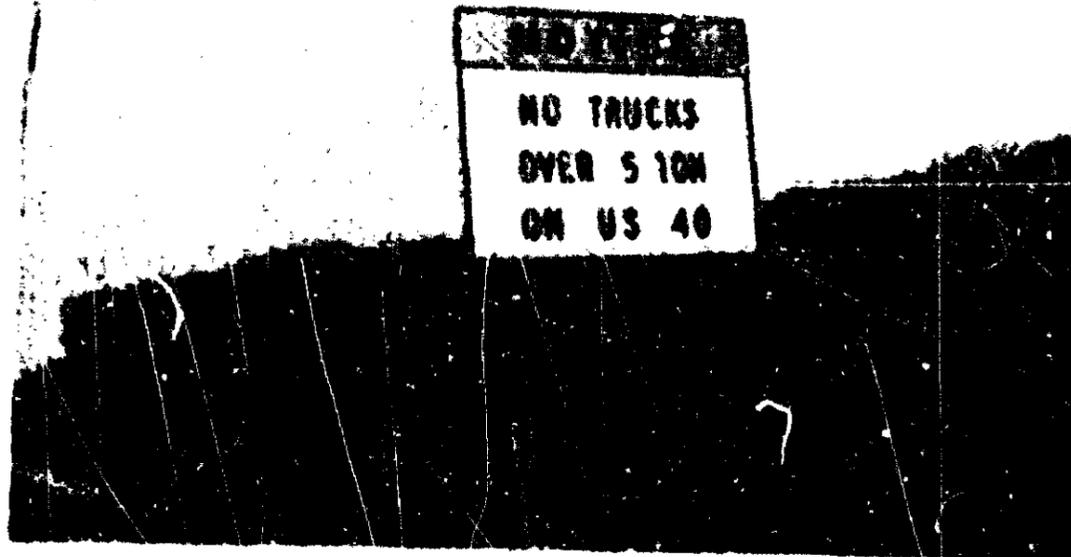
Figure 10.--Revised signs on U. S. Route 40 limiting heavy trucks weight to 5 tons.

A weight restriction of 10,000 pounds or less gross vehicle weight for all vehicles along U. S. 40 between Piney Run Road at the Md. 546 interchange with U. S. 48 to the eastern city limits of Frostburg at Md. 36 (Vale Summit Road), a distance of 4.2 miles.
