## HIGHWAY ACCIDENT REPORT

EAST SIDE CHURCH OF CHRIST  
BUS SKID AND OVERTURN  
U.S. ROUTE 183,  
NEAR LULING, TEXAS  
NOVEMBER 16, 1980

NTSB HAR 81-4

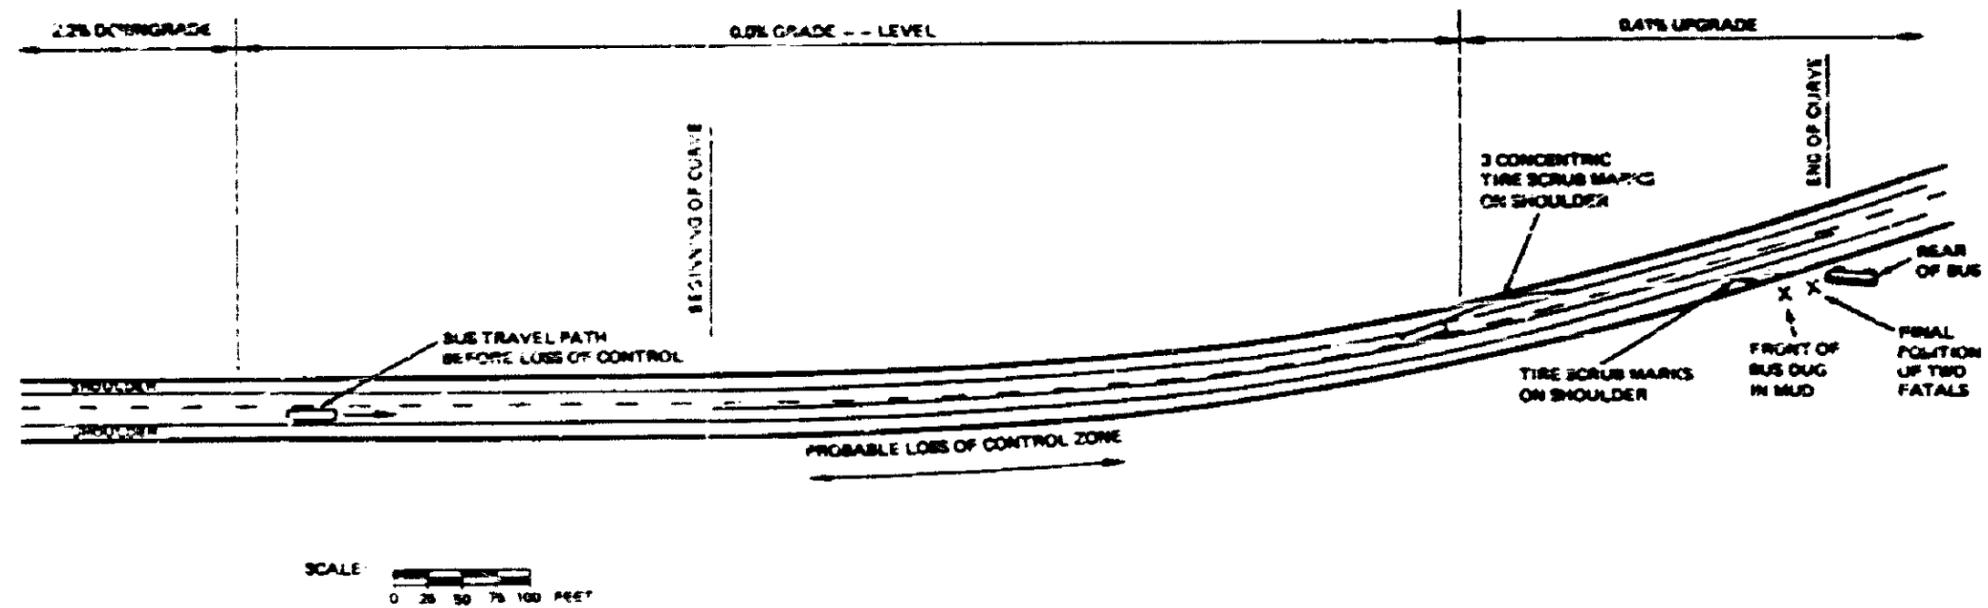
Figure 1.—Accident scene diagram.

According to the busdriver and bus passengers, the bus was traveling between 40 and 50 mph as it approached a curve to the left. The busdriver said that he had reduced foot pressure on the accelerator as he approached the curve. (See figure 1.) Shortly thereafter, the rear of the bus slid sideways. The busdriver and two passengers reported that the rear of the bus first moved to the left; three other passengers stated that the rear of the bus first moved to the right.

The busdriver reported that after the rear of the bus slid sideways, he took his foot off the accelerator and steered to the left and into the skid to regain control. He said that he seemed to regain control, and he recalled someone saying "you got it, you got it." However, the bus was on the wrong side of the road by that time so he steered to the right. The tires on the left side of the bus left three concentric tire scrub marks on the northbound shoulder from this maneuver. As the bus crossed the highway again, the rear of the bus spun clockwise about 180°, and the bus slid sideways off the road.

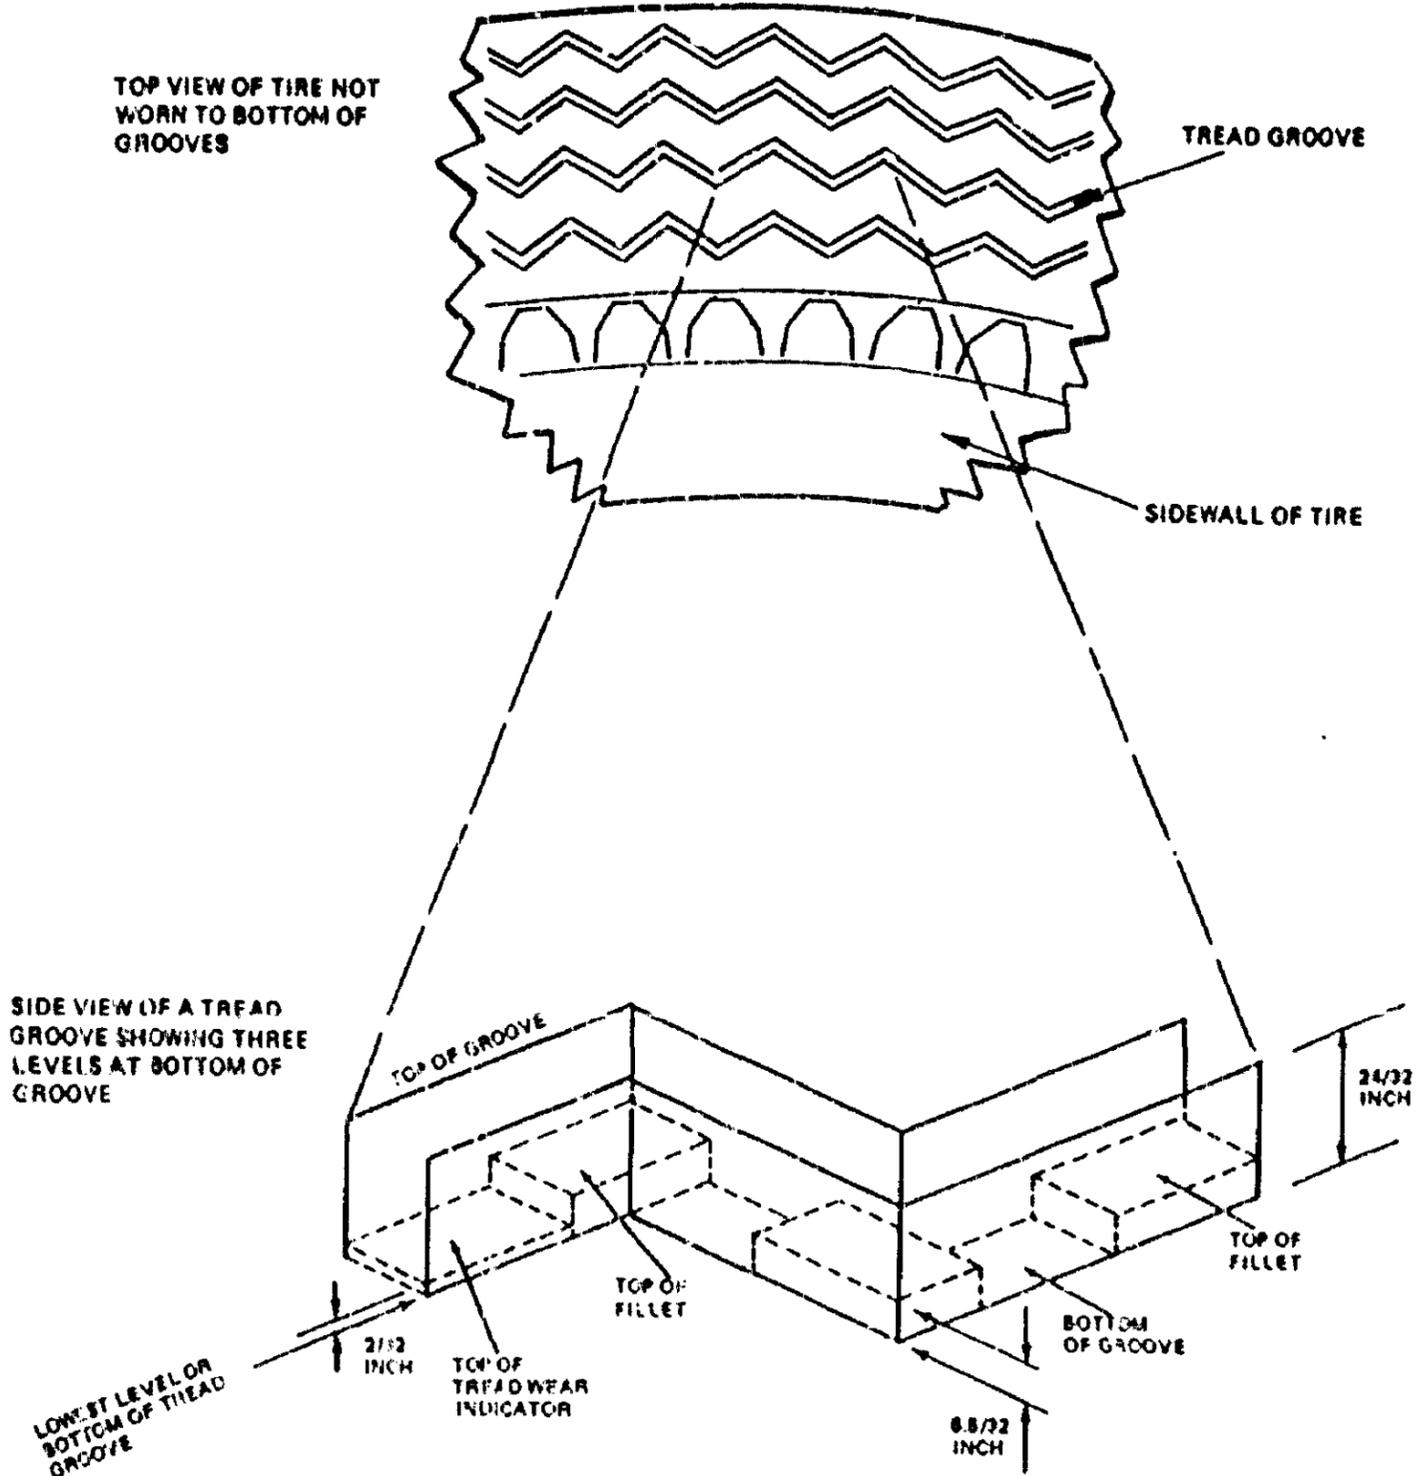
Figure 3.--Tire grooves in the rear tires.

Regrooveable tires are a special class of tire for which the grooves in the tread pattern can be cut deeper ( regrooved ) after the tire has worn. The rear tires were manufactured so that there were three levels within each groove. (See figure 3.) The lowest level was the bottom of the tread groove. The next level was the top of tread wear indicators that were molded 2/32 inch higher than the bottom of the groove. These tread wear indicators were placed at only six points equidistant around the tire and were about 3/4 inch long. According to Federal Motor Vehicle Safety Standard No. 119, the purpose of tread wear indicators is to "enable a person inspecting the tire to determine visually whether the tire has worn to a tread depth of one-sixteenth (or 2/32) of an inch." 2/ The third level was the top of "fillets" that were molded 6.5/32 inch higher than the bottom of the groove. These fillets were placed at each corner of a tread groove and were about 1/2 inch long. Fillets are used to support or stabilize the sidewalls of the tread groove so that the tire tread does not wobble or squirm while the tire is in use, since such squirming would lead to abnormal tire wear.

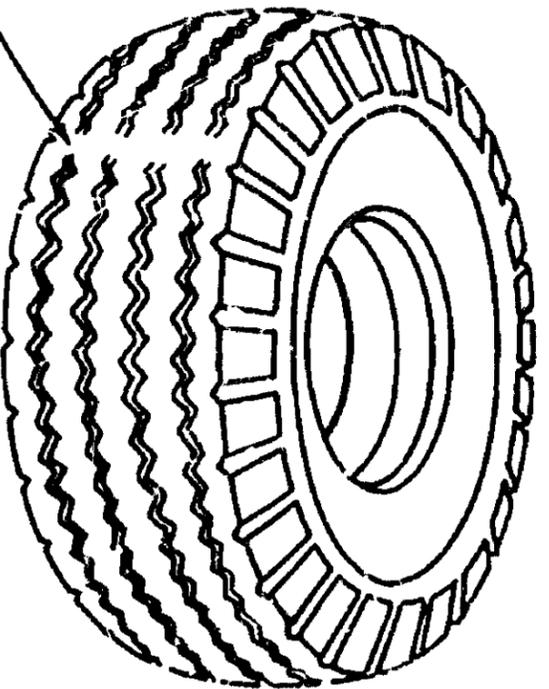
Figure 6. Tire worn to tread wear indicators  
(From Texas Inspection Manual)

Any tire with tread wear indicators worn so that the tread wear indicators contact the road in any two adjacent major grooves in the center or middle of the tire. (See figure 6.)

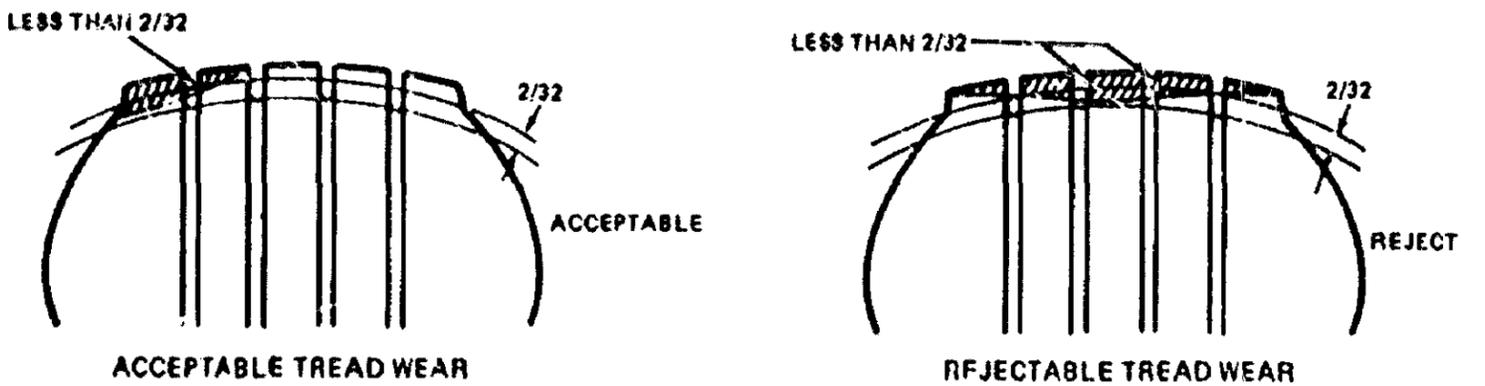
Figure 7.--Acceptable and rejectable tread wear patterns  
(From Texas Inspection Manual)

Any tire without tread wear indicators worn so that less than  $2/32$  ( $1/16$ ) of an inch of tread design depth remains when measured (with a tread depth gauge) at the lowest points in any two adjacent major grooves in the center or middle of the tire. (See figure 7.)

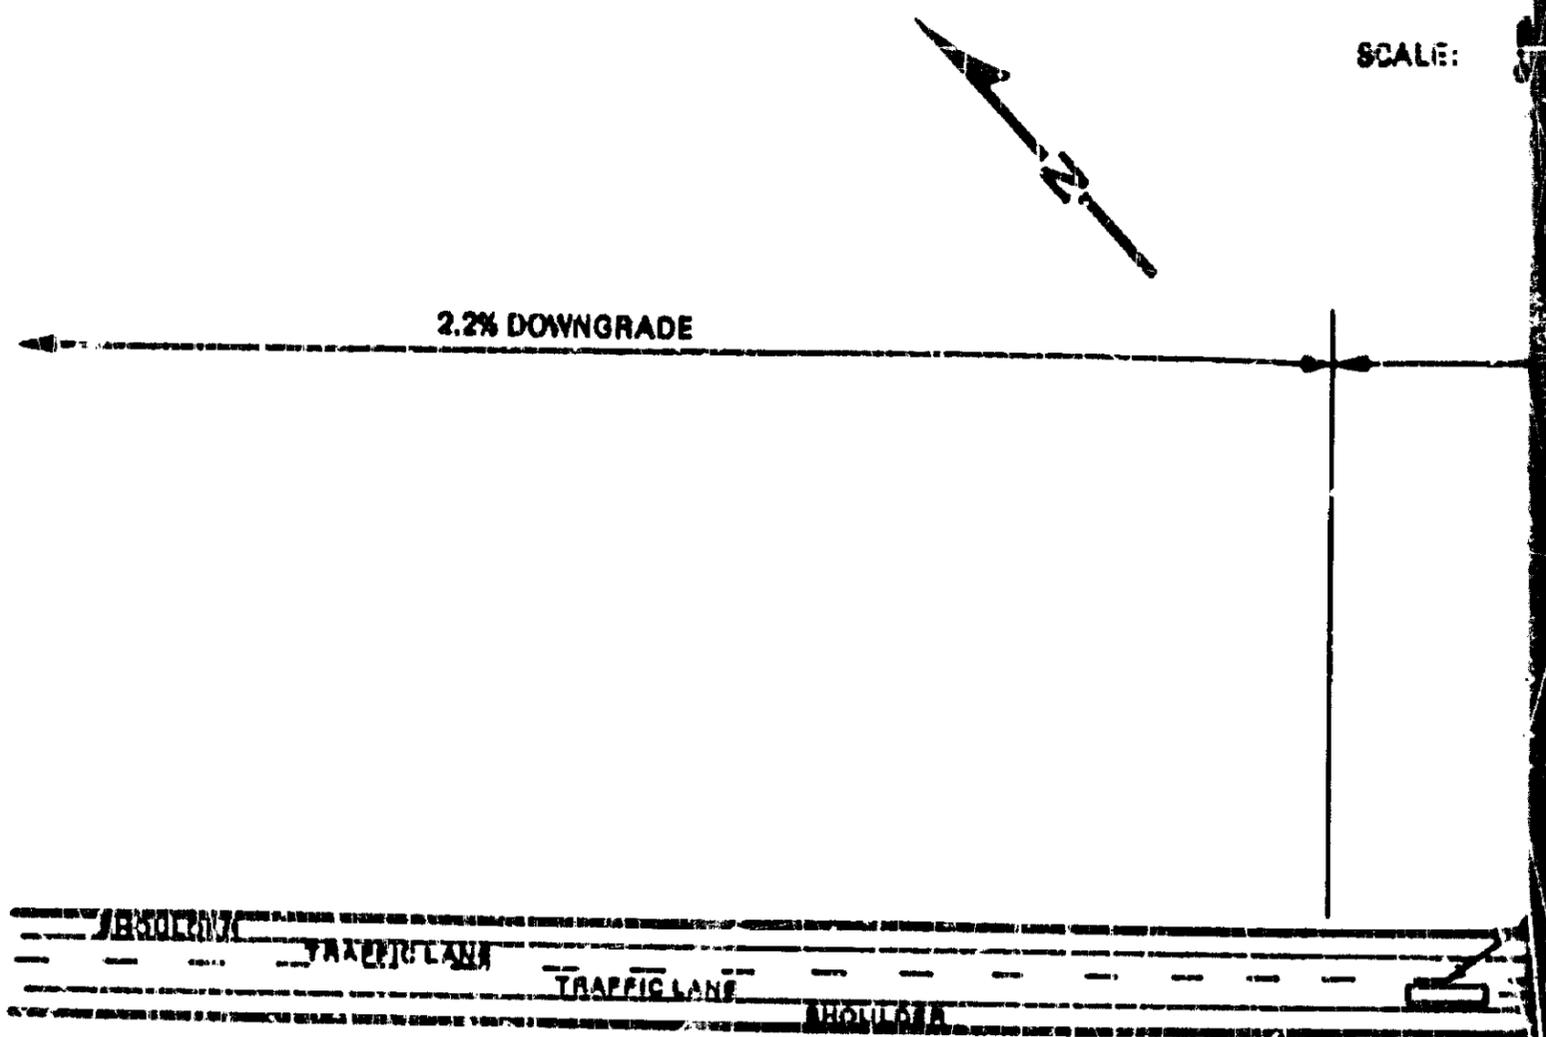
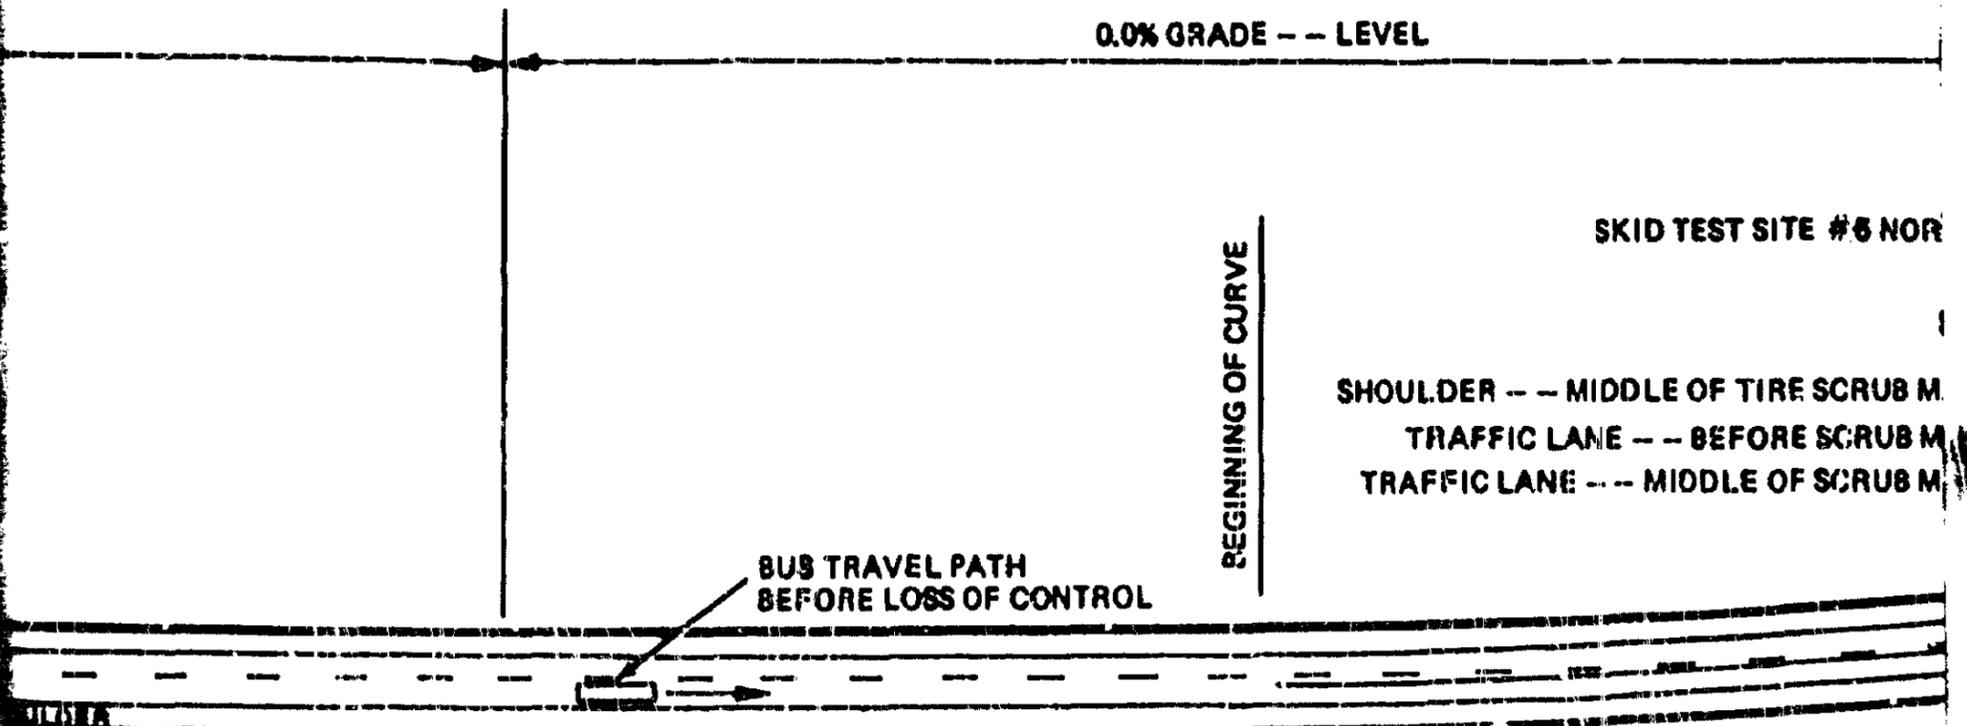
**FIGURE 10.**  
**SAND PATCH AND LOCKED-WHEEL**  
**ON NOVEMBER 20 AND 21, 1980, AT**  
**LULING, TEXAS**

SKID TEST SITE	#1	SAND PATCH	#2	SAND PATCH	#3	SAND PATCH	#4
WHEEL PATH	0.013		0.016		0.019		0.020
WHEEL PATH	0.013		0.016		0.026		0.018
SHOULDER	0.068		0.063		0.045		0.036

SKID TEST SITE #2 SOUTHBOUND		SKID TEST SITE #3 S		
SPEED	40 MPH	50 MPH	40 MPH	50 MPH
LEFT WHEEL PATH	0.32	0.23	0.26	0.2
RIGHT WHEEL PATH	0.39	0.21	0.38	0.1
SHOULDER	0.32	0.29	0.26	0.3

In keeping with a needed minimum skid number policy that would eliminate hazardous stopping conditions, the Safety Board believes that the pavement at the accident site should be updated on a high priority basis. The deteriorated condition of the pavement and increasing traffic demands provide further support for updating on a high priority basis. In the absence of a national minimum skid number policy, the Safety Board examined other State policies to determine if they could at least serve to alleviate the problems this accident illustrated.

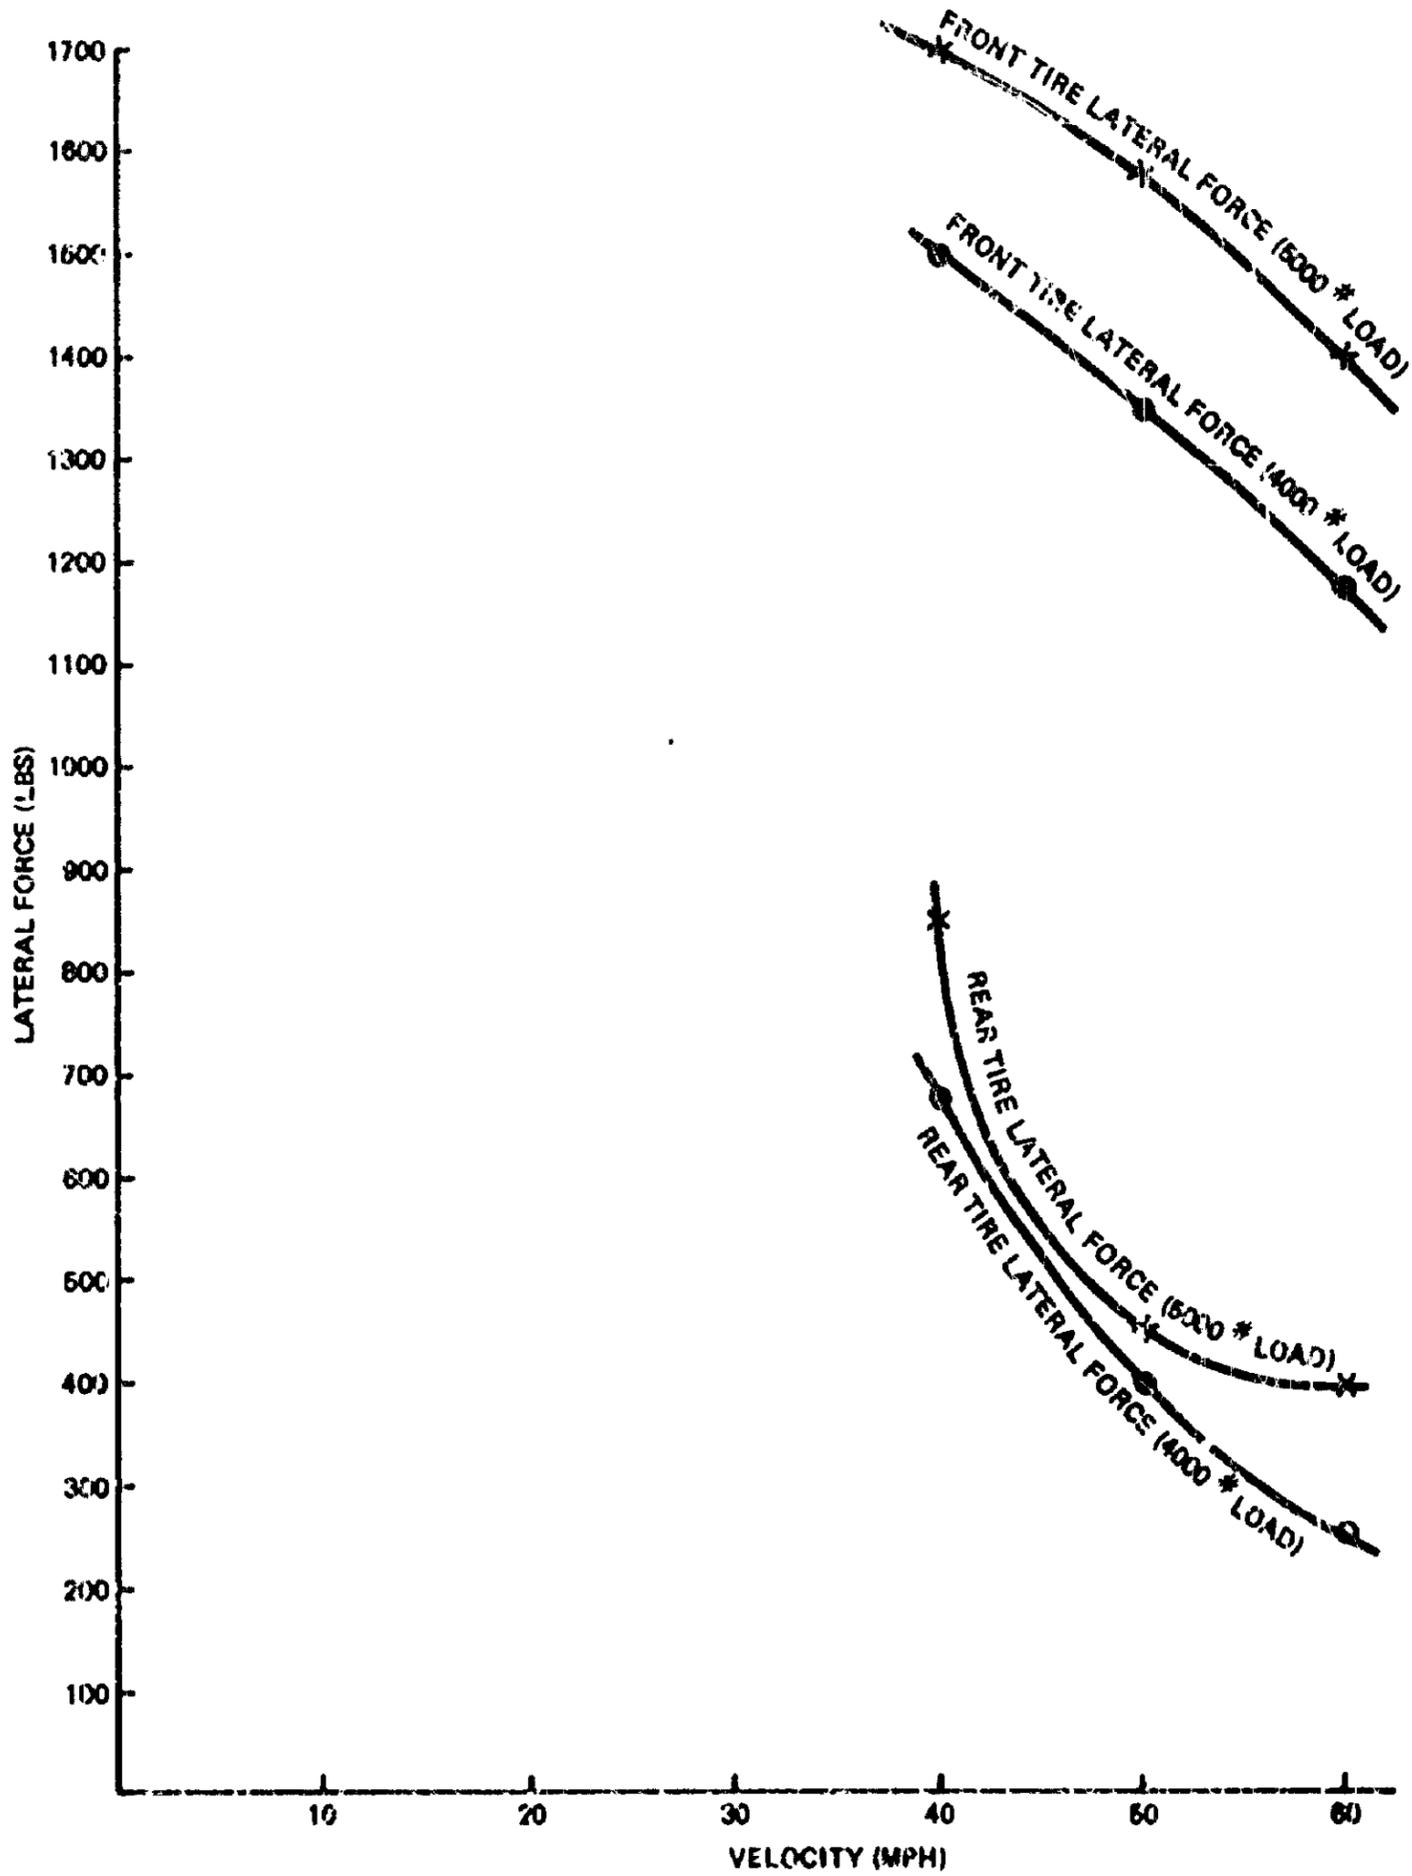
Wet pavement cornering tests on the TIRF machine indicated that the bus rear tire had a much lower resistance to sliding sideways during a turning maneuver than the front tire. (See figure 12.) For example, at a road speed of 55 mph, the posted speed limit at the accident site, and a tire load of 4,700 lbs., approximately the load on each tire of the bus at the time of the accident, the maximum lateral force capability of the front tire to resist sliding sideways was 1,430 lbs. Under the same speed and load, the maximum lateral force capability of the rear tire to resist sliding sideways was 380 lbs. When the

tire load was decreased to 4,000 lbs., approximately the load on each tire on an empty bus, the maximum lateral force capability of the front and rear tires dropped even further to 1,280 and 320 lbs., respectively.

Figure 12.-- Maximum lateral force capability of right front and right rear outer bus tires as a function of vehicle speed on a 0.23 coefficient of friction surface.

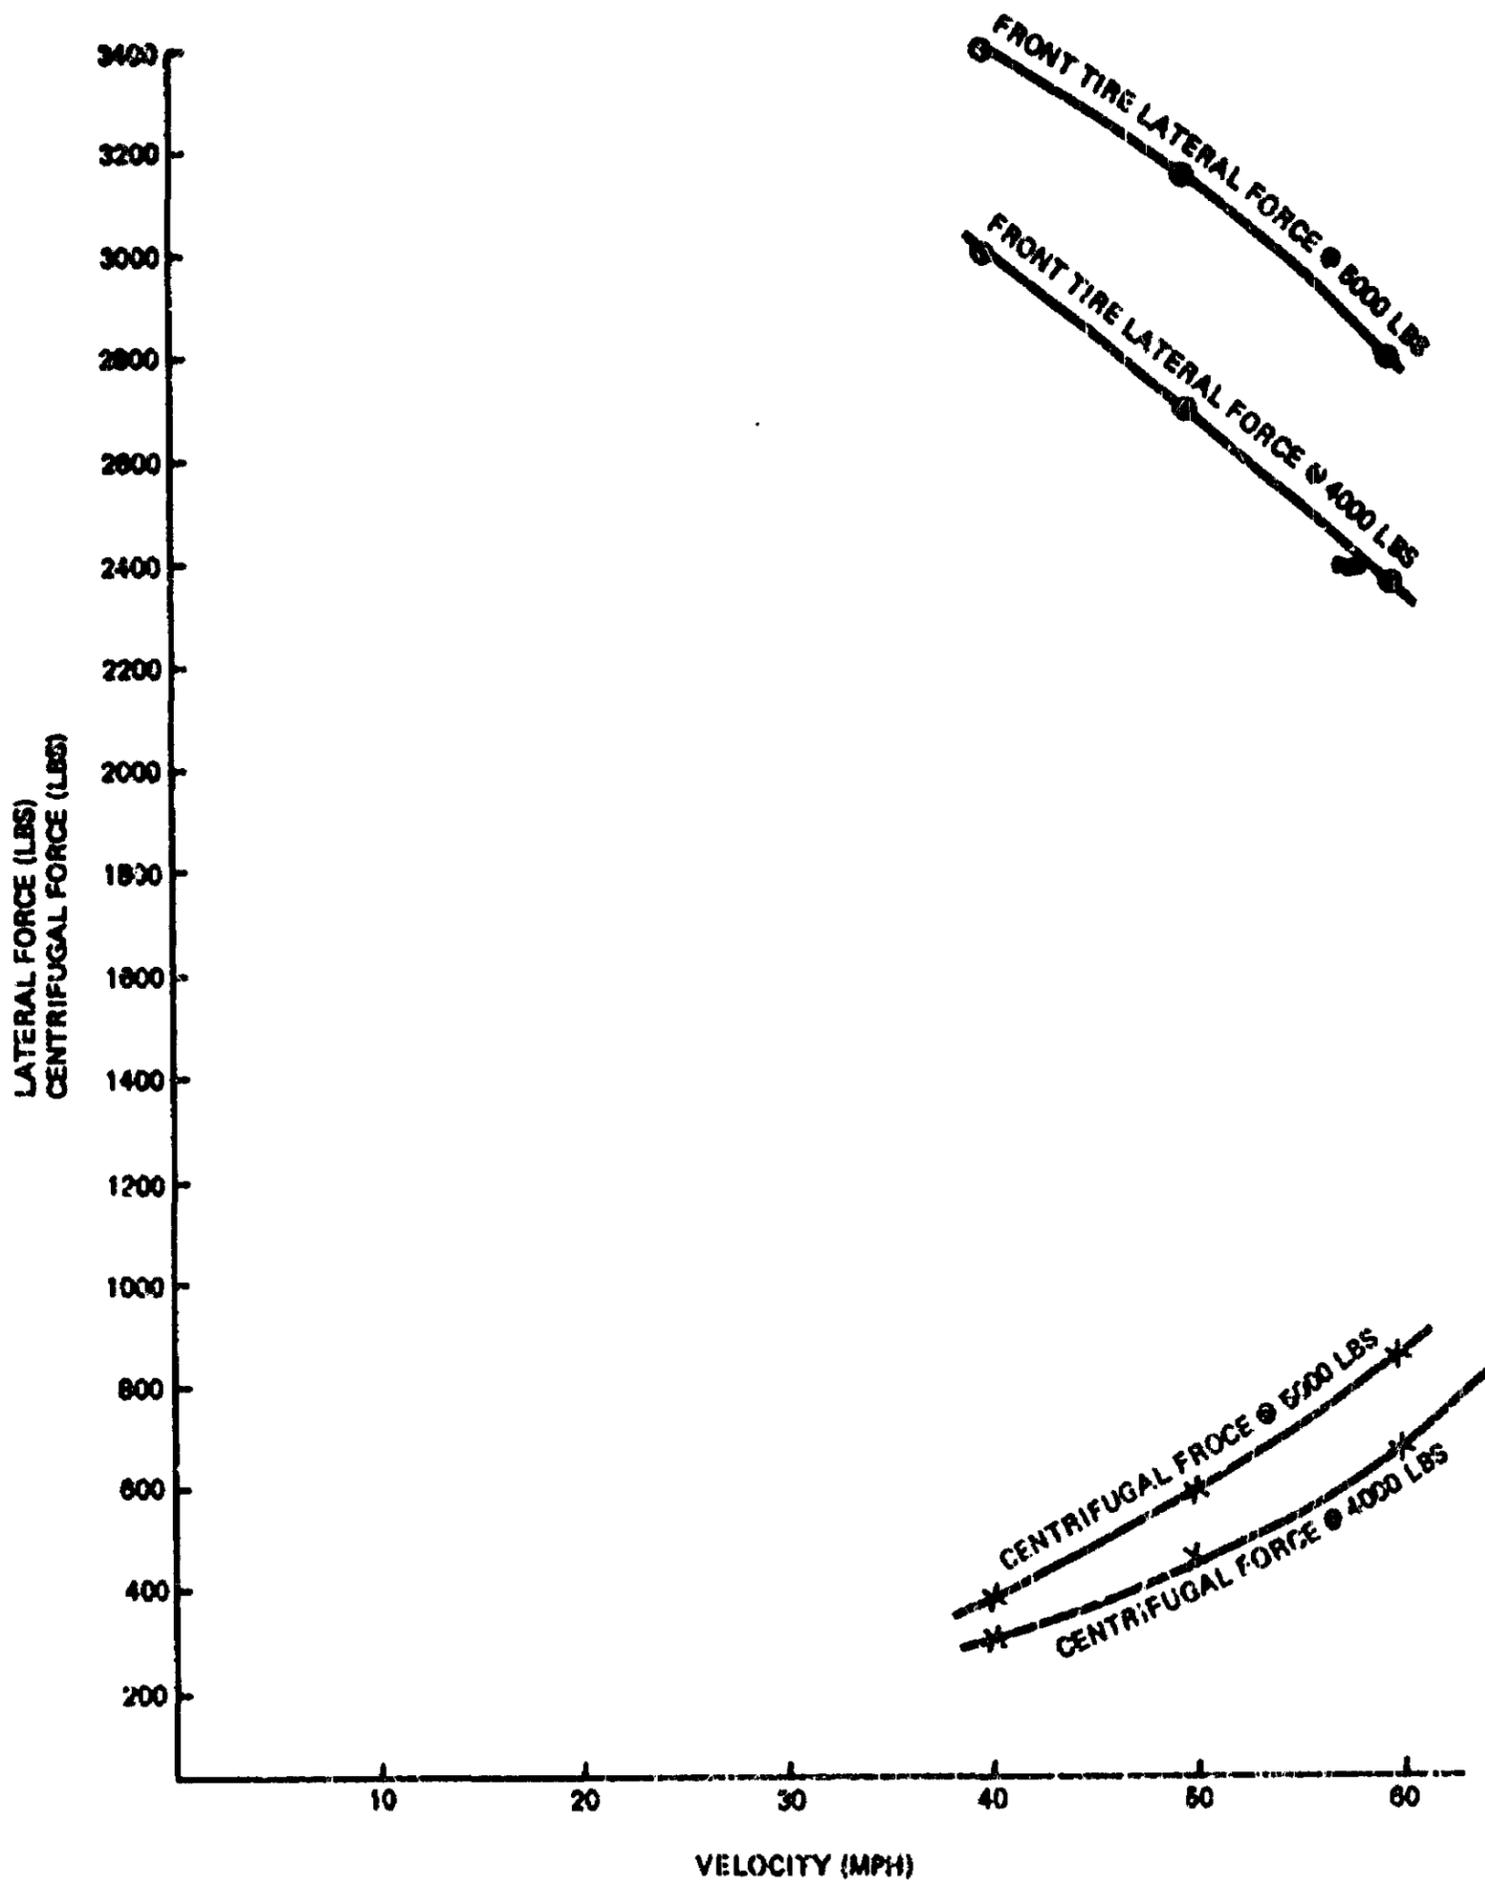
Based on Safety Board calculations, the centrifugal force that would have been produced during a normal steering maneuver through the curve did not exceed the lateral traction capability of the front tire on the low-frictional-quality pavement surface at any speed between 40 to 60 mph. (See figure 13.) On the other hand, the centrifugal force exceeded rear tire traction capability at a speed of about 57 mph, and the rear tires would have lost traction to the right. (See figure 14.) An analysis of the bus tire scrub marks on the northbound shoulder indicated that the bus was probably traveling at or near this speed as its left wheels traveled across the shoulder and its right wheels traveled primarily between the traffic lane wheel paths.

Figure 13.—Maximum lateral force capability of bus front tires and centrifugal force created during turning maneuver on a 2° curve with a 0.23 coefficient of friction as a function of vehicle speed.

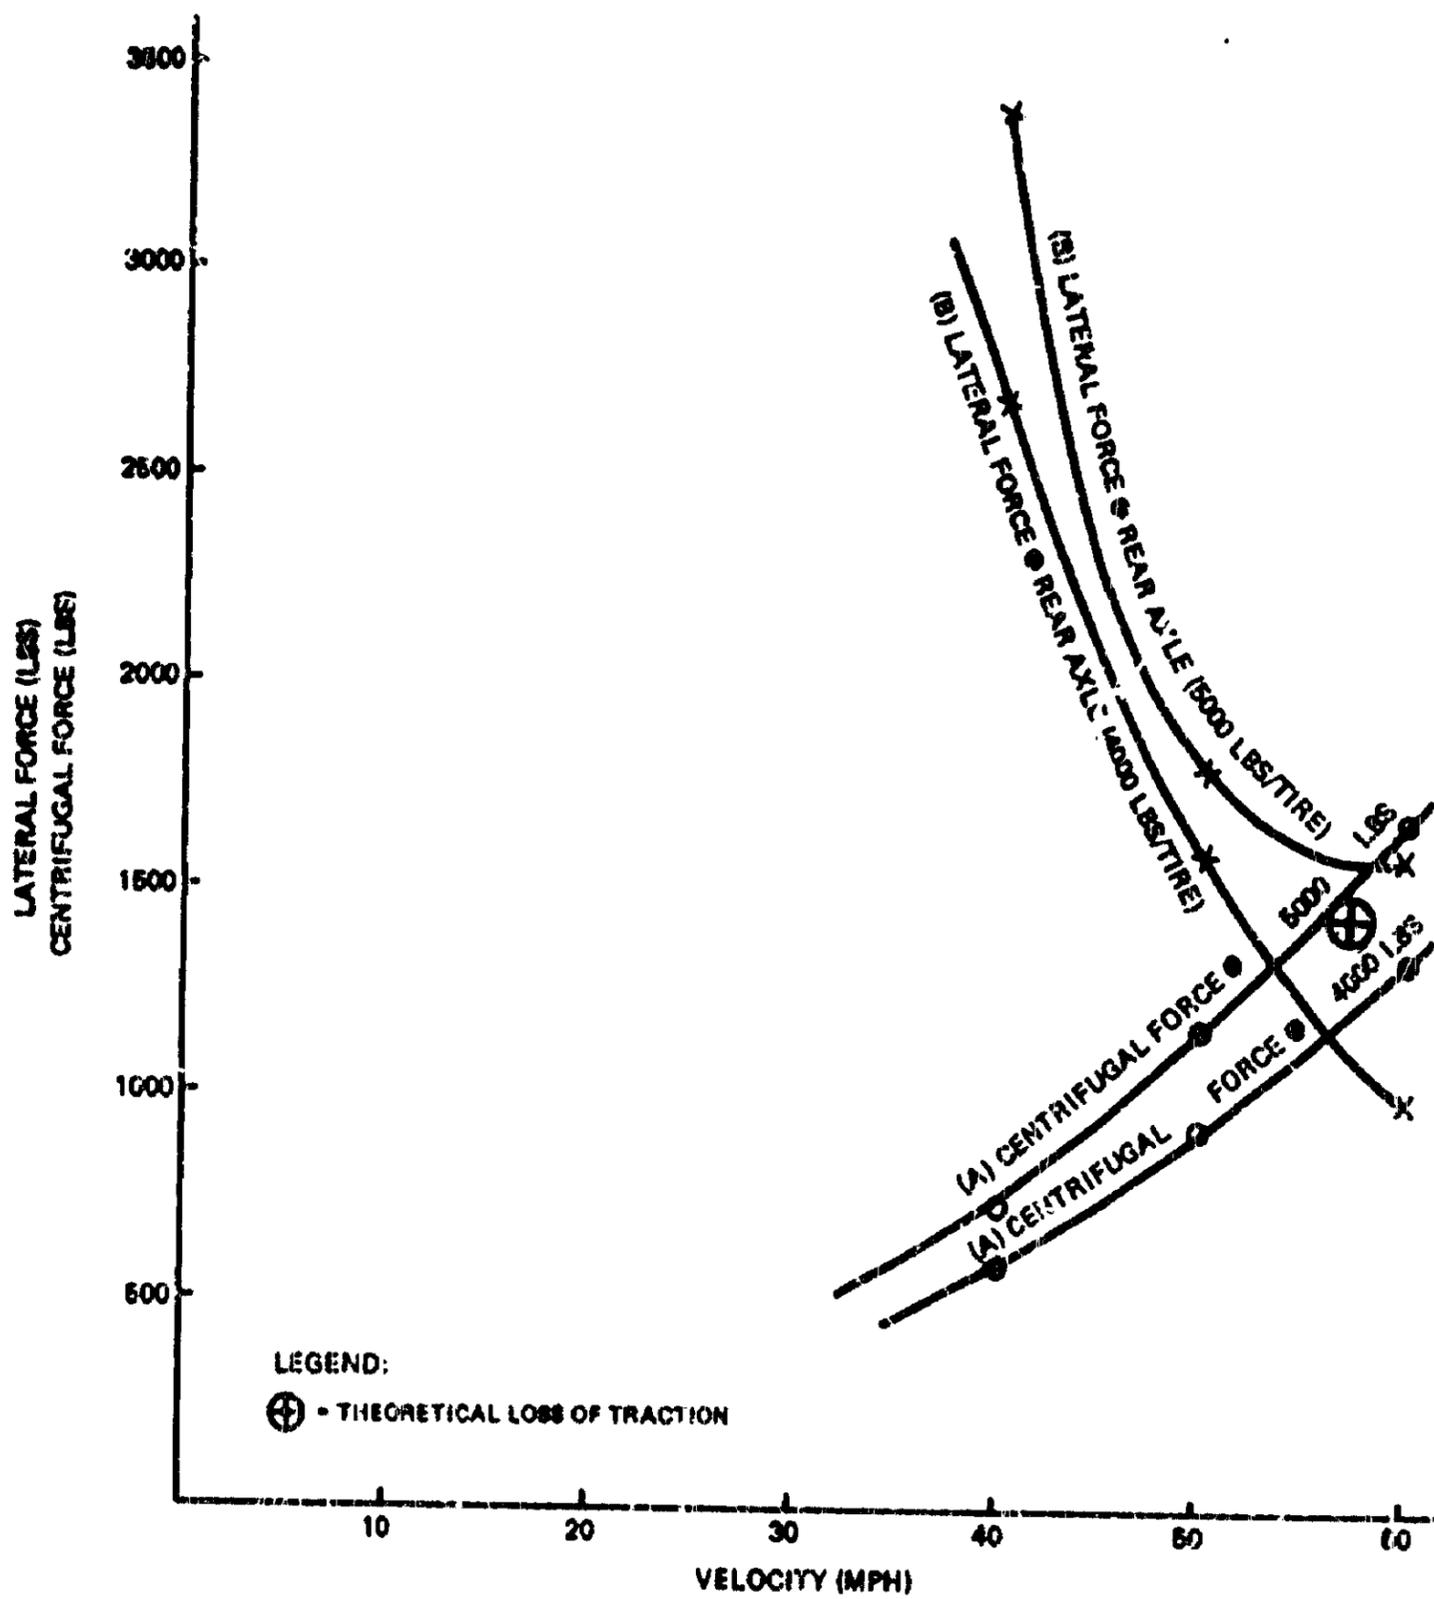
Figure 14.--Maximum lateral force capability of bus rear tires and centrifugal force created during turning maneuver on a 2° curve with a 0.23 coefficient of friction as a function of vehicle speed.

Physical evidence and test data indicated that any small reduction in traveling speed or improvement in tire or pavement condition may have prevented the accident. For example, had the busdriver reduced operating speed to slightly less than 50 mph, he would have compensated for the tire and pavement problems and maneuvered through the curve. If the rear tires had been as good as the front tires or had at least 2/32 inch of continuous tread groove depth, the accident probably would not have occurred. Since the busdriver was able to regain a high degree of steering capability while traveling on the northbound shoulder, the accident may have been prevented if the pavement in the traffic lane wheel paths had drainage and frictional qualities that were closer in character to that of the shoulder area.
