**CONTINENTAL TRAILWAYS, INC.  
SCHEDULED INTERCITY BUS/  
MULTIPLE-VEHICLE COLLISION AND FIRE  
INTERSTATE ROUTE 95  
NEAR BELTSVILLE, MARYLAND  
APRIL 20, 1981**

NTSB-HAR-81-5

**CONTINENTAL TRAILWAYS, INC., SCHEDULED INTERCITY BUS/  
MULTIPLE-VEHICLE COLLISION AND FIRE,  
INTERSTATE ROUTE 95, NEAR BELTSVILLE, MARYLAND  
APRIL 20, 1981**

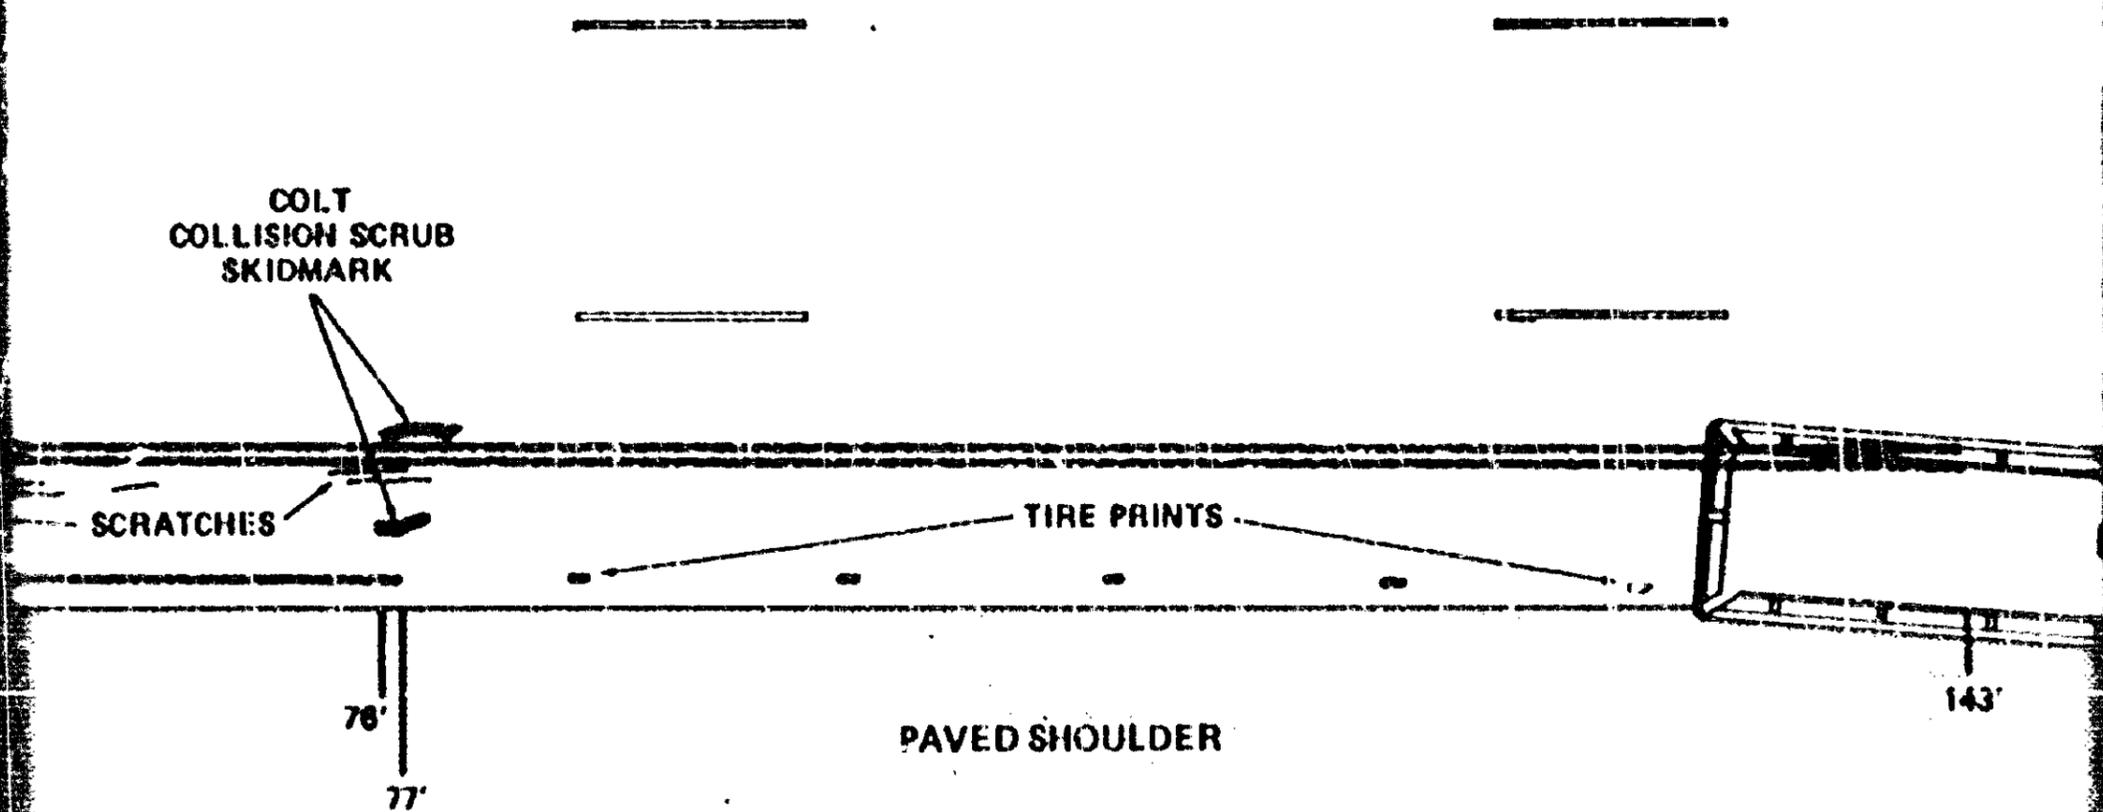
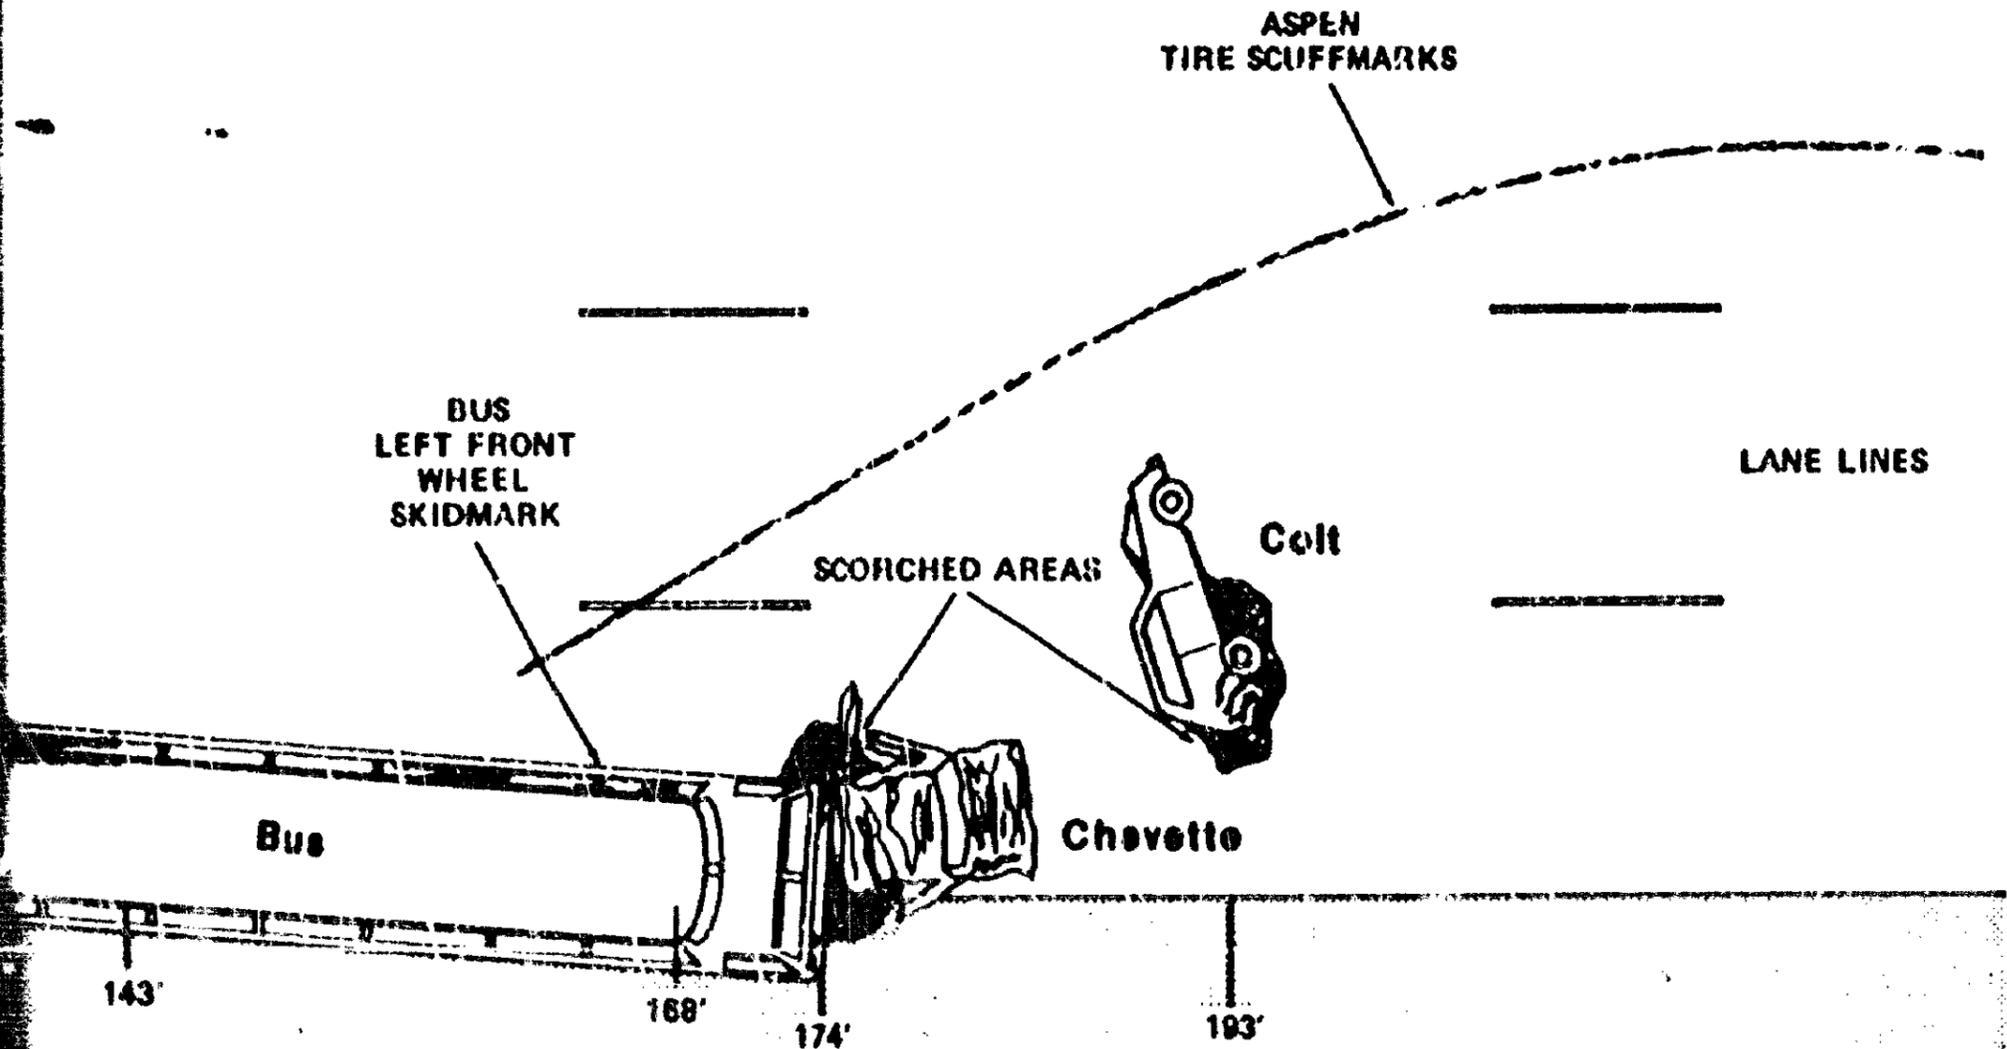
Figure 1. --Plan drawing of accident site.

Evidence found on the roadway at the crash site consisted of tire marks, gouges and scratches, and two patches of scorched pavement. (See figure 1.) Marks attributed to the bus consisted of three locked-wheel braking skidmarks and a series of tire prints. The skidmarks varied considerably in length. The left-rear dual tire left a skidmark that was 143 feet long, the right-front wheel left a skidmark that was 77 feet long, and the left front wheel left a mark that was at least 11 feet long. The right-front wheel skidmark began about 168 feet before the bus came to a halt, but the wheel ceased sliding after 77 feet and then began to roll. As the tire rolled, it left a tire print each time the "hot spot," which was created on the tire when it was sliding, came in contact with the road surface.

The marks left on the road surface as a result of the crash were instrumental in establishing the spatial relationship of the bus, the Chevette, and the Colt, and were also used in estimating the precrash speed of the bus. The braking skidmarks made by the bus showed the path of the bus before, during, and after the collision. They indicated that the bus was steered right and braked before impact. The distance between the beginning of the braking skidmarks of the bus and the first collision scrub skidmarks, which were made by the Chevette when its body sheet metal was crushed against its rear wheels locking them, revealed that the bus was being braked for at least 42 feet before it crashed into the Chevette. The bus skidmarks continued past this point to where the bus came to rest, 168 feet from where the skidmarks began.

The collision scrub skidmarks made by both the Chevette and Colt identified their location at impact and showed that the rear of the Colt was about 10 to 12 feet in front of the Chevette at the time of the collision. The scorched patches of pavement marked the location at which the burning vehicles came to rest after impact. The Chevette came to rest about 175 feet from where it was struck, and the Colt about 115 feet. Although tire scuffmarks made by the Aspen showed part of its postimpact path of travel, there were no visible marks locating the positions of the Aspen and the Mustang at impact. The absence of preimpact braking skidmarks from any of the passenger cars involved in this crash indicated that these vehicles probably had decelerated gradually and had not skidded to a halt as in a panic or sudden emergency stop.

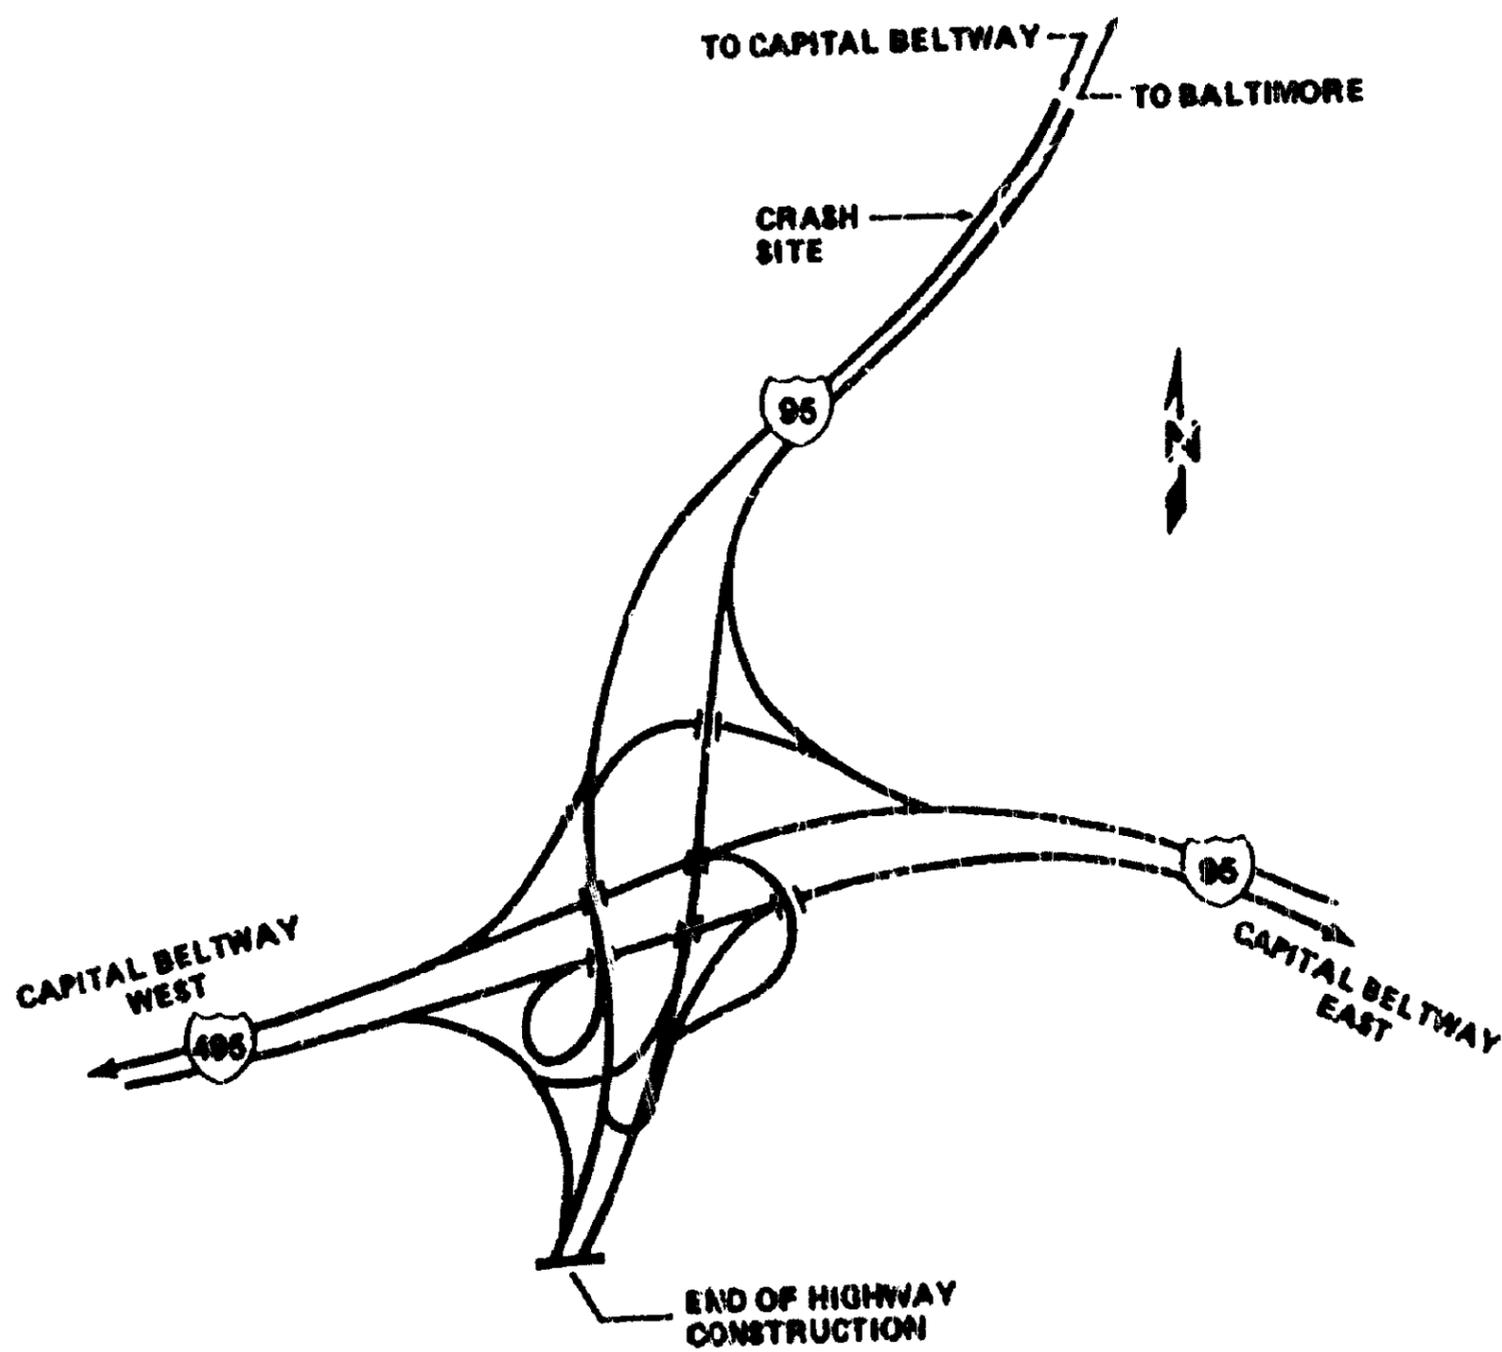
Interstate 95 is a north/south, Federal-aid, primary highway that traverses Maryland from the northeast corner of the State to the Washington, D.C., area where it joins the Capital Beltway system encircling the District of Columbia before continuing south into Virginia. Although I-95 was originally planned to extend south, past the Beltway, into the District of Columbia, the plan was abandoned and construction of I-95 was discontinued at the Capital Beltway. As a result, southbound I-95 traffic is channeled onto the Capital Beltway. Eastbound traffic is designated as a continuation of I-95 and westbound traffic is designated as I-495. The continuation of I-95 traffic exits from I-95 onto two ramps; westbound traffic uses a one-lane cloverleaf design and the eastbound traffic uses a diamond-type exit ramp with access to a U-turn area. (See figure 11.)

Figure 11.--I-95/495 Interchange.

The I-95/495 interchange was designed and constructed under the assumption that I-95 would extend south of the Capital Beltway into Washington, D.C., and that the interchange would be part of a continuing north/south highway system rather than the termination point of southbound I-95. Since it was not built to accommodate a large flow of through traffic from I-95, the traffic flow on the exit ramp from southbound I-95 to westbound I-495 increases beyond the ramp's capacity during peak hours of traffic and causes the flow of southbound I-95 traffic in the right lane to be disrupted either by forcing it to come to a complete stop or to a significantly reduced speed. To what degree and at what distance upstream this condition manifests itself depends on the traffic density, but wherever this condition exists, it increases the probability of traffic accidents and is clearly undesirable. Because the crash probably would not have occurred if the traffic had not come to a halt in the right lane of southbound I-95, and since this traffic backup was caused by the inadequacy of the interchange to accommodate the volume of southbound I-95 traffic exiting to westbound I-495 during a peak traffic hour, the Safety Board concludes that the inadequate interchange was a factor in this accident. The already planned safety improvements at the interchange should eliminate the traffic backups, and the Maryland DOT should expedite these improvements.

Review conditions at the I-95/495 interchange and determine if the planned safety improvements should be expedited. (Class II, Priority Action) (H-81-71)
