Highway Accident Report: ARA Services, Inc.
Tour Bus, Denali National Park and Preserve
(Mt. McKinley National Park), Alaska
June 15, 1981

(U.S.) National Transportation Safety Board
Washington, DC

HIGHWAY ACCIDENT REPORT

**ARA SERVICES, INC., TOUR BUS
DENALI NATIONAL PARK AND PRESERVE
(MT. MCKINLEY NATIONAL PARK), ALASKA
JUNE 15, 1981**

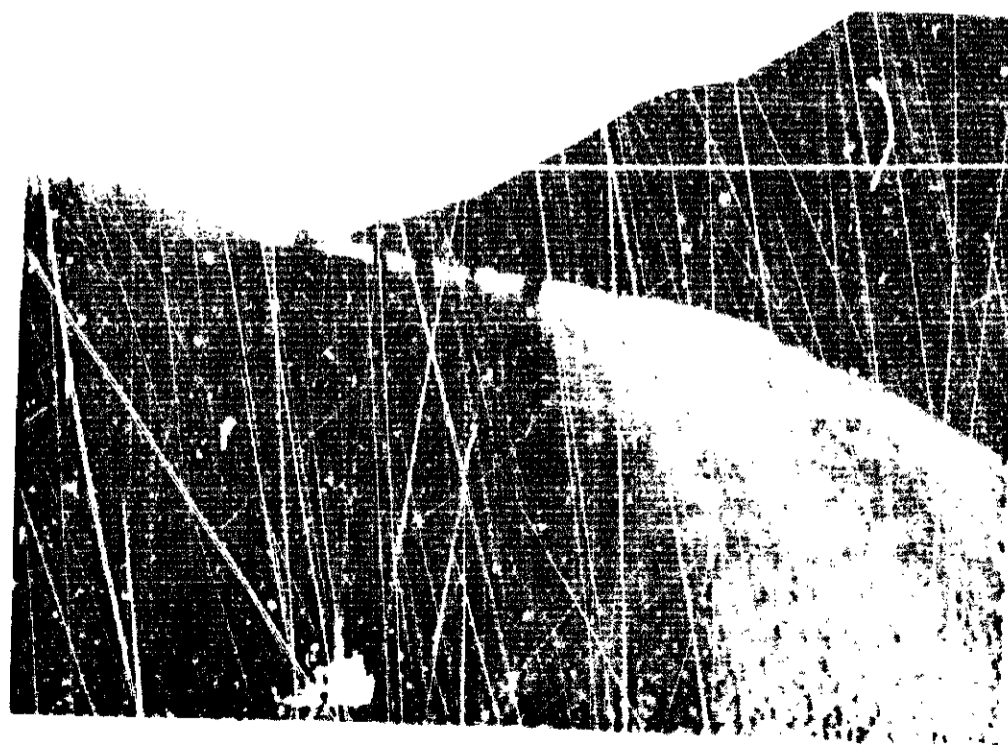
Figure 1.-- Eastbound view of area vehicle ran off road.

At the south side of the roadway, dual tire marks were visible leaving the road edge at a very shallow angle (see figure 1), traveling a short distance off the road edge, and then gouging sideways down the hillside, displacing loose dirt along the side slope. Beyond this point, a single tire mark was visible, nearly parallel with the road edge, extending the same distance as the wheelbase of the bus, and then gouging sideways down the hill. Gouge and scuff marks extended south down the hillside to the point of rest of the bus. At two points along this route, deep gouges the same distances apart as the wheels on the bus were visible. Broken glass, personal effects of occupants, and the occupants were strewn along the travel path.

The bus was moving east at a very low speed when it left the road since the final resting place of the bus was approximately perpendicular to the point to where it left the road. Any significant forward speed would have caused the bus to move in a more easterly direction during its 2 1/4 turn rollover and significant longitudinal deformation of parts would have occurred. Wheel tracks at the roadway edge indicate the bus left the road at a very shallow angle.

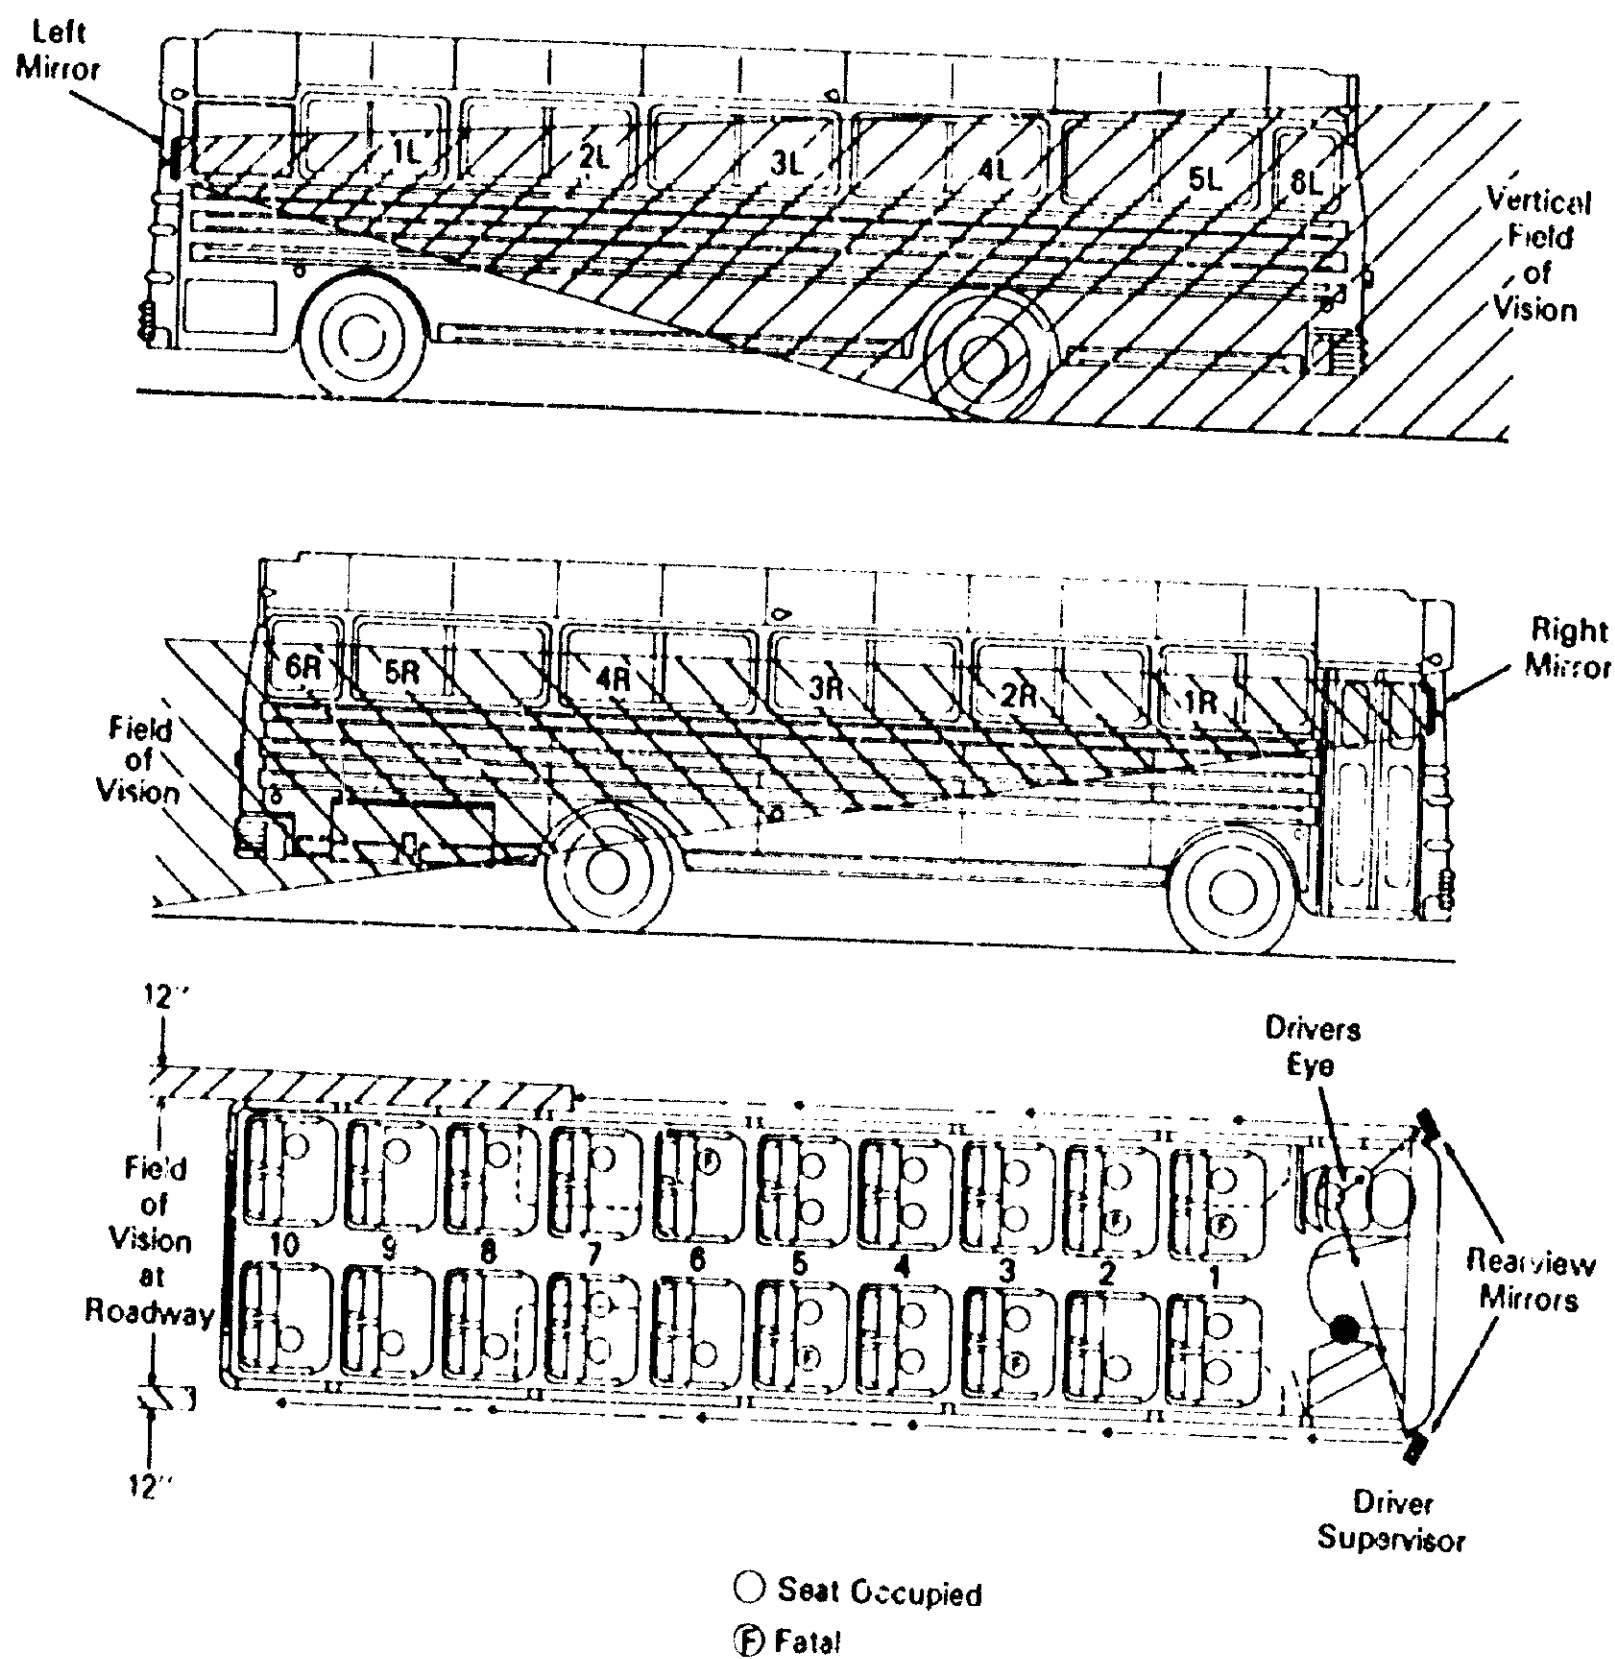
The rearview mirrors on the bus provide a limited view for the driver in determining the position of the bus on the roadway. Figure 4 illustrates the driver's rearview mirror field of vision from a similar make and model tour bus. The views do not provide a view of the roadway at the forward axle of the bus.

Figure 4.--Rearview vision capability (not to scale) and occupant seating chart.

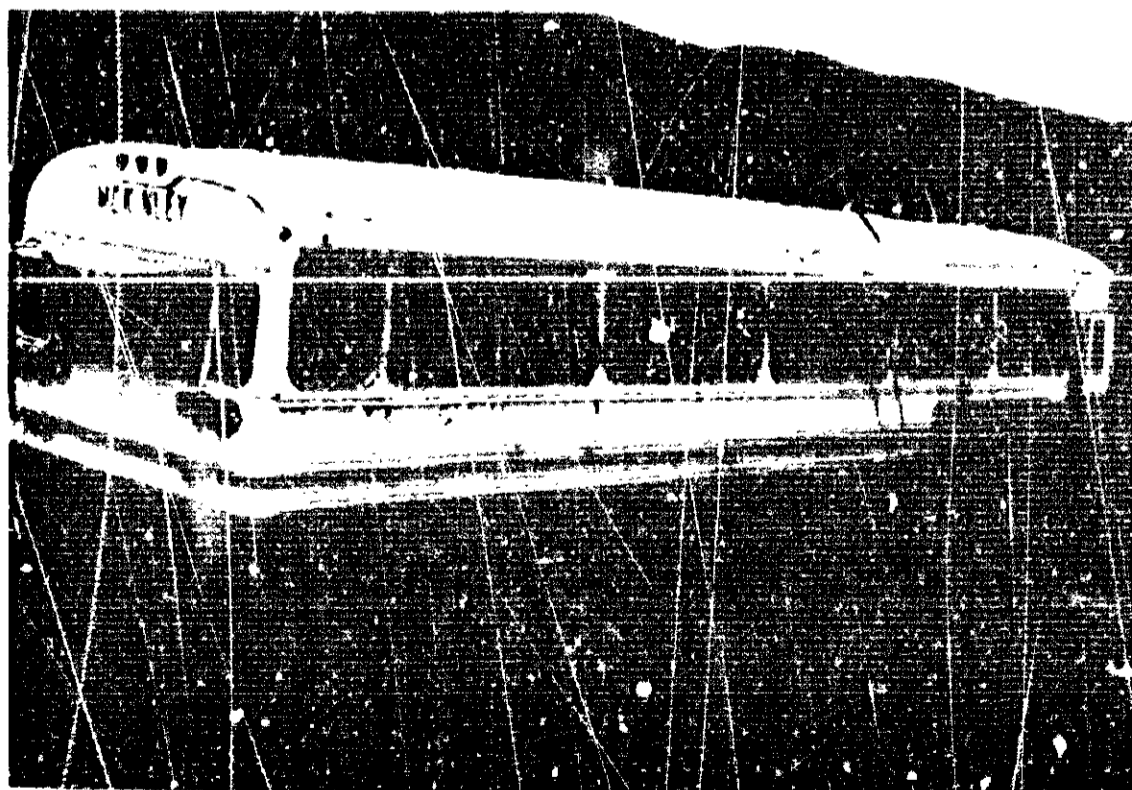
The bus body was still securely attached to the chassis frame although the top of the body was permanently deformed 7 1/2 to 11 inches toward the left. The sides were not damaged significantly. (See figures 5, 6, and 7.) The windshield and most of the side window glass had separated from the frames, and the horizontal exit window at the rear was open. The door was damaged. All chassis components appeared to be free of damage. Portions of the inside roof panels near the sides of the bus were distorted outward. (See figure 8.) There was no evidence of exterior penetration by objects, and the interior was not diminished in size. A detailed inspection of the steering, brakes, and tires indicated that they were in good operating condition. The two front tires were Bridgestone 10:00 R 20's with 11/32- to 12/32-inch tread depth inflated to about 100 and 110 psi. The four rear tires were Michelin 10:00-20's with 15/32- to 16/32-inch tread depth inflated to between 95 and 100 psi.

Figure 6.--Right rear of bus.

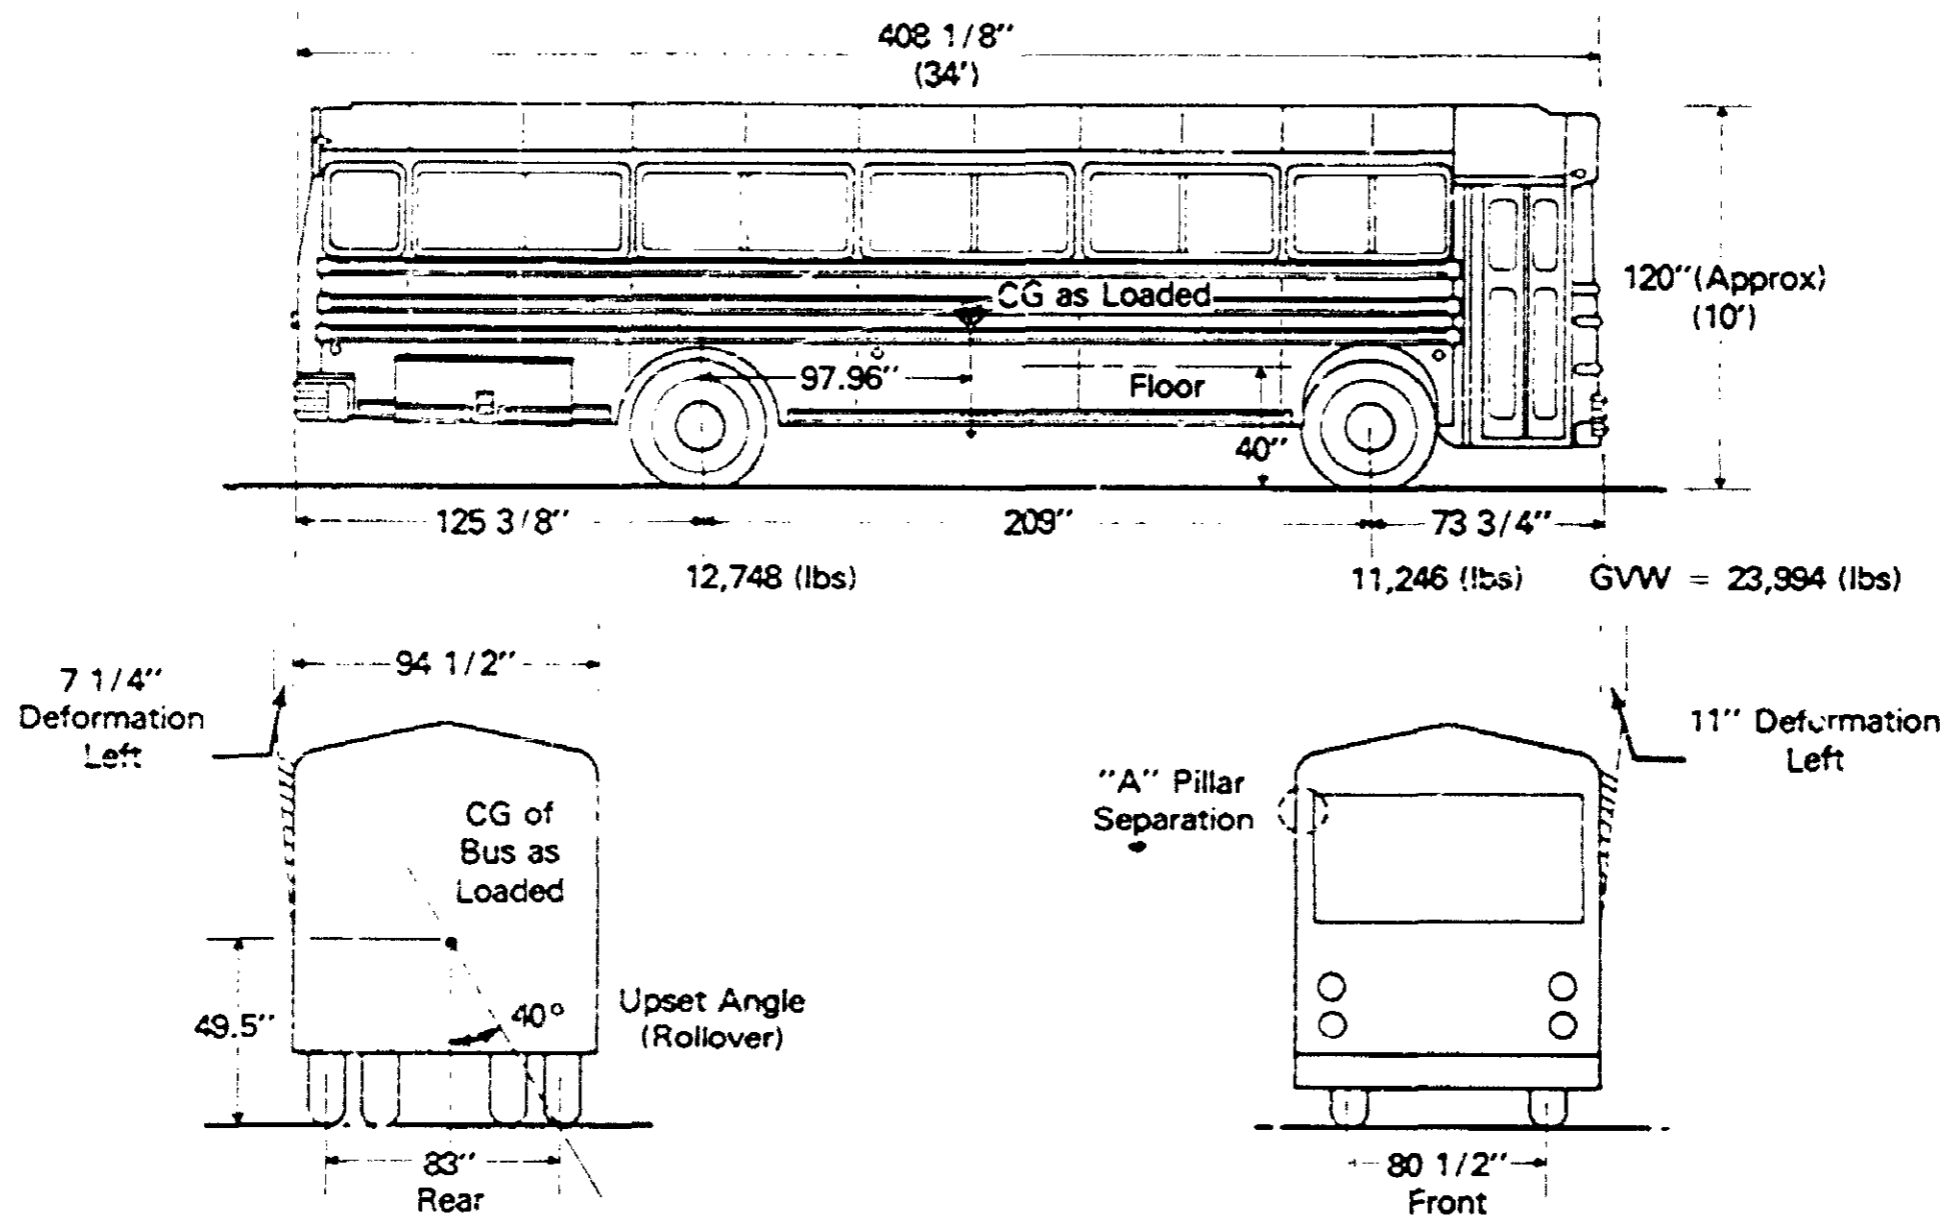
Figure 7.--Basic vehicle information.
