Highway Accident Report - Collision of Humboldt
County Dump Truck and Klamath-Trinity Unified
District Schoolbus, State Route 96 near
Willow Creek, California, February 24, 1983

(U.S.) National Transportation Safety Board
Washington, DC

1. Report No. NTSB/HAR-83/05	2. Government Accession No. PB83-916205	3. Recipient's Catalog No.	
4. Title and Subtitle Highway Accident Report--Collision of Humboldt County Dump Truck and Klamath-Trinity Unified District Schoolbus, State Route 96 near Willow Creek, California, February 24, 1983		5. Report Date December 5, 1983

COLLISION OF
HUMBOLDT COUNTY DUMP TRUCK
AND KLAMATH-TRINITY UNIFIED DISTRICT SCHOOLBUS
STATE ROUTE 96
NEAR WILLOW CREEK, CALIFORNIA
FEBRUARY 24, 1983

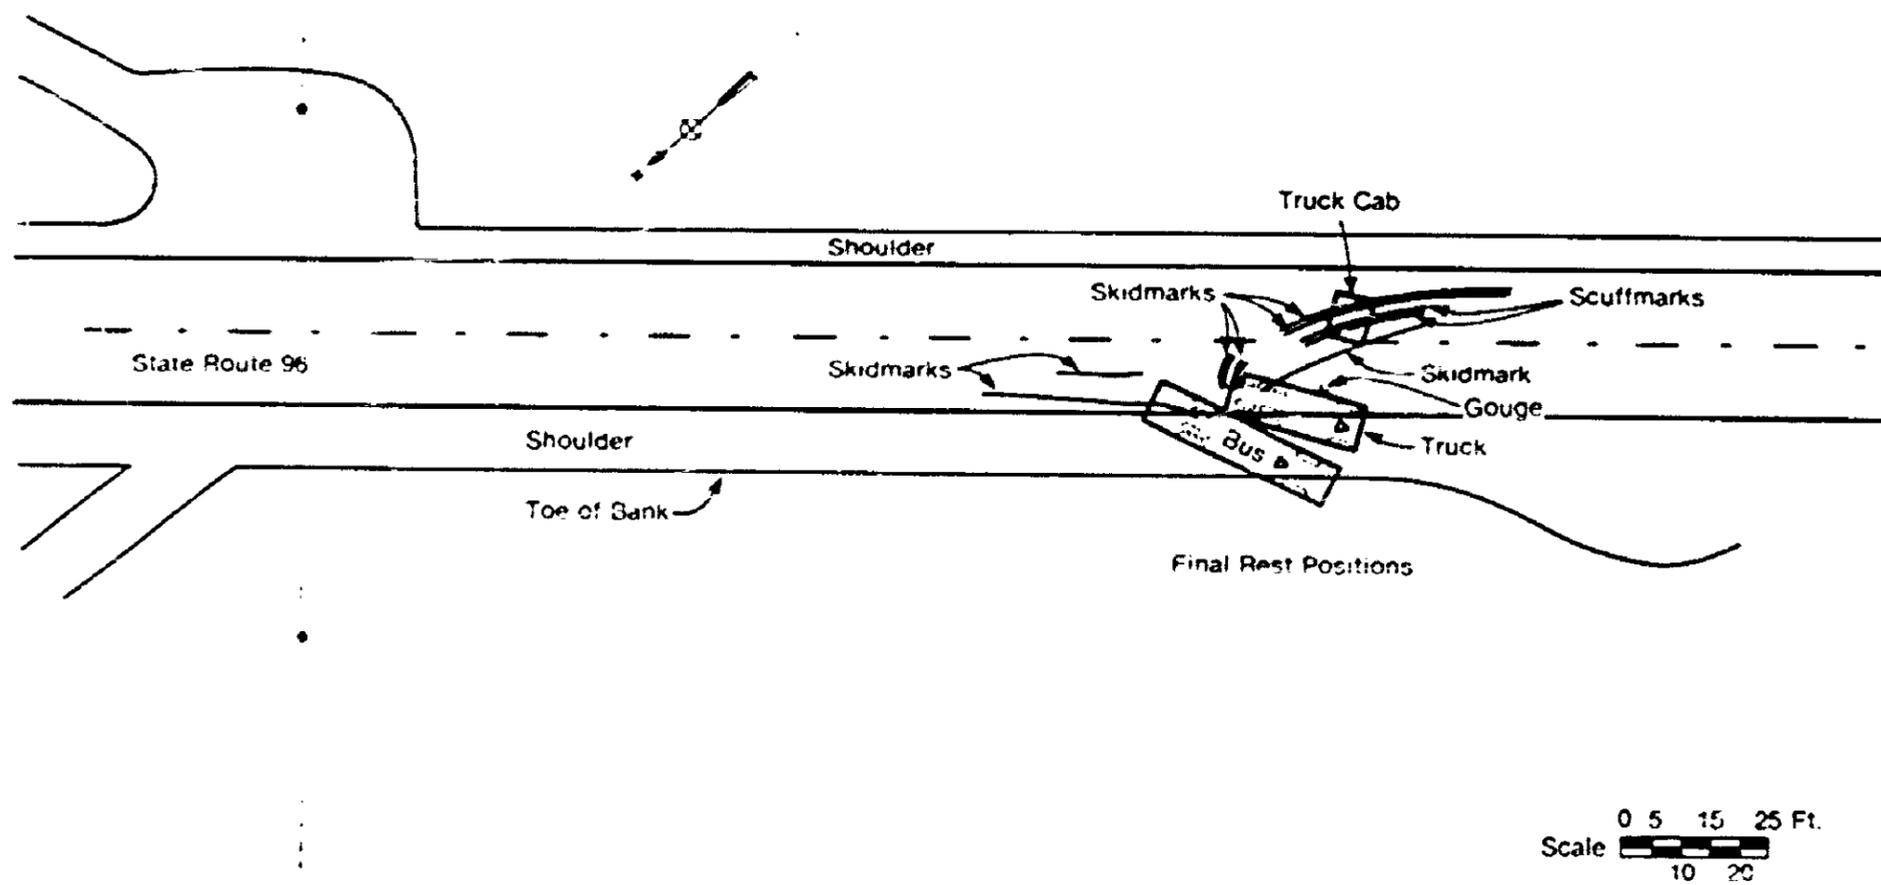
Figure 1.—Accident site.

Impact. The passengers in the accident schoolbus stated that they were not cognizant of the schoolbus driver's activities or oncoming traffic immediately before the accident. However, after the accident, heavy skid marks from both vehicles were observed on the pavement surface heading up to the point of impact. (See figure 2.) The accident schoolbus driver stated that he was traveling between 45 and 50 mph just before the collision. He stated that he saw the dump truck coming around the curve, slide sideways within the northbound lanes as if the brakes were locked, and continue into the southbound lane of traffic.

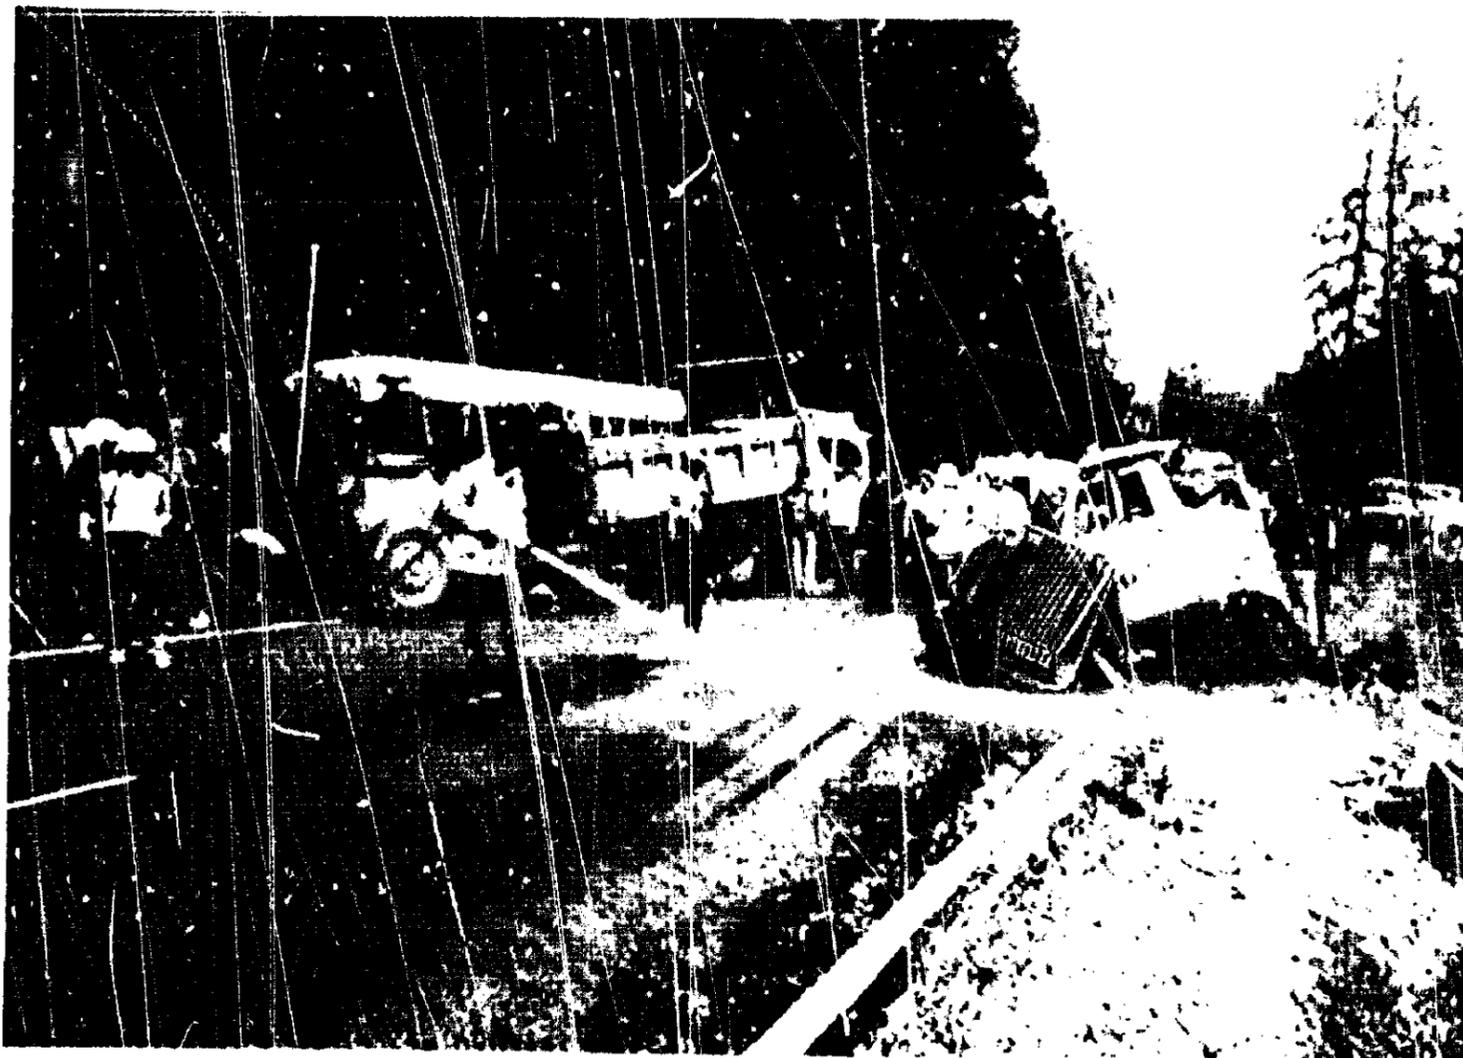
Figure 2.—Final rest positions of schoolbus and dump truck. According to witnesses, the truck cab had been pulled to the side of the roadway to allow emergency vehicles to get through.

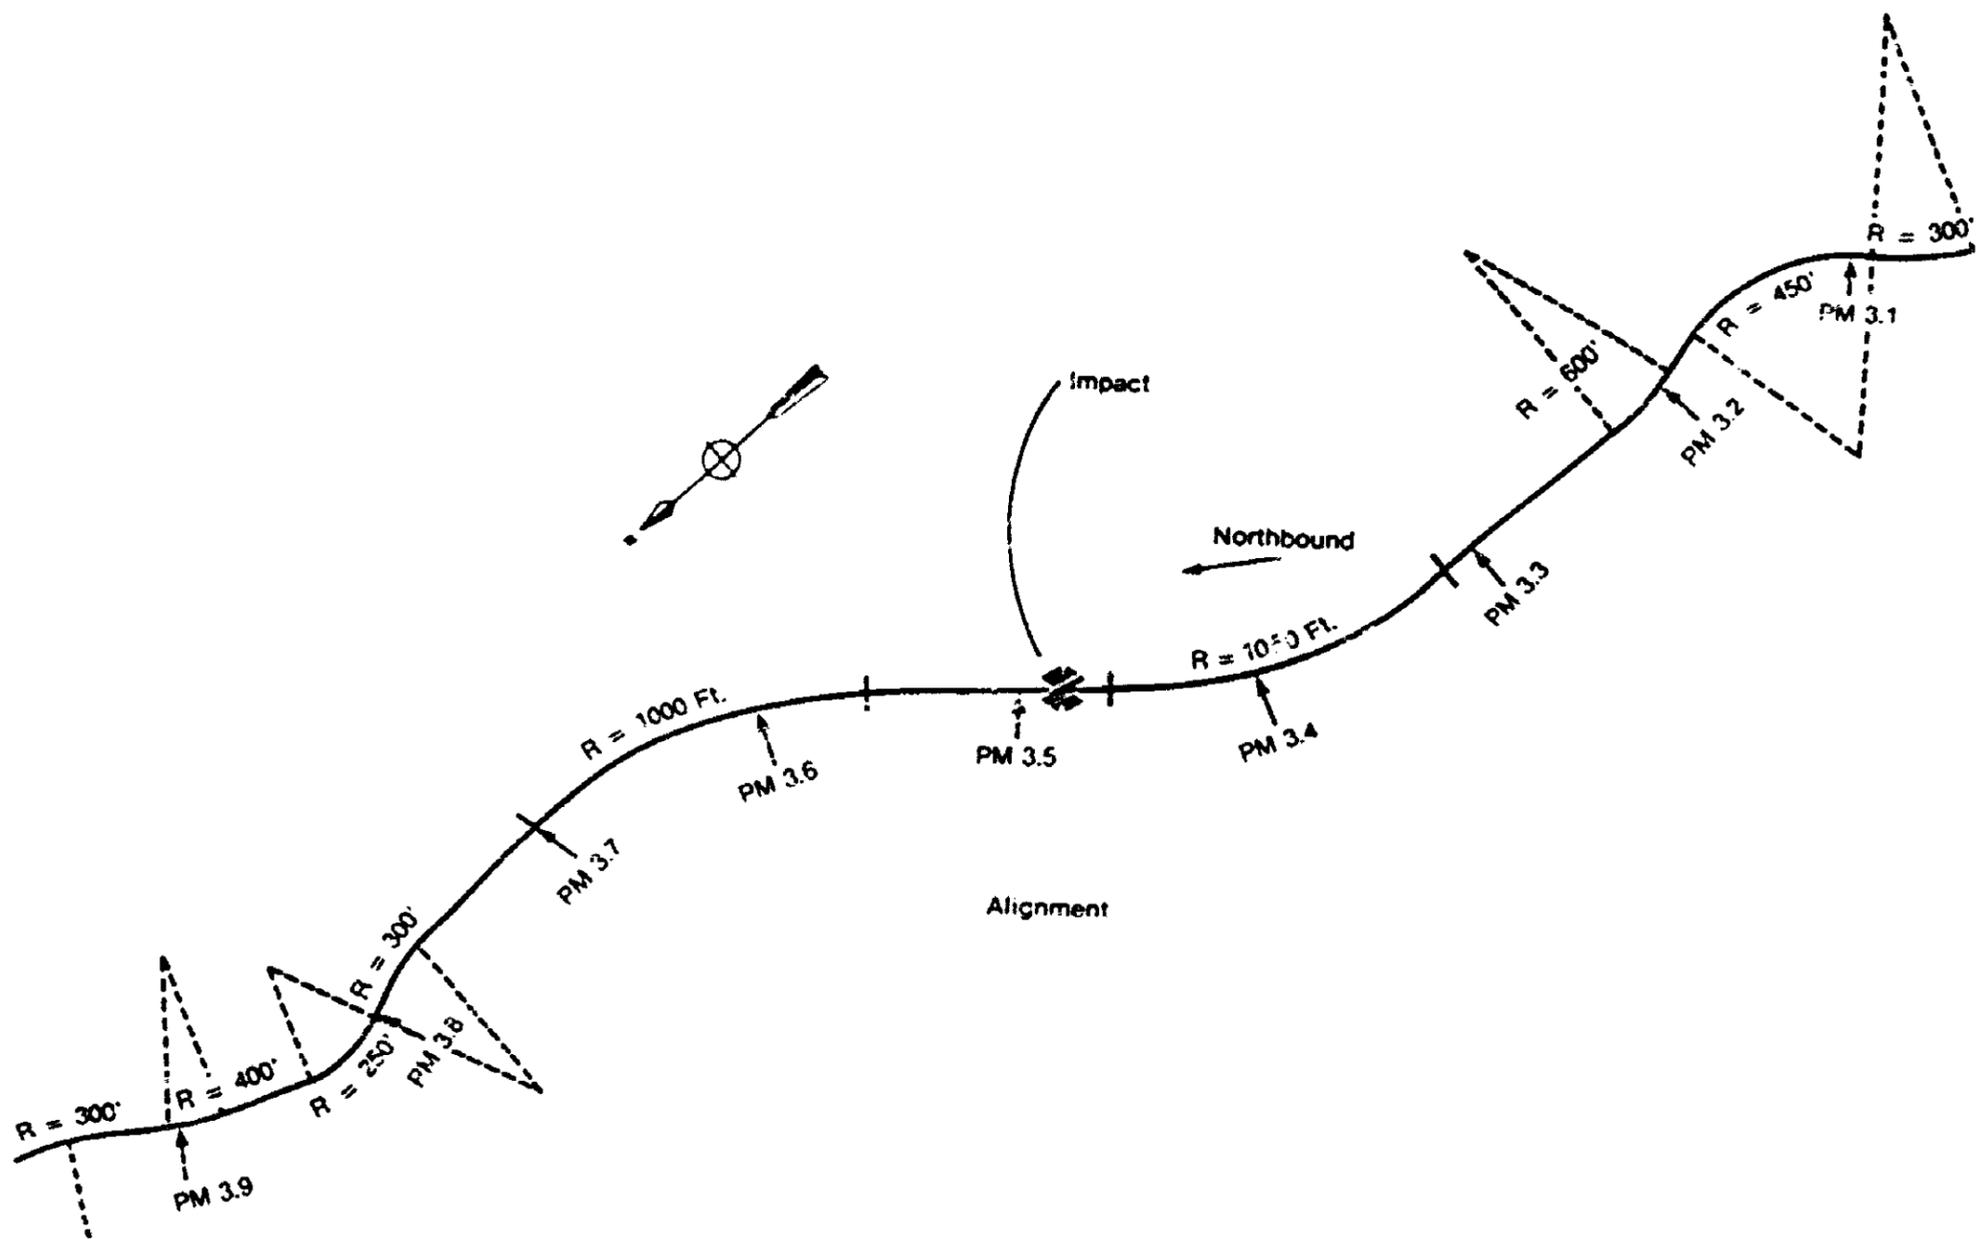
Figure 6.—Plan view of State Route 96.

Because of numerous curves on the approaches to the accident site and because of topography, roadway visibility in both directions was limited. (See figure 6.) Vegetation along the last curves in both the north and southbound directions leading up to the accident site reduced visibility to about 400 feet. No potholes were observed in the road surface, and the shoulder dropoff varied, with a maximum dropoff of 1.5 inches. Several tight radius curves were located about 0.4 mile from the point of impact. The tightest radius curve had a critical speed $\frac{7}{7}$ of 46 mph. Several advisory speed signs were posted

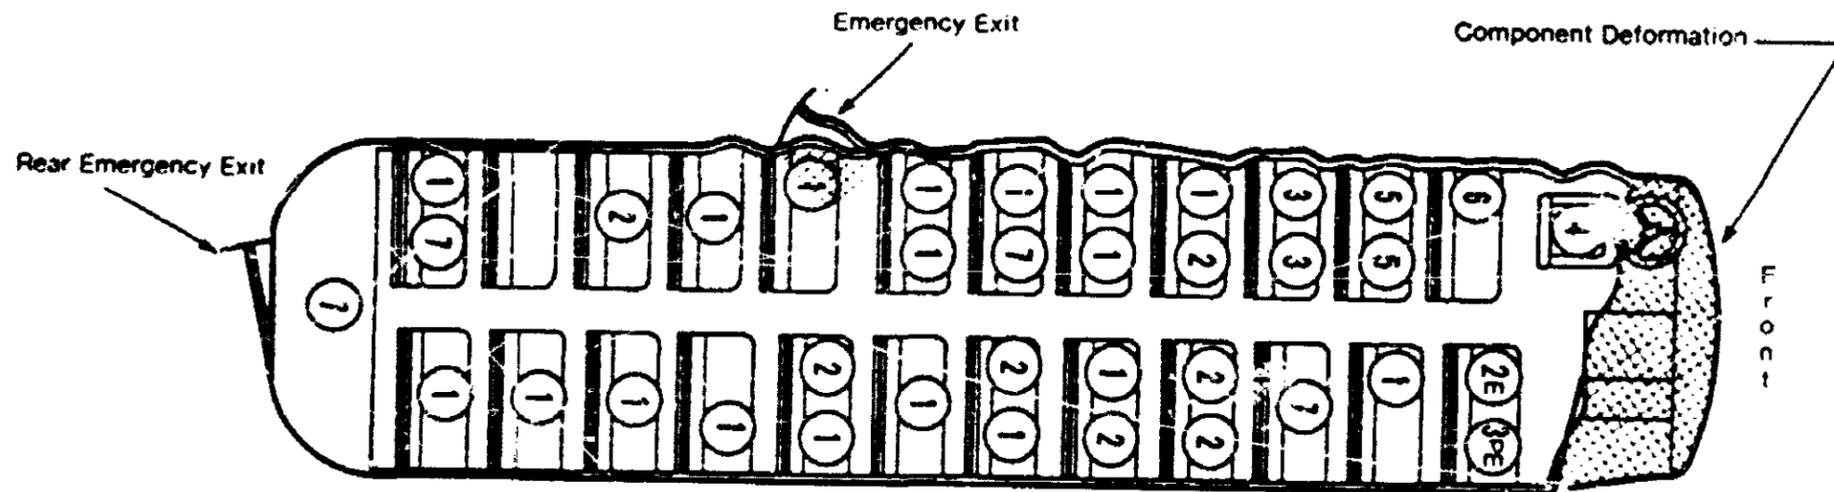
Figure 7.—Schoolbus crash damage patterns.

Although some partial separations were noted, none of the passenger seats separated completely from either its floor or sidewall anchorages. Several seatbacks were pushed forward and inboard during the impact sequence. Blood transfers were observed on the exposed seatframes and metal seatback covers. Figure 7 contains the seating positions and AIS injury level 9/ of all the schoolbus occupants. (See also appendix B.)

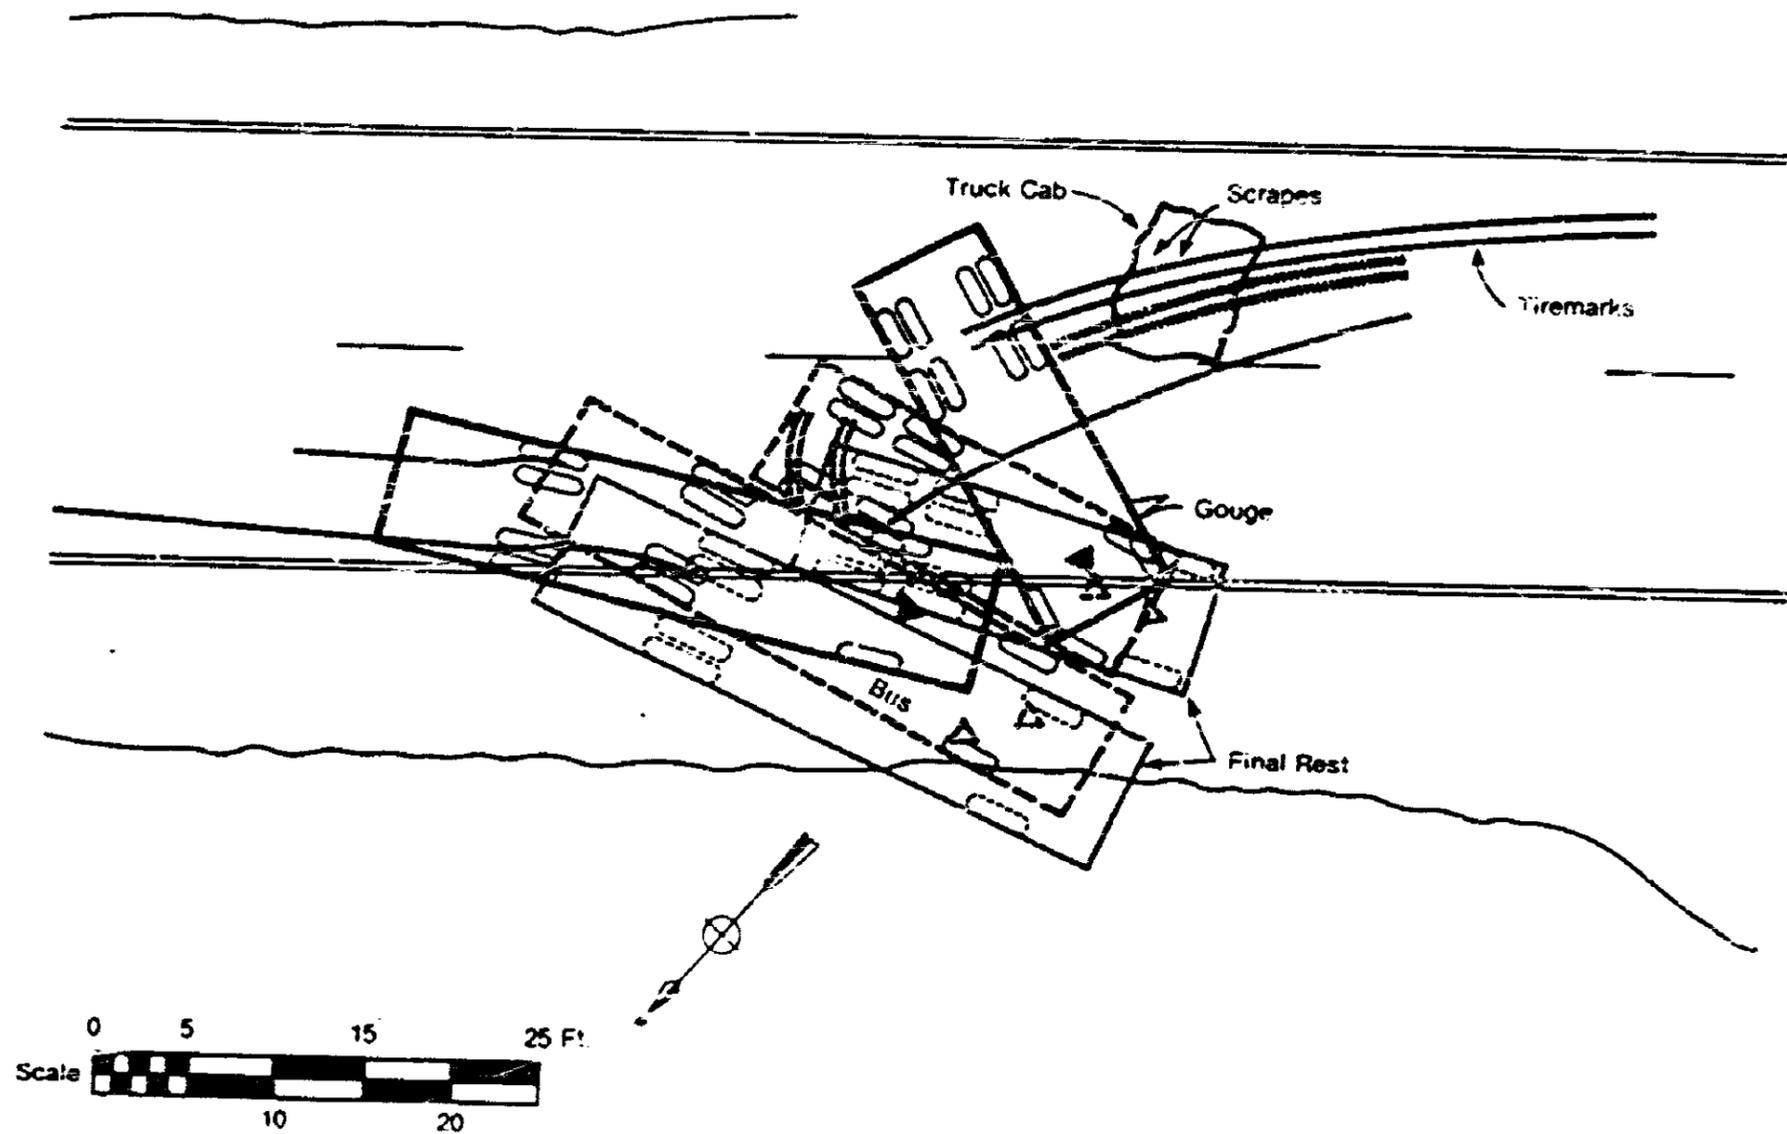
Figure 8.--Accident dynamics sequence.

present in the northbound lane indicate that the truckdriver had applied his service brakes before impact. The truck then rotated counterclockwise about 111° during the impact sequence and came to rest adjacent to the schoolbus facing in the opposite direction of original travel. (See figure 8.)

The physical evidence indicates that the schoolbus driver, having perceived that the oncoming dump truck was crossing into the northbound lane, attempted to avoid impact by steering his vehicle to the right, while simultaneously applying his service brakes. Skidmarks present in the southbound lane indicate that the schoolbus was braking while being steered to the right at about a 5° angle relative to the road. The busdriver stated that he was traveling between 45 and 50 mph when impact was imminent. At impact, the heavier and faster schoolbus had a higher momentum than the truck. As a result, the schoolbus continued forward after the collision and caused the truck to rotate counterclockwise.

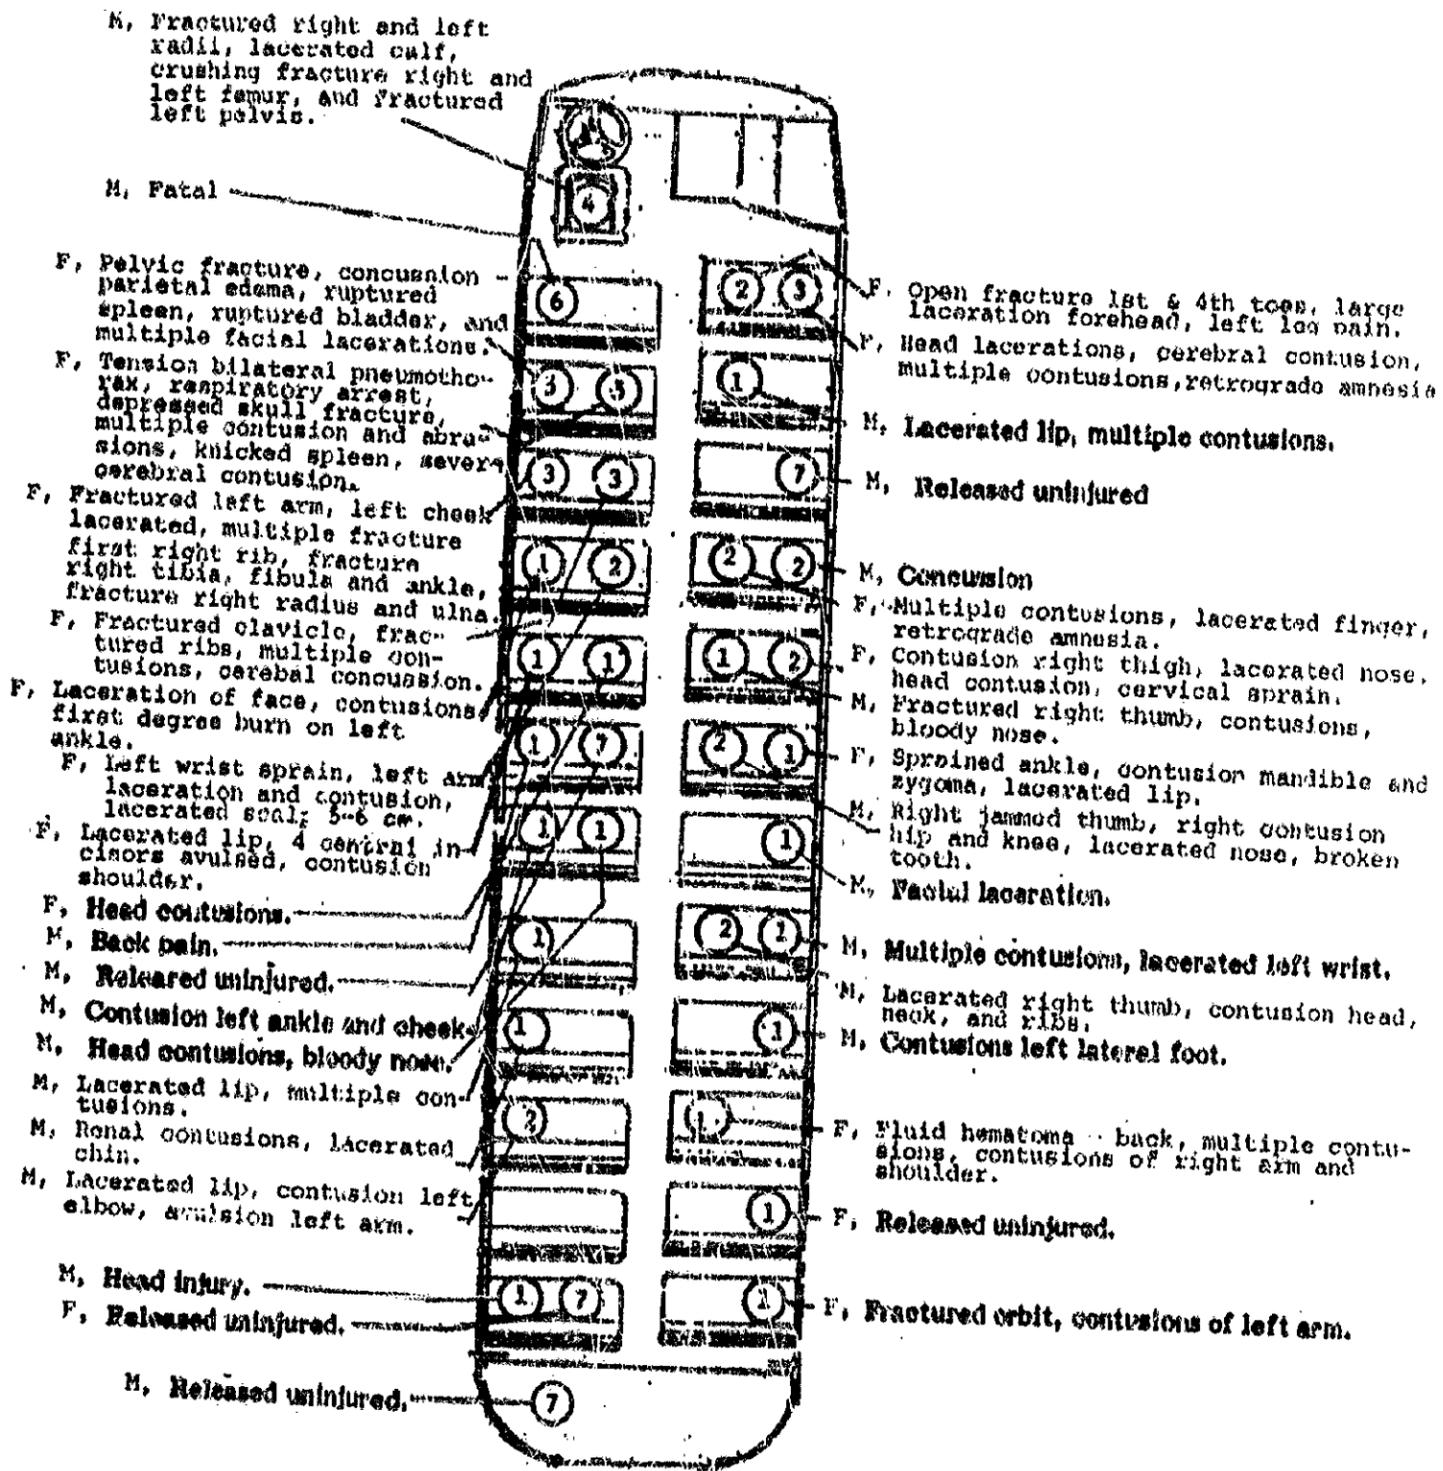
Data were obtained on all 38 persons aboard the two vehicles. (See figure 9.) Their injuries were classified according to the American Association for Automotive Medicine Abbreviated Injury Scale (AIS) and are presented in the table below:

Figure 9.--Schoolbus diagram with probable distribution of occupants and their AIS injury severity code.
