HIGHWAY ACCIDENT REPORT

VALLEY SUPPLY COMPANY
TRUCK TOWING FARM PLOW/
ANCHOR MOTOR FREIGHT INC.
CAR-CARRIER TRUCK/NEW YORK—
STATE ASSOCIATION FOR RETARDED CHILDREN BUS
COLLISION AND FIRE, STATE ROUTE 8,
NEAR HOLMESVILLE, NEW YORK
APRIL 5, 1983

NTSB/HAR-84/01

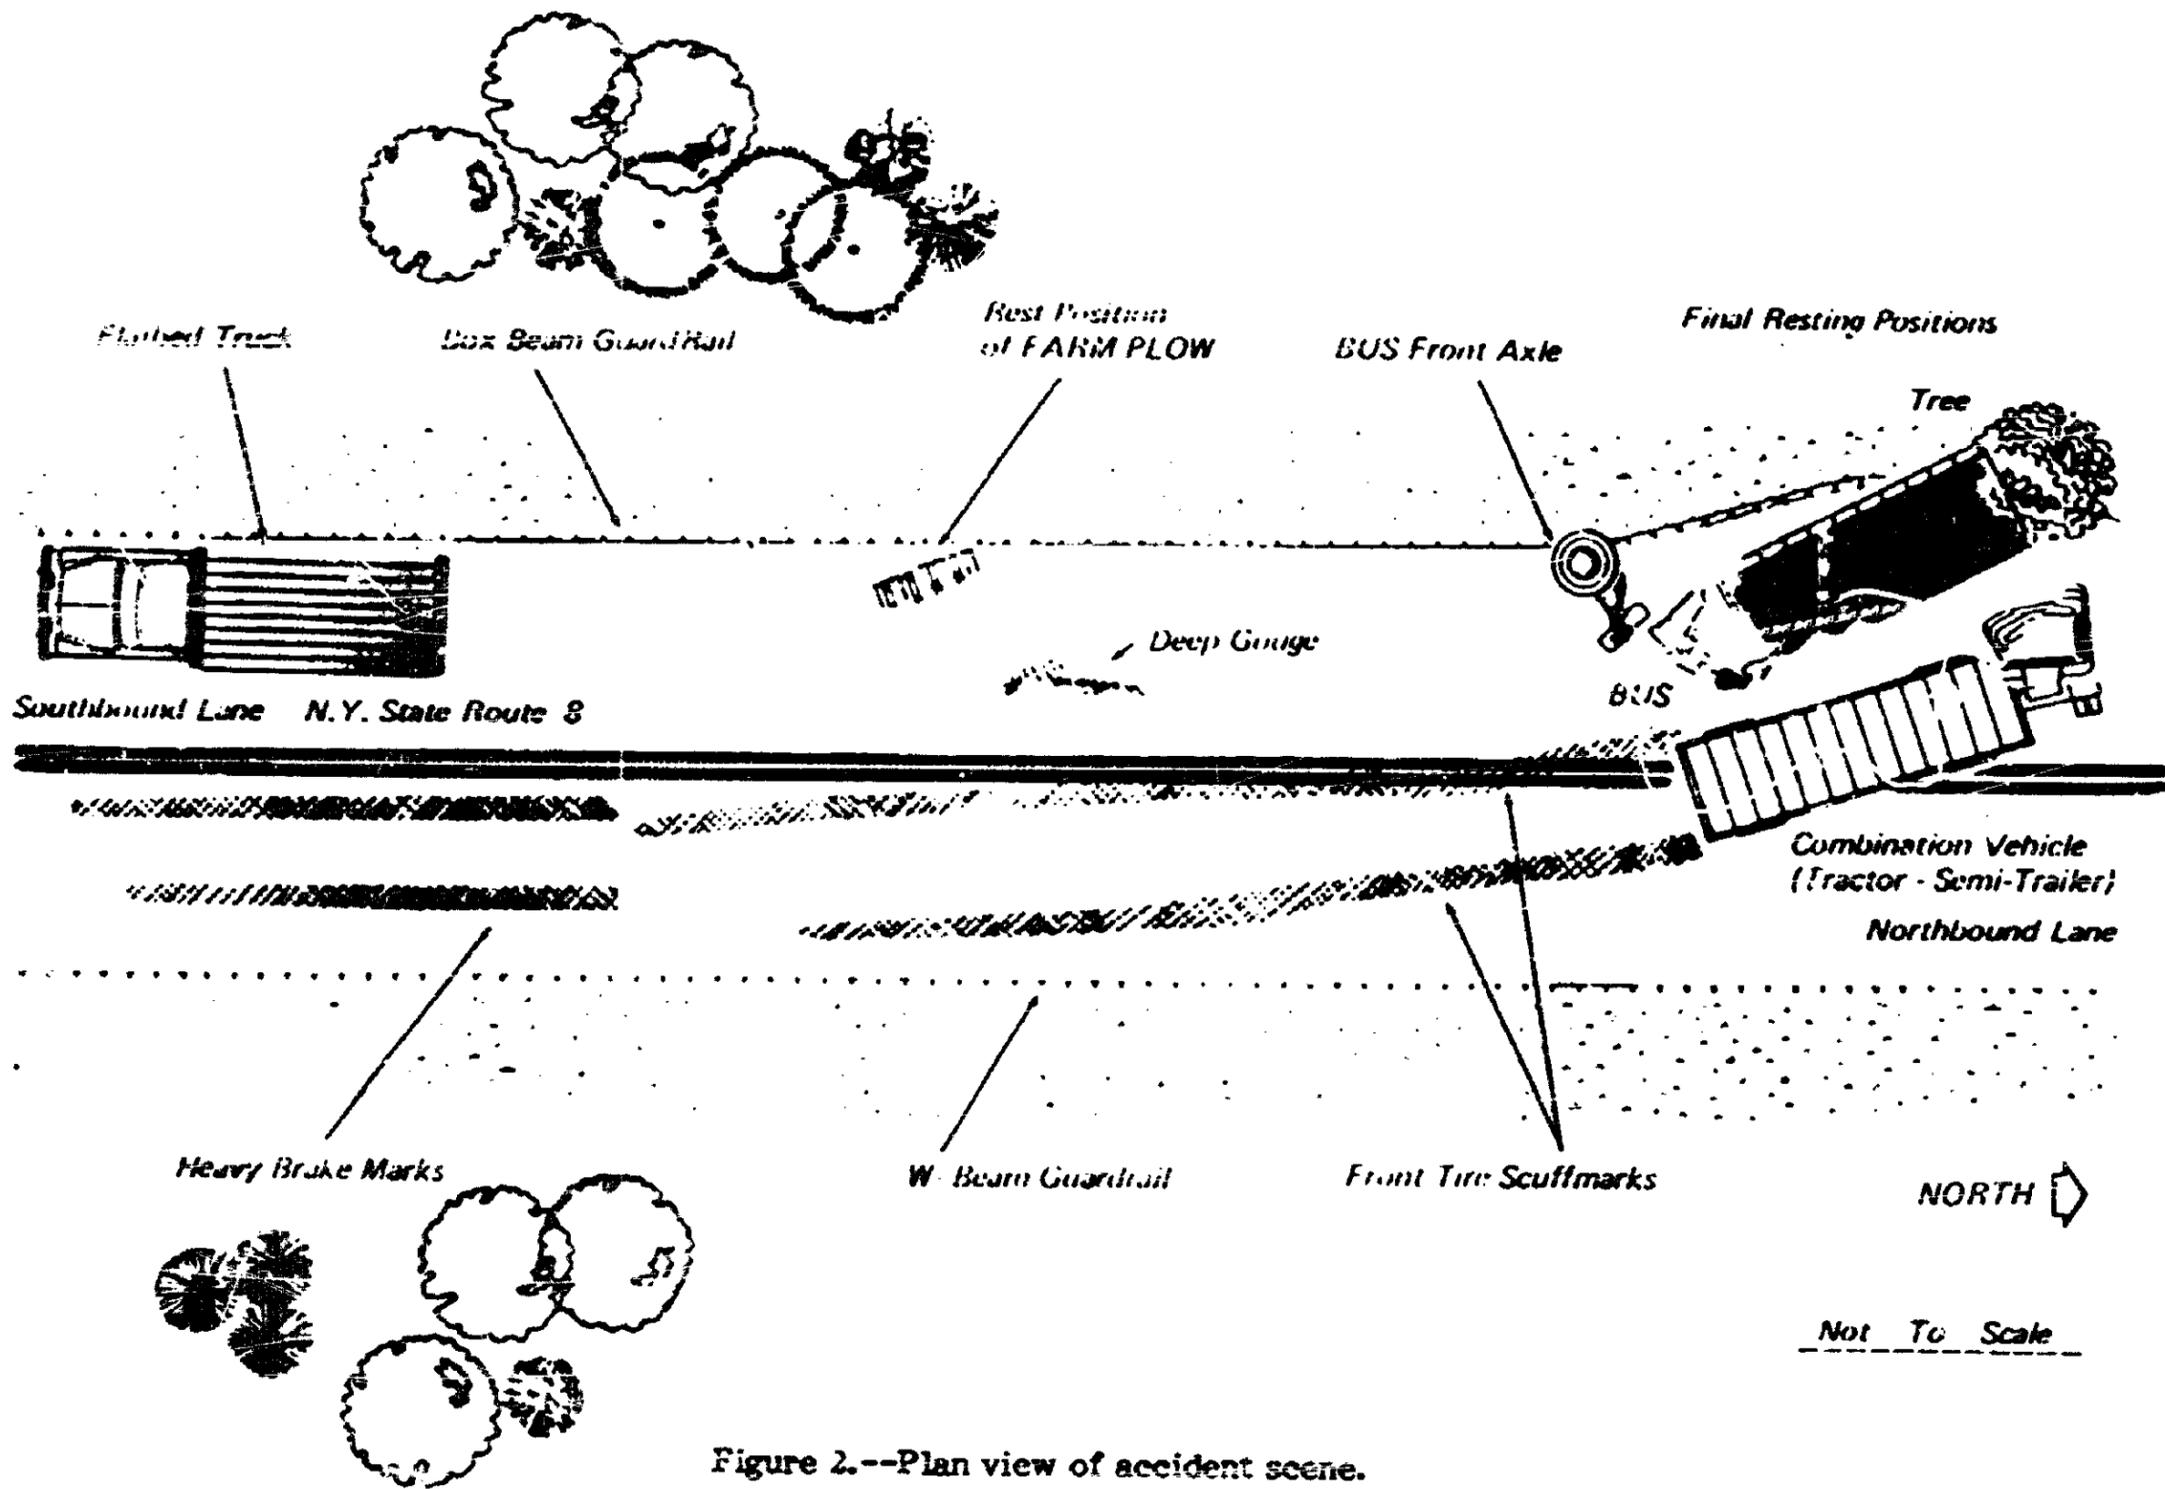
Figure 2.--Plan view of accident scene.

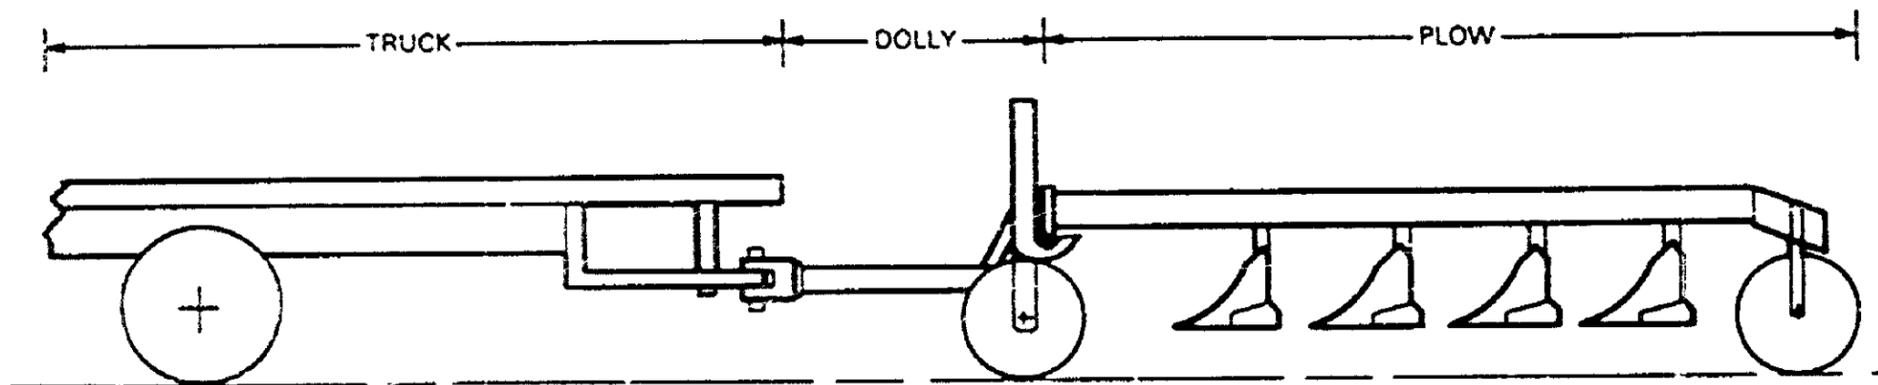
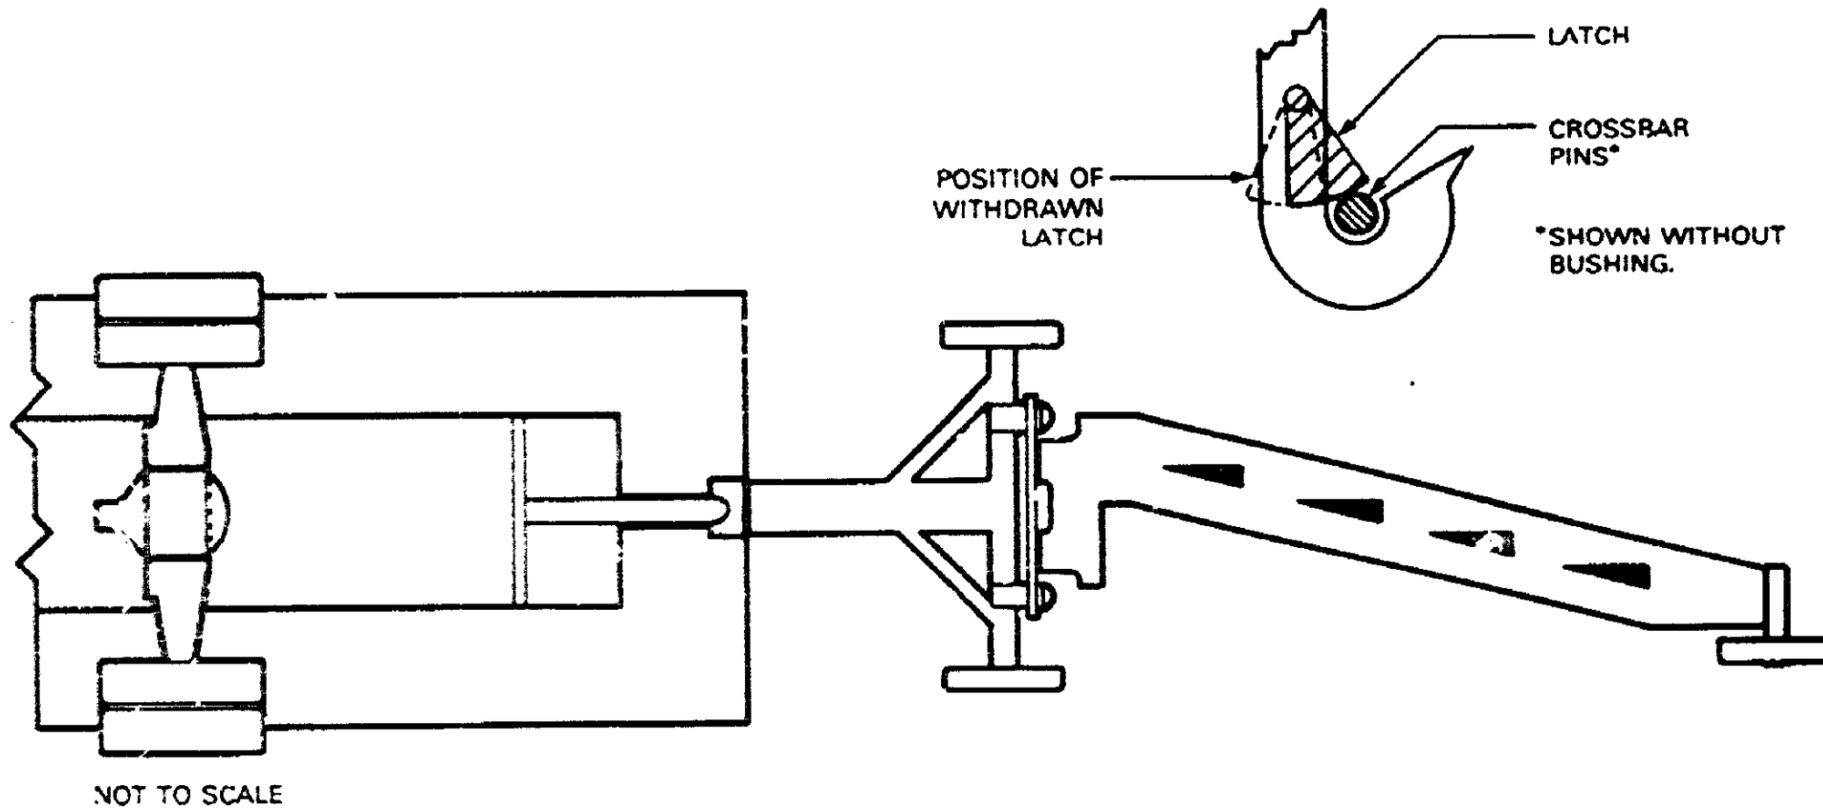
Figure 3.—Schematic arrangement of truck, dolly, and plow.

Given the size of the farm equipment, the design of the dolly, and the type of hitch attachment, the owner/operator should have secured the plow and dolly to the truck to preclude separation in transit. A fairly easy approach would have been to attach safety chains between the plow and the dolly and between the dolly and the flatbed truck. This safety practice is a recommended procedure established in SAE J 697a for users of full trailers or converter dollies. Safety chains probably would have kept the plow in its own lane or at least minimized its intrusion into the opposing lane.

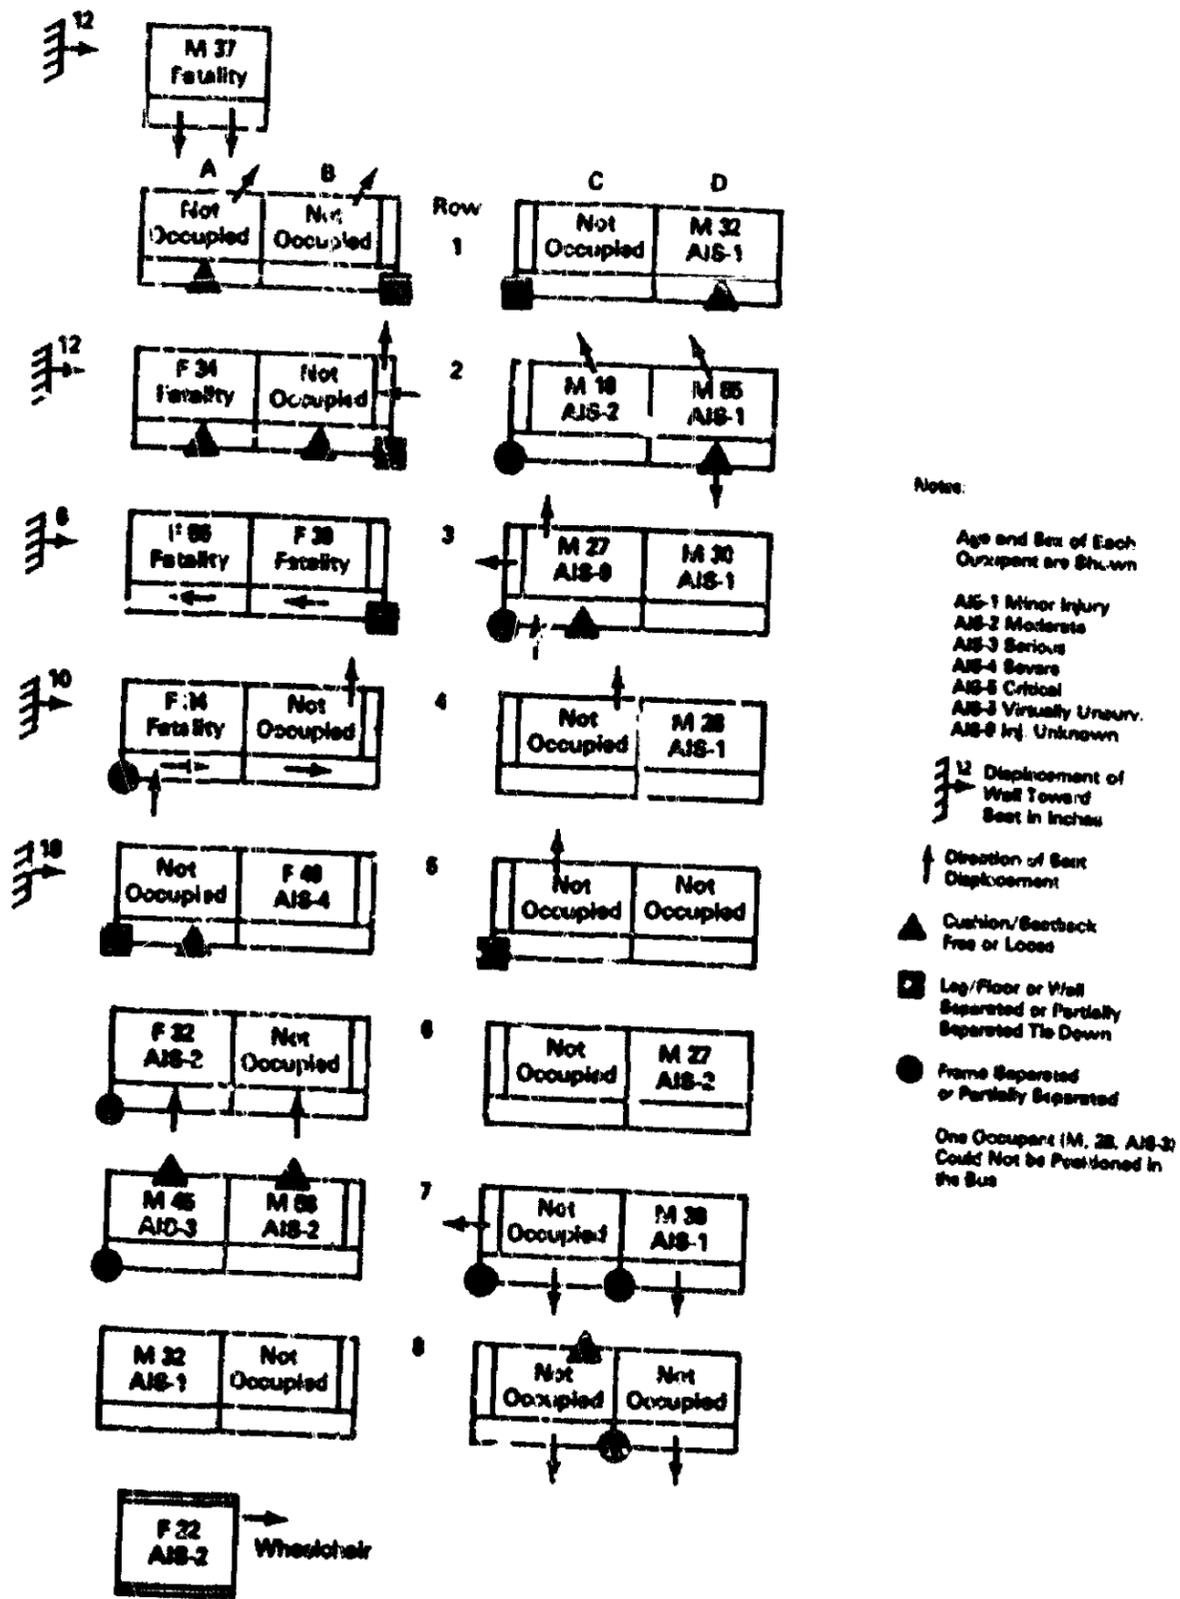
were not welded to the cap. They were pulled out axially, not sheared. All window assemblies on the left side, except for windows 5 and 6 from the front of the bus, were missing. The floor on the left side had buckled upward and inward. Maximum inward displacement was 18 inches between seat rows 4 and 5. (See figure 7.)

At least six seat assemblies were partially or completely separated from either their floor or sidewall anchorages (see figure 7). Several seat assemblies were displaced forward and inward during the impact sequence, which caused the attaching seatback and

Figure 7.—Bus occupant seating chart depicting age, sex, and AIS injury level of the occupants, and wall displacement and seat damage to bus.

seat cushion to separate from their respective seat frame. The impact penetration on the left side caused two seat units (4A and B, and 5A and B) to shift laterally, thus blocking the center aisleway in the passenger compartment.

In the first four rows of seats on the left side of the bus, the seats had partially separated from their floor or sidewall anchorages, and arm rests had separated from seats. Many of the seatbacks in this area were pushed rearward from impact with the tree and inward during the impact with the truck. Blood was observed at various locations on the seats and seatbacks on the right side of the bus. Figure 7 contains the seating positions and AIS injury levels ^{14/} of the bus occupants.
