Highway Accident Report
Multiple Collision with an Intercity Charter Bus
Passenger Car, and Transit Bus, State Route 495
North Bergen, New Jersey, October 9, 1986

(U.S.) National Transportation Safety Board
Washington, DC

27 Oct 87

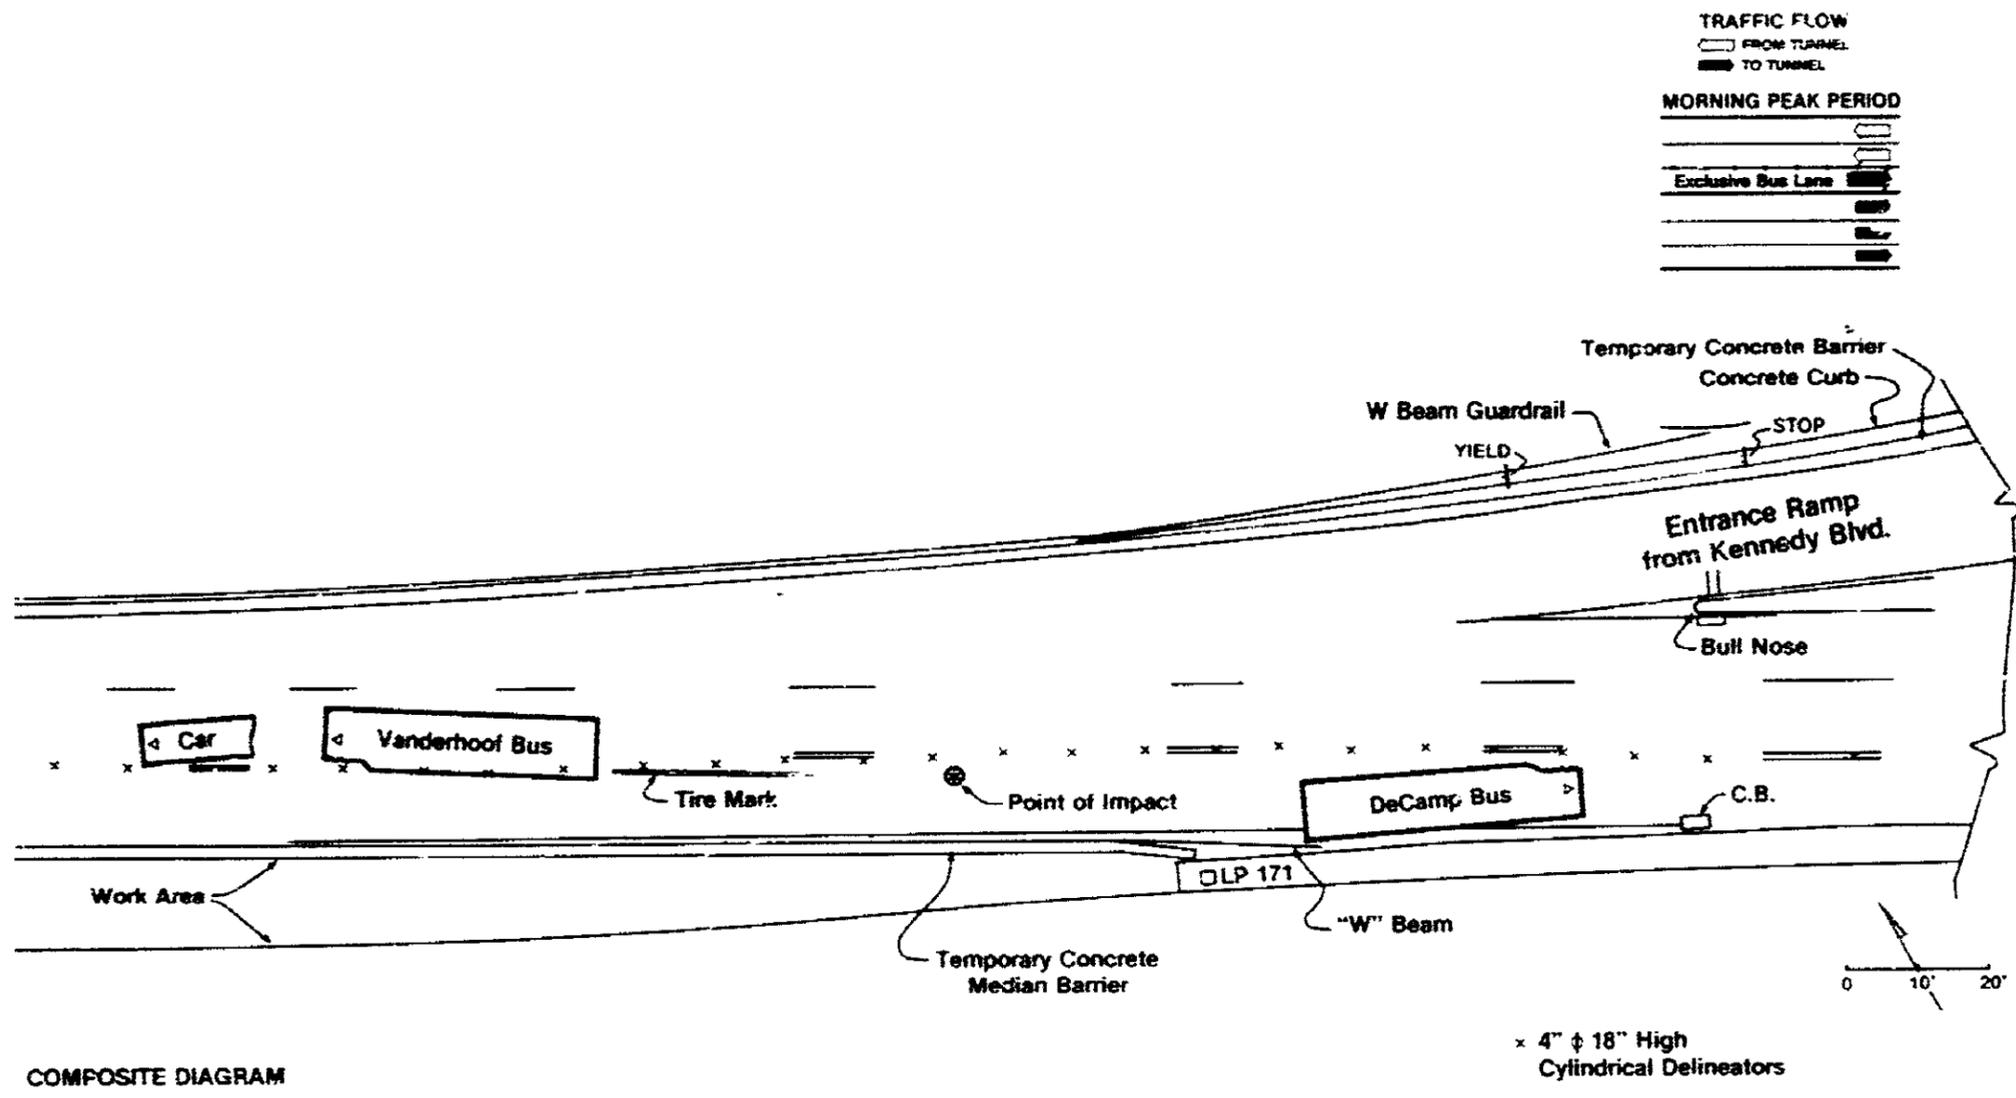
COMPOSITE DIAGRAM

Collision Between An Intercity Bus, Automobile & Transit Bus

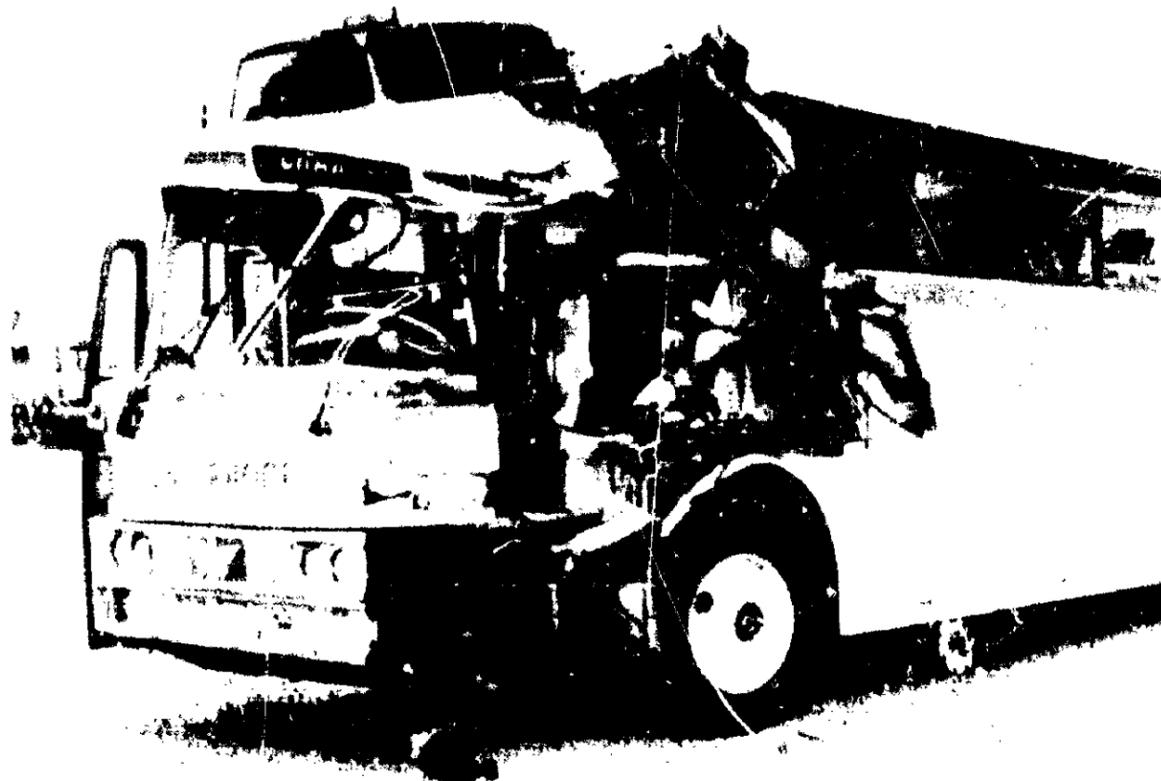
Figure 2 -- Charter bus.

Primary damage to the charter bus was confined to the front left side (see figure 2). The front bumper was missing, both the right and left portions of the windshield were destroyed, and the windshield support post was collapsed inward about 3 inches. The maximum lateral penetration of the left front was 20 inches at the roof line and 30 inches at the left corner. Contact damage was also found on the right side of the front bumper which extended inward to about 4 feet to the center of the bumper.

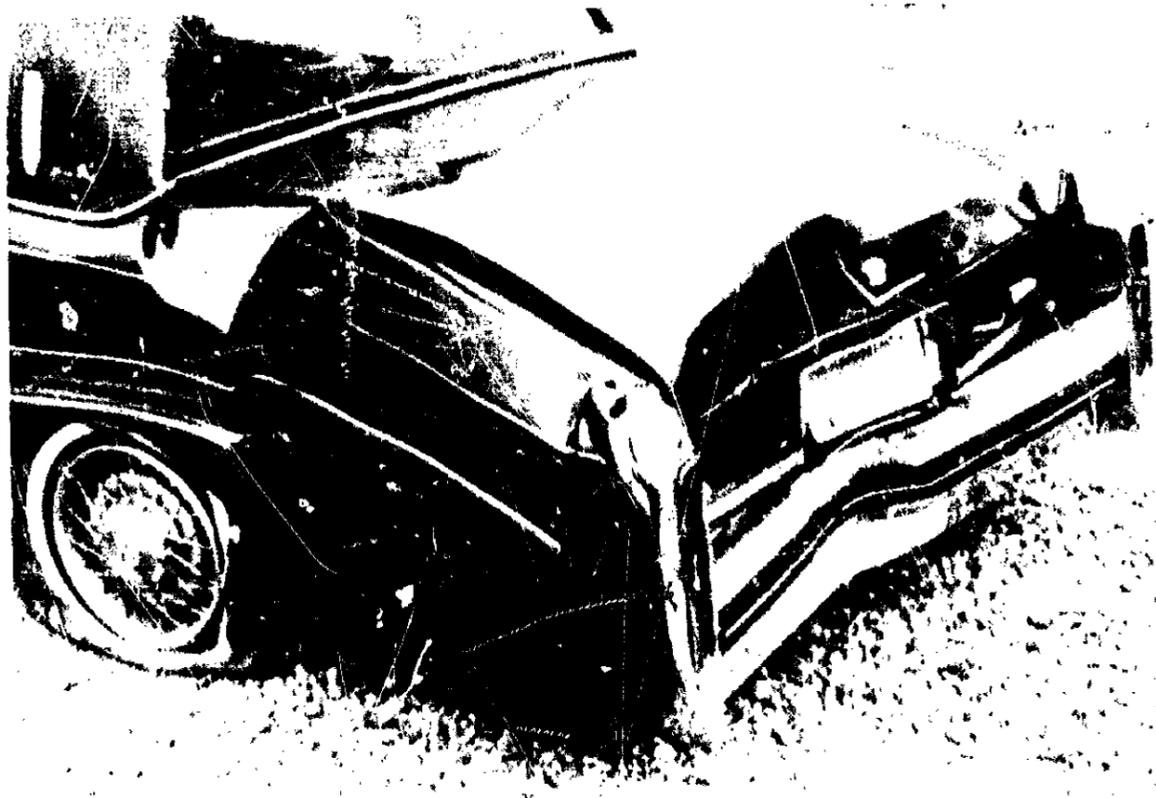
Figure 4--Passenger car.

Passenger Car.--A postcrash inspection of the 1982 Cadillac four-door sedan was conducted on October 11, 1986. The damage was primarily confined to the left rear bumper, quarter panel, and trunk areas. The left side of the rear bumper and trunk lid were displaced forward about 6 inches. Contact damage was found on the bumper and trunk lid which extended from the car's center to the left. Both rear quarter panels and the trunk lid were shifted forward about 2 inches. (See figure 4.)

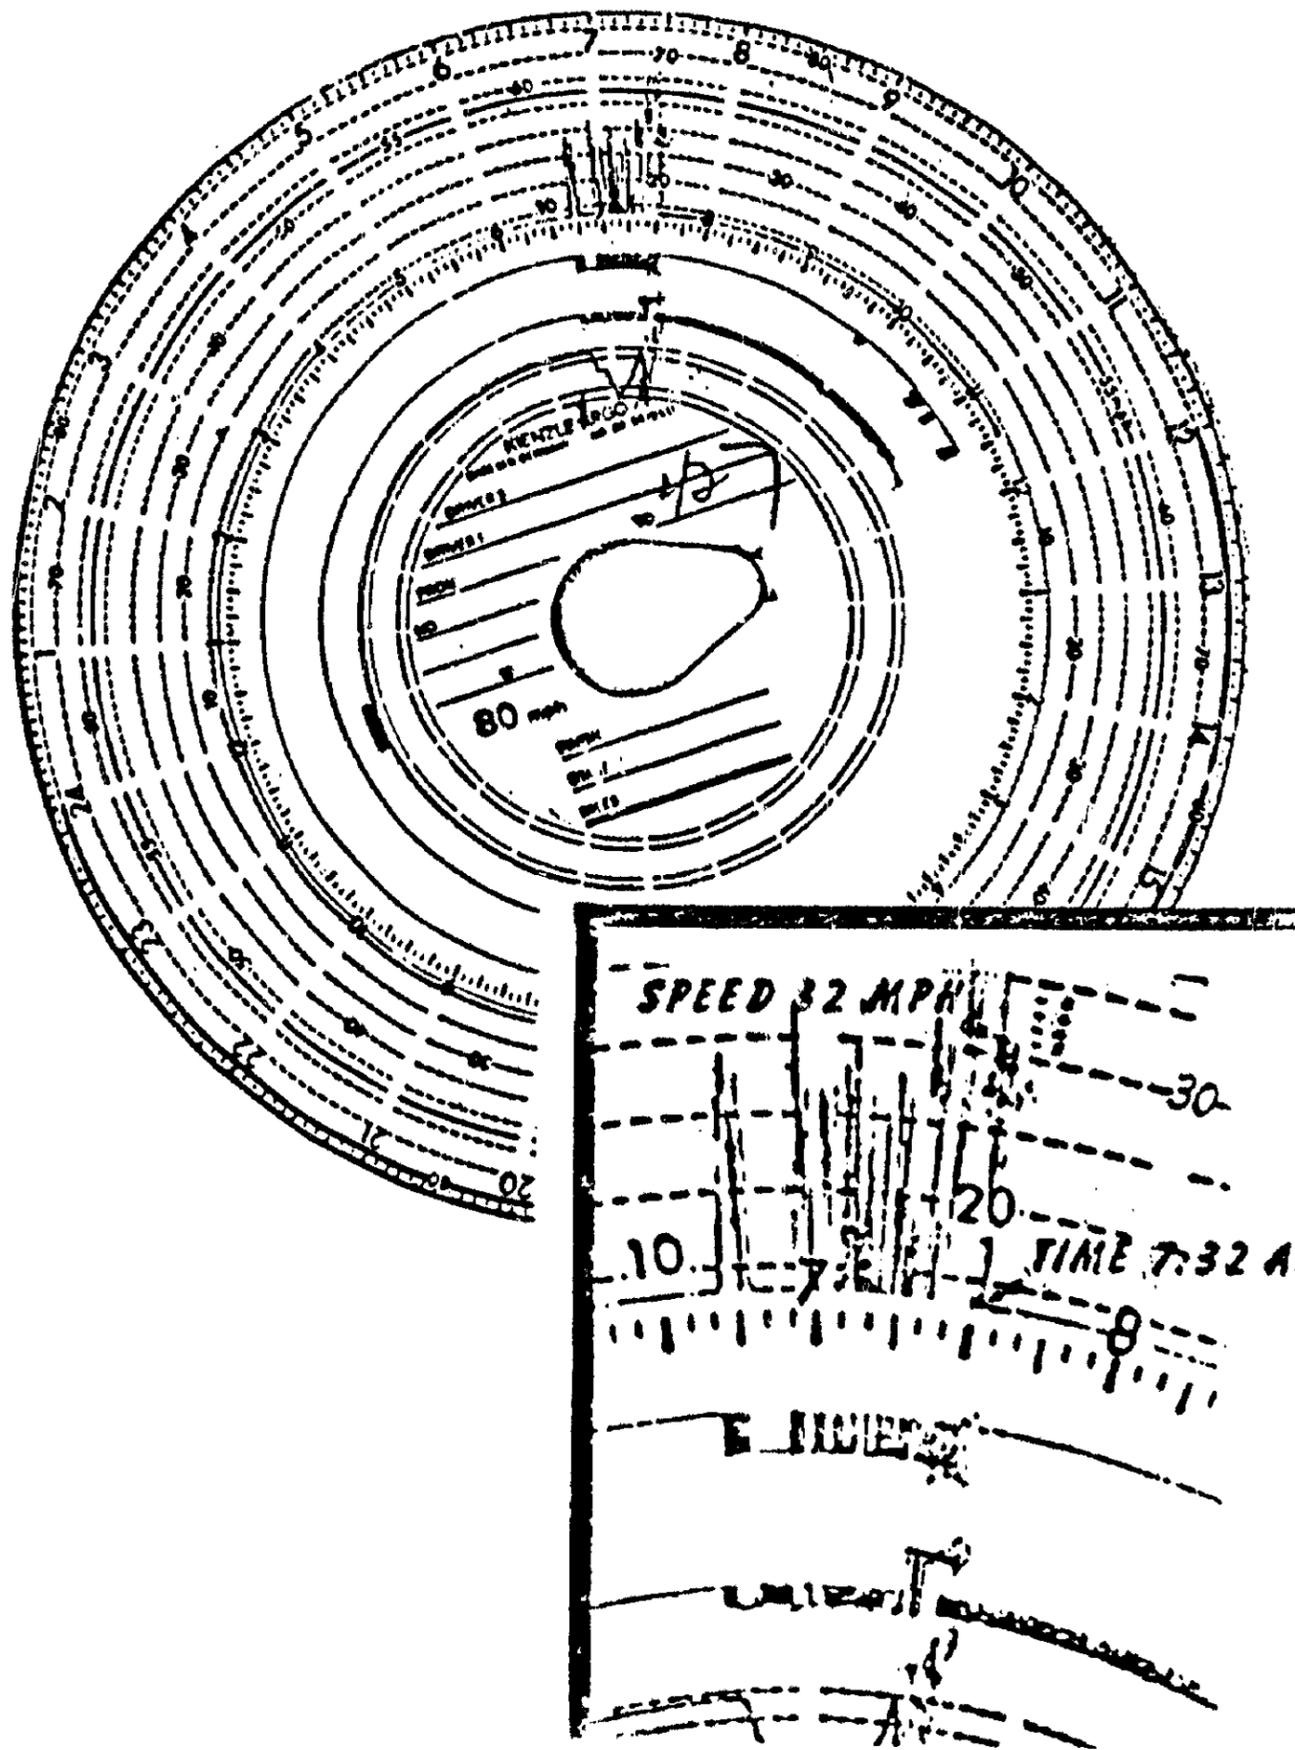
Figure 7. Tachograph card removed from DeCamp commuter bus.

The Safety Board concludes that the transit bus was traveling about 32 mph when impact occurred based on its recorded tachograph chart measurements and estimates that the charter bus was traveling between 20 and 30 mph when it sideswiped the transit bus. The estimate is based on the fact that neither driver fully applied his brakes after impact (since no brake marks were observed onscene), the tire to pavement coefficient of friction at the accident site was no more than 0.4 in the light braking situation, and that minimal momentum was lost in the previous collision between the charter bus and the passenger car. The speeds of the buses were also corroborated by driver statements and traffic conditions at the time of the accident.
