Highway Accident Report  
Tractor-Semitrailer/Intercity Bus  
Head-on Collision Interstate 10  
Beaumont, Texas, May 4, 1987

(U.S.) National Transportation Safety Board  
Washington, DC

2 Feb 88

1. Report No. NTSB/HAR-88/01		2. Government Accession No. PB88-916201		3. Recipient's Catalog No.	
4. Title and Subtitle Highway Accident Report-- Tractor-Semitrailer/Intercity Bus Head-on Collision, Interstate 10, Beaumont, Texas, May 4, 1987				5. Report Date February 2, 1988

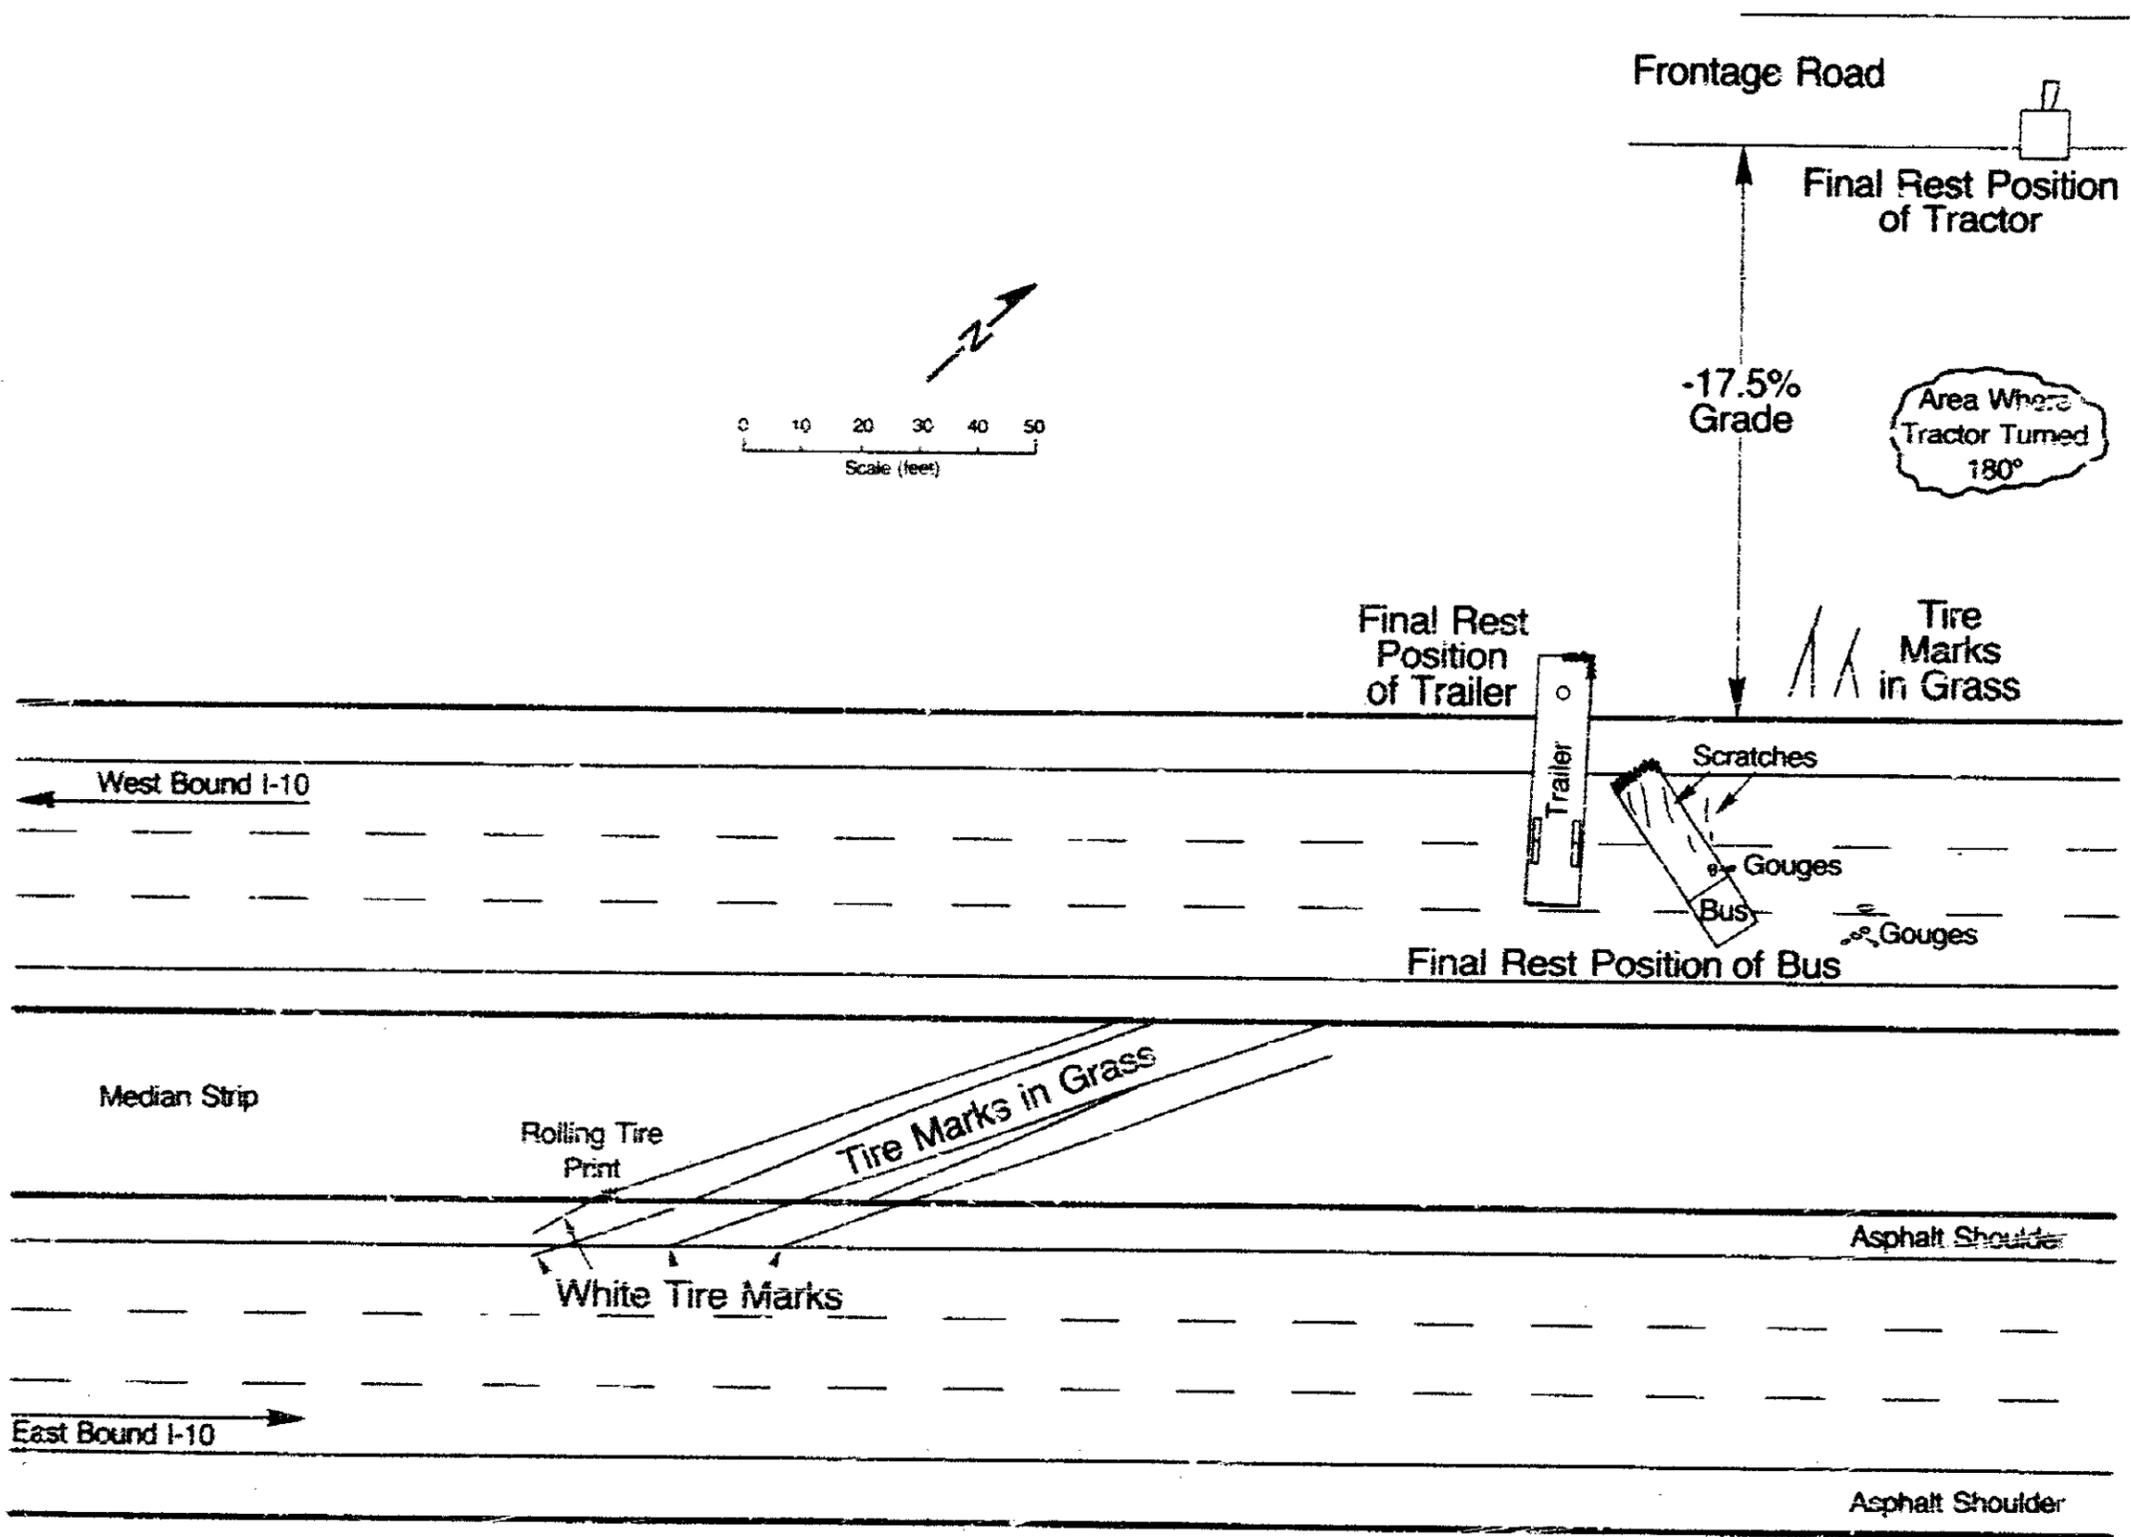
Figure 1.--Final rest position of vehicles.

The tractor separated from the fifth wheel connection of the semitrailer and came to a stop about 150 feet north of the westbound lanes. The semitrailer came to a stop in the westbound lanes about 50 feet from the point of impact. (See figure 1.) The truckdriver sustained moderate injuries and the helper sustained minor injuries.

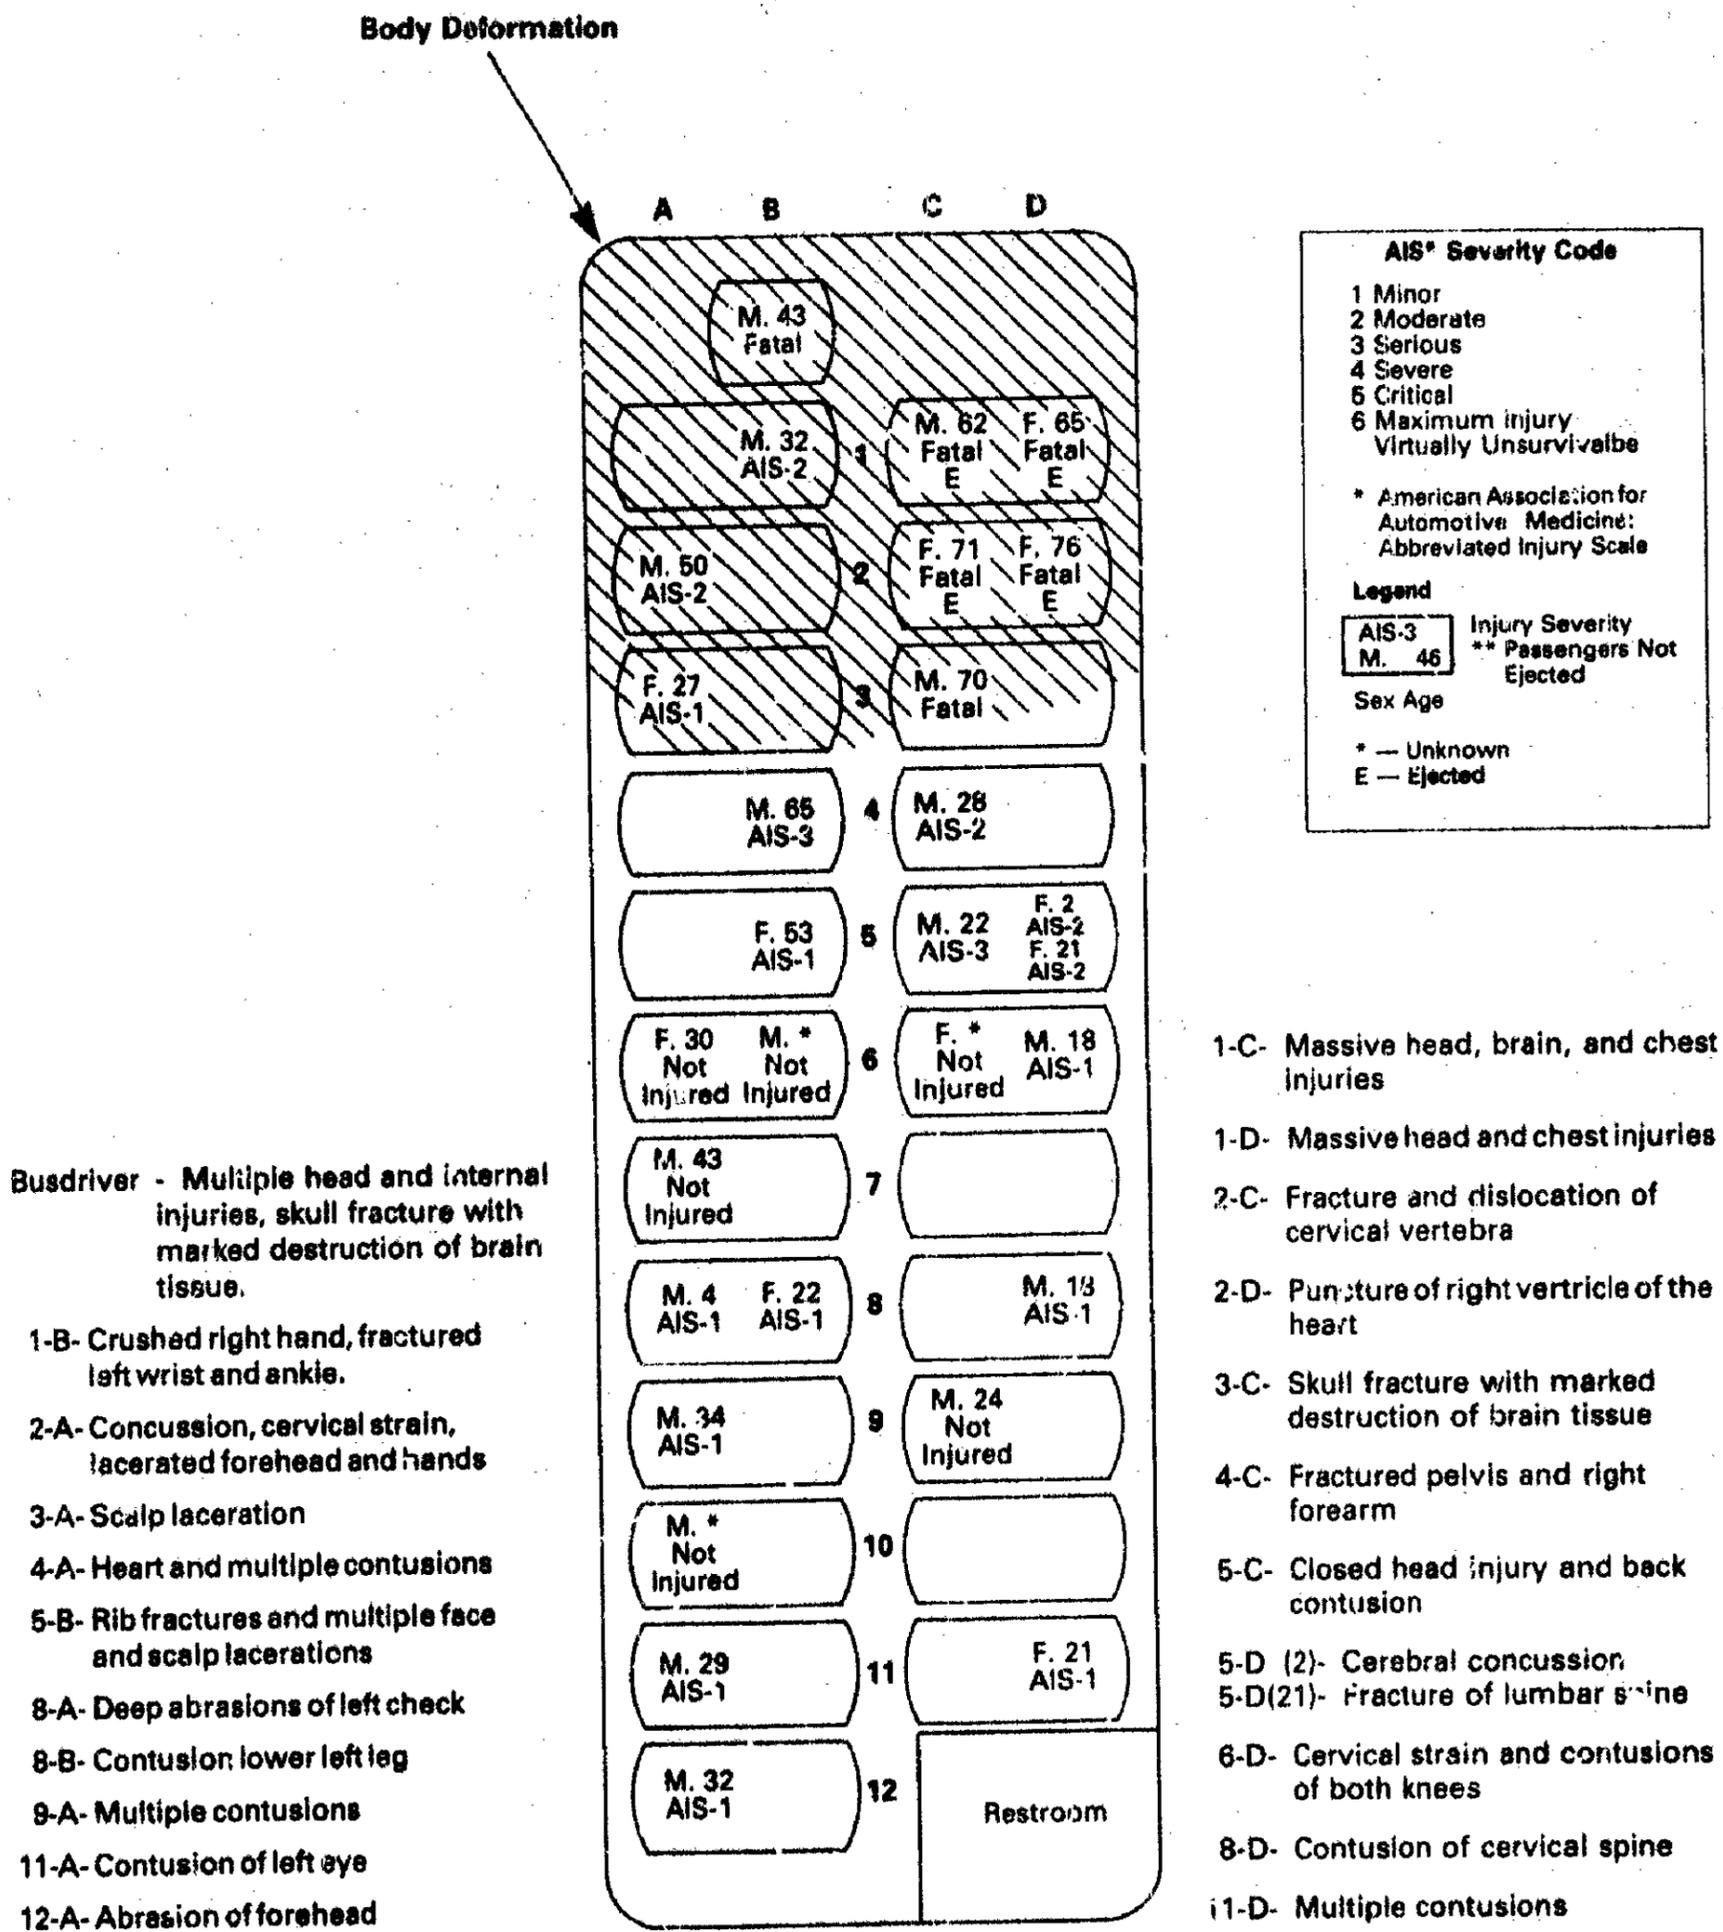
The surviving bus passengers sustained contusions, abrasions, and fractured bones. Two bus passengers seated in the fourth and fifth rows sustained serious injuries (AIS-3), a contused heart, and a closed head injury.

The bus was equipped with a lapbelt at the driver's position. None of the passenger seats were equipped with lapbelts. The first three rows of double unit seats and floor were missing. The double unit seats in rows four through eight also were missing; however, rescue personnel reported removing these seats. The sides and roof of the bus were lined with a plastic laminate material commonly found in most intercity-type buses. Blood, hair, and tissue were found on the laminated material that had shattered and broken into sharp pieces in the front area on the sides and roof of the bus. Rescue workers resorted to using ladders (brought from the nearby moving and storage company) to climb through the emergency windows to assist the injured. Some rescue workers reported that they had to stand on the sides and hold the emergency windows open for other workers to evacuate the injured from the bus, which took up considerable room and left less space to facilitate the handling of the injured passengers. (See figure 7.)

**Figure 7. Bus seating chart noting occupant age, sex, injury severity, and seat location.**
