Highway Accident Report - Academy Lines, Inc.
Intercity Bus Run-Off-Roadway and Overturn
Middletown, New Jersey, September 6, 1987

(U.S.) National Transportation Safety Board
Washington, DC

24 May 88

1. Report No. NTSB/HAR-88/03	2. Government Accession No. PB-88-916203	3. Recipient's Catalog No.	
4. Title and Subtitle Highway Accident Report--Academy Lines, Inc., Intercity Bus Run-Off-Roadway and Overturn, Middletown, New Jersey, September 6, 1987		5. Report Date May 24, 1988

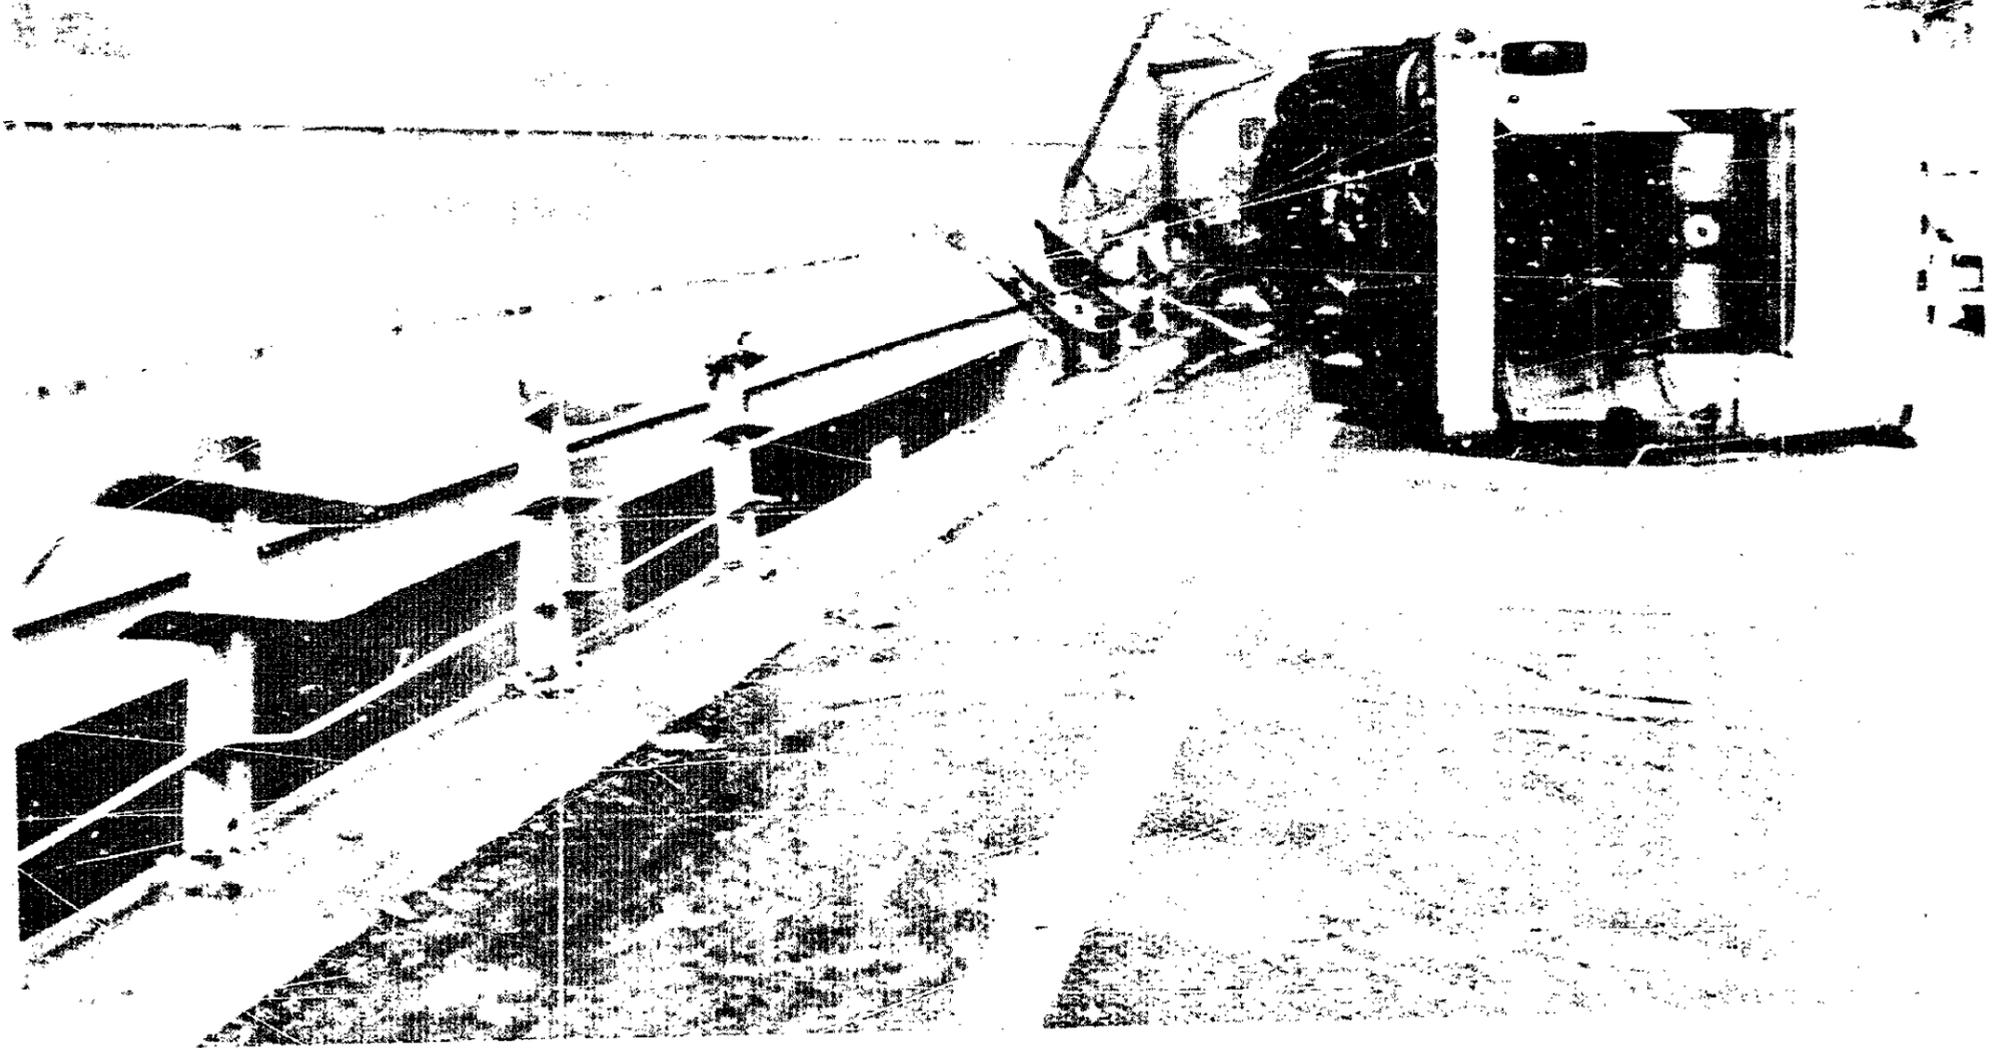
Figure 2.--View of bus facing north.

The first five sections of bridge rail were damaged in the accident. The first section of bridge rail had all the base plate fillet welds sheared, and the section was knocked off the bridge. The second section remained on the bridge with most of the base plate fillet welds sheared and some crimping of the rail. The third section was knocked off the bridge with the first three base welds sheared and the lower rail weld sheared on the fourth post. The fourth section remained on the bridge with the most southerly post fractured at the lower rail weld, the next two posts fractured at the middle rail weld, and the last post fractured at the butt weld for the extension post. The fifth damaged section of bridge rail had cracked butt welds and a slight westerly displacement of the extension post. (See figure 2.)

The Authority plans to replace the existing steel bridge rail on the local roadway with standard 32-inch-high New Jersey-type concrete barrier in the future. The express roadway bridges had the New Jersey concrete barrier installed as bridge rail at the time of the accident.

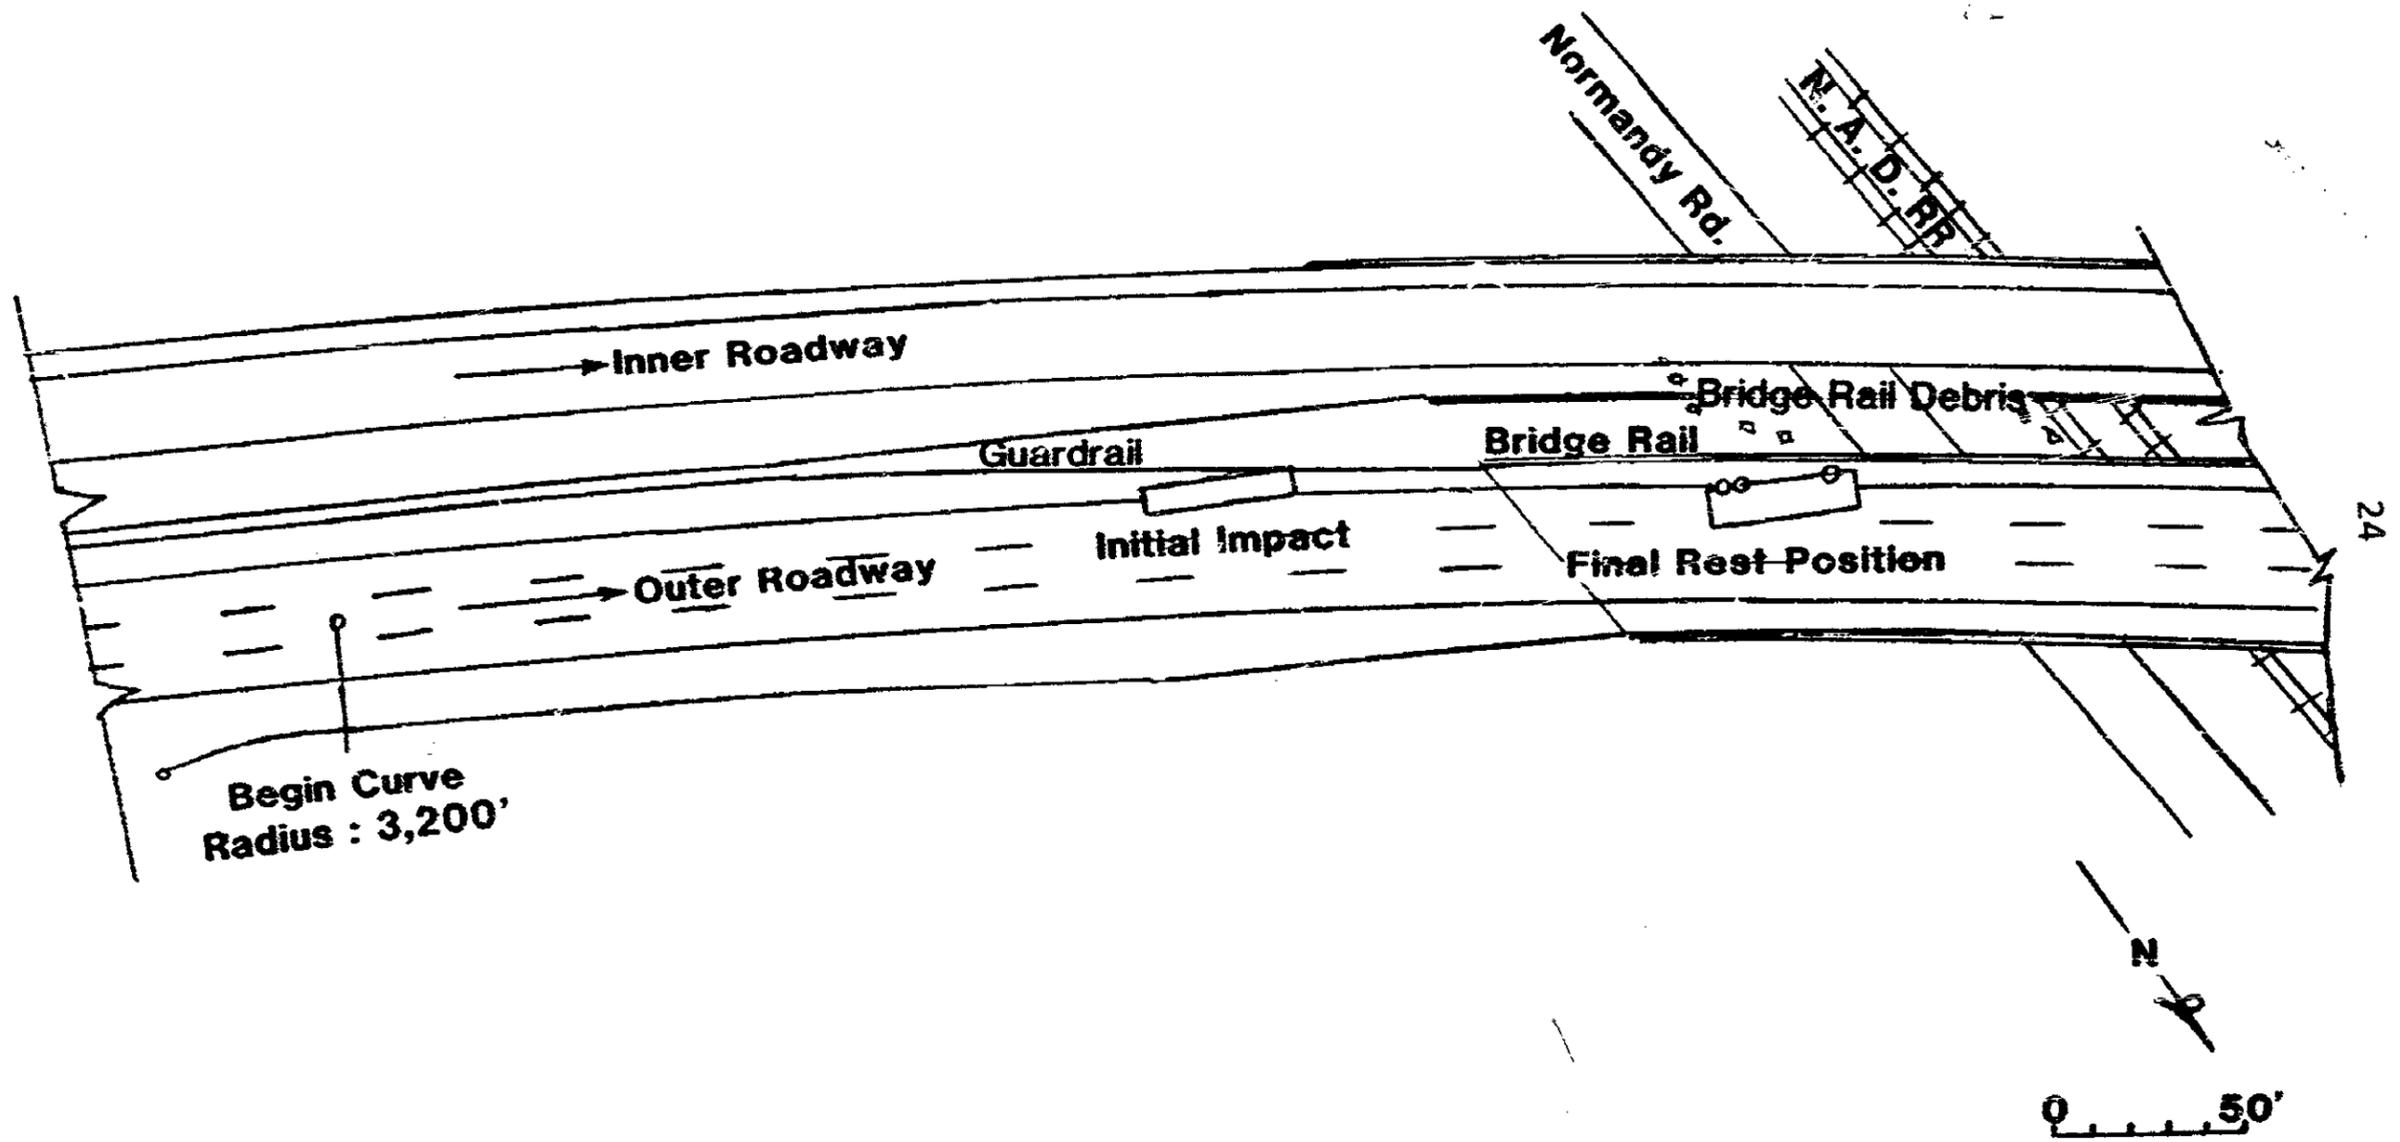
According to the NJSP, the bus first struck the guardrail 54 feet south of the bridge. There were no tire marks attributable to the bus leading up to the point of initial impact. The damaged guardrail and part of the bridge railing had been removed before the Safety Board arrived at the scene. Therefore, it was not possible to determine how the transition guardrail attachment was made to the bridge railing.

The 50°-angle of the scrape marks on the right side of the bus and the fact that these scrape marks were only 2 to 4 feet in length indicate that the forward motion of the bus had almost stopped when the bus overturned. The lateral forces that occurred when the bus overturned were probably the highest G forces the occupants experienced during the accident sequence. It was probably during this lateral deceleration that passengers were thrown from their seats.

Figure 4.—Impact with guardrail and final rest position of the bus.

The bridges for the express roadways were constructed with 32-inch-high New Jersey-type concrete barriers topped with chainlink fence at the accident site. If the bridge for the local roadway had been similarly equipped with a New Jersey barrier rather than the steel bridge rail, the Safety Board believes that, given the relatively shallow collision angle, the New Jersey-type concrete barrier may have successfully redirected the bus back into the travel lanes before it encountered the chainlink fence. The Authority reported that it plans to replace the existing steel bridge rail at the accident site with a 32-inch-high New Jersey-type barrier.

While the 32-inch-high barrier has been proven effective for redirecting vehicles at shallow angles, higher barriers are more effective in redirecting large vehicles such as buses at larger impact angles and at higher speeds. In view of this, the Safety Board believes that the Authority should replace existing steel bridge rail on the Garden State Parkway with 42-inch-high extended New Jersey Safety Shape bridge rail.
