Highway Accident Report - Multiple Vehicle Collision and  
Fire in a Work Zone on Interstate Highway 79 Near  
Sutton, West Virginia, July 26, 1990

(U.S.) National Transportation Safety Board, Washington, DC

16 May 91

**MULTIPLE VEHICLE COLLISION  
AND FIRE IN A WORK ZONE ON  
INTERSTATE HIGHWAY 79 NEAR  
SUTTON, WEST VIRGINIA,  
JULY 26, 1990**

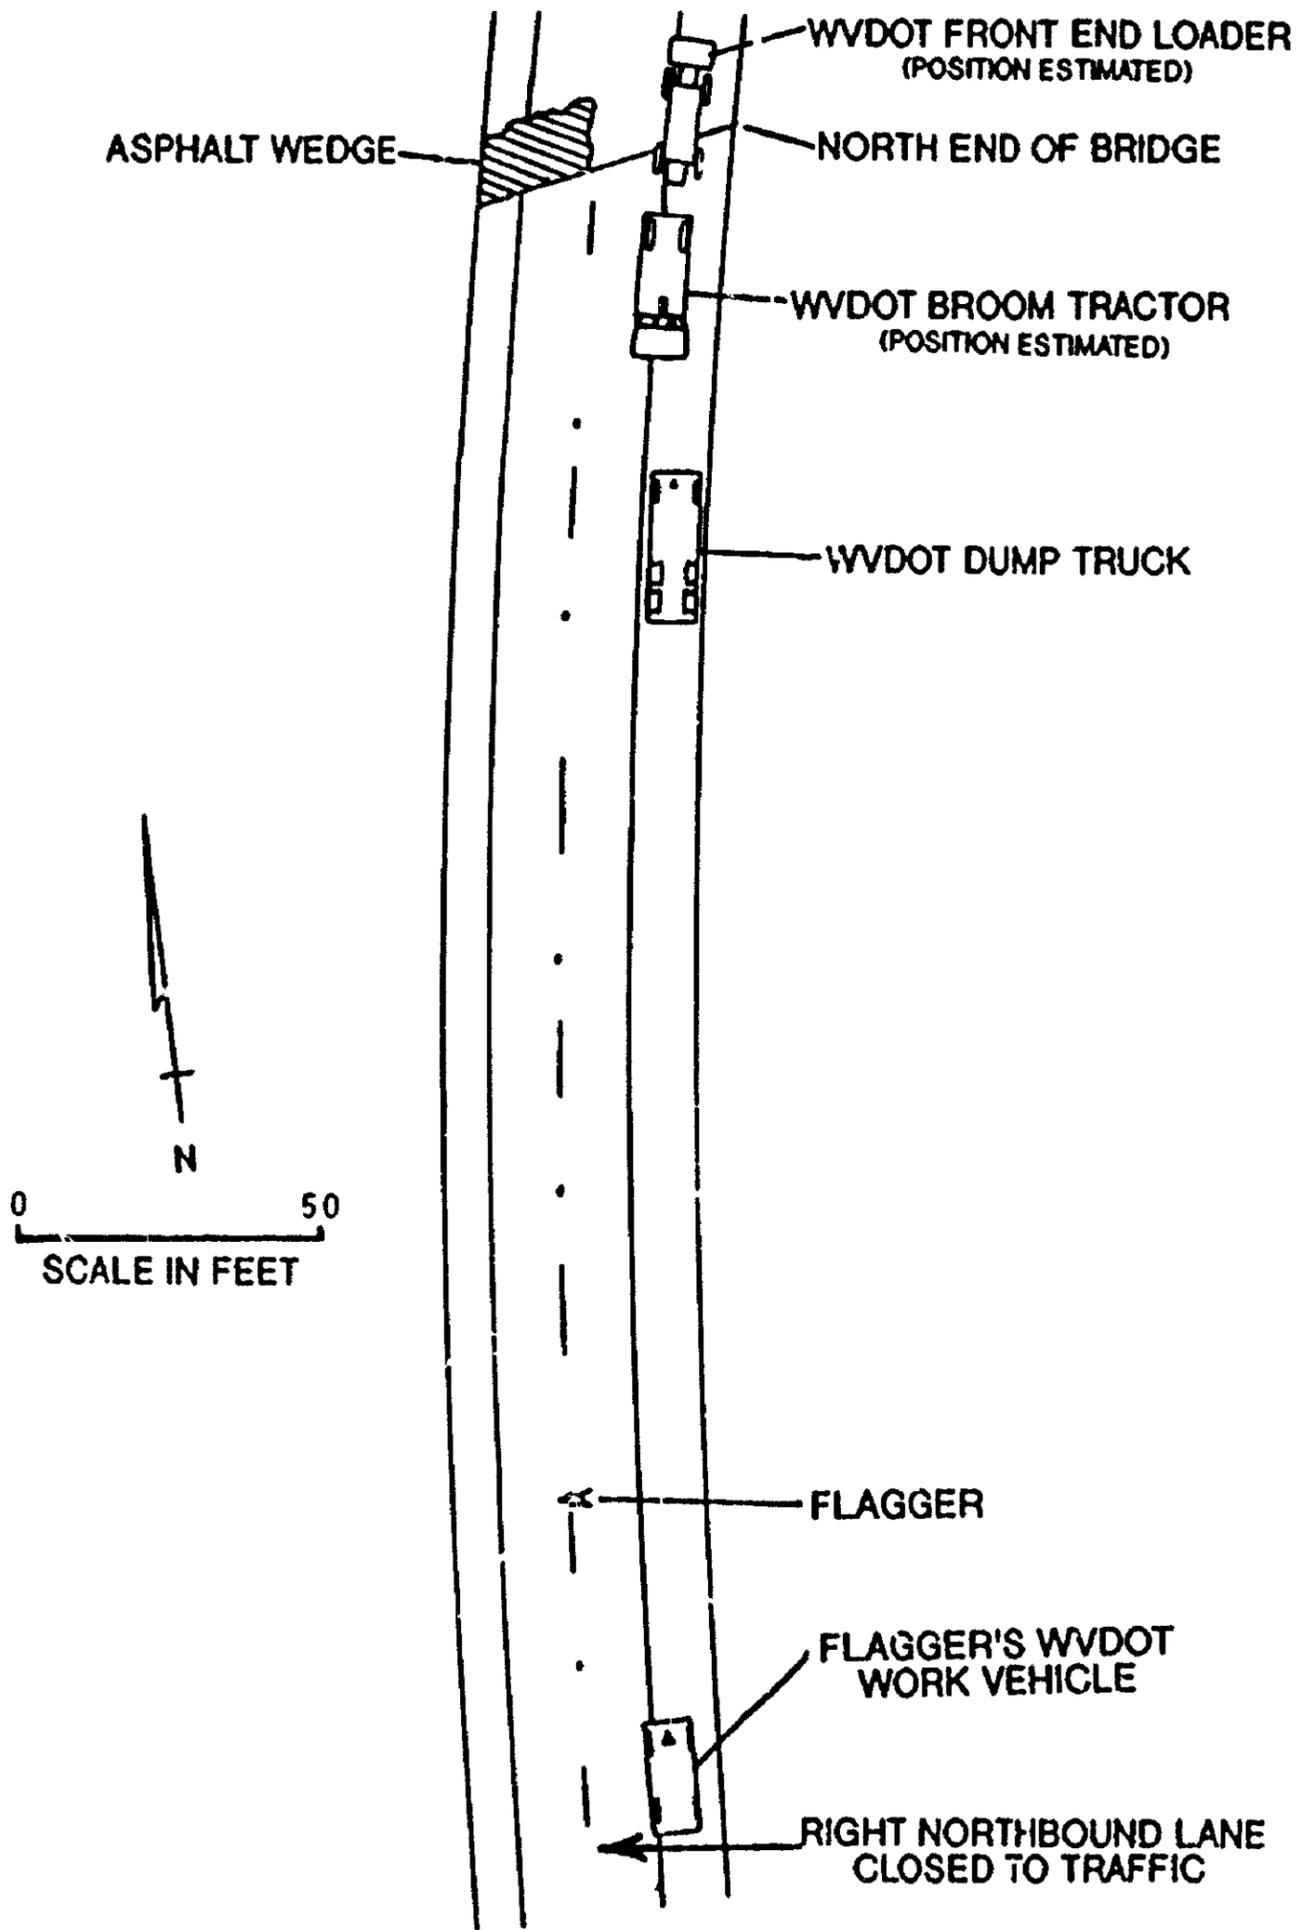
The location of tire marks, gouges, and scrapes indicate that the first collision occurred about 50 feet south of the flagger's reported position. The Double B truck initially struck a utility trailer being towed by a Dodge Aspen. The trailer hitch was torn from the Aspen's rear bumper and pushed forward, and the Aspen's fuel tank was punctured. Witnesses reported that leaking fuel from the Aspen immediately burst into flames. The Aspen then struck a Plymouth Colt, which came to rest facing south pinned between the right side of the Double B trailer and the left side of the WVDOT dump truck.

Figure 2.--Northbound lanes showing preaccident positions of flagger and WVDOT work zone vehicles on the bridge.

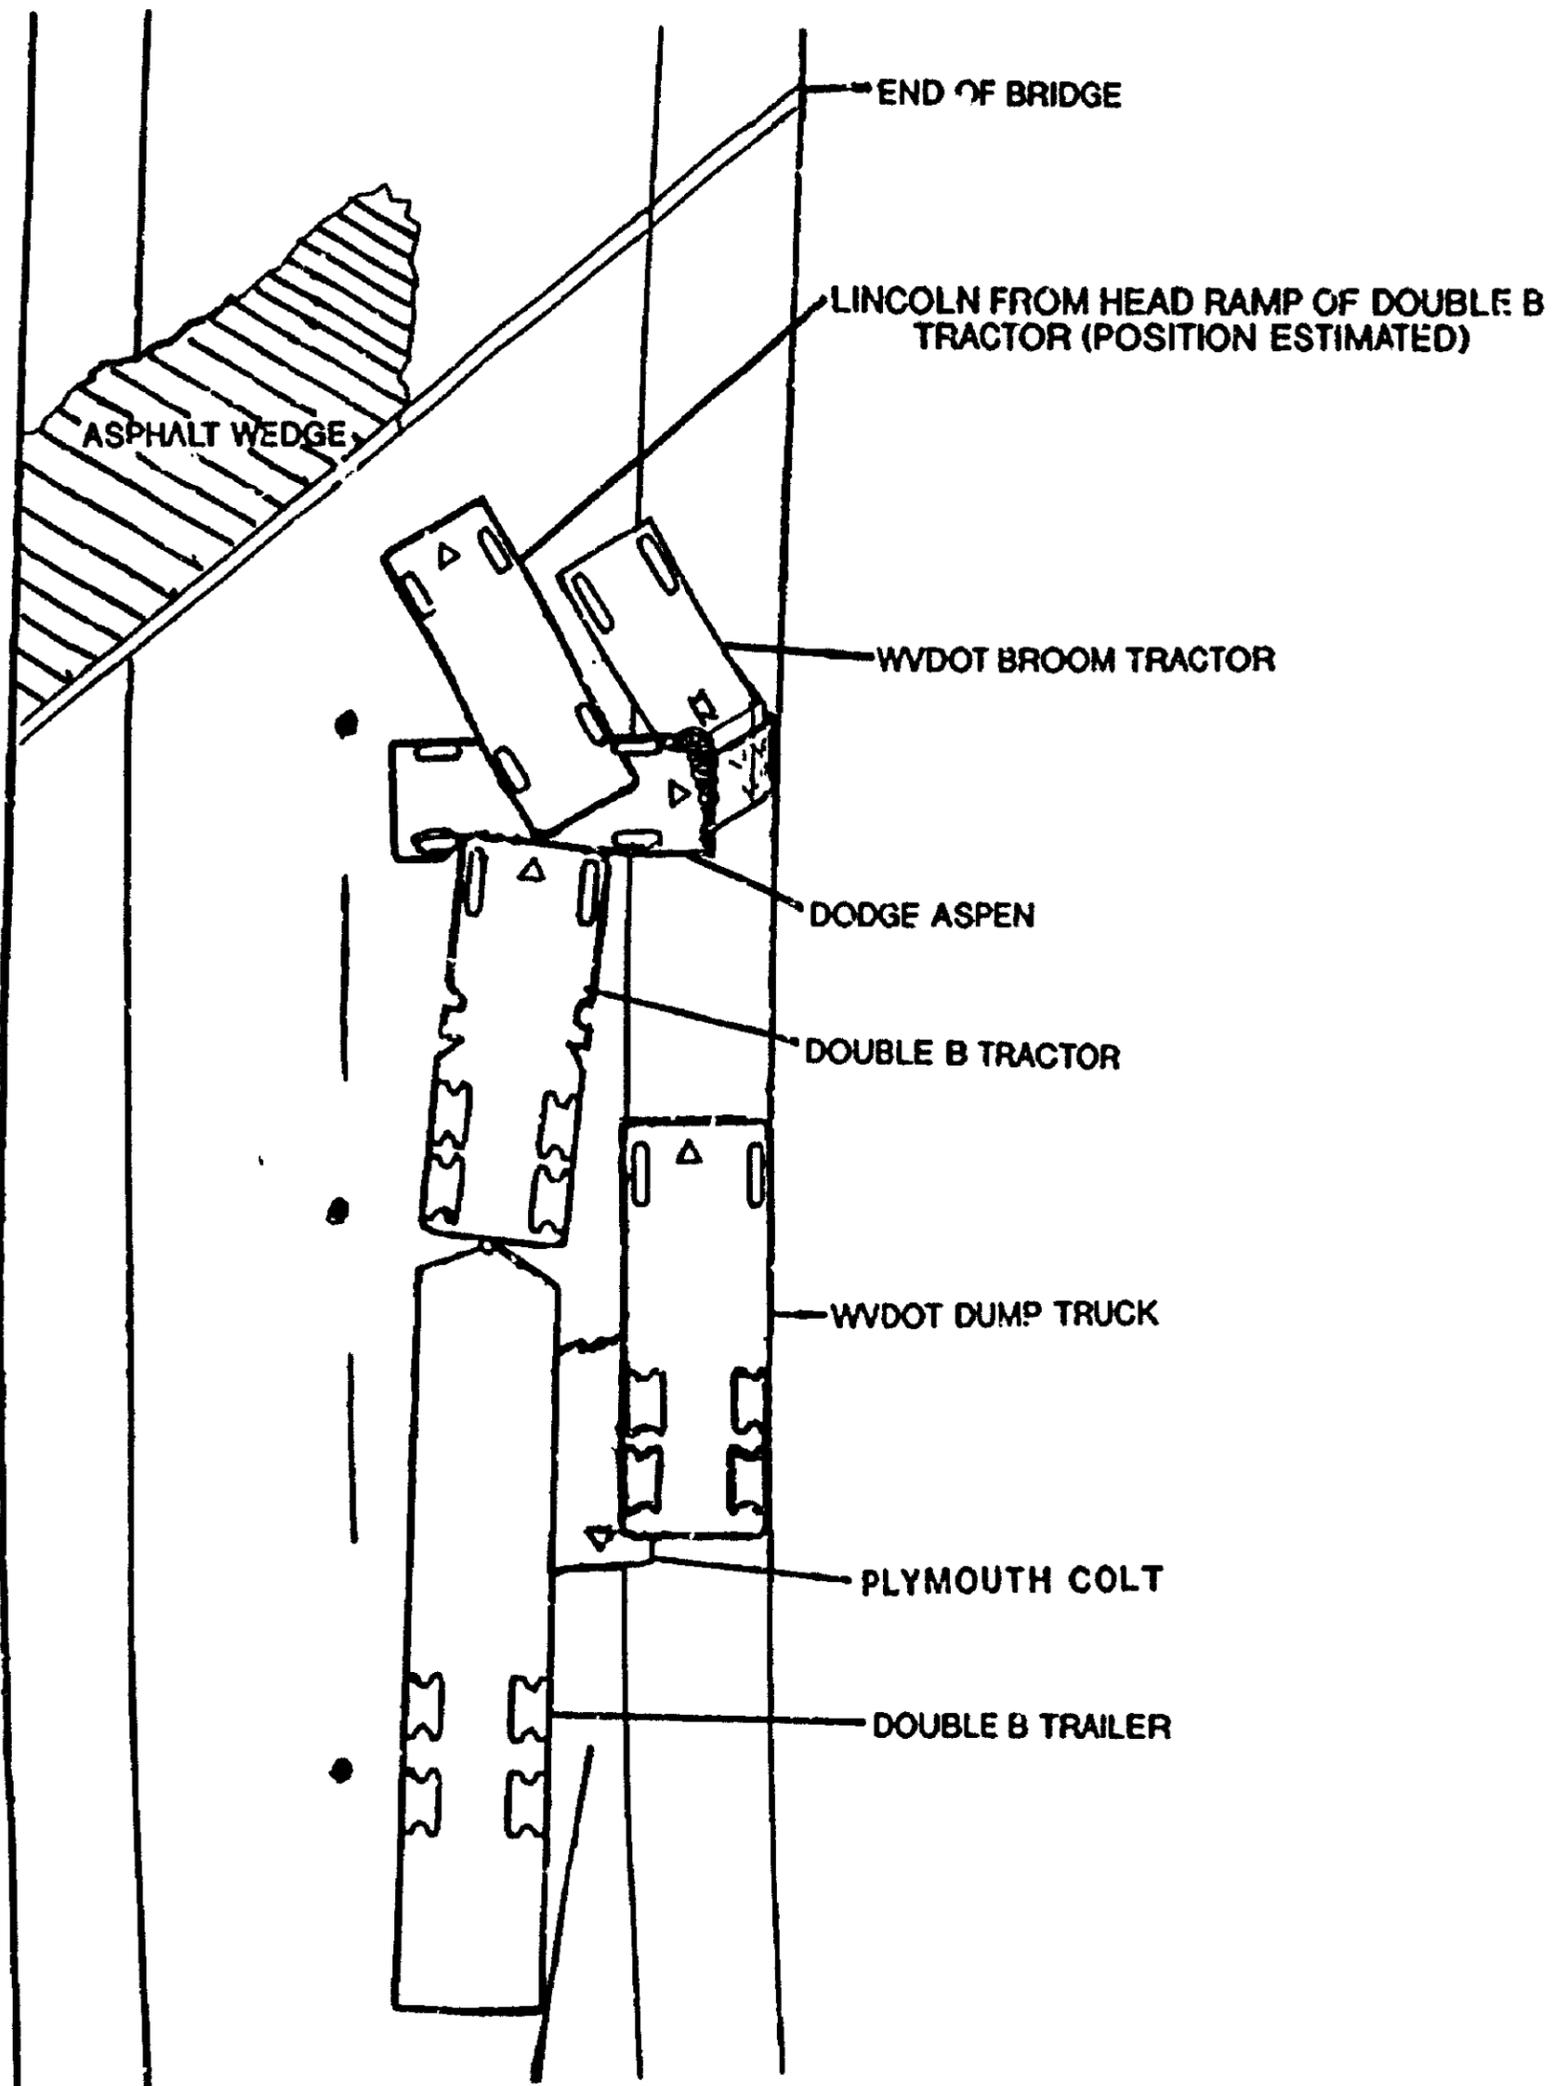
Witnesses reported that after the accident vehicles came to rest, the fire spread within minutes from the Aspen to the Lincoln, the Double B truck, the Colt, the WVDOT dump truck, and the broom tractor. All these vehicles were either destroyed or severely damaged in the ensuing fire. (See figures 3 and 4.) The front end loader sustained minor damage in the collision and was driven clear of the fire.

Figure 3.--Final rest positions of vehicles involved in the fire.

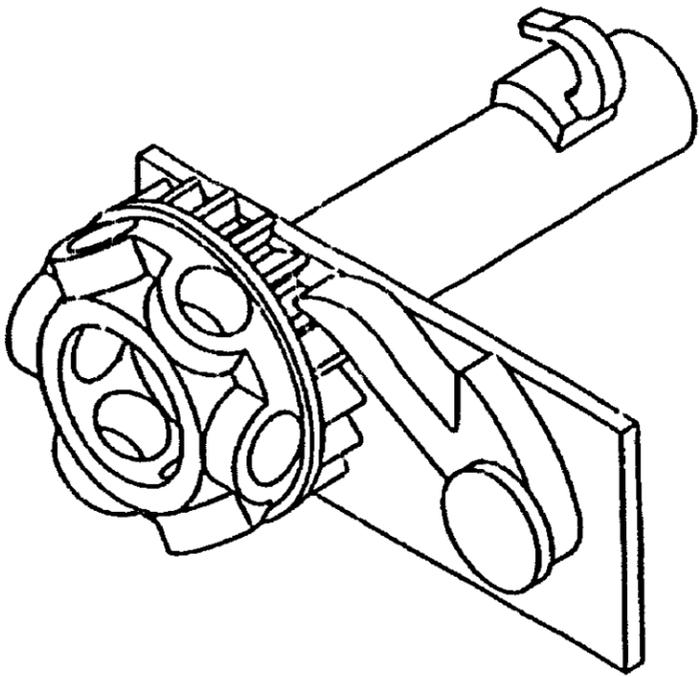
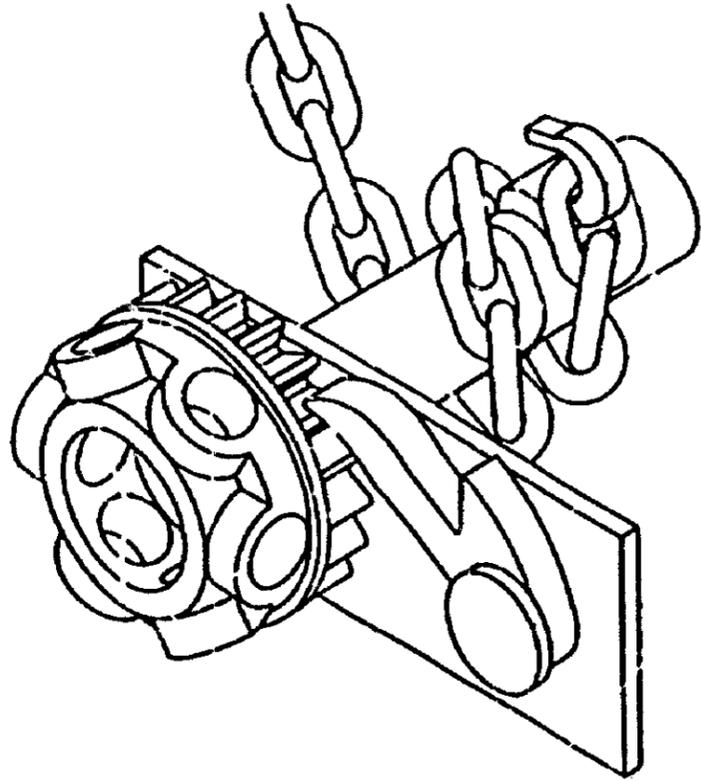
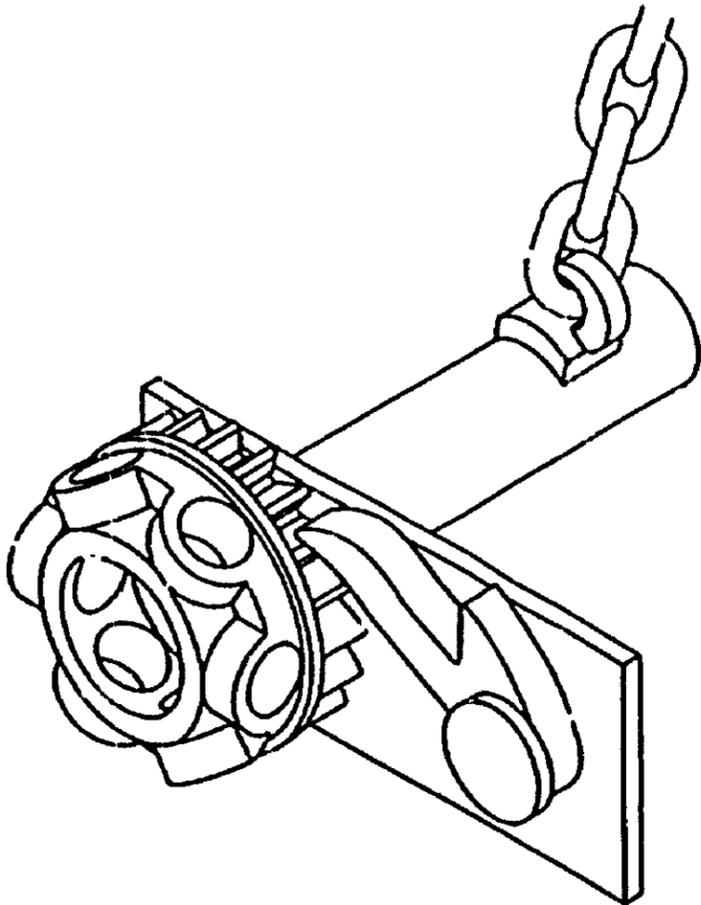
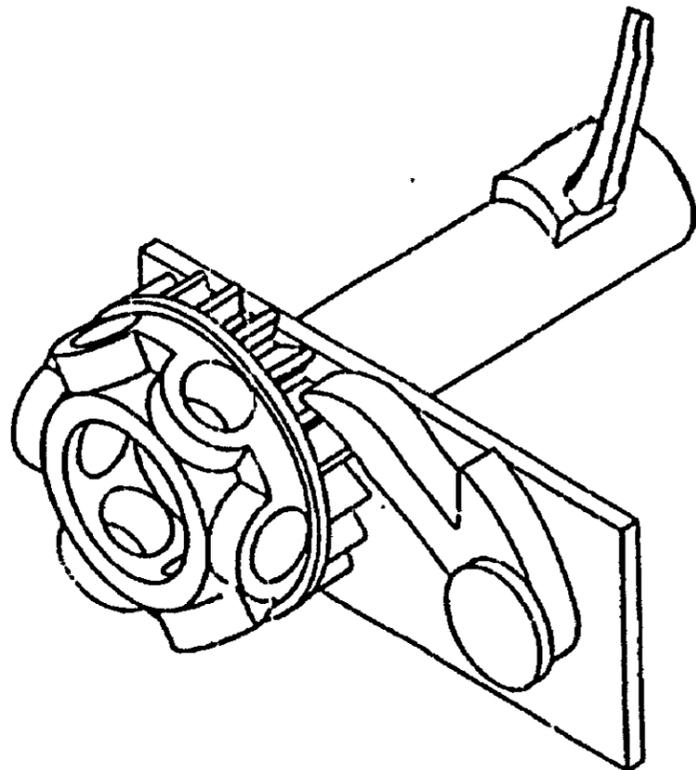
Figure 5.

After the accident, tiedown chains were found hooked to the ratchet shafts at the right front, left front, and left rear of the head ramp above the tractor cab. No tiedown chain was found hooked to the ratchet shaft at the right rear of the head ramp, and the hook was straightened up and away from the shaft. (See figure 5.) The attaching bracket of the left front tiedown assembly was ripped, the car-stopper bracket was bent, and the stopper itself was missing.

Ratchet with no chain attached.

Ratchet with properly-wrapped chain.

Ratchet with unwrapped chain.

Postaccident condition of right rear head ramp ratchet on Double B tractor.

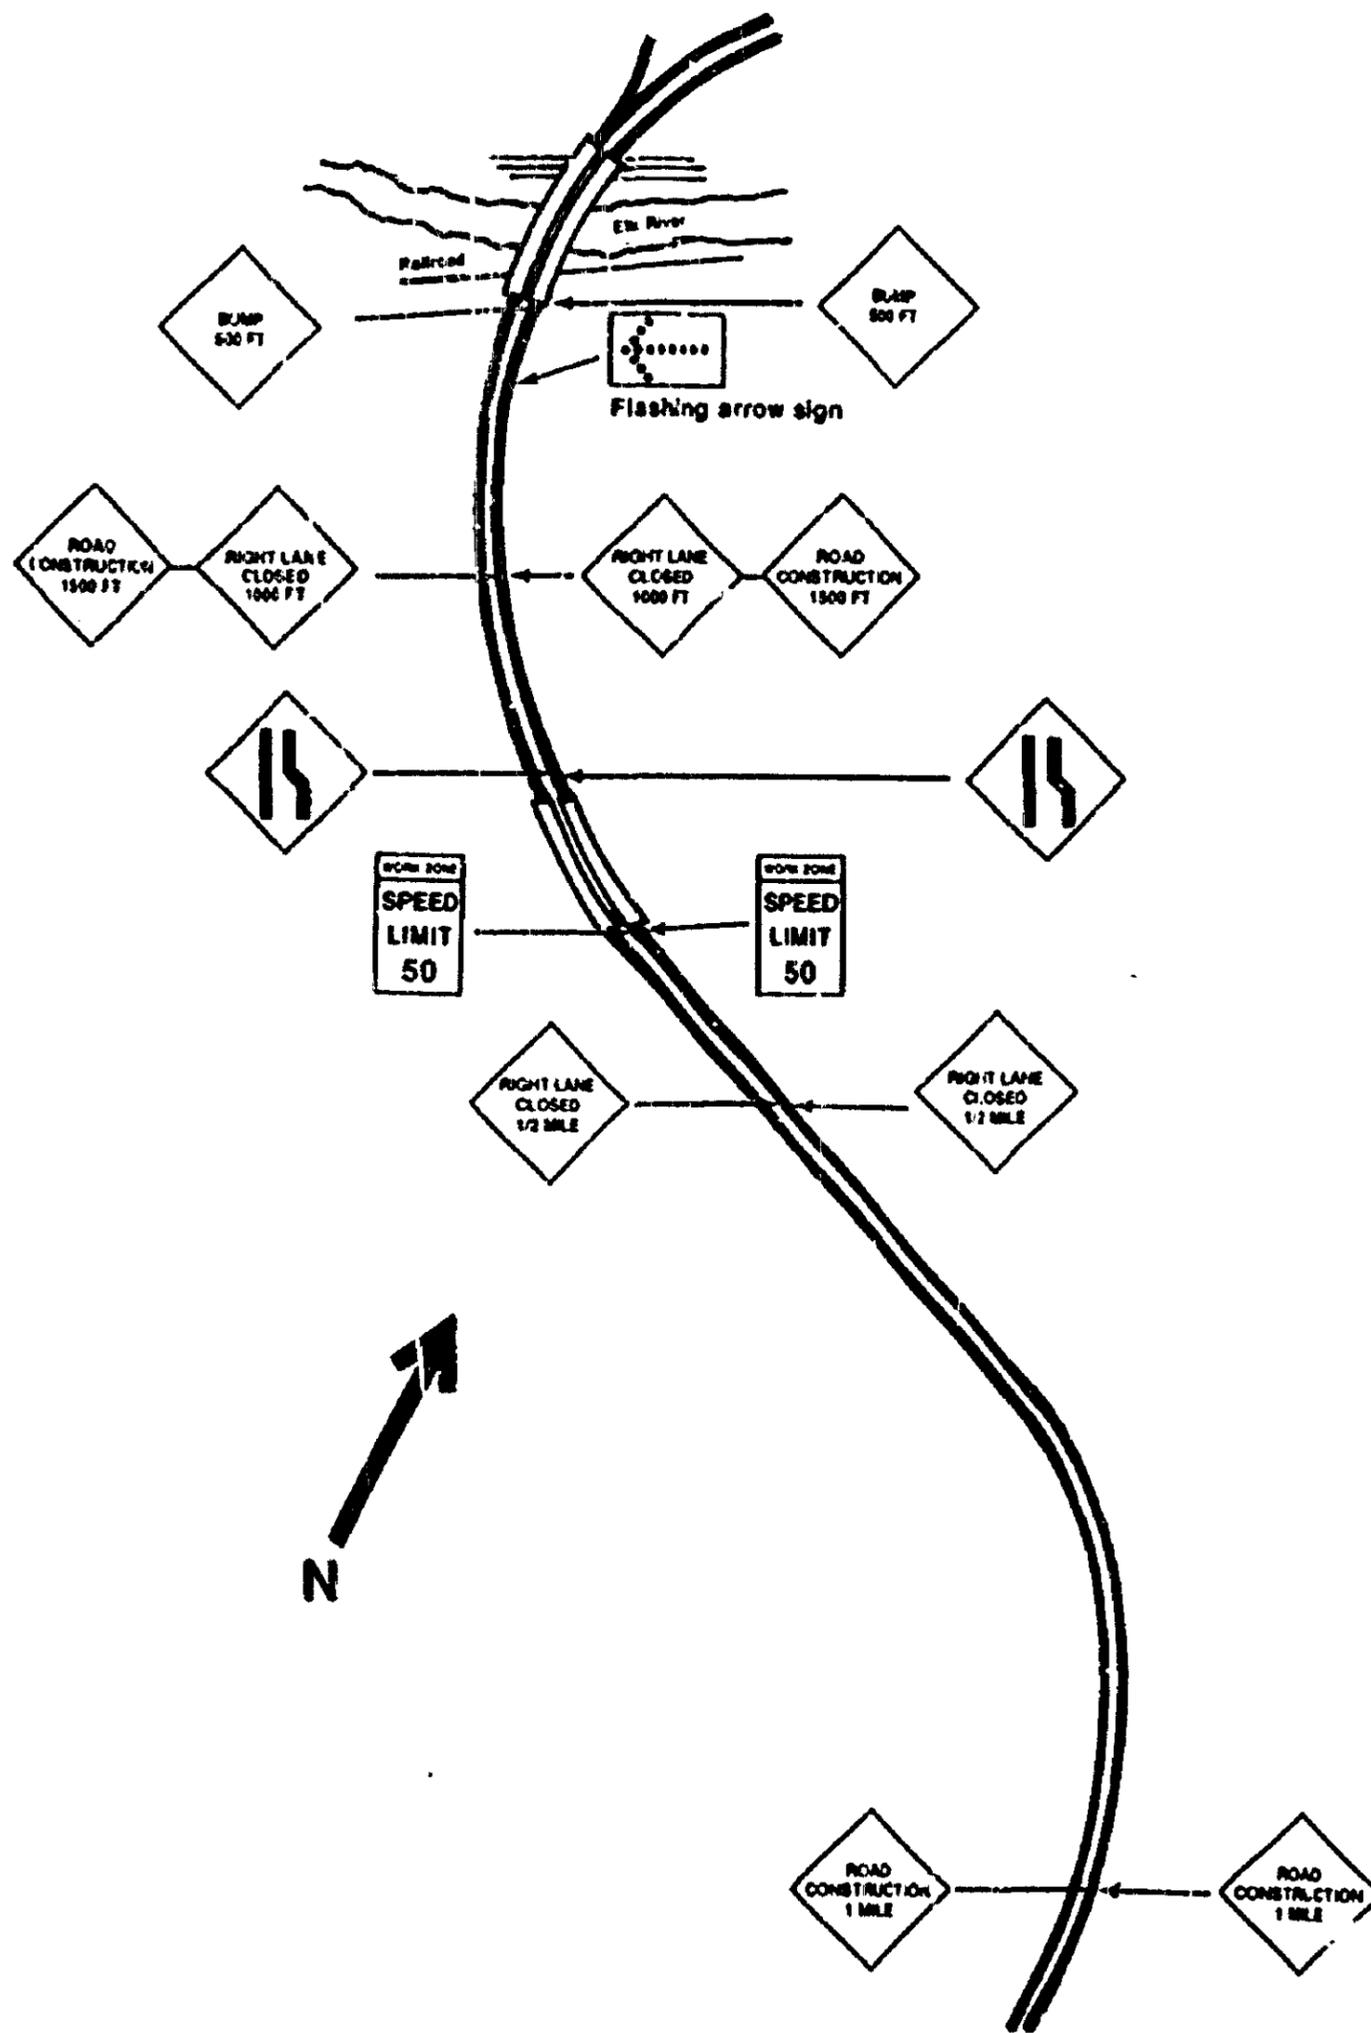
**Work Zone Traffic Controls and Advisories.**--About 2 hours after the accident, a WVDOT highway safety training officer recorded the placement of traffic signs and signals approaching the accident site. (See figure 6.) Besides the single electric advance warning arrow panel, pairs of identical work zone signs, some with amber flashing lights, were oppositely positioned on each road shoulder south of the work zone. The approximate distances between these signs and the area of initial impact are:

Figure 6.--Placement of road signs approaching the accident site.

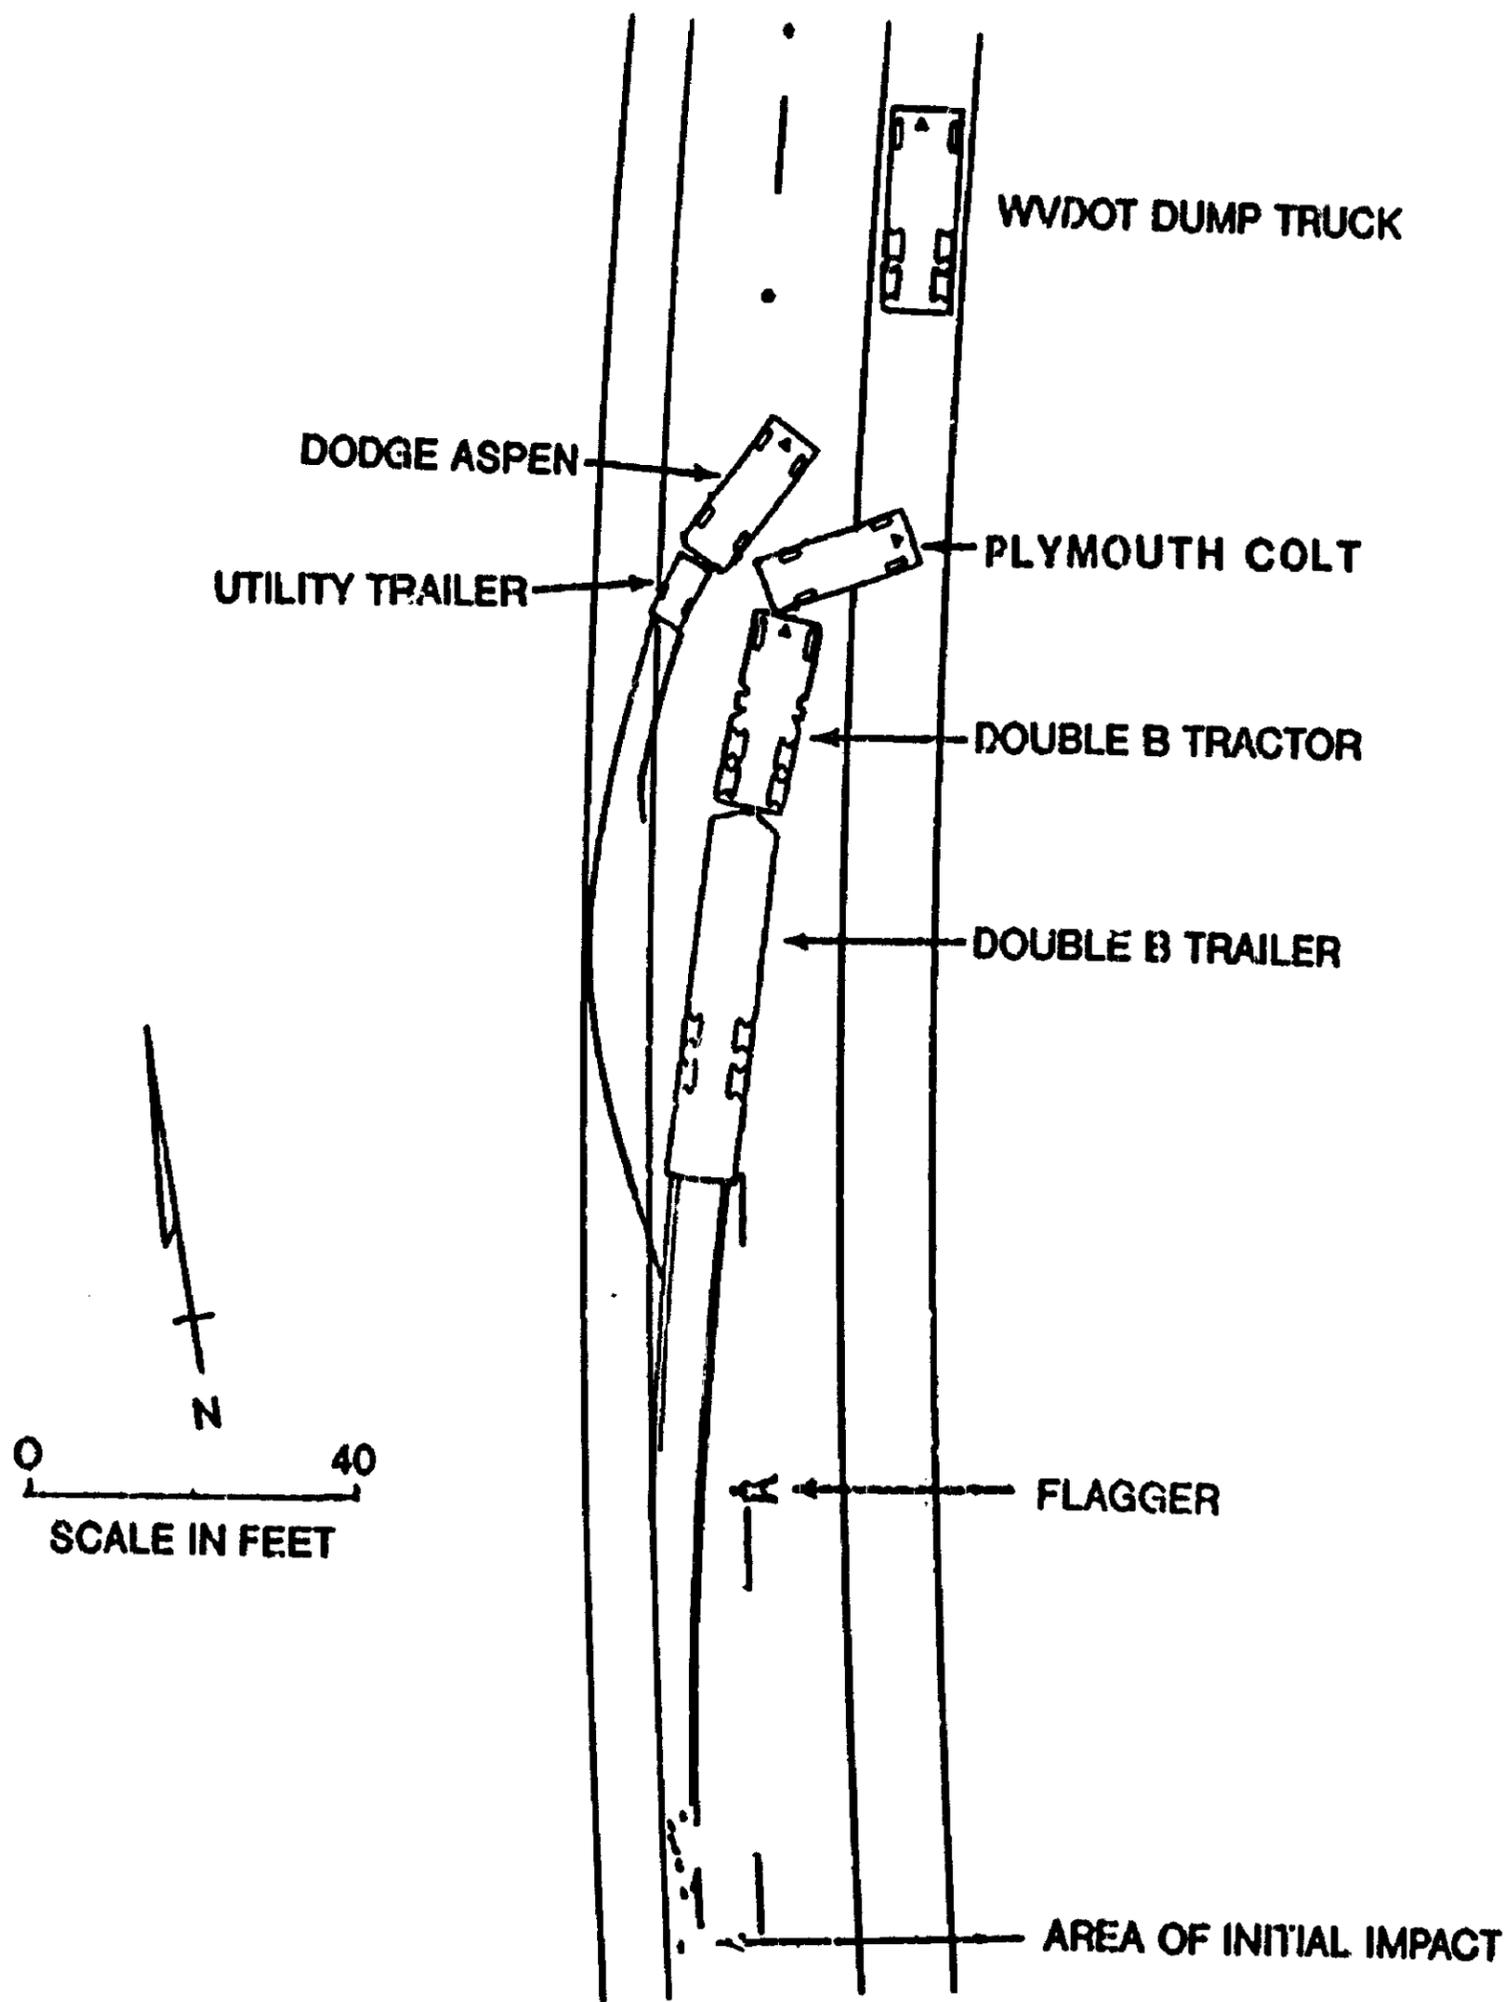
Figure 8.--Double B tractor strikes right side of Plymouth Colt.
