NATIONAL TRANSPORTATION SAFETY BOARD

HIGHWAY ACCIDENT REPORT

**HIGHWAY/RAIL GRADE CROSSING COLLISION
NEAR SYCAMORE, SOUTH CAROLINA
MAY 2, 1995**

**Adopted: March 11, 1996
Notation 6596A**

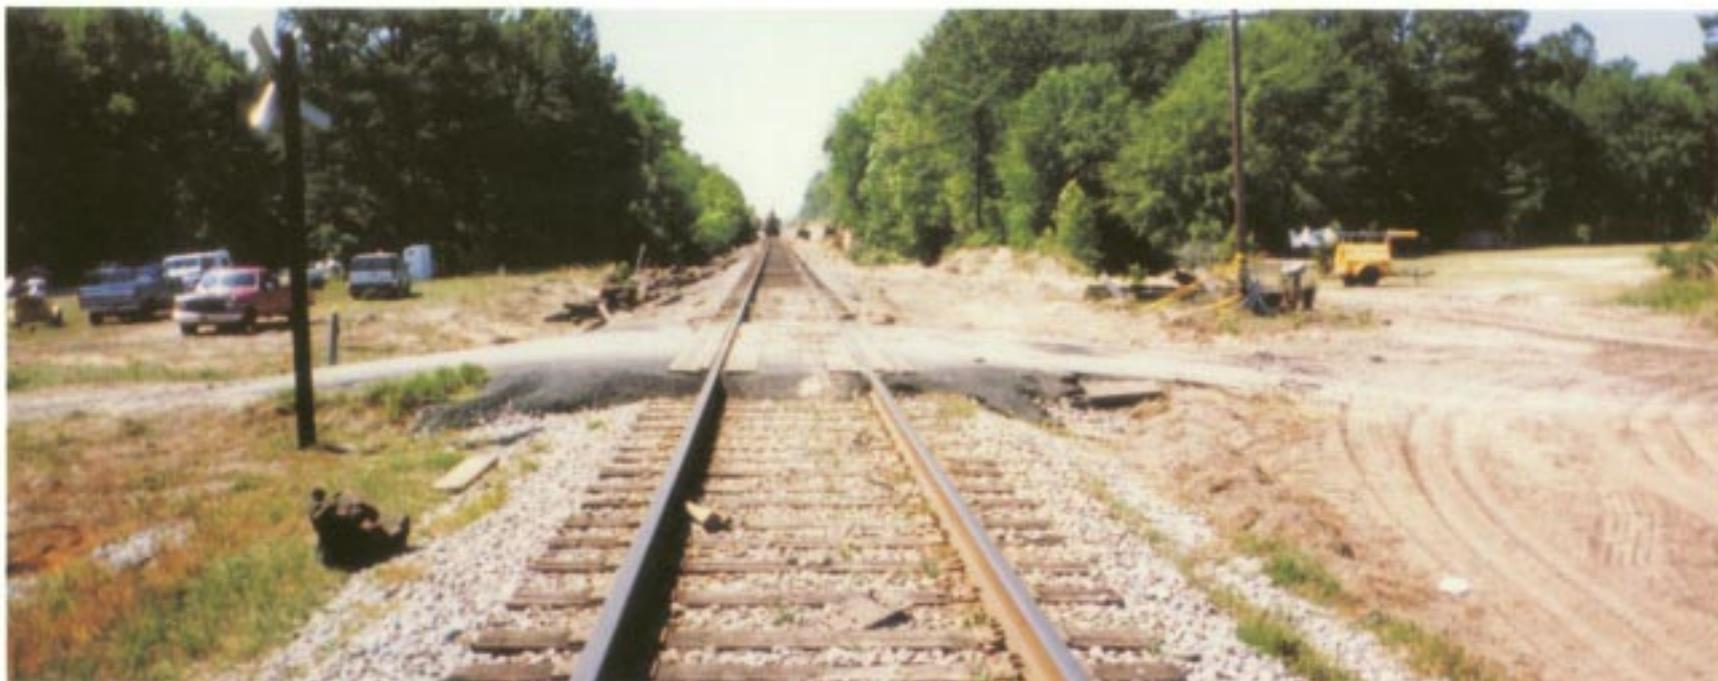
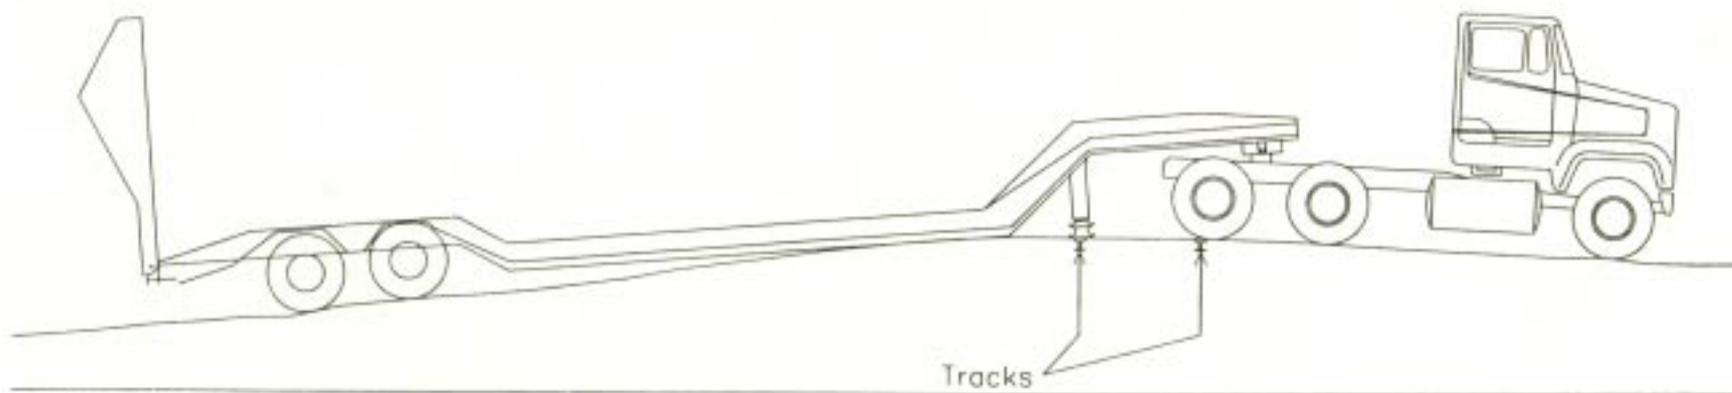
Figure 2 -- Vertical profile of accident crossing

The truckdriver stated that when he reached the grade crossing, he stopped and looked both ways before crossing. He said he continued forward over the tracks, looking in his side mirror at the semitrailer side marker lights, until he heard something scraping and felt the truck stop suddenly. He tried to back up, but the truck would not move. He said he got out of the tractor and saw that the semitrailer had about 2 to 3 inches of ground clearance. He did not notice that the semitrailer's landing gear, which protruded below the frame rails of the semitrailer, had become embedded in the crossing's asphalt surface. (See figure 2.)

The westbound approach to the crossing ascended to about a 10-percent grade. The AASHTO standard for roadway vertical profiles recommends that highway surfaces not exceed a 2-percent ascending grade 30 feet out from the rails, meaning that the accident crossing grade was almost 5 times over the recommended allowance. Taking into account this profile and the

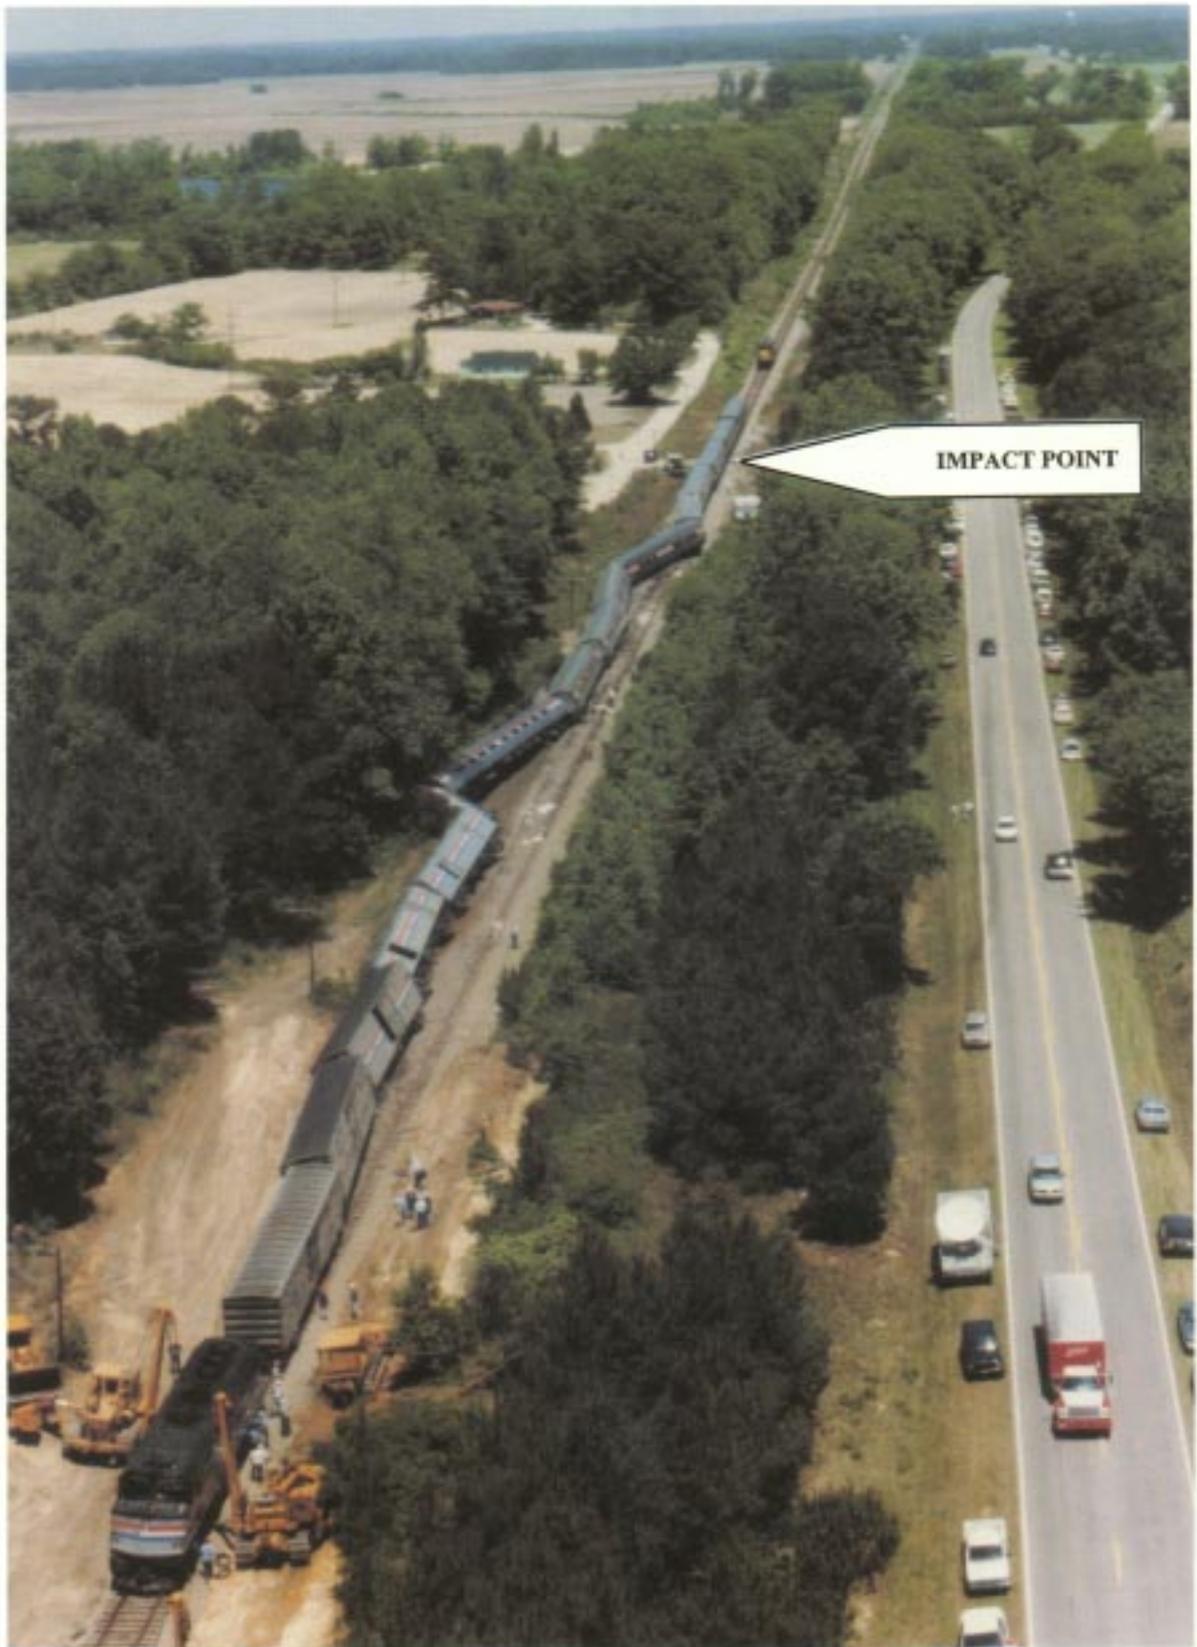
Figure 3 -- Final rest position of train

Collision -- Amtrak train 81 struck the right side of the semitrailer. The impact caused both locomotives and 14 of the 16-car consist to derail. The lead locomotive came to rest on the west side of the track about 1,200 feet from the point of impact. (See figure 3.) The tractor and semitrailer separated, the tractor rotating clockwise about 260 degrees and coming to rest about 19 feet southwest of the crossing. The semitrailer rotated counterclockwise about 285 degrees and came to rest about 43 feet southeast of the crossing. (See figure 4.) No fire ensued.

Train -- The lead locomotive sustained damage to its front plow and right-side ladder, and its rear truck derailed. The trailing locomotive derailed. No interior damage was noted in either locomotive. The three mail-handling cars behind the locomotives derailed but remained upright; the 4th through 7th cars derailed and overturned or tipped to varying degrees on their right sides;

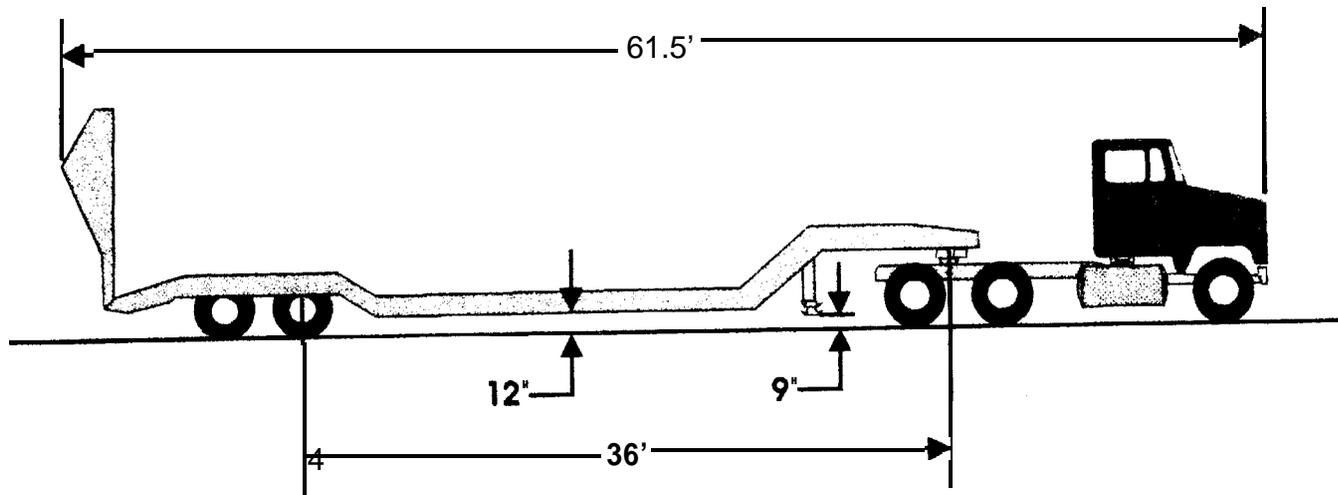
Figure 5-- Schematic of accident truck (not to scale)

Lowbed or low clearance vehicles vary greatly in their physical characteristics, primarily because most trucks are customized for special operational conditions. Typical wheelbases for lowbed vehicles range from 25 to 40 feet, and ground clearances can be as little as 3 inches. The Pioneer semitrailer was approximately 48 feet long. It had an unloaded ground clearance of 12 inches on a level surface. All tractor and semitrailer axles were equipped with standard s-cam air mechanical service brakes. The truck had a overall length of approximately 61 feet. (See figure 5.)
