HIGHWAY ACCIDENT SUMMARY REPORT

TRUCK LOSS OF BRAKING CONTROL
ON STEEP DOWNGRADE AND COLLISION WITH A VEHICLE
NEAR PLYMOUTH MEETING, PENNSYLVANIA
ON APRIL 25, 1996

Motor Carrier: JDM Materials Company, Inc.
Vehicle 1: 1988 Mack four-axle truck with a concrete mixer body
Vehicle 2: 1985 Subaru sedan

Accident Type: Loss of braking control leading to vehicle collision
Location: Plymouth Meeting, Pennsylvania

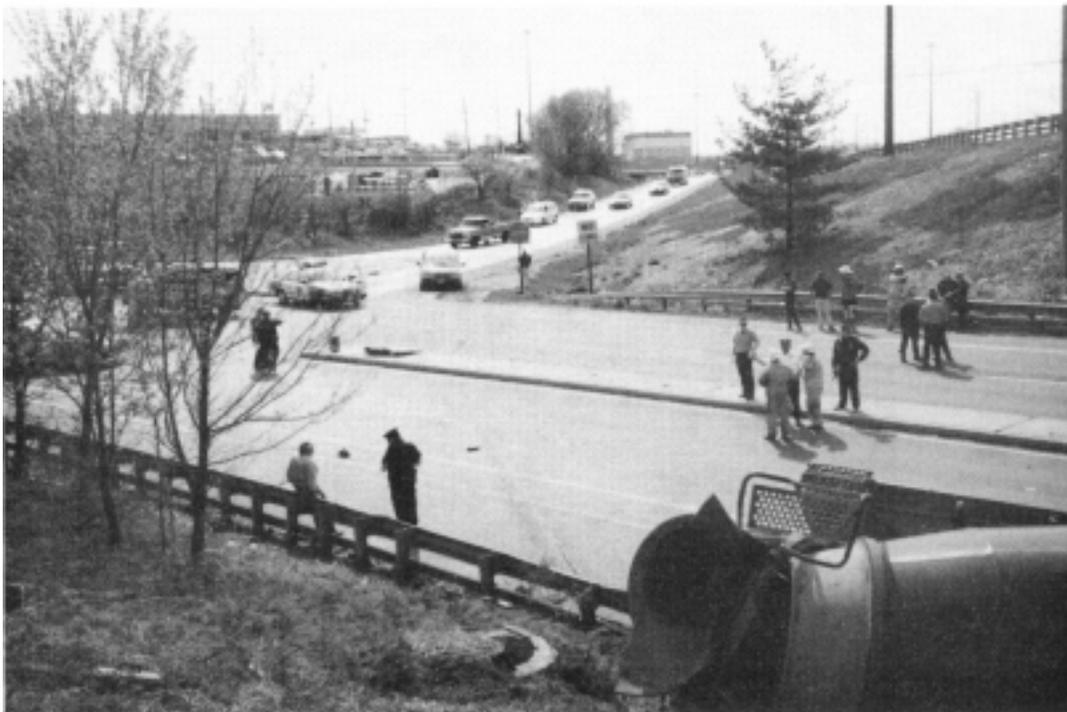
Figure 1 -- Accident scene, T-intersection, and off-ramp.
(Photograph courtesy of Plymouth Township police.)

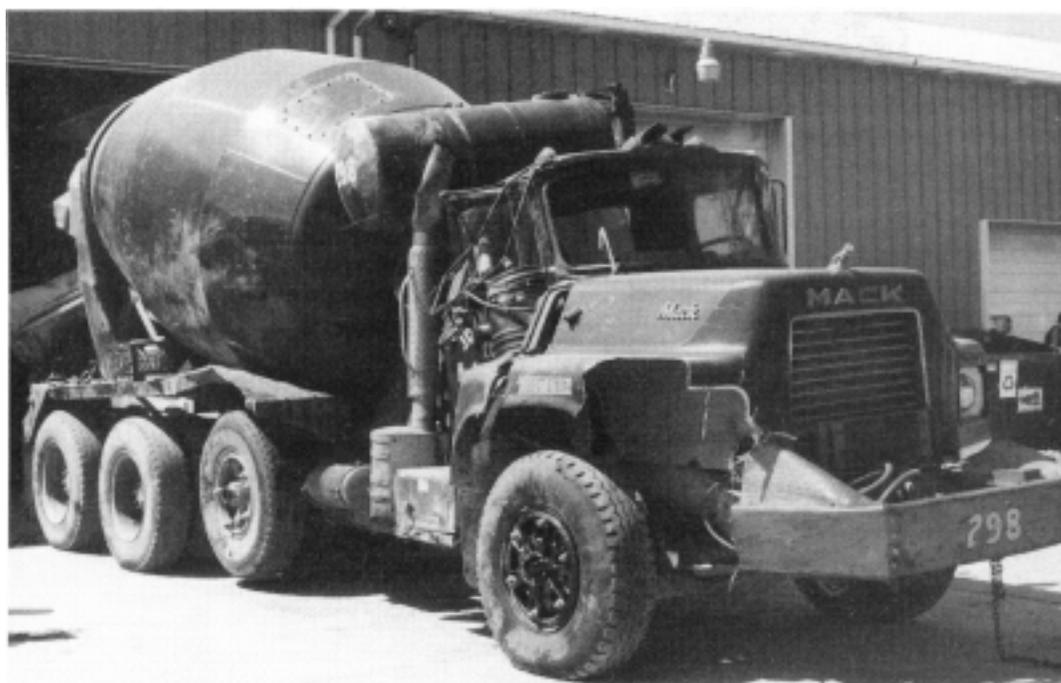
Figure 2 -- Accident truck.

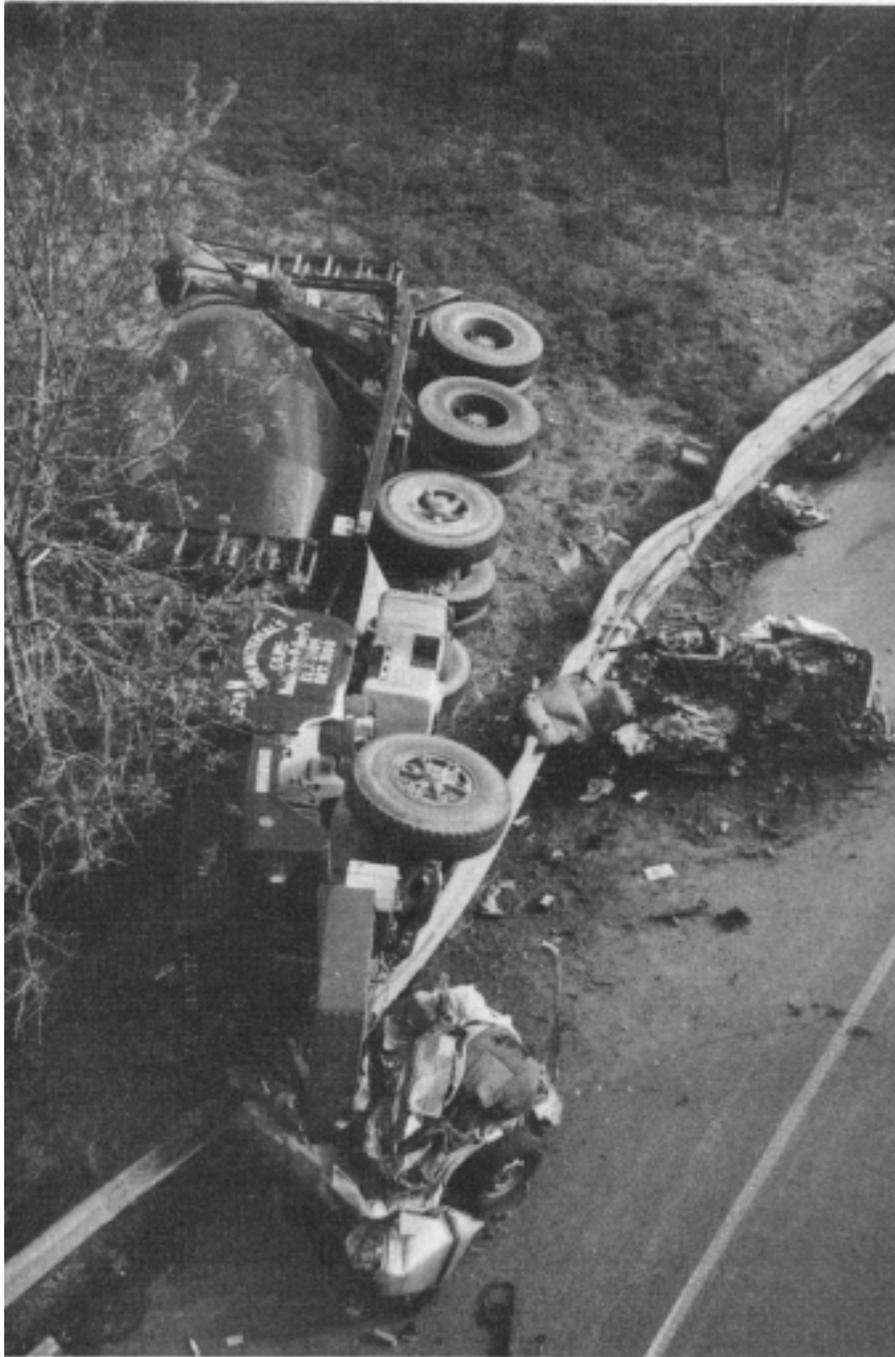
Figure 3 -- Accident vehicles at final rest position.
(Photograph courtesy of Plymouth Township police.)

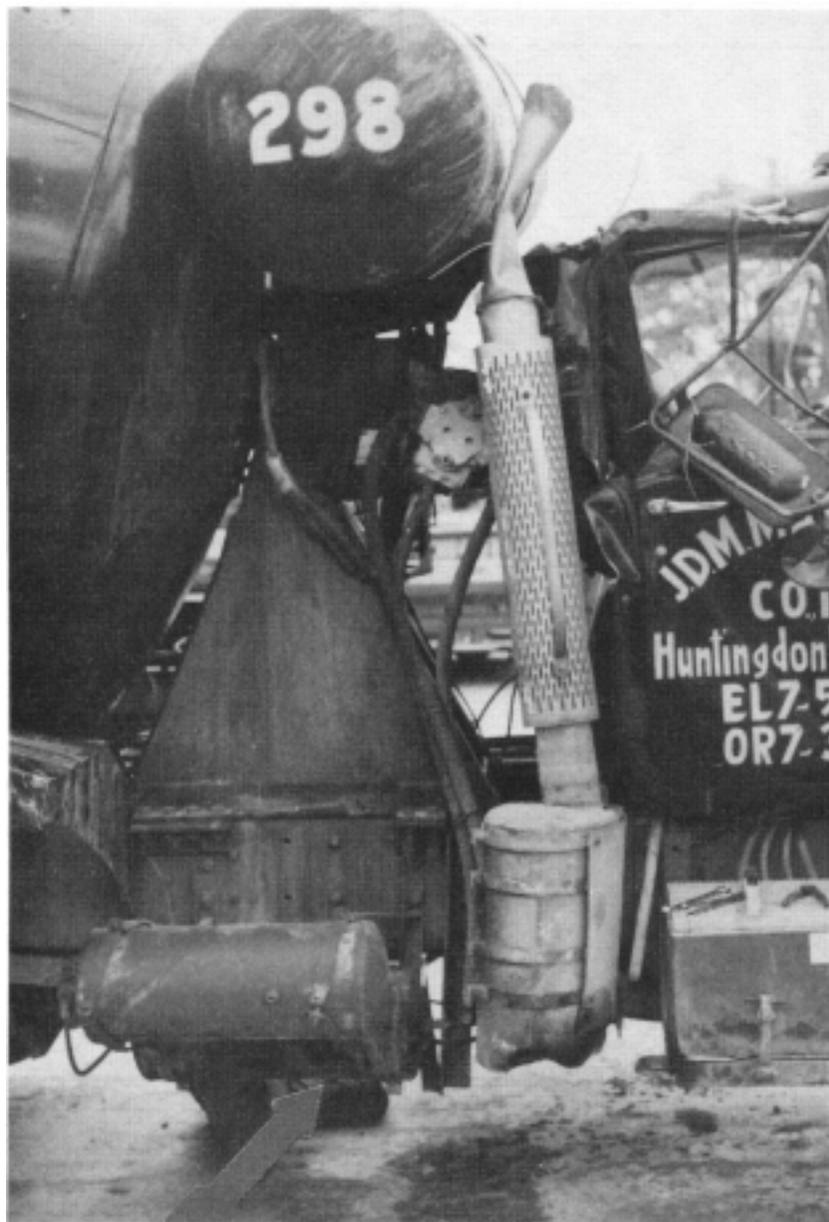
postaccident examination of the truck during the retrieval operation. The parking brake knob on the truck instrument panel was found in the depressed (off) position. The examination revealed that the drain valve located on the bottom of the air reservoir tank for the truck's secondary air system was broken off, and the air in the tank was depleted. (See figure 4.) A fractured piece of the valve was still threaded into the drain port. Scrape marks were visible on the underside of the tank in the area of the drain valve port.

Figure 4 -- Location of missing drain valve indicated by arrow.

engine retardation). The Safety Board therefore concludes that the drain valve on the secondary air supply tank was probably fractured when the truck struck a tire carcass while en route to the accident site.

The day after the accident, the fractured drain valve was replaced, and the truck's secondary air system was recharged. The truck's entire air brake system was then tested by the chief mechanic of the towing company and found to be in compliance with Pennsylvania State safety inspection standards. Also, the Pennsylvania State Police conducted a separate inspection of the truck using the Federal Motor Carrier Safety Assistance Program (MCSAP) criteria. The MCSAP program, which is administrated by the Federal Highway Administration, has adopted the Commercial Vehicle Safety Alliance out-of-service criteria for air brake inspections of large trucks. The inspection criteria have been adopted by most States, including Pennsylvania. The accident vehicle, including the air brake system, passed the Pennsylvania State Police postaccident MCSAP inspection.

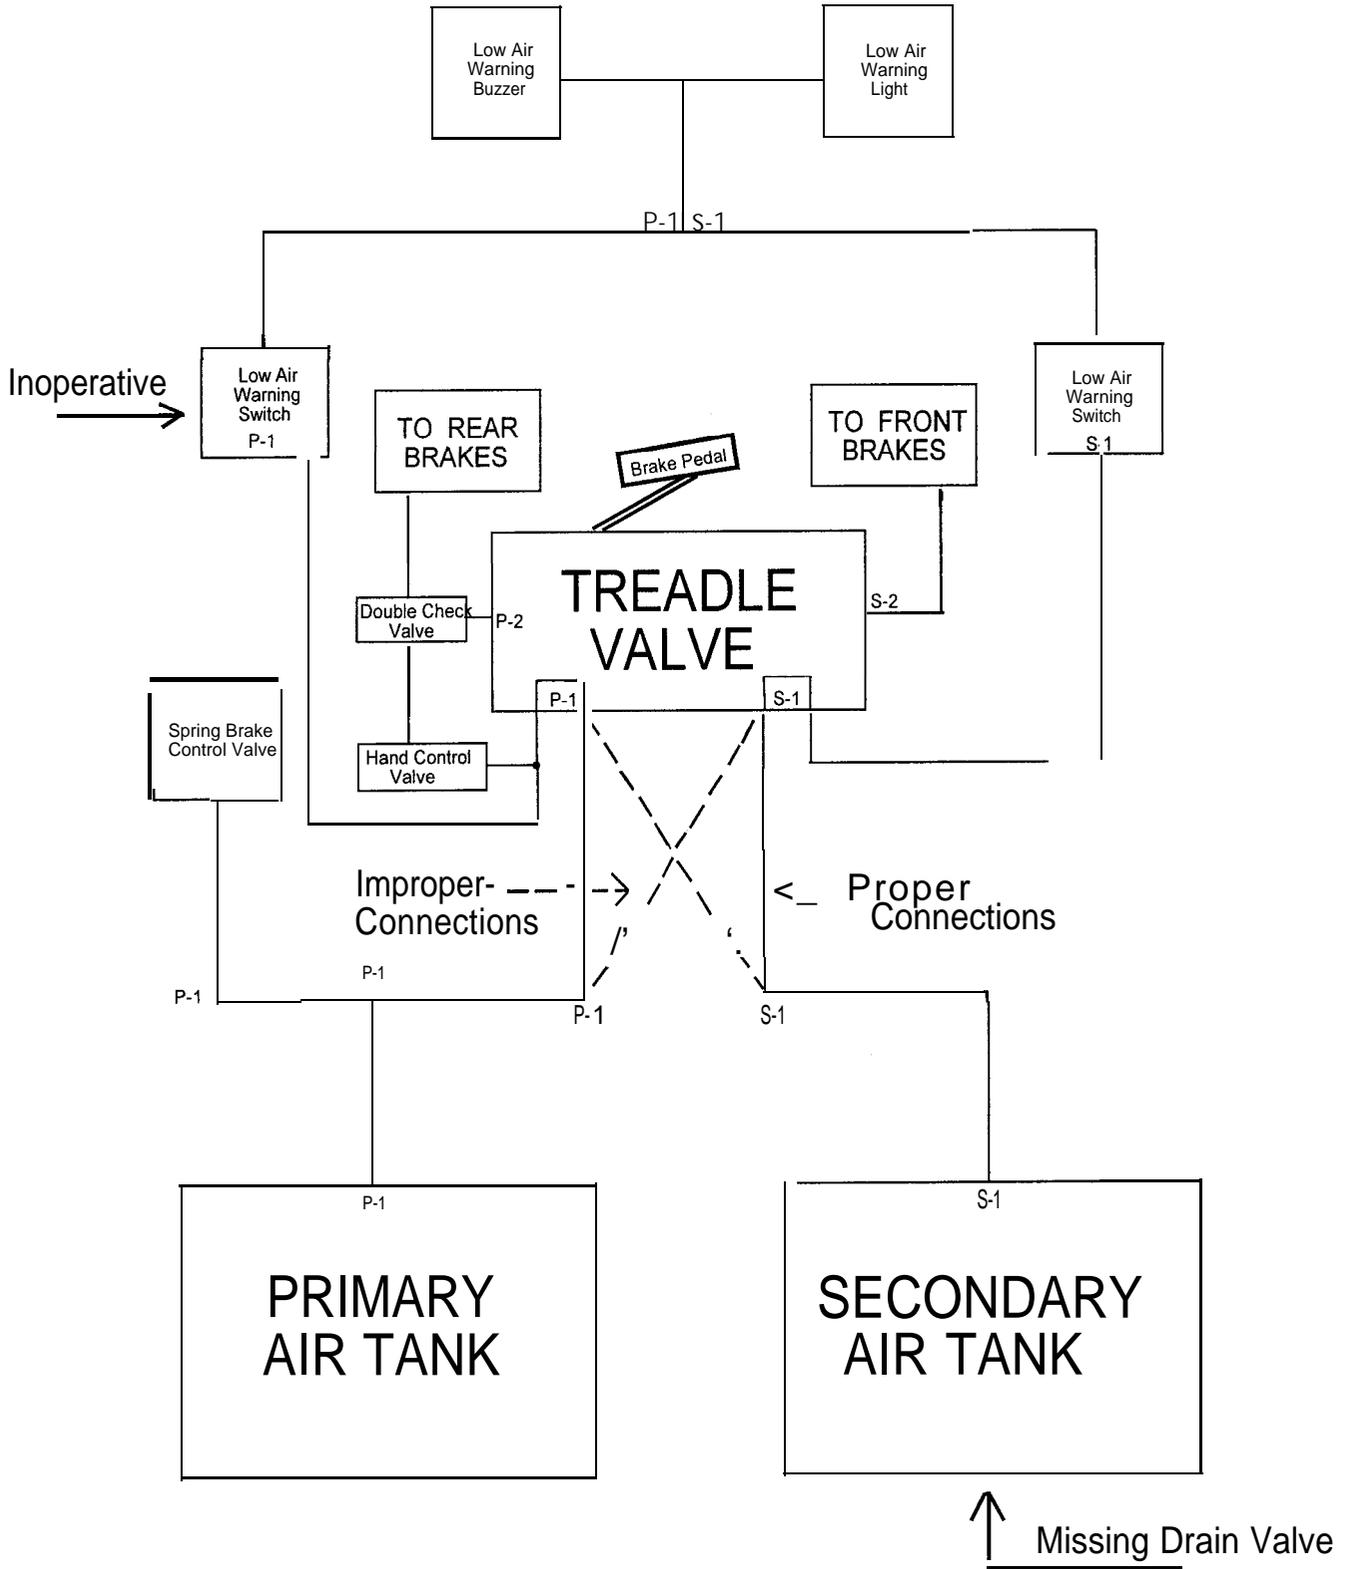
Figure 5- Air brake system diagram.
(Simplified for illustration only.)

On the accident truck, the low-air-pressure warning switch for the primary air system was monitoring pressure in the secondary air supply, but because this switch was inoperative, it did not warn the truckdriver when the secondary air supply tank became depleted. The Safety Board concludes that had both low-air-pressure warning switches on the accident truck been operable, the truckdriver would have had earlier warning of the depleted air supply and may have been able to stop the truck and avoid the accident.

So long as both of the truck's air systems remained intact, the operation of the truck's brakes appeared normal; however, the reversed air lines bypassed a vital backup in the air brake system. The rear axle spring brakes, which automatically activate when a loss of air occurs in the primary air system, did not activate in this accident, because the primary air system remained intact. The secondary air system, which on the accident truck was providing air to operate the rear brakes, was not equipped with a backup system. The Safety Board concludes that the motor carrier's improper installation of the treadle valve air lines on the accident truck effectively bypassed an important safety feature and resulted in reducing the truck's braking capability under certain emergency conditions.
