NATIONAL TRANSPORTATION SAFETY BOARD

HIGHWAY ACCIDENT SUMMARY REPORT

**BUS COLLISION WITH PEDESTRIANS
NORMANDY, MISSOURI
JUNE 11, 1997**

| Accident No.: | CRH-97-F-H007 |

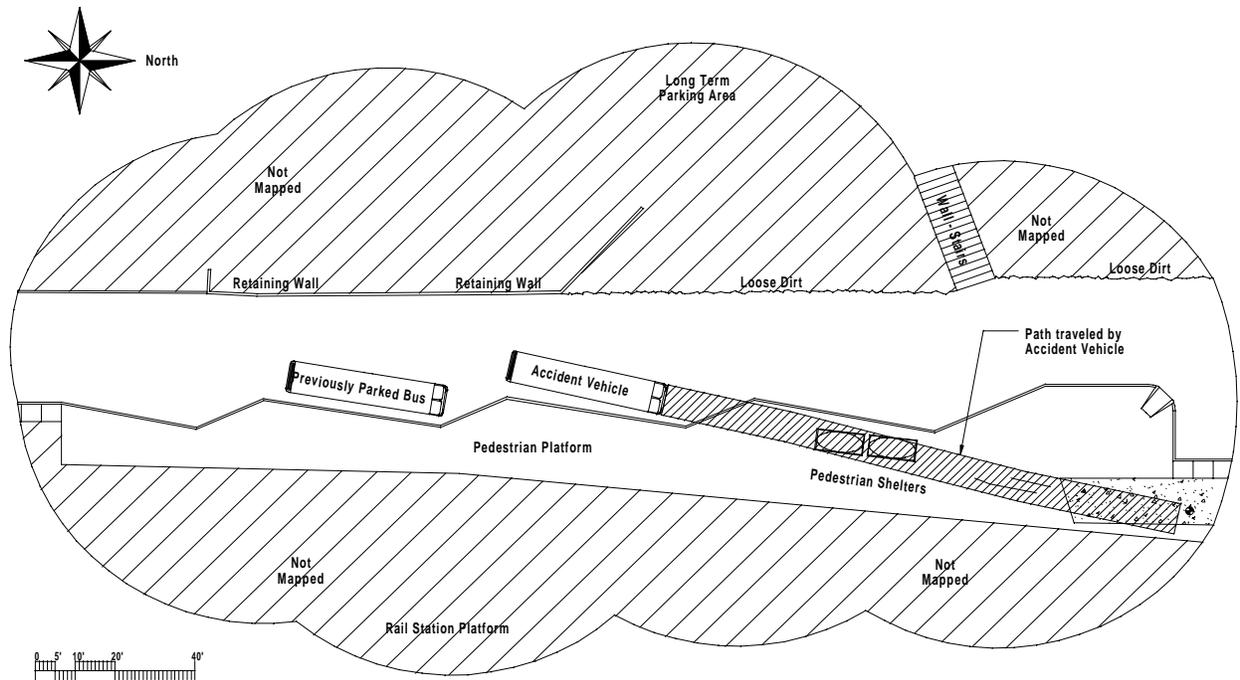
Figure 1 -- Diagram of accident scene

pulled around and parked in front of another bus that was already parked at the location. (See figures 1, 2, and 3.)

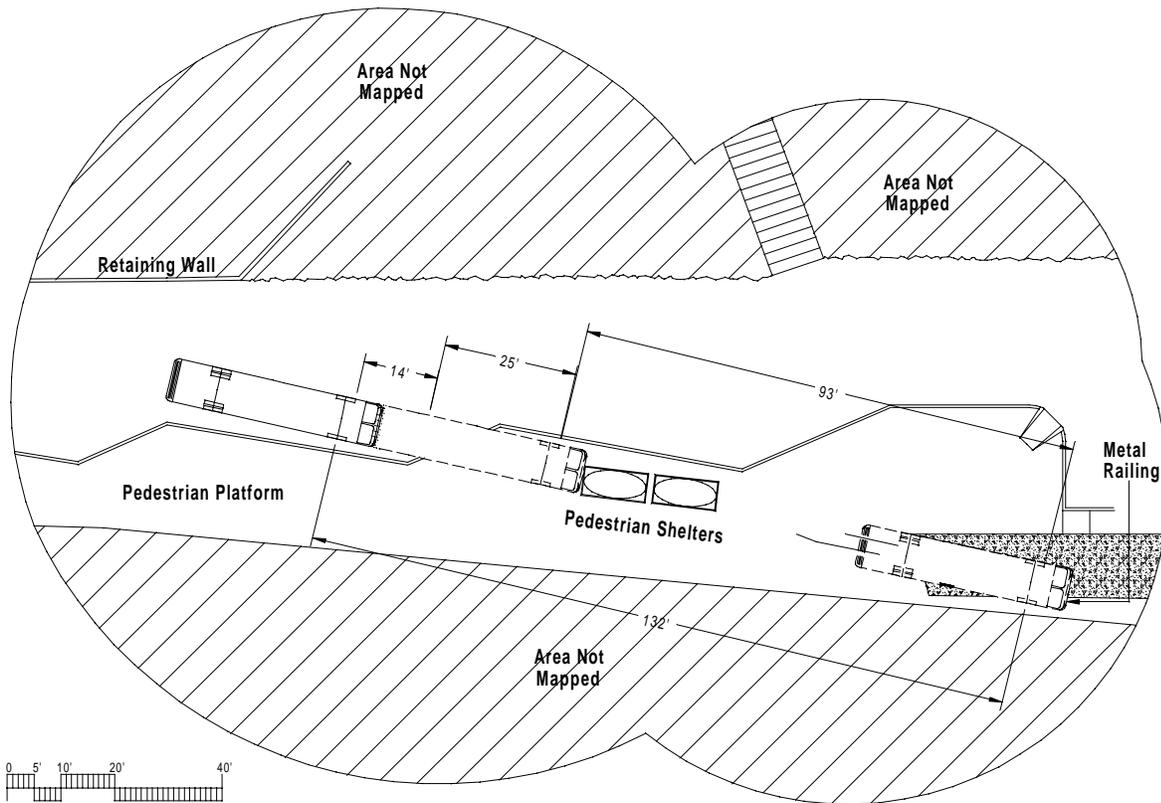
Figure 4 -- Bus collision movements

The bus moved forward approximately 14 feet before surmounting the 5-inch-high curb dividing the roadway from the pedestrian

platform. The bus continued forward onto the platform for a distance of 25 feet before making contact with the first of two pedestrian shelters. Then, after striking the second shelter and traveling an additional 93 feet, the bus came to a halt against a section of metal railing. (See figure 4.) The resulting encroachment onto the platform and collision with two pedestrian shelters resulted in the death of four pedestrians and injury to three others.

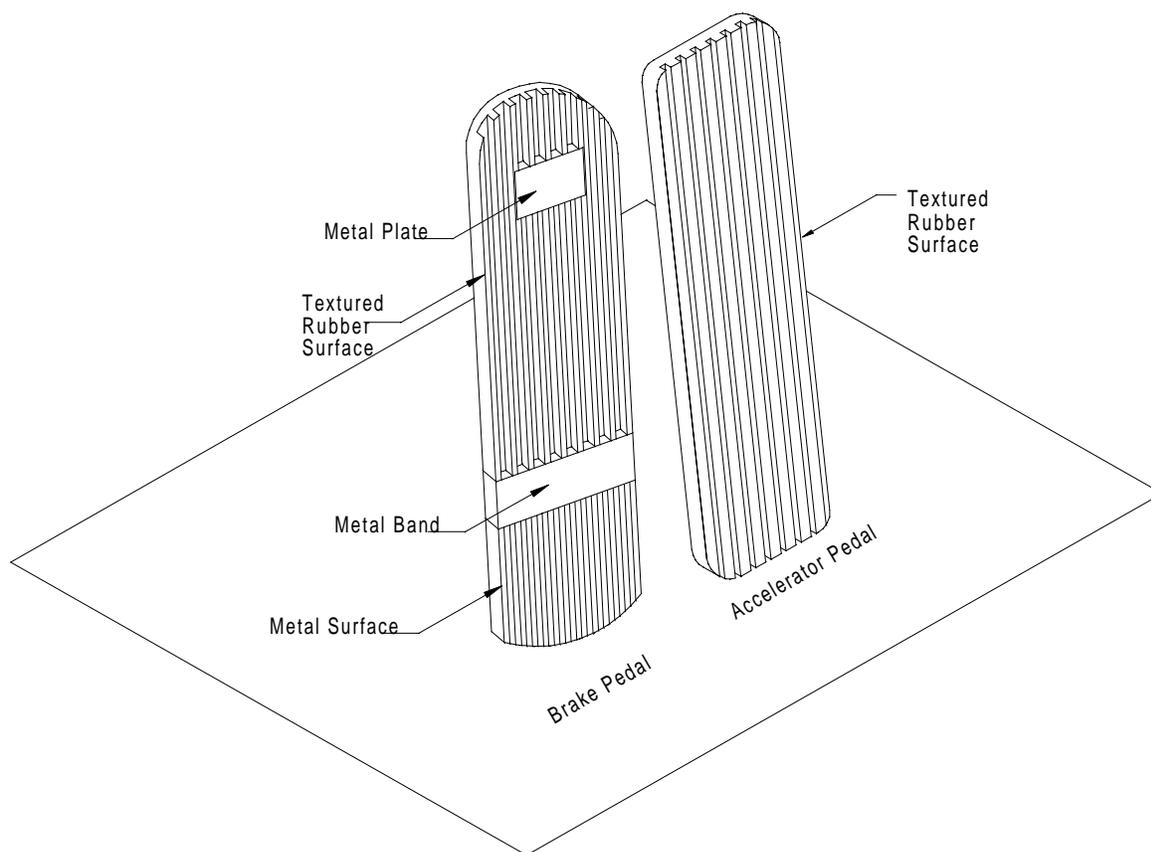
Figure 5 -- Pedal configuration

and surface texture. The accelerator pedal was approximately 11 3/8 inches long by 3 inches wide. The brake pedal was approximately 12 inches long by 3 1/8 inches wide. The spacing between the bases of the pedals was 1 3/4 inches, while the tops of the pedals were separated by 1 inch. The brake pedal was mounted so that it angled back, toward the fire wall, at 47°. The accelerator was mounted in a similar manner, except that it had a steeper 54° angle. The accelerator facing was of textured rubber with longitudinal grooves extending from top to bottom. The lower portion of the brake pedal was exposed metal; the upper portion was covered by a grooved rubber insert. (See figure 5.)

Experienced bus operators from the BSDA Debaliviere facility were interviewed regarding the vehicle's pedal design and layout. Their general belief about the pedals was that, because of their similarity and close proximity, the pedals' configuration might appear ergonomically awkward, especially to an inexperienced operator such as the driver trainee. They considered, however, that once an individual had been trained, the arrangement of the pedals represented no hindrance to proper bus operation. Their experience-based opinions are supported by past research that found no systematic link between unintended acceleration due to misapplication of pedals and pedal design.⁶

In her statements to investigators, the driver trainee maintained that she had applied the brake throughout the accident sequence. The investigation did not find any corroborative evidence to verify the driver trainee’s assertion. Analysis of the results from all the foregoing tests demonstrated that the bus’s brake system was adequate to hold the vehicle stationary regardless of throttle position. Had the driver trainee placed her foot on the service brake, as she indicated to investigators, the bus would not have accelerated forward, over-ridden the curb, and traveled onto the pedestrian platform. Additionally, had the driver trainee inadvertently placed her foot on the accelerator and then either removed it from the accelerator and applied the service brake or applied the service brake while the accelerator was still depressed to wide open throttle, the bus would have stopped. The Safety Board therefore concludes that the driver trainee misapplied her foot to the accelerator pedal, thereby causing the unintended acceleration of the bus.

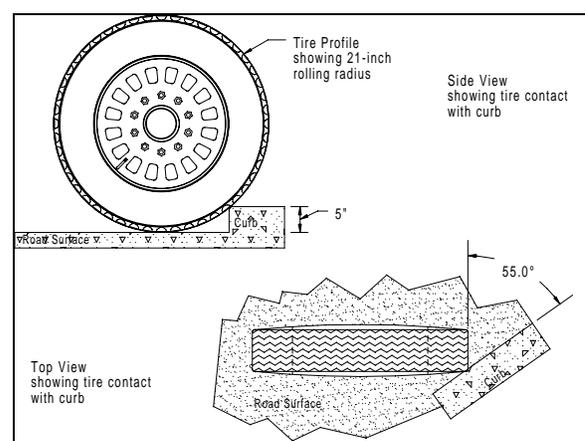
Figure 6 -- Curb and tire profiles

complete stop; the bus was then timed as it accelerated over a distance of 150 feet. The test conditions did not include provision of a 5-inch curb, such as that in place at the accident location, because investigators determined that the curb did not provide enough obstructive force to affect the acceleration of the vehicle in any significant way. The height of the curb relative to the circumference of each bus tire (21-inch rolling radius), the fact that each tire surmounted the curb independently, and the steep (55°) angle of approach taken by each tire (see figure 6) indicated that the 5-inch curb was not a meaningful barrier to the bus.

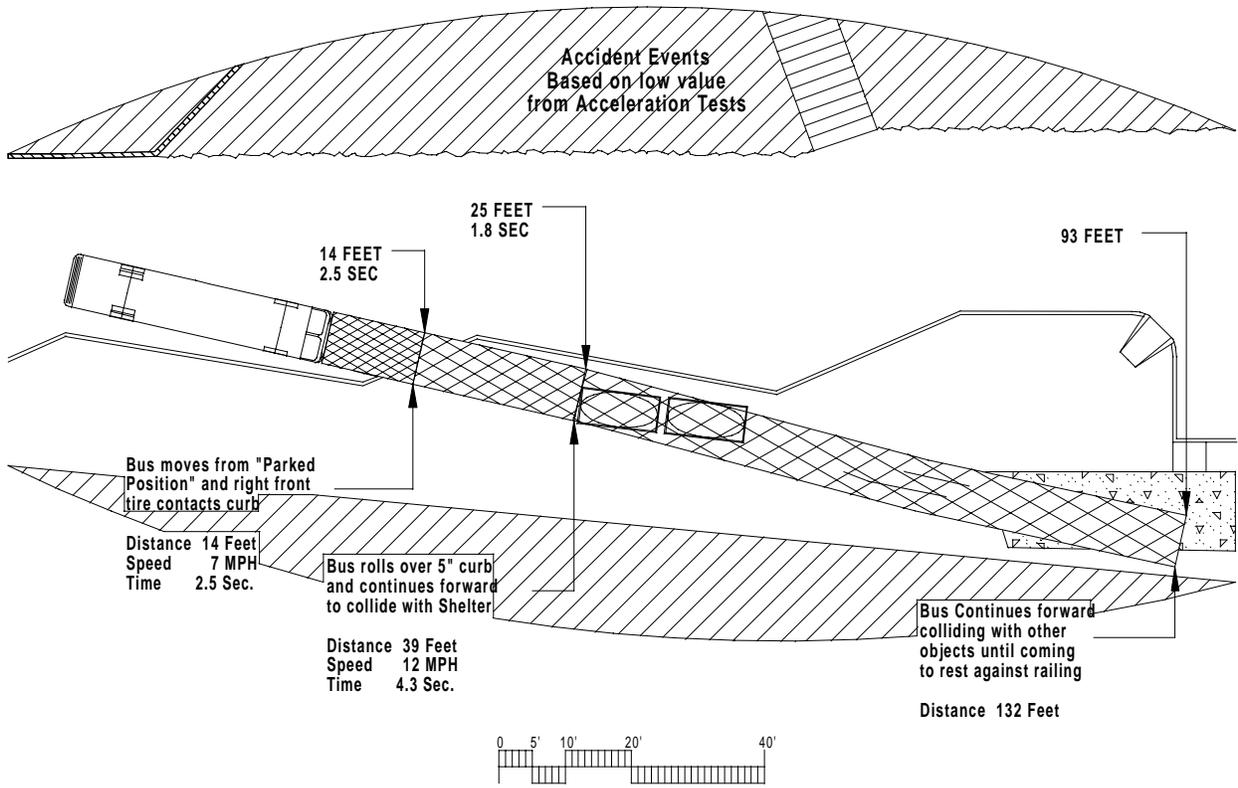
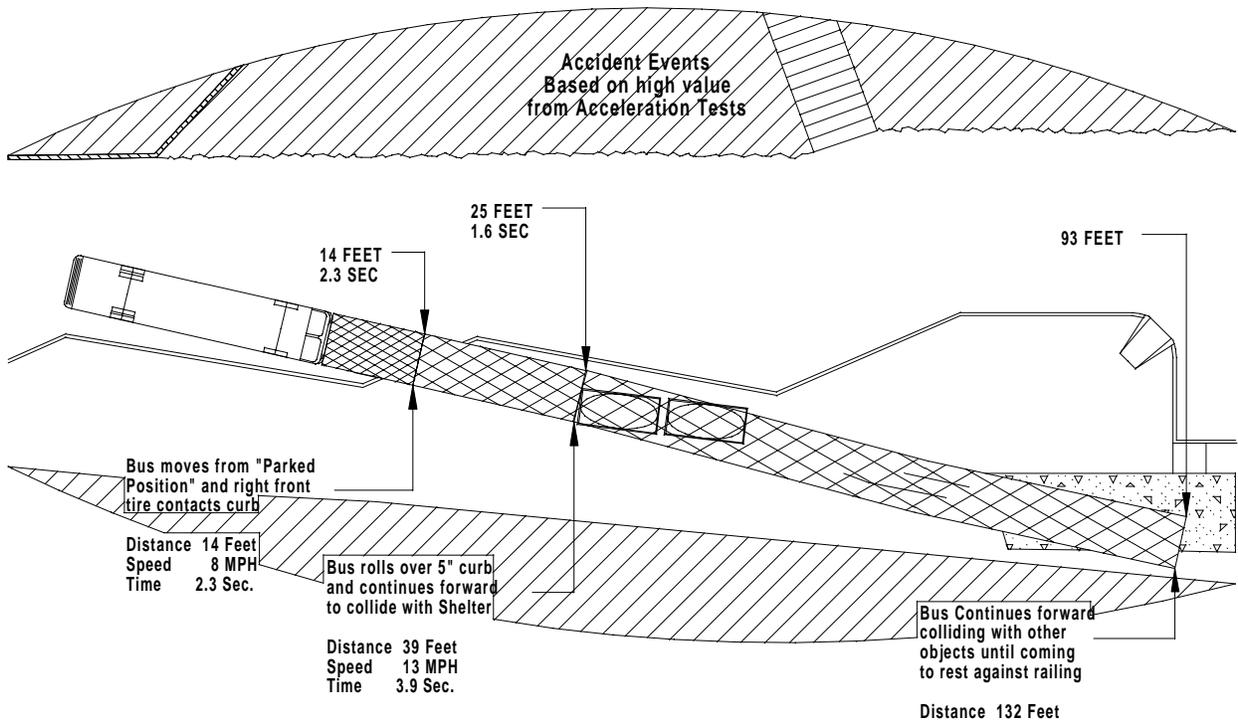
Figure 7 -- Acceleration test scenarios

The misapplication of the accelerator resulted from the associated effect of numerous conditions, including the inexperience of the driver trainee, the close proximity of the pedals, and the pedals’ similarity in shape and feel. Under the influence of these conditions, the driver trainee believed, as is common during incidents of unintended acceleration,¹² that she was applying pressure to the brake pedal. Because of this misapprehension, she maintained a continuous application of the accelerator until some point after the bus collided with the pedestrian shelters. The Safety Board therefore concludes that a combination of factors contributed to the driver trainee’s pedal misapplication. In light of the driver trainee’s failure to recognize her mistake about the pedal application, the relatively short distance traveled by the accident vehicle before striking pedestrians, and the limited time available under the acceleration scenarios tested, the Safety Board concludes that, once the bus began to accelerate, the driver trainee did not have sufficient time to avoid the encroachment onto the pedestrian platform.

Given the rapidity with which the accident developed, and the fact that the driver trainee did not immediately recognize her error, she did not have time to use steering input to avoid the pedestrians. Investigators determined that once the bus had surmounted the curb, the driver
