Highway Investigation Report HIR-24-05

# Rear-End Collision Between Combination Vehicle and Medium-Size Bus

Williamsburg, Virginia  
December 16, 2022

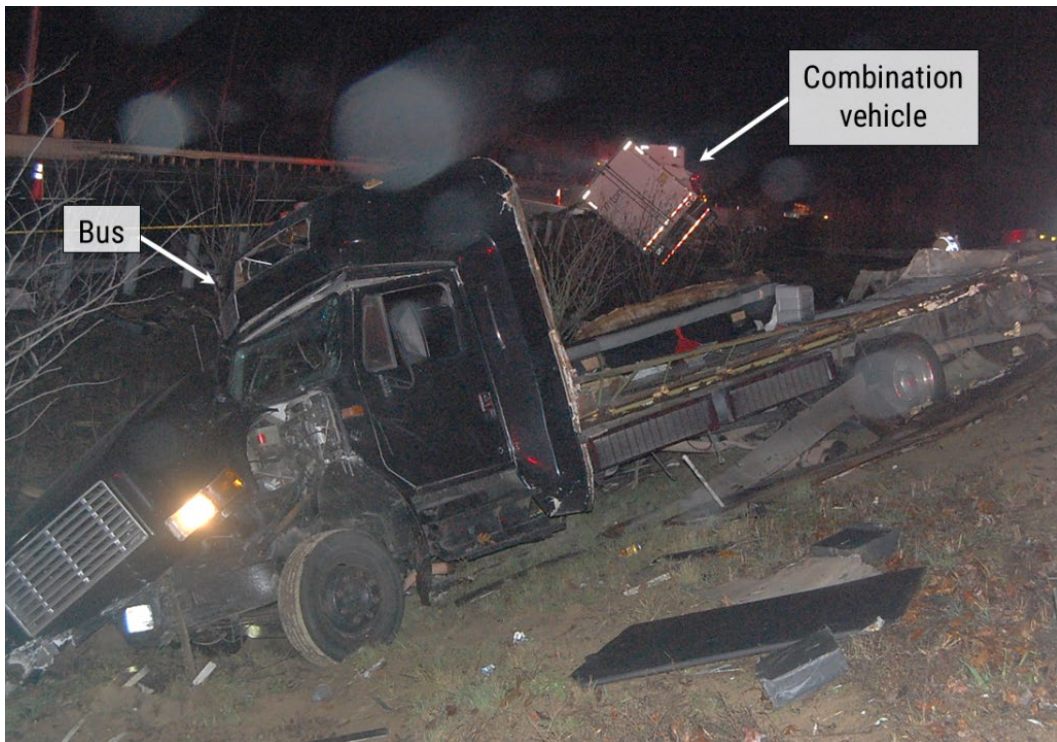
**Figure 1.** Eastbound view of final rest positions of the bus and combination vehicle (Source: Virginia State Police with annotations by the NTSB).

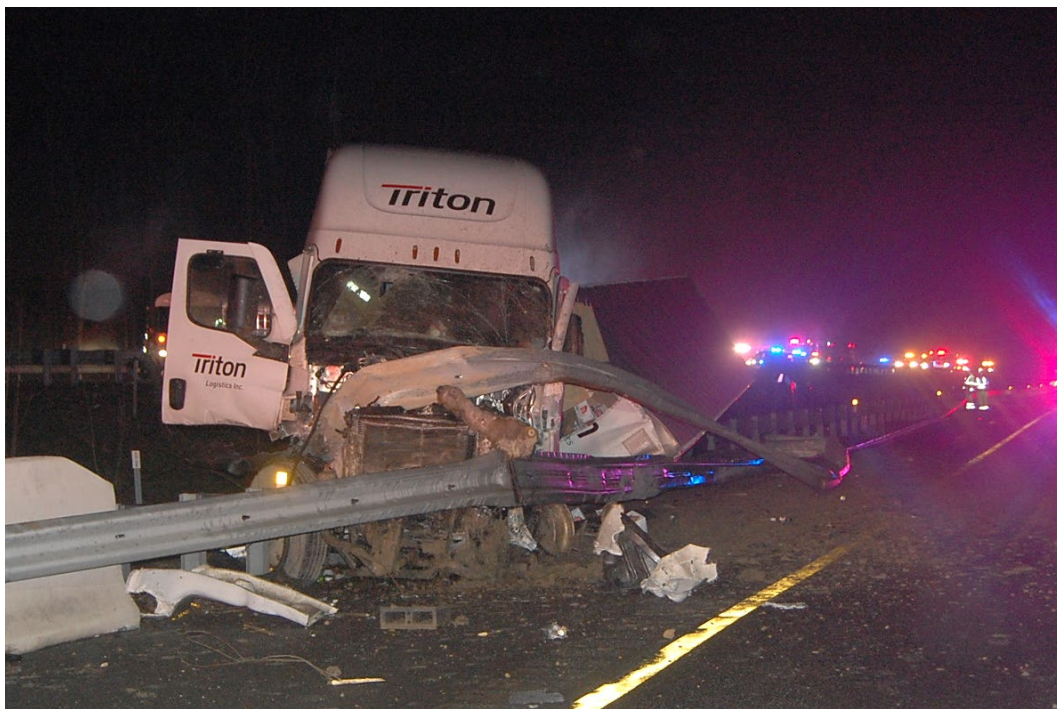
**Figure 2.** Westbound view of the combination vehicle's final rest position (Source: Virginia State Police).

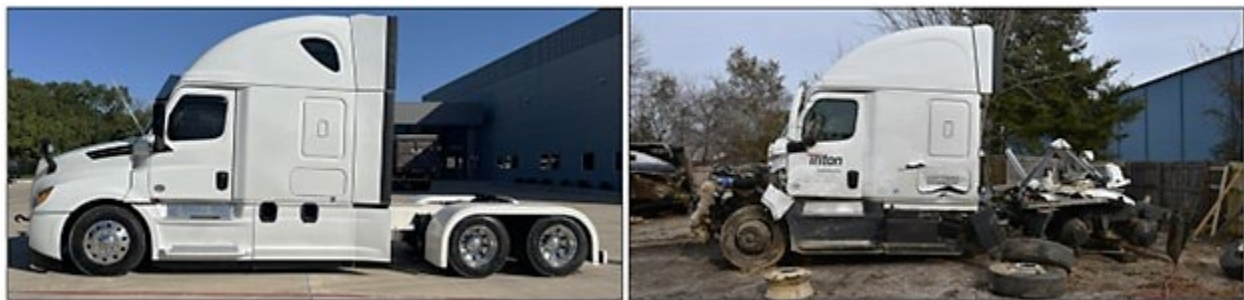
**Figure 6.** Exemplar truck-tractor (left; source: Vanguard Truck Center). Crash-damaged truck-tractor (right).

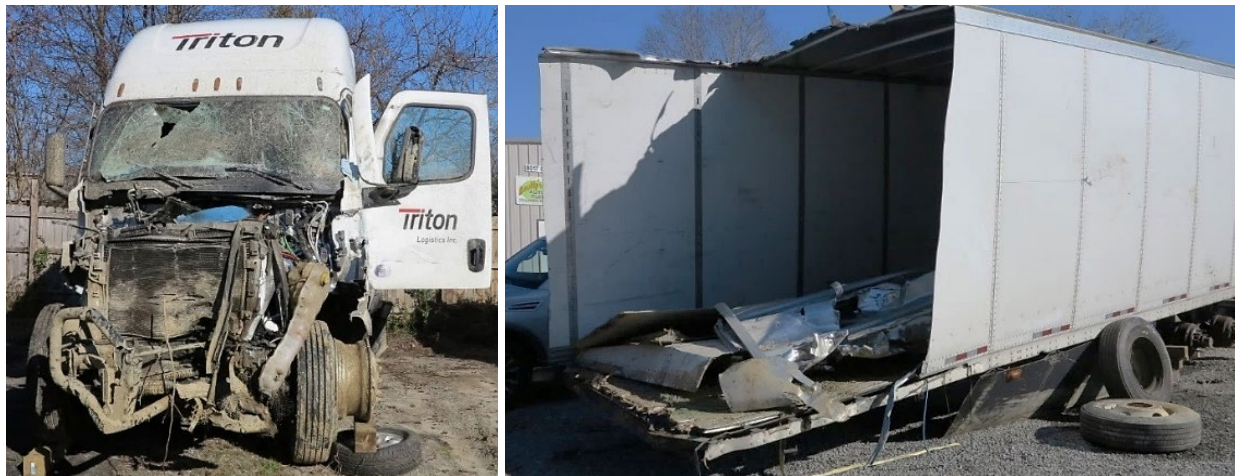
Figure 7 shows the postcrash damage to the truck-tractor and semitrailer. The truck-tractor sustained significant damage to its front end with damage trailing along the left side. The hood and front bumper were missing and the bumper guard was bent and creased in multiple locations. The full width of the windshield was shattered.

**Figure 7.** Postcrash photographs showing the front of the truck-tractor (left) and the front left of the semitrailer (right).

The front portion of the semitrailer was missing along with the fifth wheel kingpin, upper fifth wheel plate, and landing gear. The damage sustained by the combination vehicle was consistent with a frontal impact with the rear of the bus and a sudden stop, which caused the cargo inside the semitrailer to propel forward and break through the forward bulkhead.

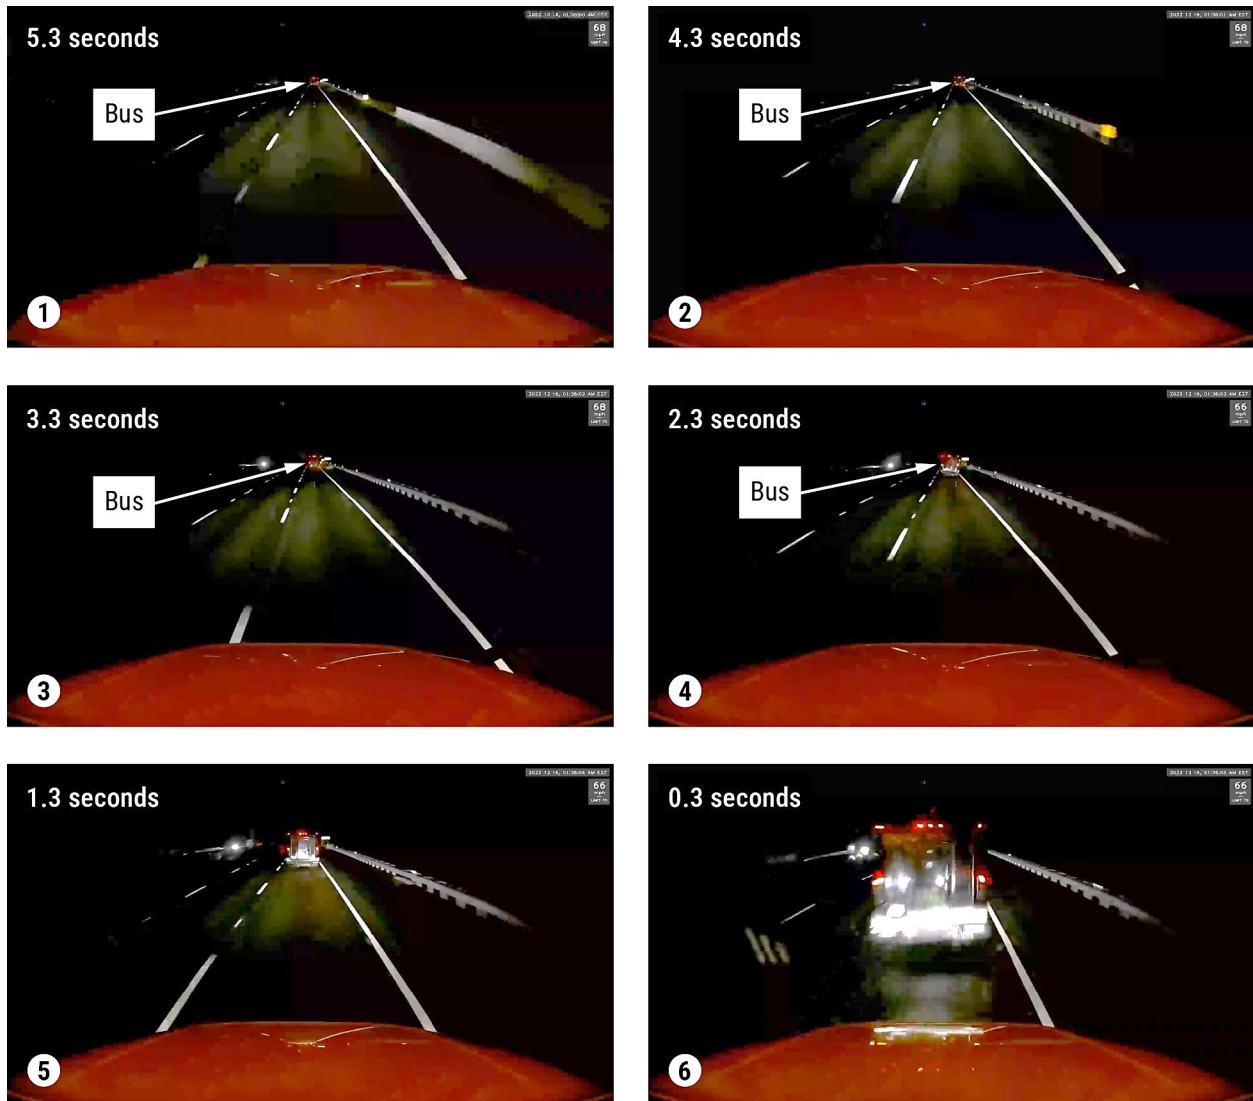
**Figure 8.** Video still-shots from the truck-tractor's forward-facing camera. Annotations indicate the time to collision, in seconds.

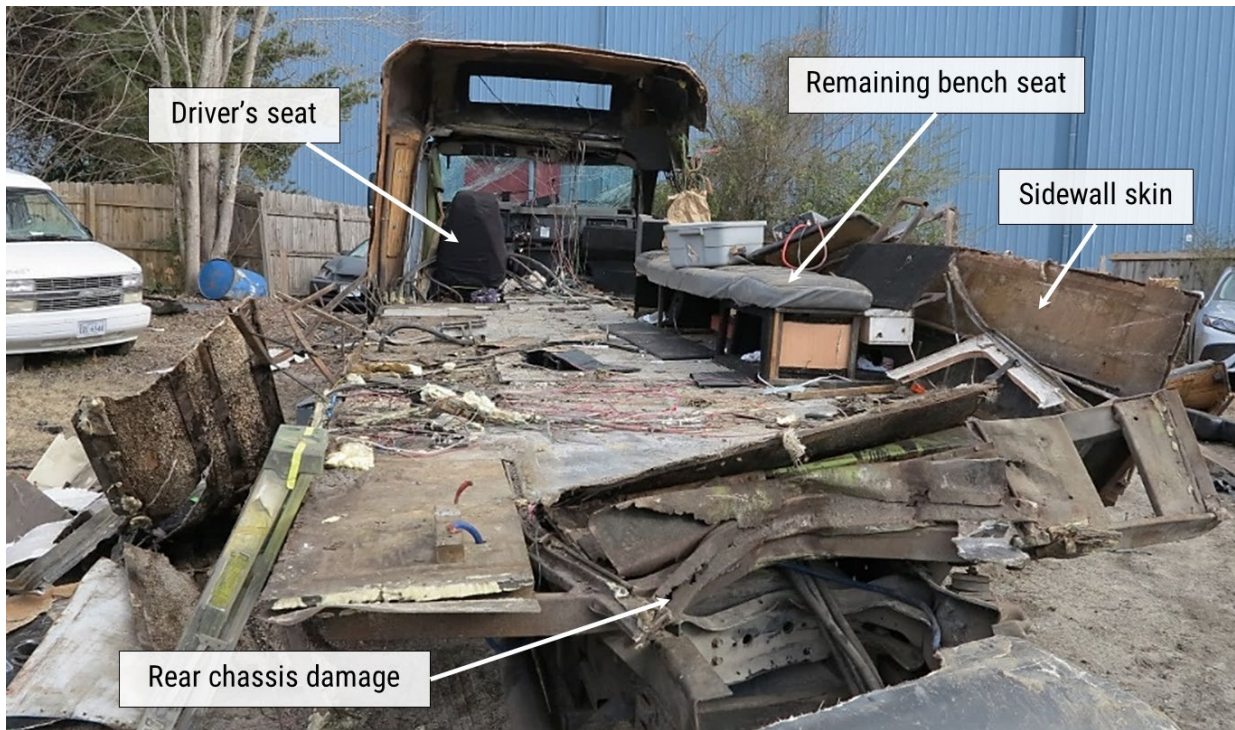
The bus sustained catastrophic rear damage from the collision with the combination vehicle. The frame rails on the chassis were bent to the right, with the rear of the right frame rail crushed in a forward direction. The rearmost frame crossmember was displaced forward and broken. The bus body compartment, including the roof and sidewalls, completely separated from the vehicle chassis (see figure 11). On the left side, the sidewall, seat rail, and all passenger seating detached from the chassis. On the right side, the seat rail and one bench seat remained intact; the remaining seats and the sidewall skin detached from the rail. Additional damage was sustained at the front due to the subsequent contact with the guardrail. Both sides of the front bumper were displaced rearward. The windshield was shattered and had separated from the upper part of the window frame.

**Figure 11.** Postcrash photo showing the bus from the rear.

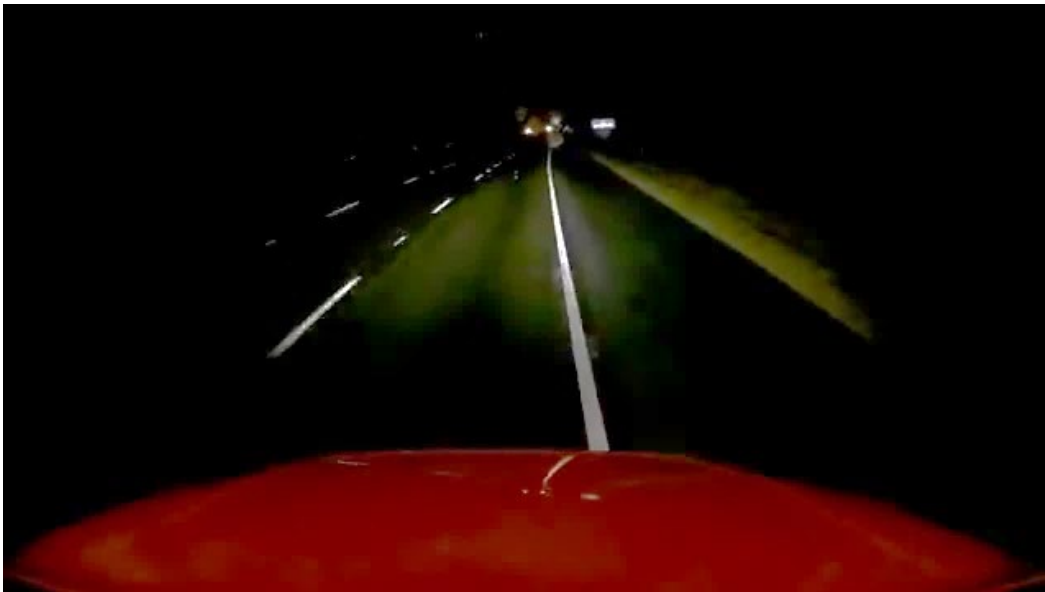
Footage from the truck-tractor’s forward-facing video showed that in the 3 minutes before the crash, the combination vehicle repeatedly drifted over into the shoulder area and then back into the right lane. Specifically, the vehicle crossed the white shoulder line nine times. A still-shot from the forward-facing video is shown in figure 13.

**Figure 13.** Still-shot from the forward-facing video, showing the combination vehicle crossing the white shoulder line in the 3 minutes leading up to the crash.
