Pickup Collision with a Group of Bicyclists

Goodyear, Arizona
February 25, 2023

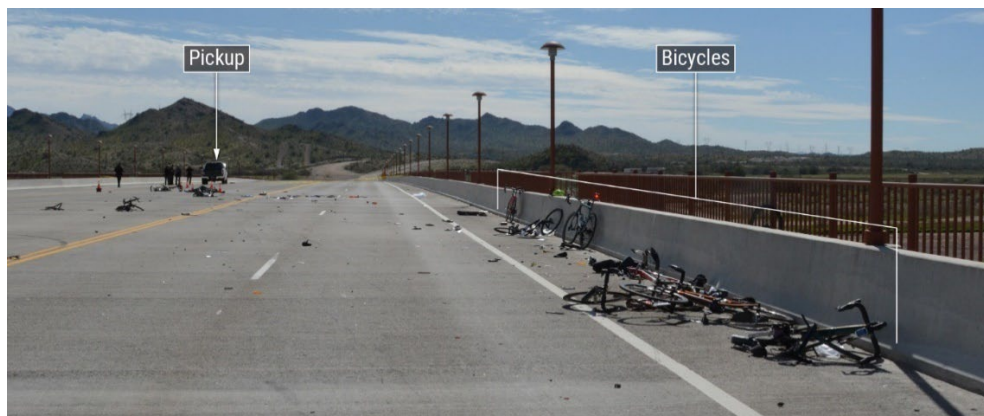
Figure 1. View of the southbound lanes of Cotton Lane Bridge, showing the final rest positions of the pickup and some of the involved bicycles. (Source: Goodyear Police Department; annotations by NTSB)

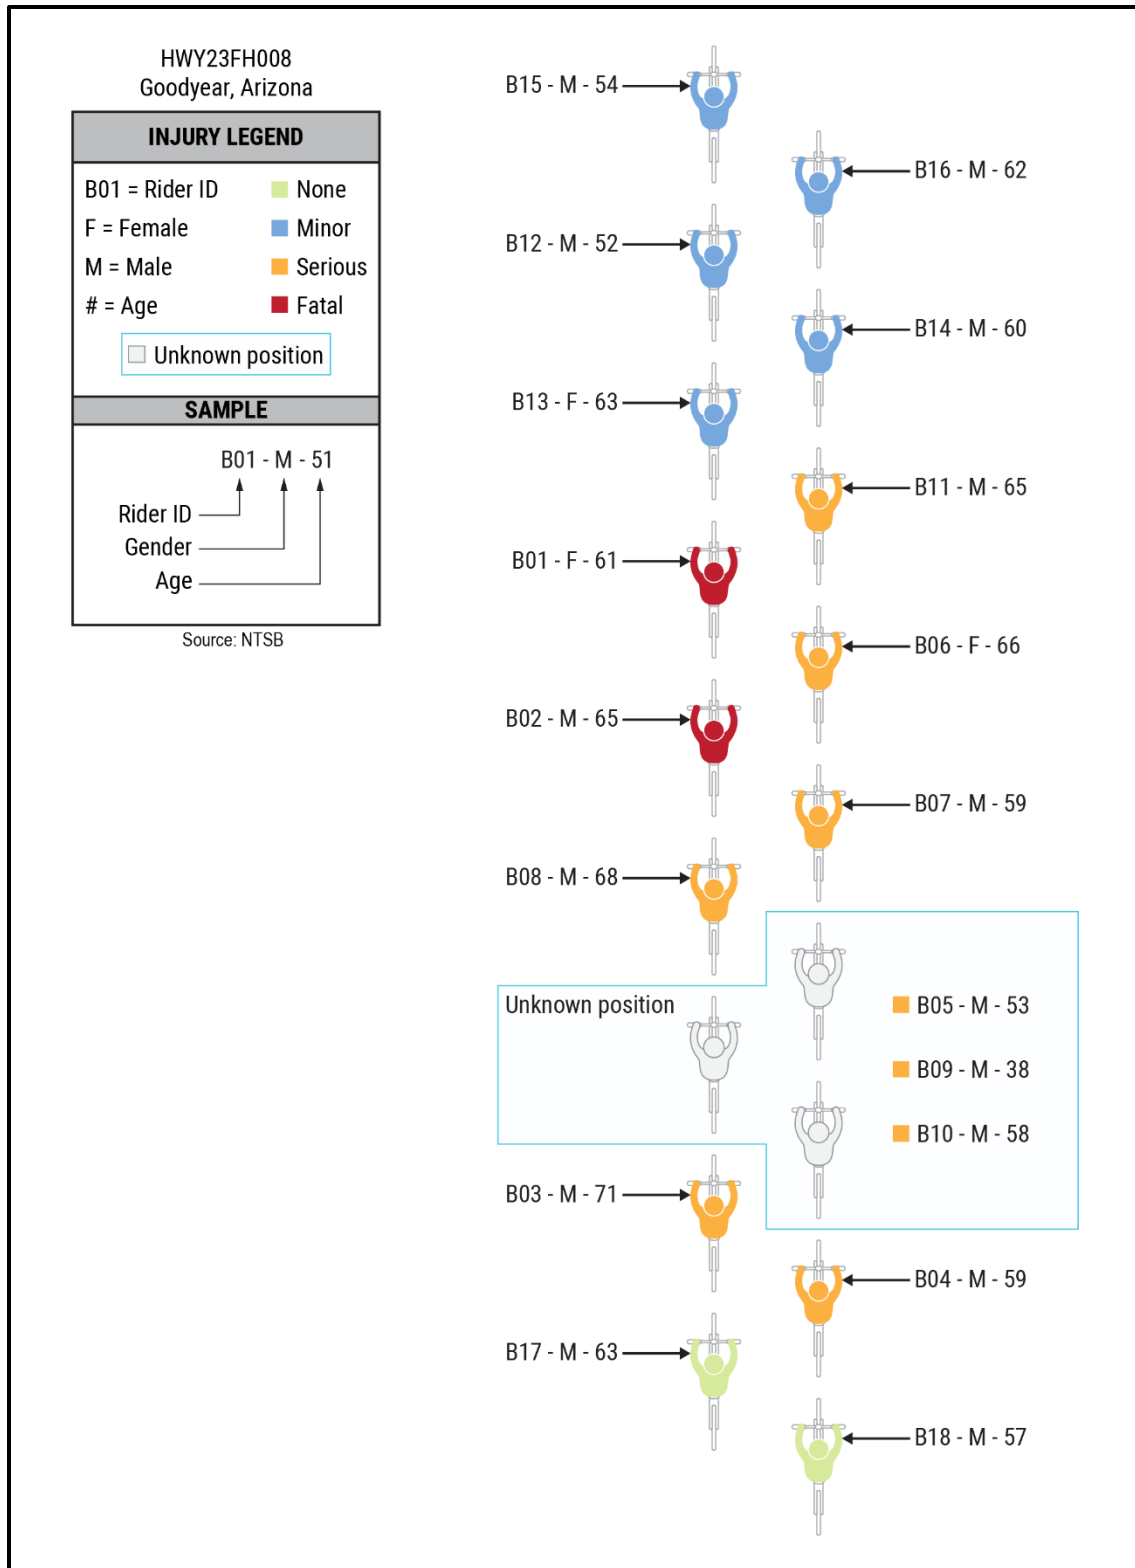
The bicyclists were riding in a group formation, primarily on the southbound shoulder. All riders were wearing bicycle helmets and had rearward-facing lights and/or reflectors. The biking order was estimated from NTSB and police interviews and shown in figure 3. Three of the riders' positions were unknown. Although the exact formations (single file or two abreast) are unknown, the figure shows a two-abreast configuration with a slight offset to depict the biking order while maintaining readability and spacing.

Figure 3. Estimated biking order and injury summary.

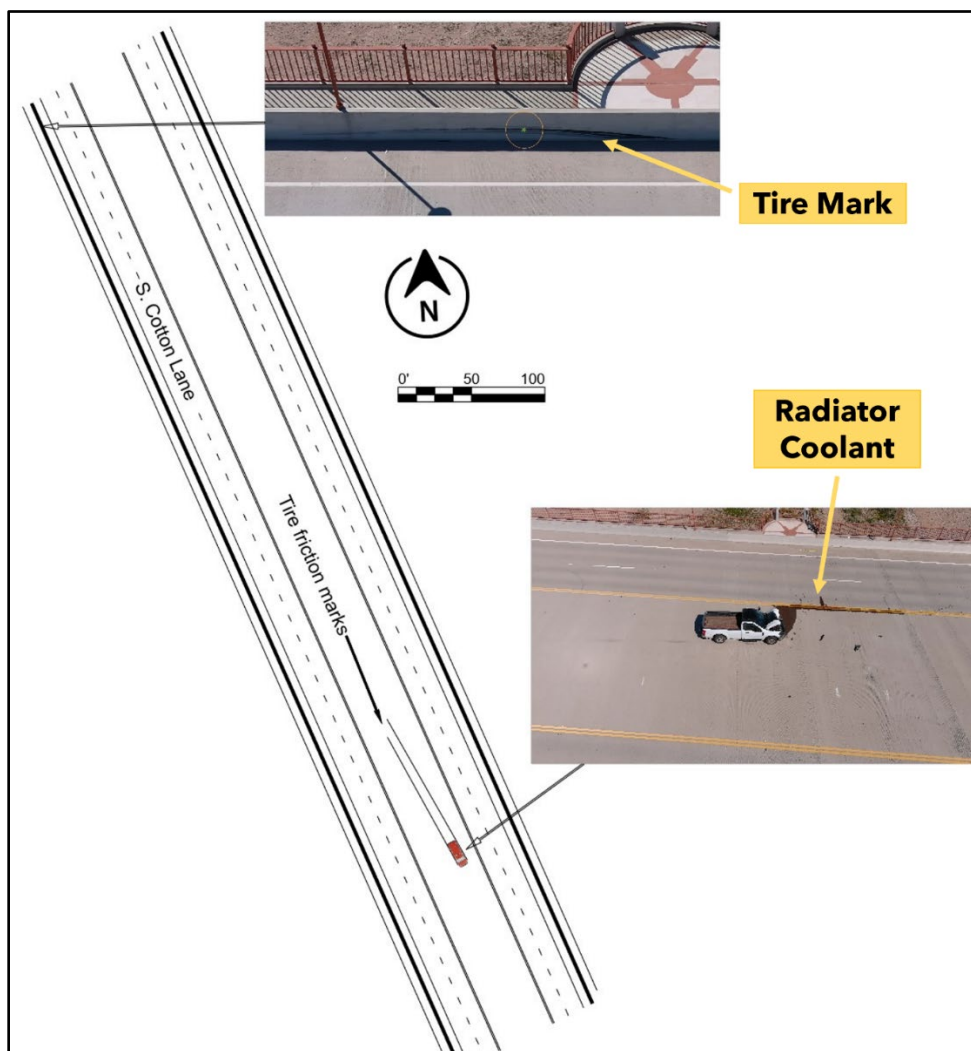
About 7:55 a.m., the pickup was traveling south on Cotton Lane Bridge when it departed the left lane and crossed the right southbound lane and the shoulder before striking the southbound bridge barrier, leaving a 33-foot-long tire friction mark on the concrete barrier. The pickup then struck a bicyclist about 3 feet after the last tire mark on the barrier. The pickup veered left, struck additional bicyclists, crossed over both southbound travel lanes, and stopped in the median of the roadway. Two bicyclists were not struck and were uninjured. Two additional tire-friction marks—about 99 and 110 feet long—terminated at the right front and left front of the pickup. Bicycle component debris coupled with surface scrapes and narrow rubber smears were found between the tire mark on the concrete barrier and the final rest position of the pickup—a distance of about 597 feet (see figure 4). After the tire marks on the barrier, no tire marks or evidence of skidding were found on-scene until the onset of the tire friction marks leading up to the final rest position of the pickup.

Figure 4. Scaled diagram of crash scene. (Source: Goodyear Police Department; annotated by NTSB)

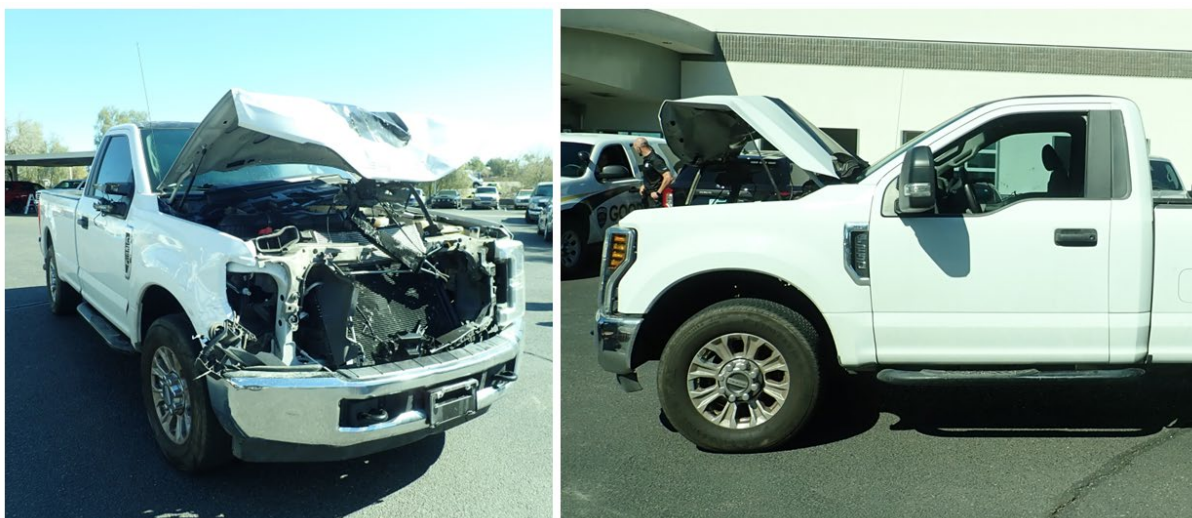
The pickup sustained damage to the front above the bumper and into the radiator and right-front headlamp, as shown in figure 5. The undercarriage showed no significant frame damage. Evidence found on the muffler, bottom of the gas tank, right-rear shock, and the spare tire mounted to the rear undercarriage was consistent with transfer from one or more victims as they contacted the bottom of the pickup's chassis. Also, light scrapes were noted along the front of the right-side step bar and scuff marks on the outer wall of the right-front tire.

Figure 5. Damage to the front of the Ford F-250.

Damage to the front of the pickup—specifically the location and shape of the front grille and hood deformation—was consistent with impact with one or more of the bicyclists. Evidence found on the muffler, bottom of the gas tank, right rear shock, and the spare tire was consistent with transfer from one or more victims as they contacted the bottom of the pickup’s chassis. Data from NHTSA showed that over 85% of bicyclist fatalities involving pickups were caused by impact from the front end (NHTSA 2024a). Compared with cars, pickup trucks and SUVs have a higher ride height, increased mass, and blunt front ends, making these vehicles particularly dangerous to pedestrians, bicyclists, and motorcyclists (Monfort and Mueller 2023). The front end of the crash-involved pickup had a blunt shape, as shown in figure 5, with a hood height of about 55 inches—higher than typical bicycle handlebars.
