National Transportation Safety Board

Safety Recommendation Report

Addressing Motorcoach Driver Seat Design to Prevent Separation in a Crash

Accident Number:	HWY16MH005
Location:	San Jose, California
Date:	January 19, 2016
Recommendation Number:	H-17-1
Adopted:	February 28, 2017

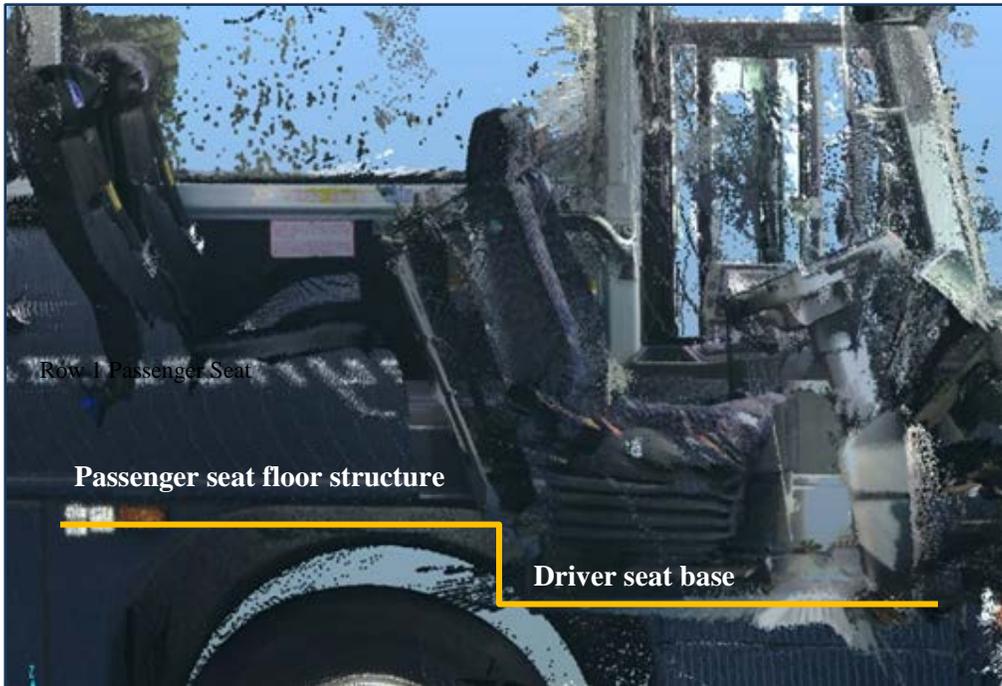
Figure 1. 3D laser scanner image showing view through right side of motorcoach, revealing theater-style seating positions of driver seat and first row of passenger seats, with driver seat base attached to lower section of floor.

Four bolts and nuts with flanges attached the base of the driver seat to the lower section of the floor structure. The back of the driver seat base was located about 3.5 inches from the front of the passenger seat floor structure. During the crash sequence, the driver seat detached from the floor but remained predominantly inside the bus. Broken portions of all four bolts were located after the crash and submitted to the NTSB materials laboratory. The metallurgical evaluation revealed that the bolts were in good condition; met design specifications; and failed in a manner consistent with tension overstress—that is, they fractured while being stretched.³

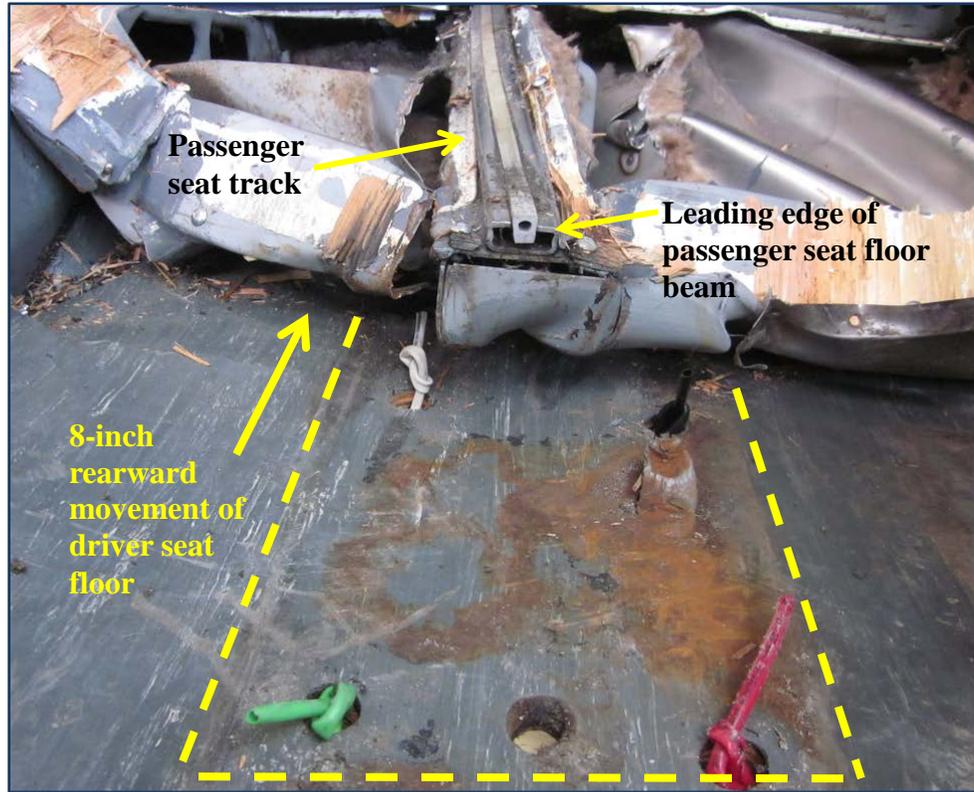
As a result of the collision with the concrete barrier, the bus sustained significant deformation to the front and right side. However, the postcrash examination of the driver seat floor structure on the left side showed little deformation. Rather, it was pushed about 8 inches rearward and under the forward edge of the passenger seat floor structure—including the floor beam and seat track for the first row of passenger seats—as shown in figure 2. The lap/shoulder belt-equipped passenger seats are attached to the passenger seat floor beam and seat track. These two structural

components had been redesigned to support the additional load of belted occupants in the event of a crash. Impact points documented on the passenger seat floor beam matched impact points on the driver seat base; and, postcrash, the two rear attachment points for the driver seat base were located rearward of the forward edge of the passenger seat floor beam.

Figure 2. Depiction of extent to which driver seat floor was pushed back and under passenger seat floor beam and seat track for first row of passenger seats, with (a) white, black, red, and green wires denoting each attachment point for driver seat base; (b) two rear attachment points (white and black wires) pushed rearward and under passenger seat floor beam; and (c) yellow dashed lines indicating area where driver seat base was attached.

As a result of the impact between the driver seat base and the passenger seat floor structure, the seat base rotated upward and was displaced forward, resulting in the failure of the four attachment bolts and the complete separation of the driver's seat from the floor structure. As the bus rolled onto its right side, the lap-belted driver—in his seat—fell into the front boarding door area of the bus, with the seat straddling the boarding door. Figure 3 shows the location of the driver seat at final rest. Despite the complete seat separation and partial ejection of the driver, he sustained only minor injuries.

Although, in this crash, the driver seat separated completely—which clearly poses significant risk of injury and ejection—even less severe damage to the seat base could affect a driver’s ability to control the vehicle. Therefore, the NTSB recommends that MCI evaluate and, if appropriate, modify the driver and passenger floor structure design on new motorcoaches to prevent driver seat separation during crashes.

Evaluate and, if appropriate, modify the driver and passenger floor structure design on new motorcoaches to prevent driver seat separation during crashes. (H-17-1)

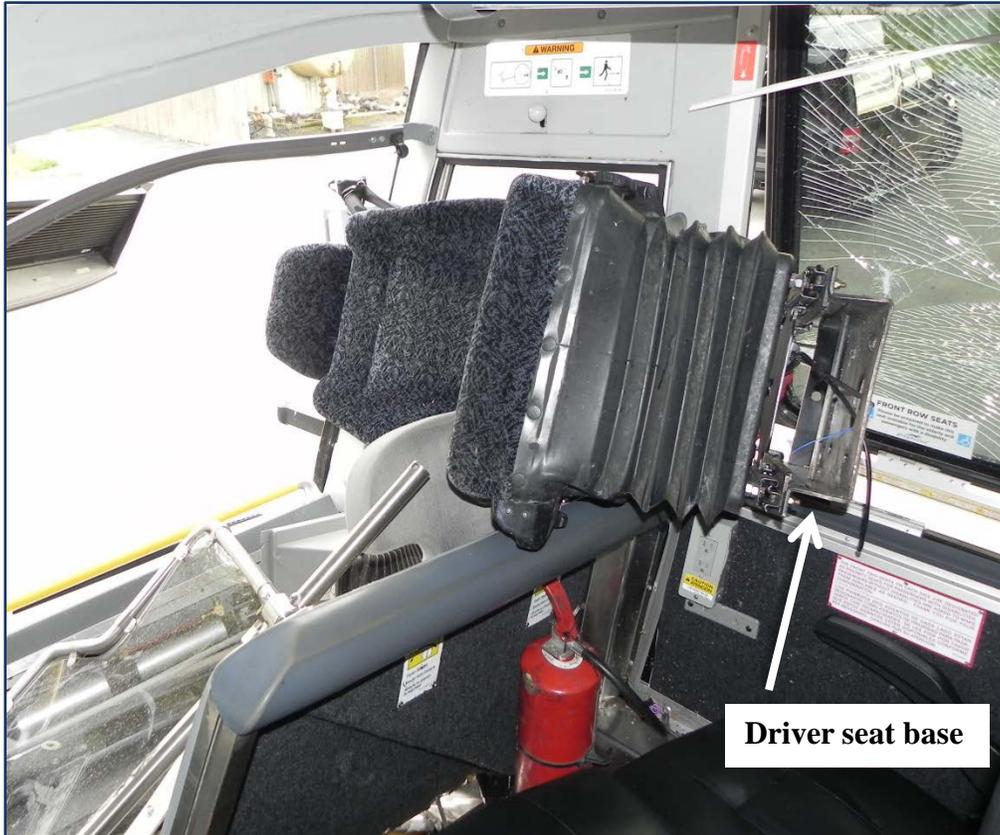
Figure 3. Location of driver seat postcrash, in front boarding door area of bus, with base still attached to seat bottom.
