PRELIMINARY REPORT

HIGHWAY

HWY14MH012

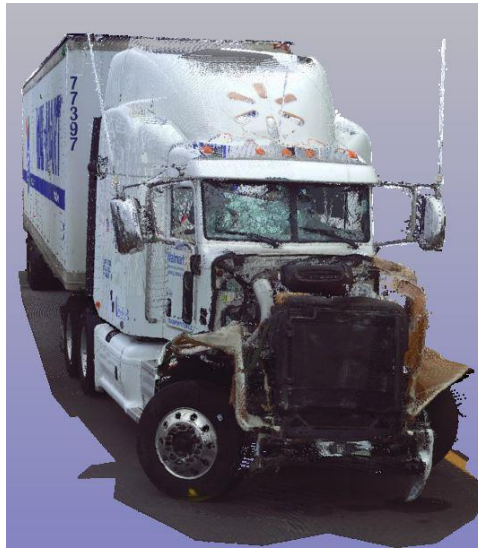
Figure 1. Three-dimensional scan of the Peterbilt combination vehicle involved in the June 7, 2014, crash in Cranbury, New Jersey.

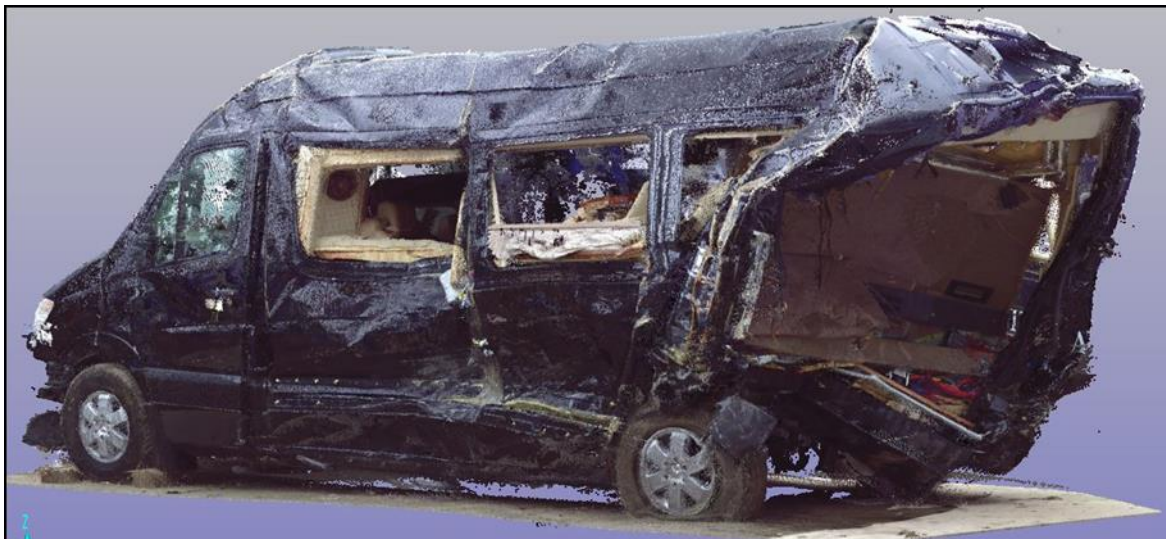
Figure 2. Three-dimensional scan of the Mercedes-Benz limo van involved in the June 7, 2014, crash in Cranbury, New Jersey.
