PRELIMINARY REPORT

HIGHWAY

HWY15MH004

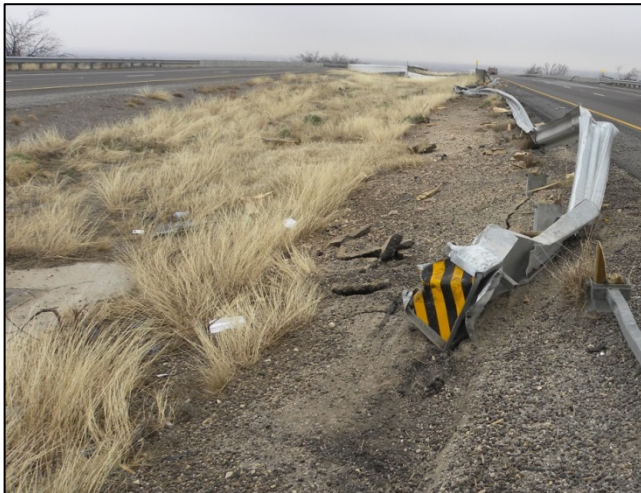
On the previous day, the 225-foot-long metal beam guardrail leading up to the overpass was damaged in a vehicle collision. The Texas Department of Transportation responded, photographed the damage and placed traffic cones in the area.

Figure 1. Prior damage to median guardrail from vehicle collision on January 13.
(Source: Texas Department of Transportation)

Early on the morning of January 14, three additional crashes, attributed to icy road conditions, occurred, with the last crash taking place about 7:35 a.m. In two of these crashes, an eastbound vehicle went out of control, crossed the center median, and traveled through the area of the previously damaged guardrail—possibly displacing it partially into the left traffic lane. A witness in a vehicle traveling forward of the bus reported that moments before the bus reached the overpass the guardrail wreckage was about 2 feet into the travel lane.

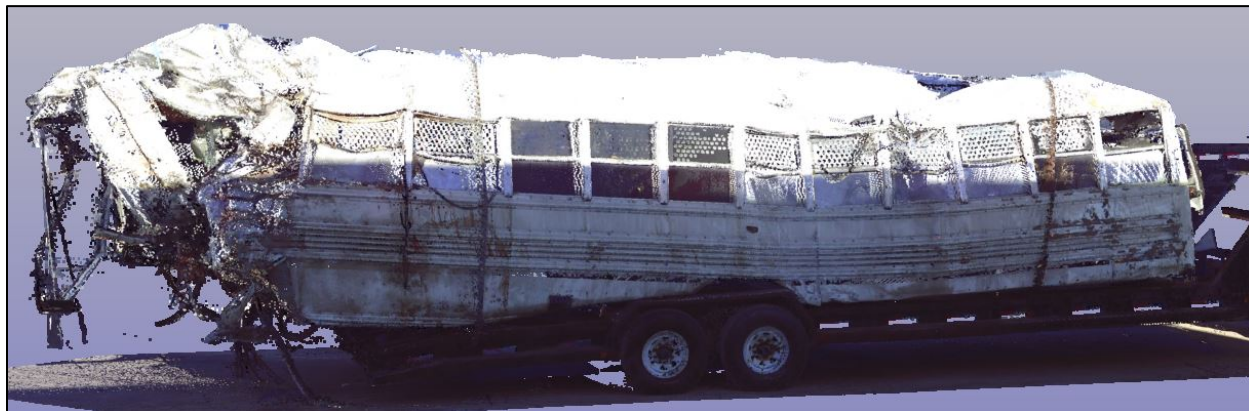
NTSB investigators documented the damage to the crash scene and the bus using three-dimensional (3D) laser scanning technology. A 3D scan of the left side of the bus is provided in figure 2 below.

Figure 2. Three-dimensional scan of the left side of the bus involved in the January 14 crash in Penwell, Texas.
