PRELIMINARY REPORT

HIGHWAY

HWY15MH011

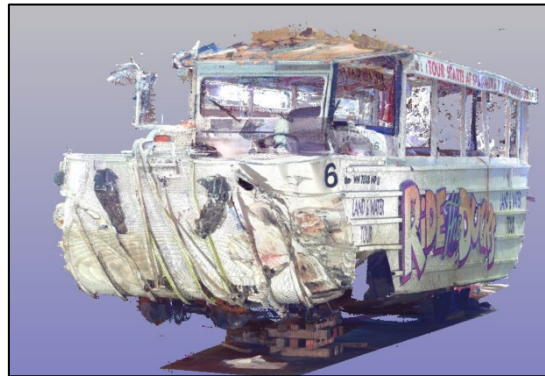
An axle housing modification described in an October 2013 notice issued by Ride The Ducks International, which refurbishes and modifies DUKW amphibious vehicles into passenger-carrying tour vehicles for commercial use, is being reviewed as part of the investigation. The stated purpose of the notice was to alert owners and provide guidance on a modification to strengthen the DUKW axle housing to prevent fractures. The left front axle assembly that failed on the accident vehicle had an earlier modification to the axle housing that

had been recommended by Ride The Ducks International but did not have an associated service bulletin.

Figure 1: Linked 3D laser scans depicting frontal damage on the accident DUKW vehicle.

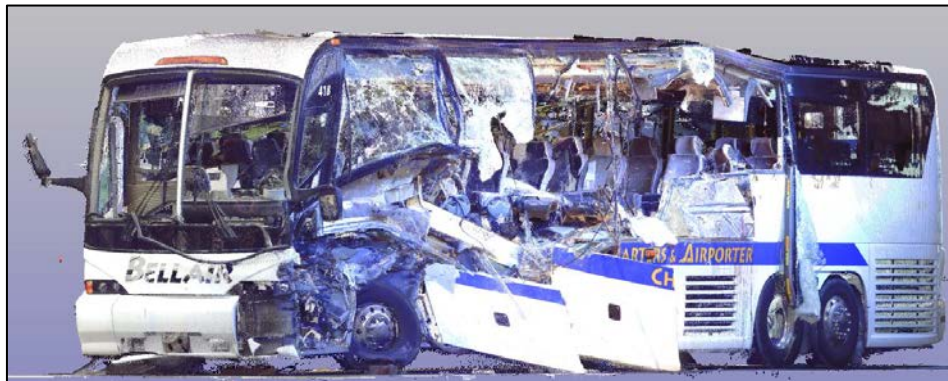
Figure 2: Linked 3D laser scans depicting the damaged left side of the motorcoach.
