# PRELIMINARY REPORT

## HIGHWAY

### HWY16MH005

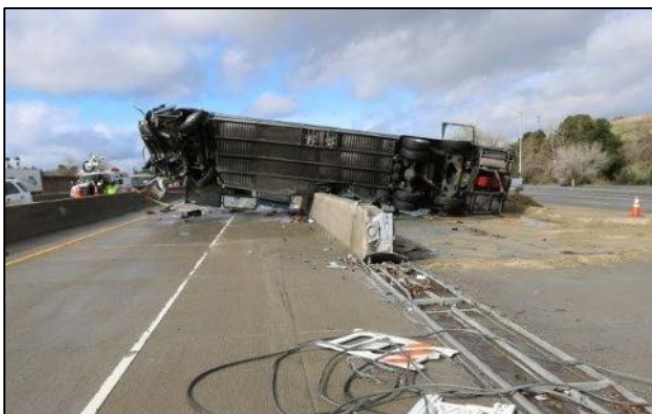
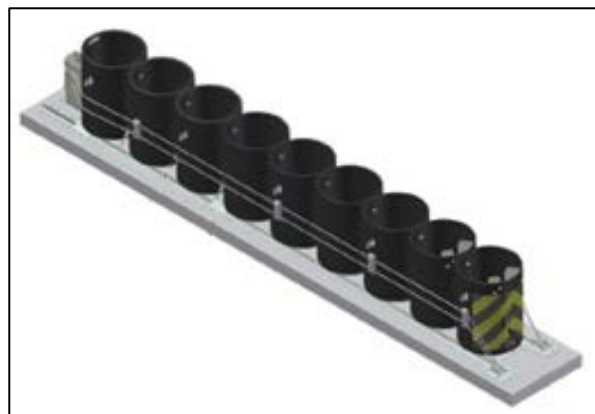
Rather than continuing with either the left HOV SR-85 exit lane or the US-101 mainline travel lanes, the bus traveled through the gore and collided with the crash attenuator. The bus then rode up on the concrete barrier, rotated counterclockwise, and rolled 90 degrees to the right. The bus came to rest on its right side on top of the concrete barrier, with the rear of the bus resting on the northbound US-101 travel lanes and the front of the bus hanging over the left HOV SR-85 exit lane. The bus traveled approximately 65 feet from the point of initial impact with the crash attenuator to its final rest position (see figure 1).

**Figure 1.** Final rest position of bus and remains of REACT 350 crash attenuator base (left); diagram of exemplar REACT 350 crash attenuator (right). Note: The retroreflective sheeting shown on the first barrel had been damaged and was not present at the time of the crash.

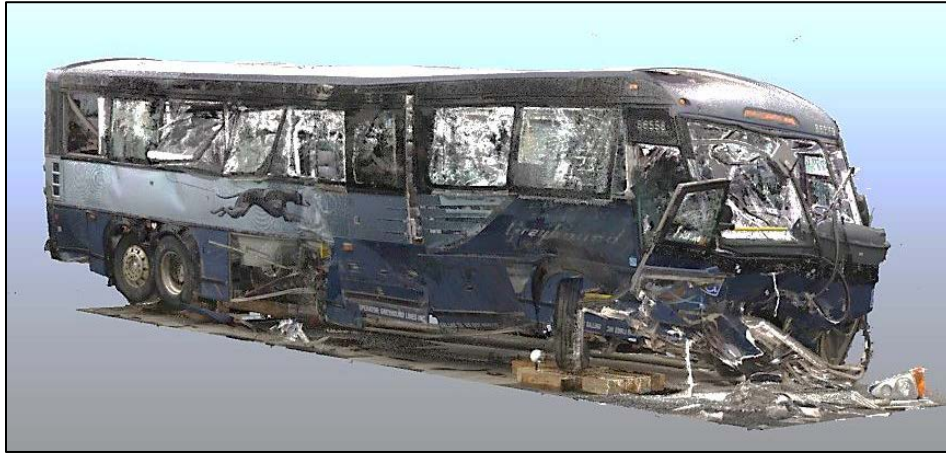
**Figure 2.** 3D scan image of damaged MCI motorcoach.

No mechanical defects were identified in the initial inspection of the bus. The driver's preliminary toxicology test results were negative for alcohol and illicit drugs. The bus was equipped with multiple systems capable of recording and transmitting event-related data, including inward- and outward-facing cameras and location tracking. NTSB investigators will continue to collect and analyze these data, including all pertinent information in the areas of human performance, survival, highway, vehicle, and motor carrier factors.
