# PRELIMINARY REPORT

## HIGHWAY

### HWY18FH011

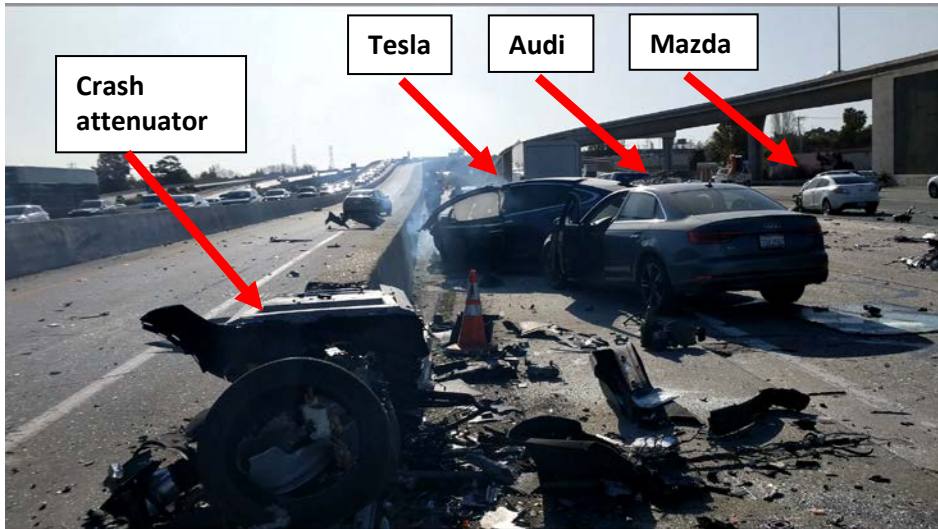
According to performance data downloaded from the vehicle, the driver was using the advanced driver assistance features traffic-aware cruise control and autosteer lane-keeping assistance, which Tesla refers to as “autopilot.” As the Tesla approached the paved gore area dividing the main travel lanes of US-101 from the SH-85 exit ramp, it moved to the left and entered the gore area.<sup>1</sup> The Tesla continued traveling through the gore area and struck a previously damaged crash attenuator at a speed of about 71 mph.<sup>2</sup> The crash attenuator was located at the end of a concrete median barrier. The speed limit on this area of roadway is 65 mph. Preliminary recorded data indicate that the traffic-aware cruise control speed was set to 75 mph at the time of the crash.<sup>3</sup> The impact rotated the Tesla counterclockwise and caused a separation of the front portion of the vehicle. The Tesla was involved in subsequent collisions with two other vehicles, a 2010 Mazda 3 and a 2017 Audi A4 (see figure 1).

**Figure 1.** Southbound view of US-101 depicting Tesla, Audi, and Mazda vehicles at final rest. (Source: S. Engleman)

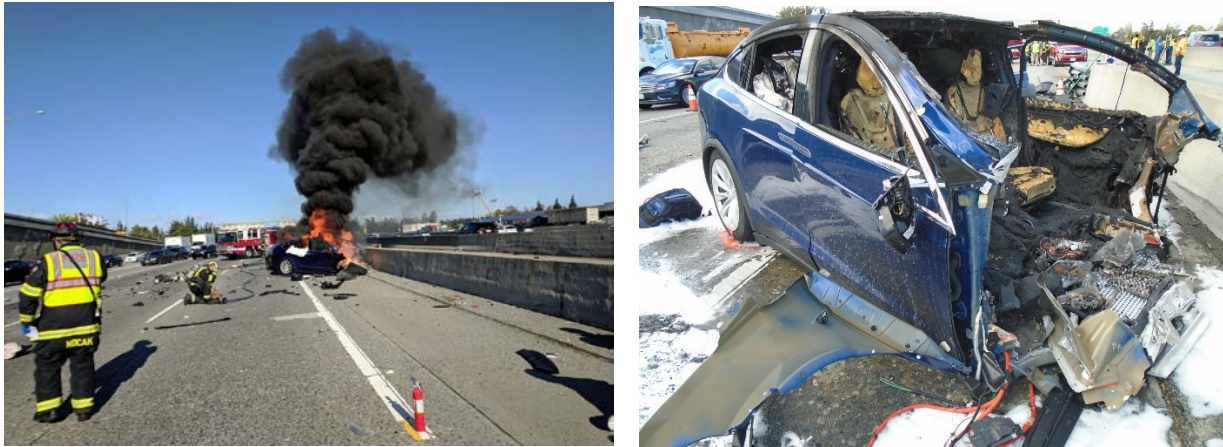
During the collision sequence, the Tesla's 400-volt lithium-ion high-voltage battery was breached, and a postcrash fire ensued (see figure 2). The driver was found belted in his seat. Bystanders removed him from the vehicle before it was engulfed in fire. The driver was transported to a local hospital, where he died from his injuries. The driver of the Mazda sustained minor injuries, and the driver of the Audi was uninjured.

**Figure 2.** Northbound view of US-101 depicting Tesla postcrash fire (left) and remains of Tesla after initial fire was extinguished (right). (Source: S. Engleman)

The Mountain View Fire Department applied approximately 200 gallons of water and foam during a period of fewer than 10 minutes to extinguish fires involving the vehicle interior and the exposed portion of the high-voltage battery. Technical experts from Tesla responded to the scene to assist in assessing high-voltage hazards and fire safety. After being allowed to cool, the vehicle was transported with a fire engine escort to an impound lot in San Mateo. The highway was reopened at 3:09 p.m.

Around 4:30 p.m. that afternoon, at the impound lot, the Tesla battery emanated smoke and audible venting. The battery was monitored with a thermal imaging camera, but no active fire operations were conducted. On March 28, 5 days after the crash, the battery reignited. The San Mateo Fire Department responded and extinguished the fire.

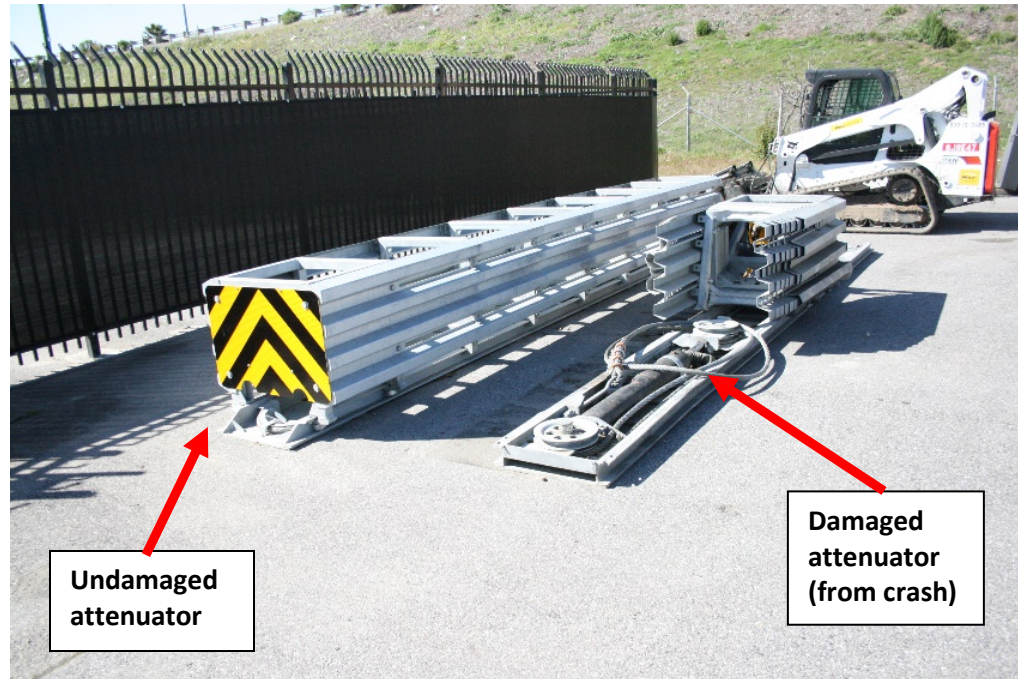
The crash attenuator was an SCI smart cushion attenuator system, which was previously damaged on March 12, 2018, in a single-vehicle crash involving a 2010 Toyota Prius (see figure 3).

**Figure 3.** Undamaged attenuator (left) next to crash-damaged attenuator (right).
