PRELIMINARY REPORT HIGHWAY

Construction Zone Multivehicle Collision HWY18FH015

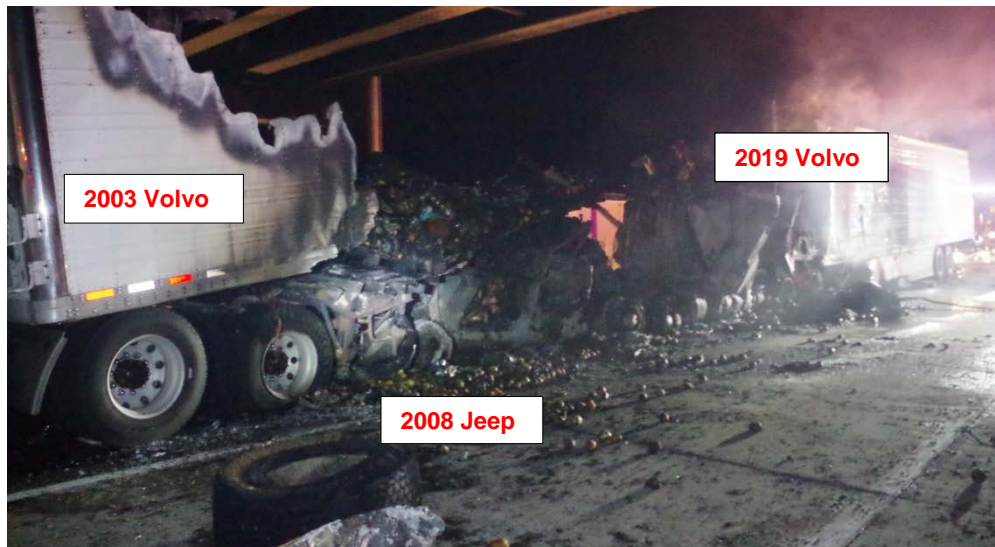
On I-84 east, a traffic queue had formed in the second to the right lane. A 2008 Jeep Wrangler was located at the end of the queue. Meanwhile a 2019 Volvo truck-tractor in combination with a 2015 Great Dane refrigerated semitrailer was approaching the end of the traffic queue from the west. The driver did not react to the stopped traffic in the queue and collided with the rear of the Jeep. As both vehicles moved forward, the Jeep was pushed into the rear of a 2003 Volvo truck-tractor in combination with a 2008 Great Dane refrigerated semitrailer, which was stopped in front of the Jeep. Figure 1 shows the final rest positions of the two combination vehicles and the Jeep.

Figure 1: Vehicles at final rest under Cloverdale overpass (Idaho State Police).

A postcrash fire consumed the Jeep and the 2003 and 2019 Volvo combination vehicles. The fire also damaged other vehicles and the Cloverdale overpass. The driver and two passengers in the Jeep and the driver of the 2019 Volvo died, while the driver and passenger of the 2006 Ford Fusion and the driver of the 2014 Ford F150 were injured. The occupants of the other involved vehicles were uninjured.
