INVESTIGATIVE UPDATE

Collapse of Pedestrian Bridge Under Construction Miami, Florida (HWY18MH009)

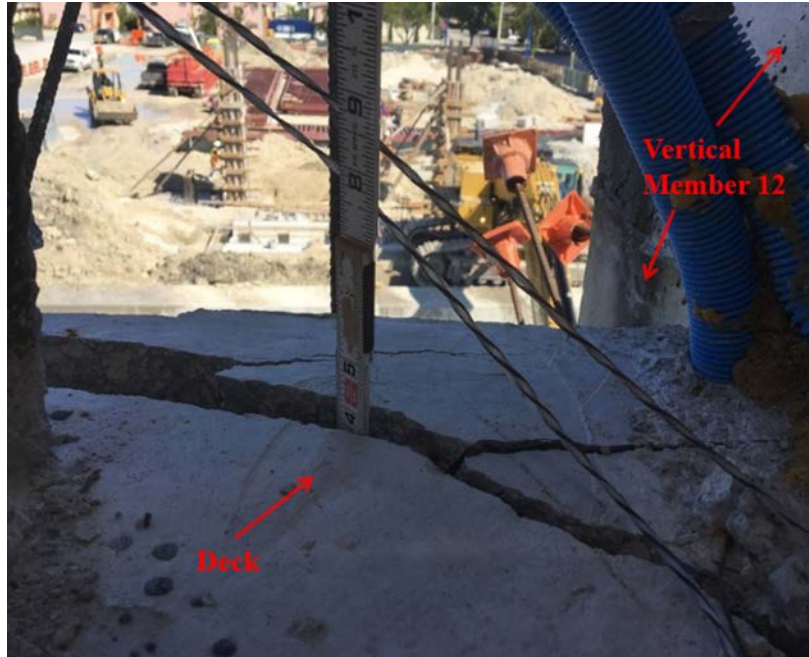
Figure 1. Location: Diaphragm II, west side directly adjacent to vertical member 12, top deck view of crack, looking to the north. Time stamp: March 13, 2018, at 11:16:50 a.m., labels added by the NTSB. (Source: Munilla Construction Management)

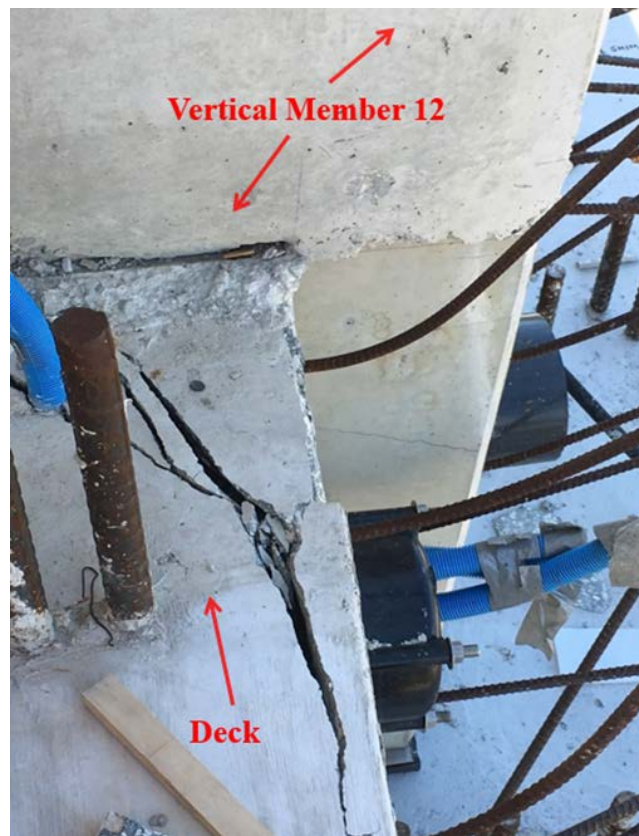
Figure 2. Location: Diaphragm II, east side directly adjacent to vertical member 12, top of deck looking down view of crack. Time stamp: March 14, 2018, at 1:50 p.m., labels added by the NTSB. (Source: Bolton, Perez & Associates Consulting Engineers)

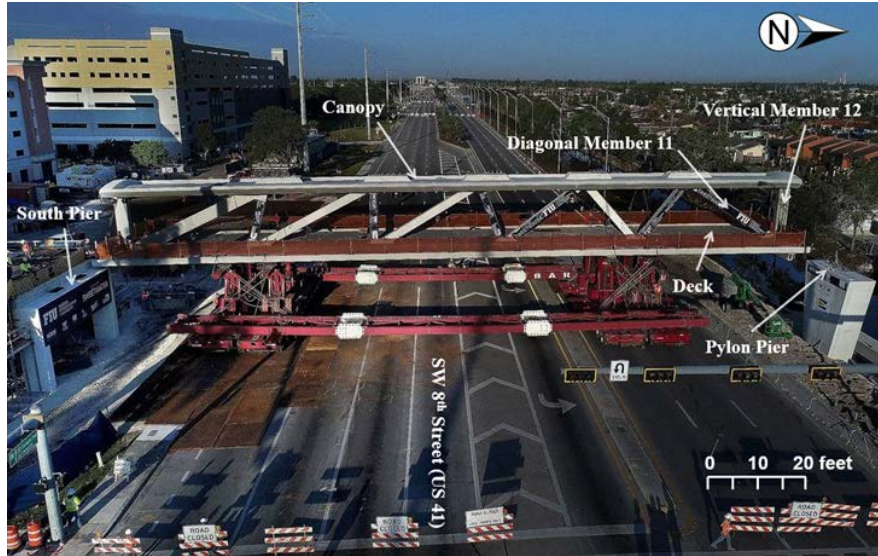
Figure 5. Main span being moved on March 10, 2018, prior to placement on the south pier and north pylon pier, looking to the west, labels added by the NTSB. (Source: Internet)
