PRELIMINARY REPORT HIGHWAY HWY19MH001

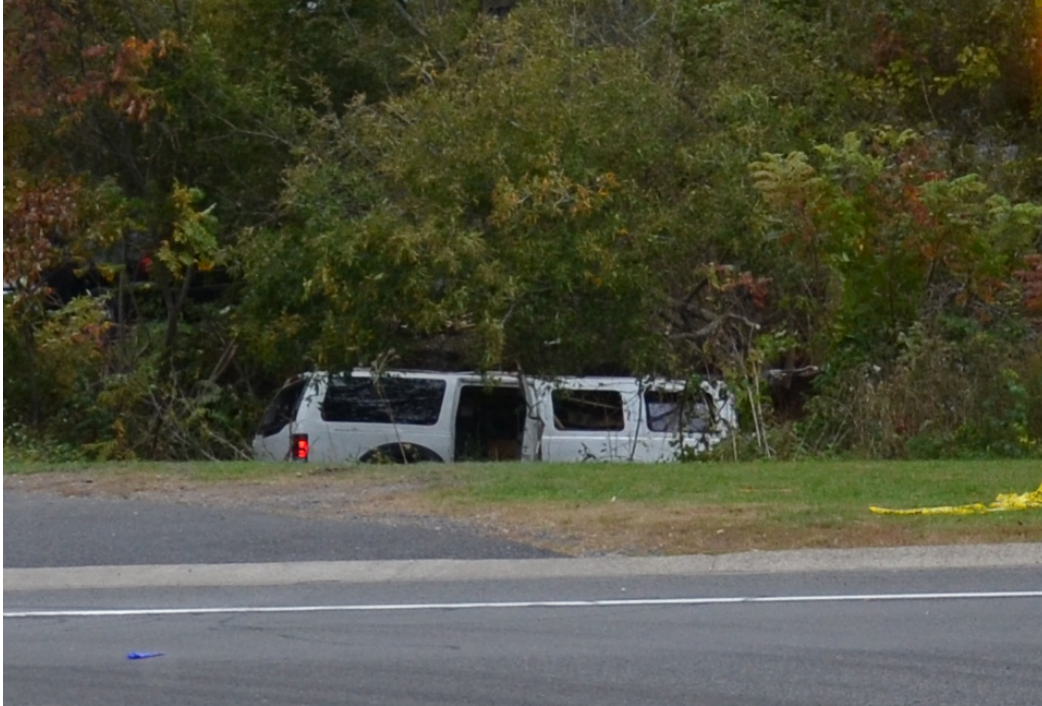
Figure 2. Crash-involved 2001 Ford Excursion stretch limousine at final rest in the ravine. (Source: New York State Police)

The original 137-inch-long wheelbase for the 2001 Ford Excursion had been lengthened by 180 inches to increase the seating capacity to 18 occupants (including the driver). To accommodate the additional passenger capacity, non-OEM (original equipment manufacturer) seats were installed in the vehicle. These non-OEM seats were equipped with lap belts and oriented passengers away from a traditional forward-facing seating configuration. Additionally, the vehicle's increased passenger capacity required the passenger-carrying operations of the limousine to be regulated by the New York State Department of Transportation. The National Transportation Safety Board (NTSB) continues to gather information on the modifications and mechanical condition of the vehicle, the seat belt usage and survivability of the passengers, and the oversight of the passenger-carrying operation by the New York State Department of Transportation and New York State Department of Motor Vehicles.
