National Transportation Safety Board

Hazardous Materials Accident Brief

Accident No: DCA99MZ006
Location: Whitehall, Michigan
Date of Accident: June 4, 1999
Time: 3:50 a.m. eastern standard time
Carrier: Quality Carriers, Inc.
Vehicles: MC-307 Cargo Tank
Injured: 1 fatality and 1 injury
Evacuated: 11 people from the plant
Property Damage: In excess of \$411,000
Materials Involved: Sodium hydrosulfide solution reacting with ferrous sulfate solution
Type of Accident: Chemical reaction during cargo transfer

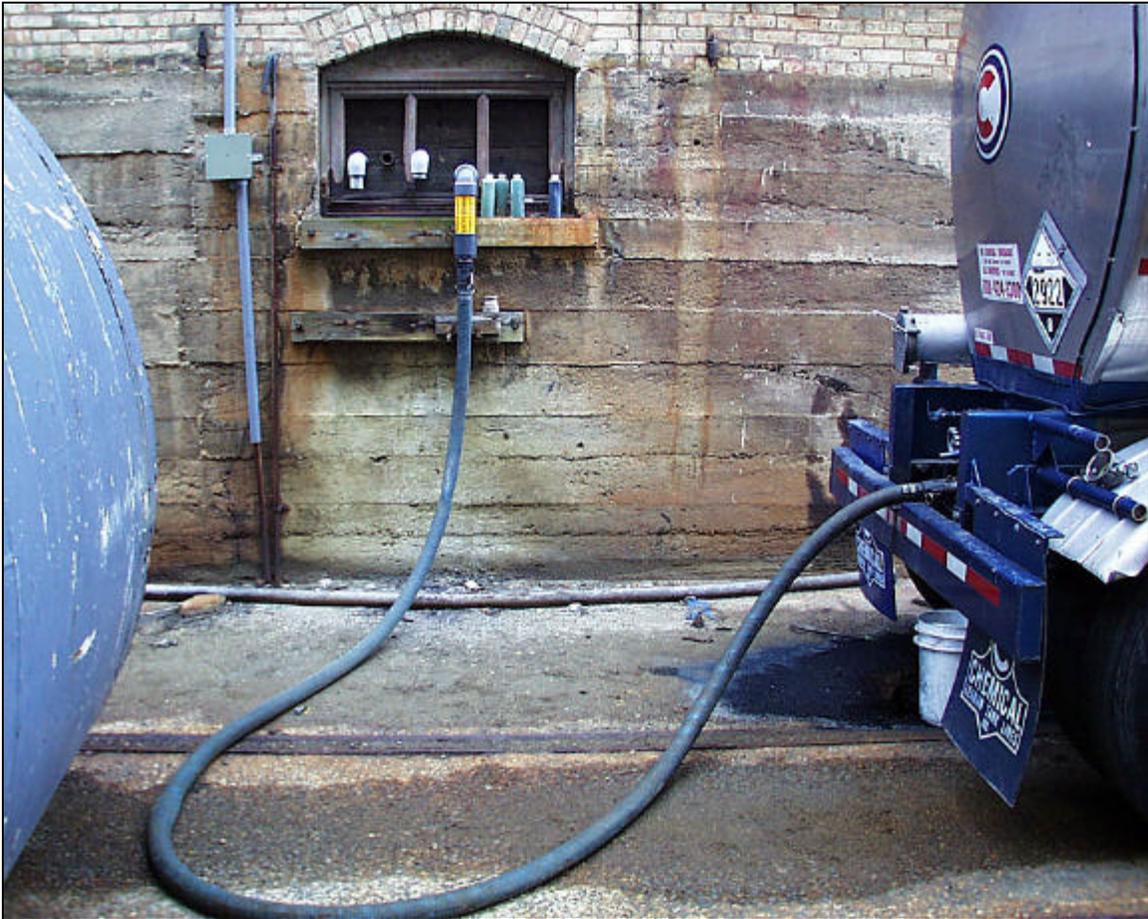
The shift supervisor showed the driver the ferrous sulfate connection (the only working transfer connection at that location) so he could deliver his product. (See figure 1.) The shift supervisor then unlocked a gate to allow the driver to bring his vehicle onto the plant property. The driver asked the supervisor to sign the shipping documents so he would not have to find the supervisor after the transfer was completed. According to the supervisor, he signed the paperwork without reading it and left the area. The signature block that the supervisor signed stated the following: “I have checked the documents for this shipment and verify that there is adequate storage room to receive this shipment and connection has been made to the proper storage facility.”

Figure 1. Postaccident view of the cargo tank (right) with transfer hose attached to the ferrous sulfate transfer coupler. The two pipes seen at the left of the ferrous sulfate coupling are no longer used and do not have couplers attached.

No plant employees were in the vicinity of the transfer area. When the driver arrived at the transfer area, a transfer hose was already connected to a pipe, marked “FERROUS SULFATE,” on the side of the transfer building. During the postaccident investigation, investigators found the other end of the transfer hose connected to the cargo tank and determined that sodium hydrosulfide solution had been transferred from the

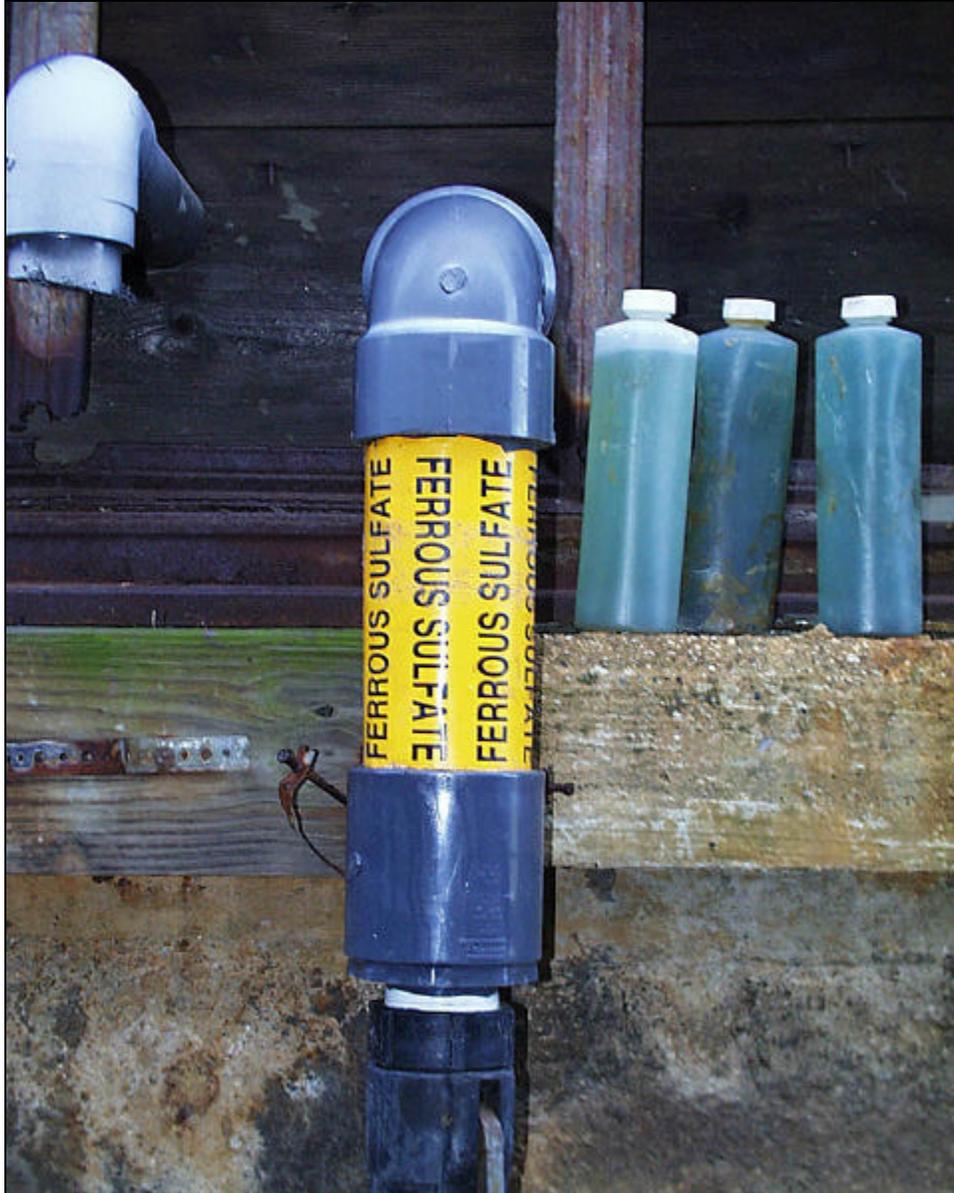
cargo tank into the storage tank containing ferrous sulfate. (See figure 2.) (Sodium hydrosulfide solution reacts with ferrous sulfate solution to produce hydrogen sulfide, a poisonous gas.)

Figure 2. Close-up view of ferrous sulfate transfer coupler

The ferrous sulfate transfer area was on the northeast side of the tannery facility. (See figure 3.) The connection was not equipped with a lock or any other safety or protective device.

In addition to establishing the new procedures, the company has placed barrier gates at the entrances to all three bulk chemical unloading areas, placed locks on all access doors and transfer couplers, and installed an emergency remote alarm button at each transfer location.

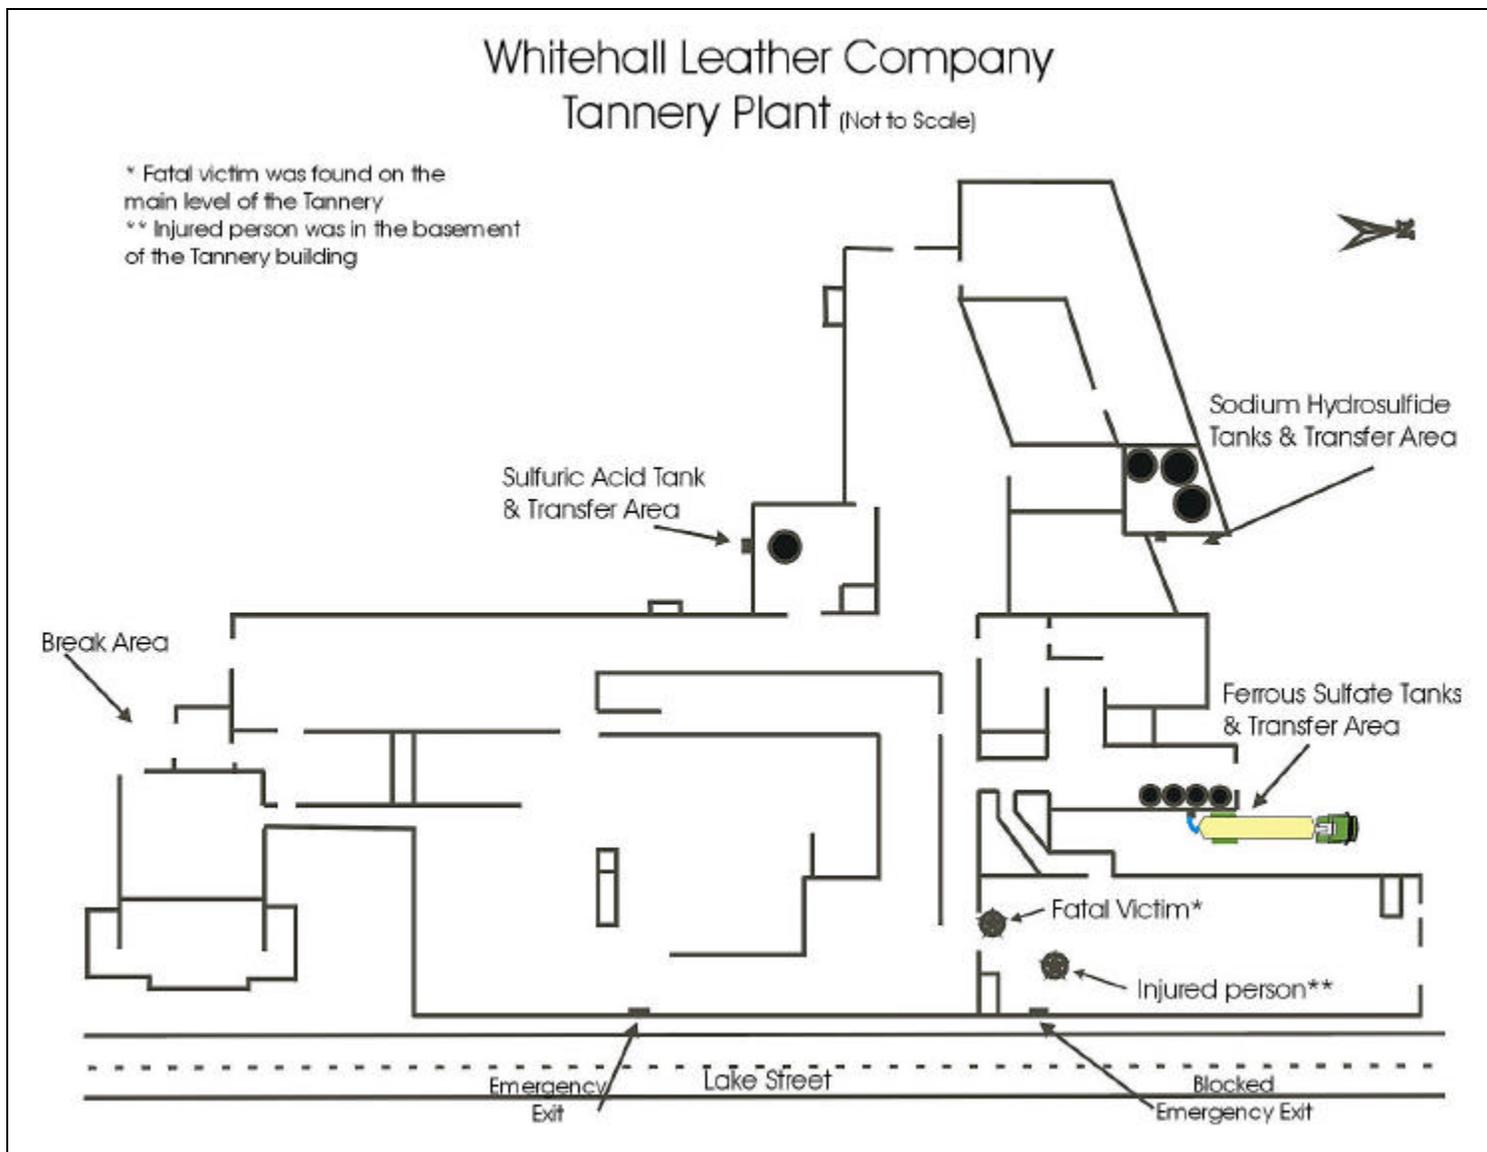
Figure 3. Whitehall tannery layout indicating the locations of the sodium hydrosulfide and ferrous sulfate transfer areas and the location of the cargo tank at the time of the accident
