National Transportation Safety Board
Washington, D.C. 20594

Hazardous Materials Accident Brief

Accident No.: DCA-09-FZ-001
Transportation Mode: Highway
Location: Upper Pittsgrove Township, New Jersey
Date: July 1, 2009
Time: 1:46 a.m., eastern daylight time¹
Carrier: Ross Fogg Gas Company
Shipper: Ross Fogg Fuel Oil Company
Vehicles: 2002 Kenworth tractor; 1989 Fruehauf MC-306 cargo tank semitrailer
2002 Mitsubishi Diamante
Fatalities: 1
Injuries: None
Property Damage: About \$27,000
Materials Involved: Gasoline, a flammable liquid
Type of Accident: Vehicle collision and fire

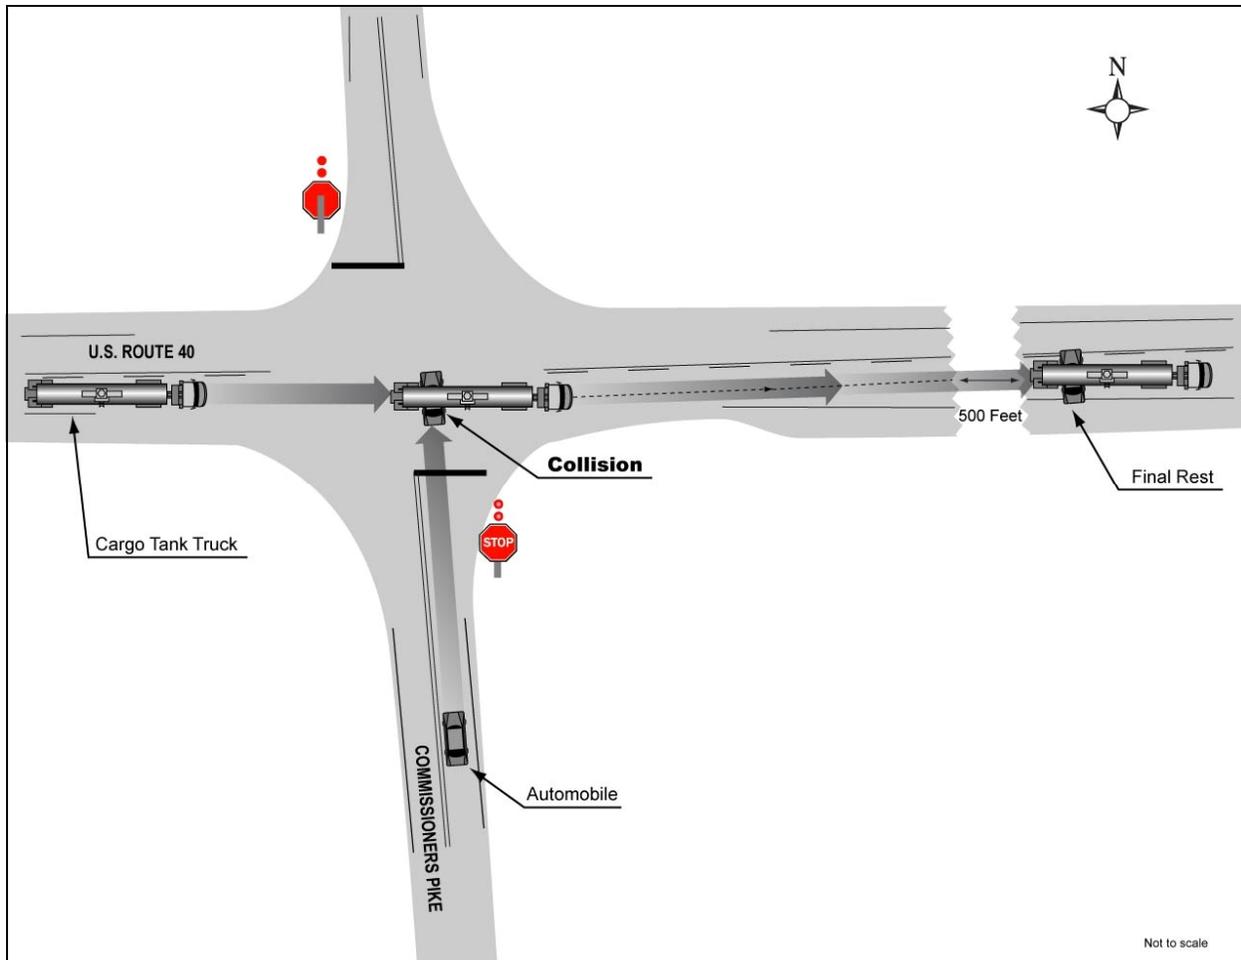
On July 1, 2009, about 1:46 a.m., a 2002 Kenworth tractor pulling a 1989 Fruehauf MC-306 cargo tank semitrailer (the cargo tank truck) was traveling eastbound on U.S. Route 40 in Upper Pittsgrove Township, New Jersey, when it was struck by a 2002 Mitsubishi Diamante (the automobile) traveling northbound on Commissioners Pike. The automobile driver failed to obey a stop sign equipped with flashing red lights and collided with the external loading lines² on the passenger side of the cargo tank truck. Loading line 4 was ruptured and about 13 gallons of gasoline were released as the automobile became wedged beneath the cargo tank truck and was dragged about 500 feet. (See figure 1.) A postcrash fire consumed the automobile, killing the driver; the cargo tank truck also was damaged. The Daretown Volunteer Fire Department arrived within 15 minutes and extinguished the fire. Property damage was about \$27,000.

Figure 1. Schematic of accident scene.

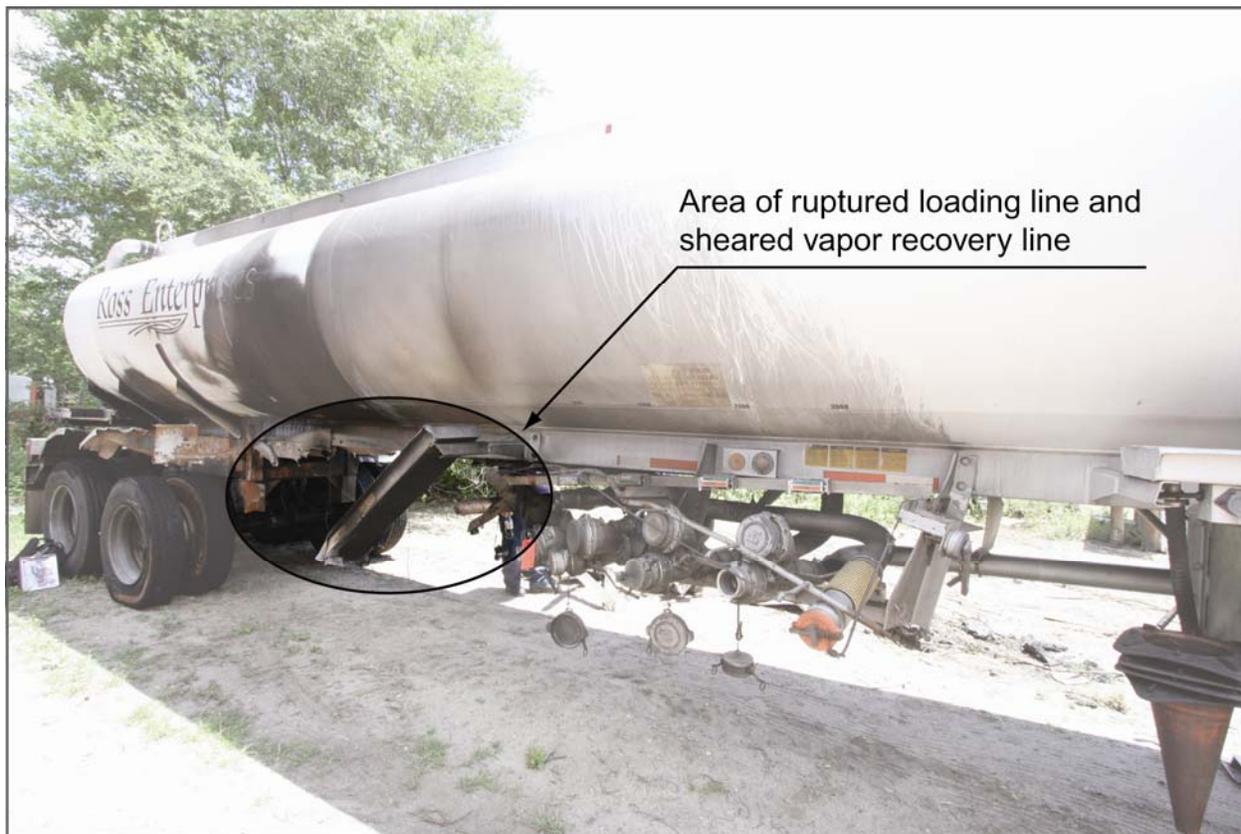
Various components external to the cargo tank, including the aluminum fenders, hose shelf, storage containers, and tires on the rear passenger side were destroyed as a result of the impact and fire. Additionally, the loading rack on the passenger side at the bottom center of the tank was twisted and bent. The rear section of the rack nearest to loading line 4 was pushed inward and shifted forward, and the aluminum angle mount connecting the rack to the tank was sheared off the tank at this point. Loading lines 1, 2, and 3 were not visibly damaged as a result of the impact, and each of these lines remained connected to the tank. However, lines 1 and 3 had separated from the couplings, just behind the loading rack, as a result of the rack's shifting.

Loading line 4 and the vapor recovery line were destroyed as a result of both the impact and fire. The impact of the collision ruptured loading line 4 and also sheared the rear vapor recovery line and valve from the loading rack. (See figure 2.) As a result, the estimated

13 gallons of gasoline contained inside loading line 4 were released onto the automobile below. The gasoline was ignited, most likely by an unknown ignition source from the automobile, and a fire engulfed the automobile, loading line 4, and the vapor recovery line. The self-closing stop valve on the fourth compartment of the cargo tank functioned properly, and the 2,999 gallons of fuel contained in the compartment prior to the accident were safely offloaded after the fire was extinguished. Consequently, the release of gasoline and the subsequent fire likely would not have occurred if the cargo tank's loading lines had been empty.

Figure 2. Rear passenger side of accident cargo tank truck showing external damage from collision and fire.

The NTSB remains concerned about this safety issue. This accident illustrates once again why the NTSB strongly believes that PHMSA should prohibit the unsafe practice of transporting flammable materials in the external loading lines of cargo tanks.

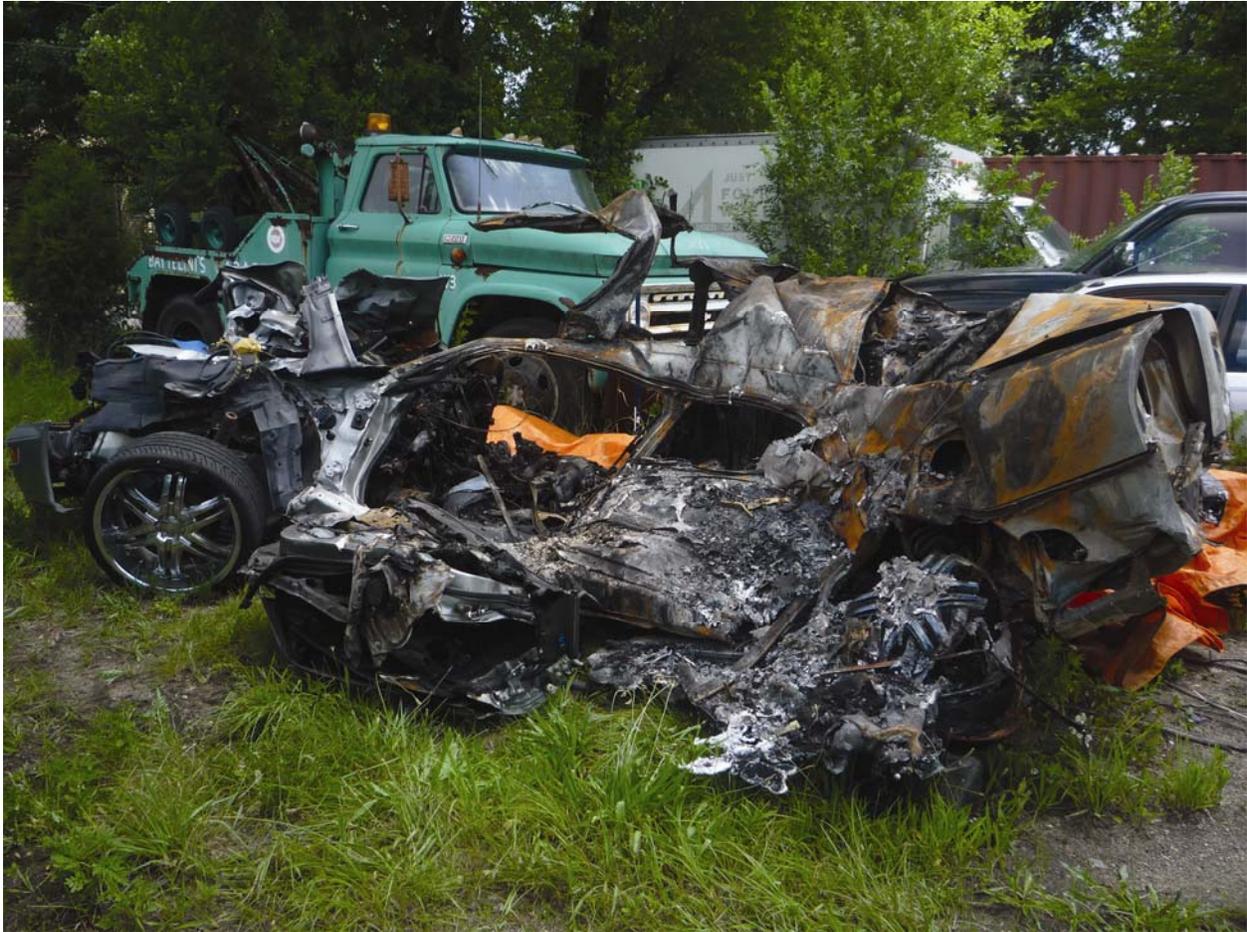
The automobile was destroyed by the impact and fire. (See figure 3.) Postaccident examination revealed that the most severe fire damage was concentrated toward the rear of the automobile. With the exception of some foam from the passenger seat behind the driver, all of the combustibles in the back seat area were consumed. Large portions of foam from the driver seat and the adjacent passenger seat remained. Heavy char was present on all of the remaining combustible materials.

Figure 3. Left side view of automobile showing damage from collision and fire.

Several samples were collected from the remaining combustible materials³ and sent to the Bureau of Alcohol, Tobacco, Firearms and Explosives (ATF) to determine whether petroleum products were present. ATF positively identified gasoline in a sample taken from the rear seat cushion, confirming that gasoline entered the automobile.
