NATIONAL TRANSPORTATION SAFETY BOARD

SPECIAL INVESTIGATION REPORT

**PHOSPHORUS TRICHLORIDE RELEASE
IN BOSTON AND MAINE YARD 8
DURING SWITCHING OPERATIONS
SOMERVILLE, MASSACHUSETTS
APRIL 3, 1980**

NTSB-HZM-81-1

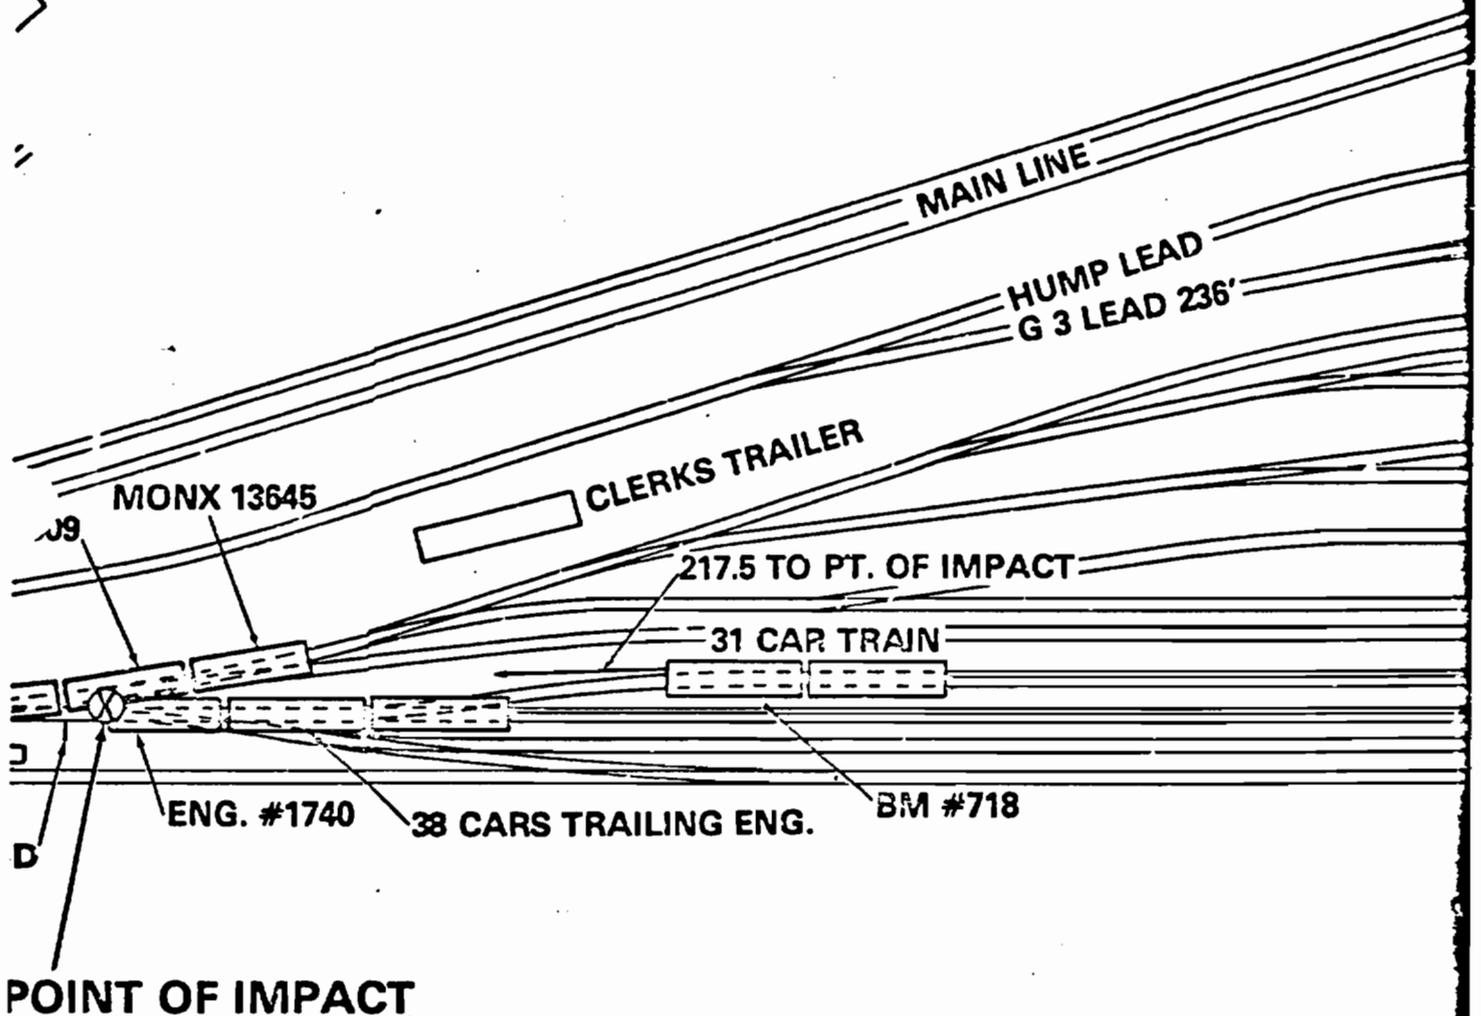
URE 1.--ACCIDENT SCENE

About 9 a.m., e.s.t., April 3, 1980, a Boston and Maine Corporation (BM) Boston switcher (1740) consisting of a locomotive and 38 cars collided, while moving at a speed of 4 mph, with a standing draft of cars in Somerville Yard 8 at Somerville, Massachusetts. (See figures 1 and 2.) The locomotive struck and punctured tank car TLDX 113009, the second car of the standing draft; the tank car contained about 13,000 gallons of phosphorus trichloride (PCl₃), a hazardous material classified by DOT as a corrosive liquid. The product spilled onto the moist ground and created a cloud, which ultimately necessitated an evacuation of a 1 1/2 square mile area containing 23,000 people. During the first 48 hours of the emergency, 418 persons were treated at the Somerville hospital. Damage to train equipment amounted to \$8,100 and cleanup costs were reported to be \$130,253.

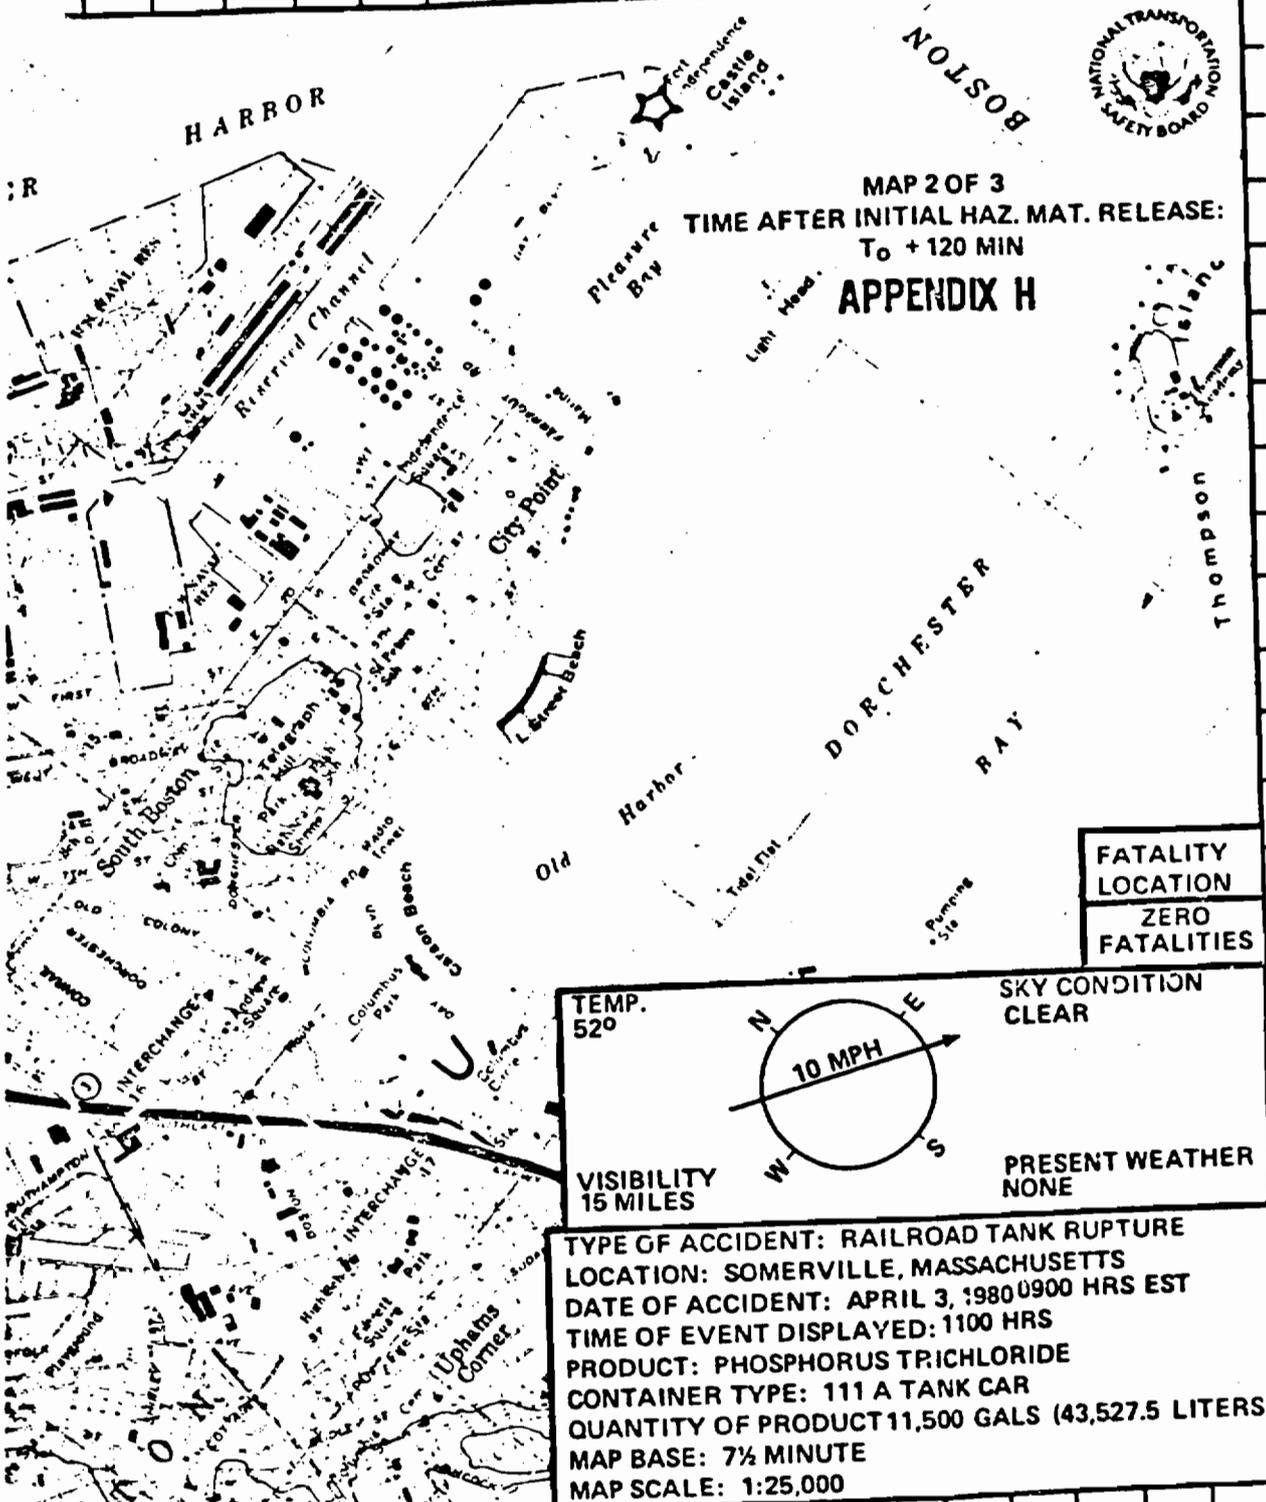
MAP 2 OF 3
TIME AFTER INITIAL HAZ. MAT. RELEASE:
T₀ + 120 MIN
APPENDIX H

FATALITY LOCATION
ZERO FATALITIES
