## HAZARDOUS MATERIALS ACCIDENT SUMMARY REPORT

FAILURE OF TANK CAR TEAX 3417 AND SUBSEQUENT  
RELEASE OF LIQUEFIED PETROLEUM GAS  
PASADENA, TEXAS, NOVEMBER 22, 1997

**NTSB/HZM-98/01/SUM  
PB98-917007**

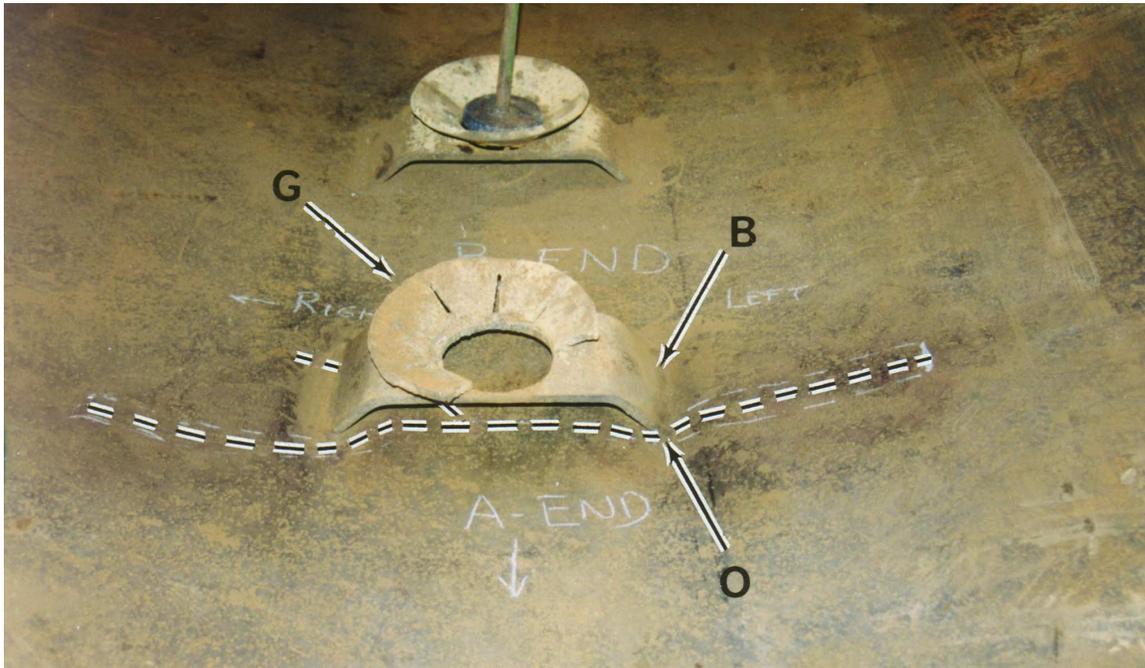
**Figure 2. Interior of tank car TEAX 3417**

directly below the eduction pipe. (See figure 2.) A smaller crack branched off from this crack at a location between the legs of the pipe guide bracket. From the exterior of the tank car wall, the two cracks appeared to be a single Y-shaped crack. (See figure 3.)

**(The A-end eduction pipe bracket *B* and guide *G* are in the foreground. The circumferential crack is indicated by the dotted line. The location of the crack origin is marked by the arrow *O*.)**

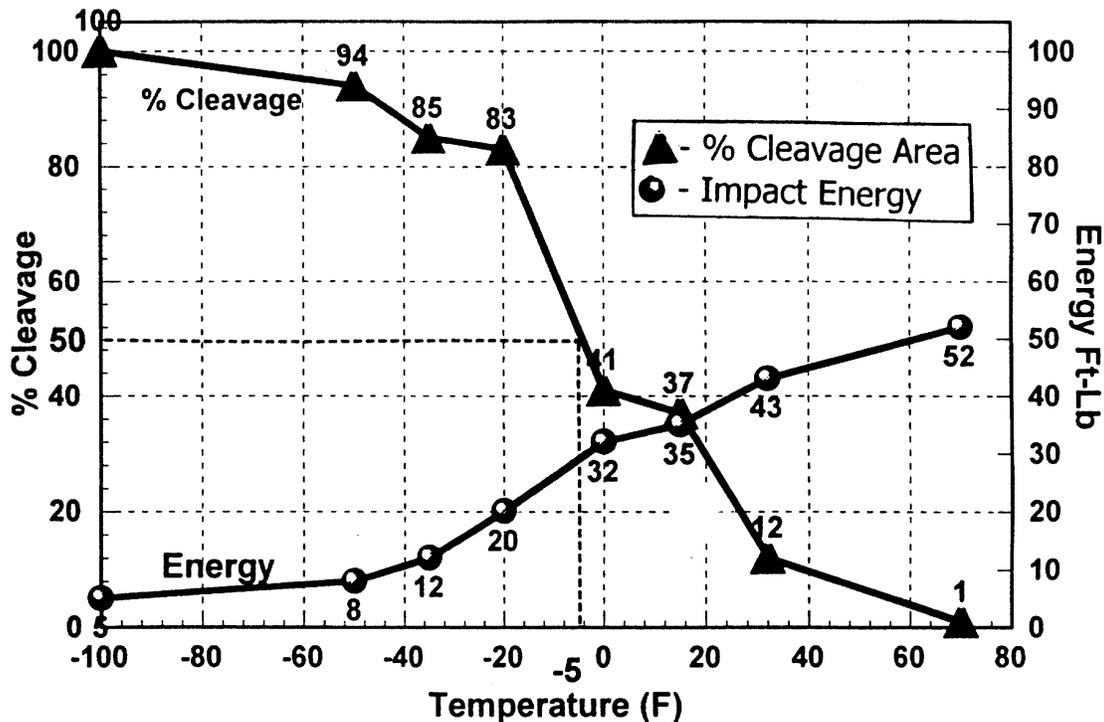
Figure 4. Percentage of fracture surface exhibiting brittle features versus test temperature for Charpy test specimens

The percentage of the fracture surface exhibiting brittle features from the Charpy test specimens was plotted versus the test temperature. (See figure 4.) From this plot and the industry-accepted definitions of transition temperature described in the appendix, the fracture appearance transition temperature (FATT) with 50-percent cleavage for the TC-128 steel from the tank car was about -5 °F, and the shear area transition temperature for the TC-128 steel was about 30 °F. The nil ductility temperature, the temperature at which the TC-128 steel exhibited no ductility (was completely brittle), was between -50 °F and -100 °F.
