National Transportation Safety Board
Washington, D.C. 20594

Marine Accident Brief No. DCA 99MM024

**Collision of Two Recreational Motorboats on the
St. Croix River near Bayport, MN
July 3, 1999**

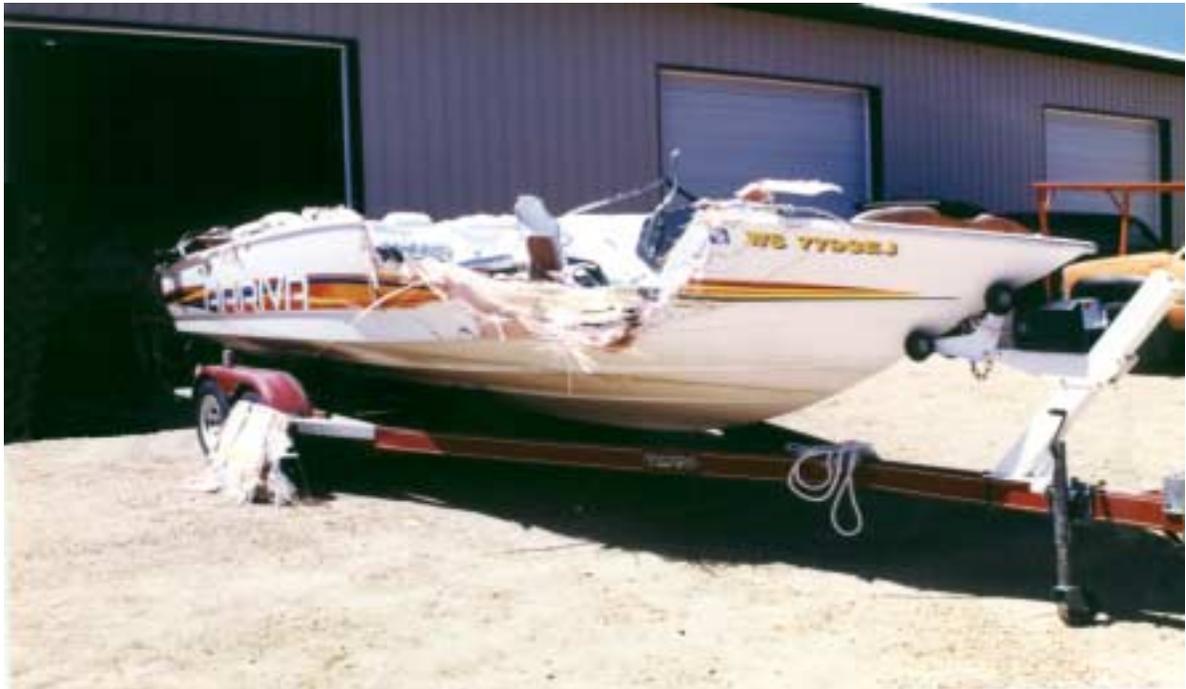
Figure 2. Bayliner, postaccident

The Safety Board investigator measured the angle of the damage path across the Bayliner at approximately 45° on the starboard bow. (See figure 2.) The fixed fiberglass deck over the cuddy cabin of the Bayliner was knocked off by collision. Minnesota Highway Patrol investigators conducted a laser survey of the Bayliner, which was used in a computer analysis to determine the angle of the damage path. The analysis showed that the Advantage's bow struck the Bayliner on its starboard side forward, and then passed over the motorboat on a path about 43° to 45° to that vessels centerline axis, and that the Advantage probably rotated to the left as it passed over the Bayliner. (See figure 3.)

When divers recovered the Advantage, its throttle was in the full speed position. The Advantage was capable of reaching speeds of 60 mph. The Bayliner's gearshift lever was in the forward position and the throttle was in the idle position. Also, the throttle cable at the engine was against the idle screw, which conforms to the setting of the throttle lever. However, the Bayliner's control console with the speed controls was severely damaged, and it was not possible to determine what, if any, effect the boat's operator or the collision impact had on the engine controls. The Bayliner's damage path is consistent with substantial forward movement, and the Safety Board calculated that, at impact, the Bayliner was traveling between 18 and 35 mph; the Advantage's estimated speed was 50-60 mph.⁶
