**Marine Accident Brief**

Vessel No. 1: Liberian Containership *Columbus Canada*, Lloyd's No.7800162,602.5 feet long, 92.1 feet wide, 32.8 foot draft, 24,080 gross tons, built in 1979

Vessel No. 2: U.S. Fishing Vessel *Black Sheep*, O.N. 1055544,81.7 feet long, 24.0 feet wide, 12.0 foot draft, 147 gross tons, built in 1997

Accident Type: Collision

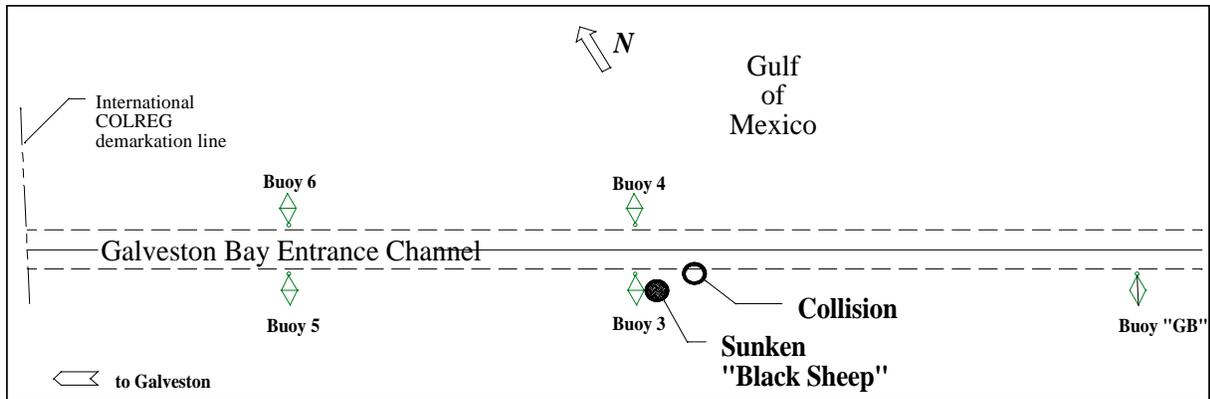
According to the master of the *Black Sheep*, when the *Columbus Canada* was about 1 1/2 miles away, he believed that there was a risk of collision. As the vessels converged, the master of the *Black Sheep* stated that the image of the on-coming radar contact appeared on the radar scope to be crossing into the *Black Sheep's* side of the channel. To avoid collision, he turned the *Black Sheep's* rudder hard to port and passed ahead of the bow of the on coming ship. However, at 2122, the *Columbus Canada* struck the starboard quarter of the *Black Sheep*. The location of the collision was on the outbound starboard edge of the channel, just past buoy no. 3. (See Figure 1.) At impact, the *Black Sheep's* hull was breached and immediately began to flood.

**Figure 1.** Sketch of Galveston Bay Entrance Channel Showing Location of Collision and Sunken Position of the *Black Sheep*.
