National Transportation Safety Board

Marine Accident Brief

Accident No.: DCA-05-MM-018

Vessel: Bahamas-flag passenger vessel *Norwegian Dawn*, IMO No. 9195169, 965 feet long, 105 feet wide, 92,250 gross tons, draft 27 feet, built in 2002

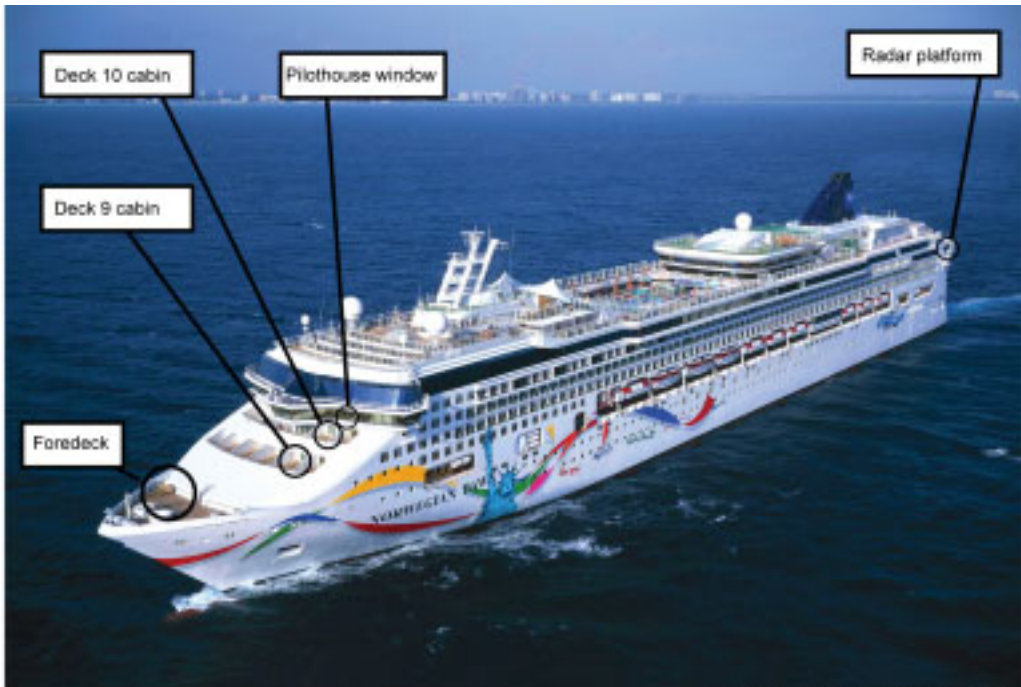
Damage Survey. The *Norwegian Dawn* arrived in Charleston at 1608 on April 16. The Coast Guard and Det Norske Veritas, the ship's classification society, boarded and inspected the vessel. In addition to the damage to the two cabins, the Det Norske Veritas survey showed damage to the deck supports under the spare anchor, on the starboard side of the bow.⁶ An outside firehose station on the forward superstructure was destroyed. One forward-facing window frame in the pilothouse was knocked out of alignment. The watertight door to the open bow area on the foredeck was also damaged. Sixty-three cabins on the forward parts of decks 9 and 10 were flooded with an inch of seawater that had spread from the two cabins with broken windows, requiring the carpets and associated fixtures to be replaced. Temporary repairs were made by welding steel plates over the damaged windows.

Figure 2. Circles in upper photo indicate damaged areas on *Norwegian Dawn*—from left to right, foredeck (crew hot tubs, deck supports under anchor, firehose support, watertight door), two cabins overlooking bow, pilothouse window frame, and stern navigation light platform. Lower left photo shows outside of damaged cabin before its window was broken by waves during heavy seas. Lower right photo shows missing rail supports on balcony of damaged cabin.

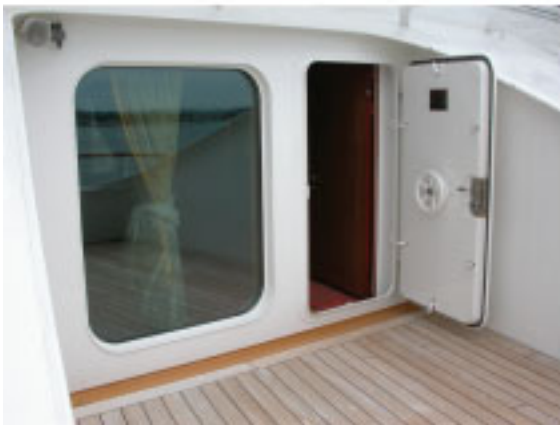
The seas damaged one cabin on deck 9 and one cabin above it on deck 10 (figure 2). The cabins face forward and have balconies overlooking the bow area. The balconies have a teak rail supported by welded aluminum vertical supports mounted on top of a low steel bulwark. The aluminum rail supports failed, and the teak handrails shattered the fixed stateroom windows. The broken glass blocked the drains on the weather side of the windows so the water could not escape. Seawater was then trapped between the steel bulwark and the aft interior cabin bulkheads. At least 1 foot of seawater entered the cabins and traveled under the cabin doors into the corridors. Both cabins sustained severe water damage to the windows, bulkheads, fixtures, and carpeting.

The prevailing wind and sea conditions caused the vessel to pitch and seas to break over the bow. The localized area of damage on the *Norwegian Dawn* was consistent with waves striking the ship's superstructure. The water exerted enough force to shear off the welds for the aluminum rail supports on the balconies of two cabins, allowing the teak balcony rails to break loose and crash into the cabin windows. The broken glass filling the drains compounded the water damage by allowing a large amount of water to enter
