## Marine Accident Brief

**Accident No.:** DCA-05-MM-008

**Vessel:** Malaysian-registered bulk carrier M/V *Selendang Ayu*, International Maritime Organization No. 9145528, 738 feet long, 39,755 gross tons, steel construction, built in 1998

**Accident Type:** Loss of power with subsequent grounding

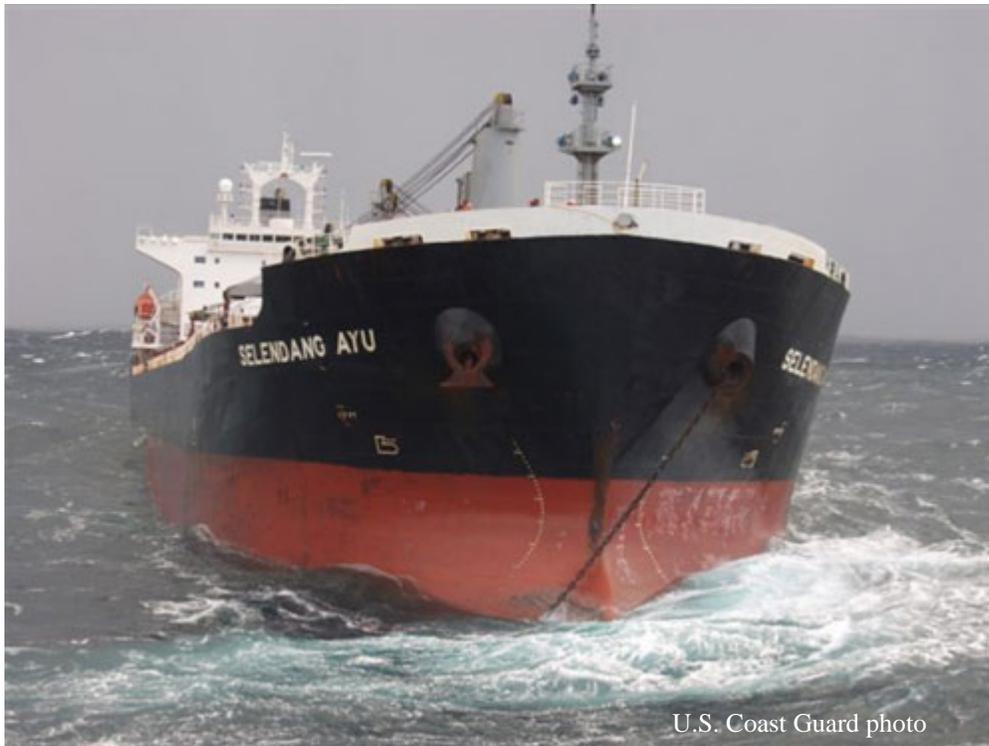
**Figure 2.** *Selendang Ayu* drifting with port anchor chain wrapped tightly around the stem.

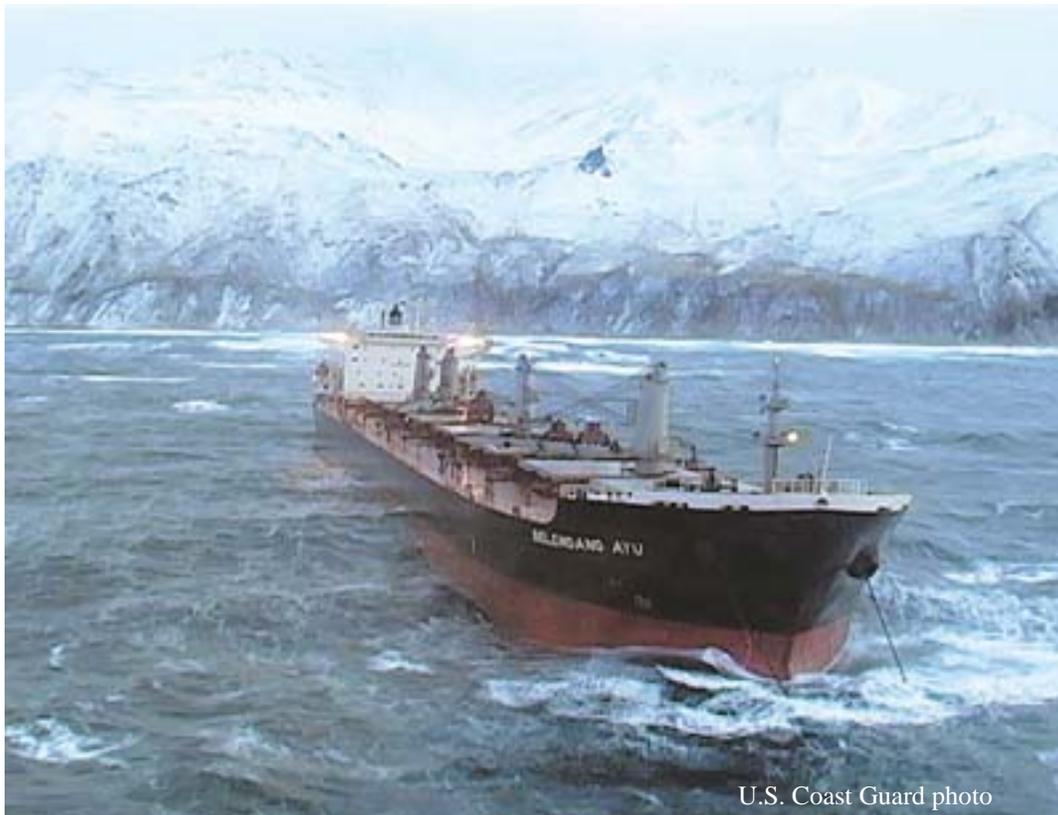
At 1431, the *Selendang Ayu* master lowered his starboard anchor. The anchor held with 10 shots on the winch. The *Alex Haley's* deck log reports that at 1450, the vessel was about 1 mile from the beach, holding to two anchors with 10 shots of chain on each (figure 3).

**Figure 3.** *Selendang Ayu* off shore of Unalaska Island. Both anchor chains are out and deck lights are visibly illuminated, showing that ship's generators are still producing power.

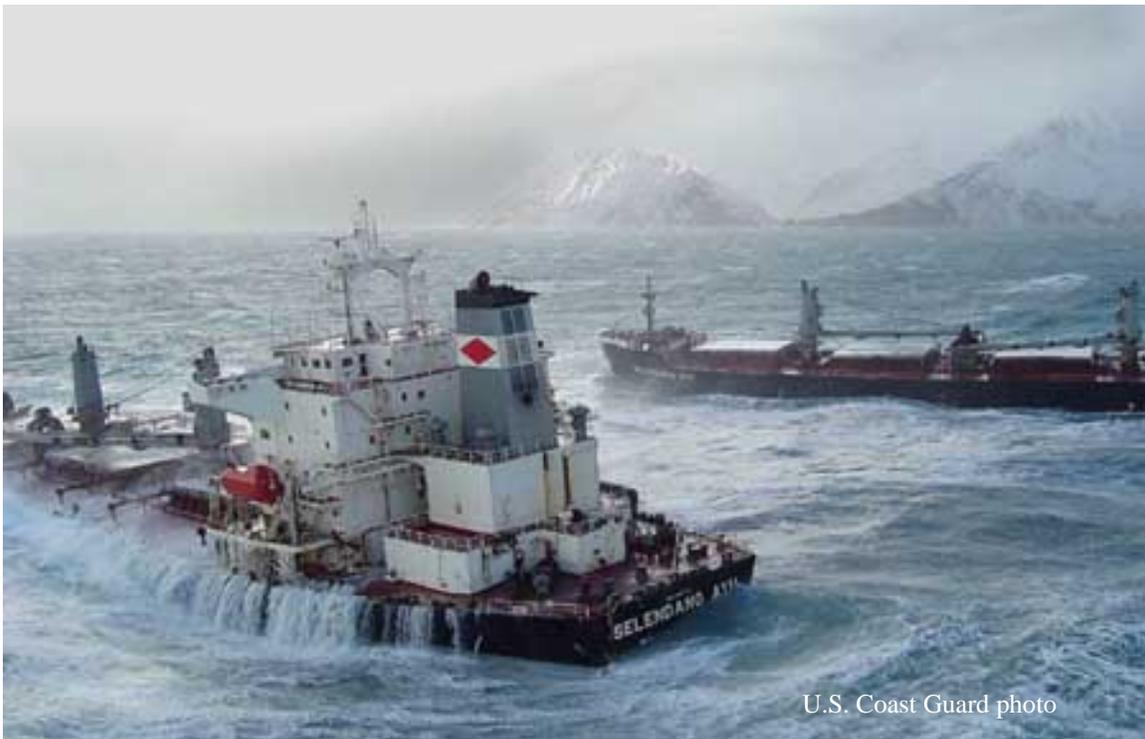
At 1913, with the master of the *Selendang Ayu* and Coast Guard rescue swimmer still awaiting rescue, the freighter broke in half on the rocks (figure 5). At 2035, the *Alex Haley*'s HH-65 Dolphin helicopter returned and rescued the master and the Coast Guard swimmer. After sweeping the shoreline for survivors, the Dolphin flew back to Dutch Harbor, where the *Selendang Ayu* master and the rescue swimmer were treated for exposure. On December 11, the *Alex Haley* docked in Dutch Harbor, bringing with it the nine *Selendang Ayu* crewmembers who had been rescued in the first helicopter evacuation.

**Figure 5.** *Selendang Ayu* after breaking in half off Unalaska Island—stern section in foreground, bow section in background. (Photo taken December 9, 2004, day after accident.)
