National Transportation Safety Board

Marine Accident Brief

Accident No.: DCA-09-LM-010

Vessel: U.S. commercial fishing vessel *Lady Mary*, official number 520834, 76-foot length overall (71.2-foot documented length), 105 gross registered tons, 21.2-foot beam steel construction, built 1969, converted 2001

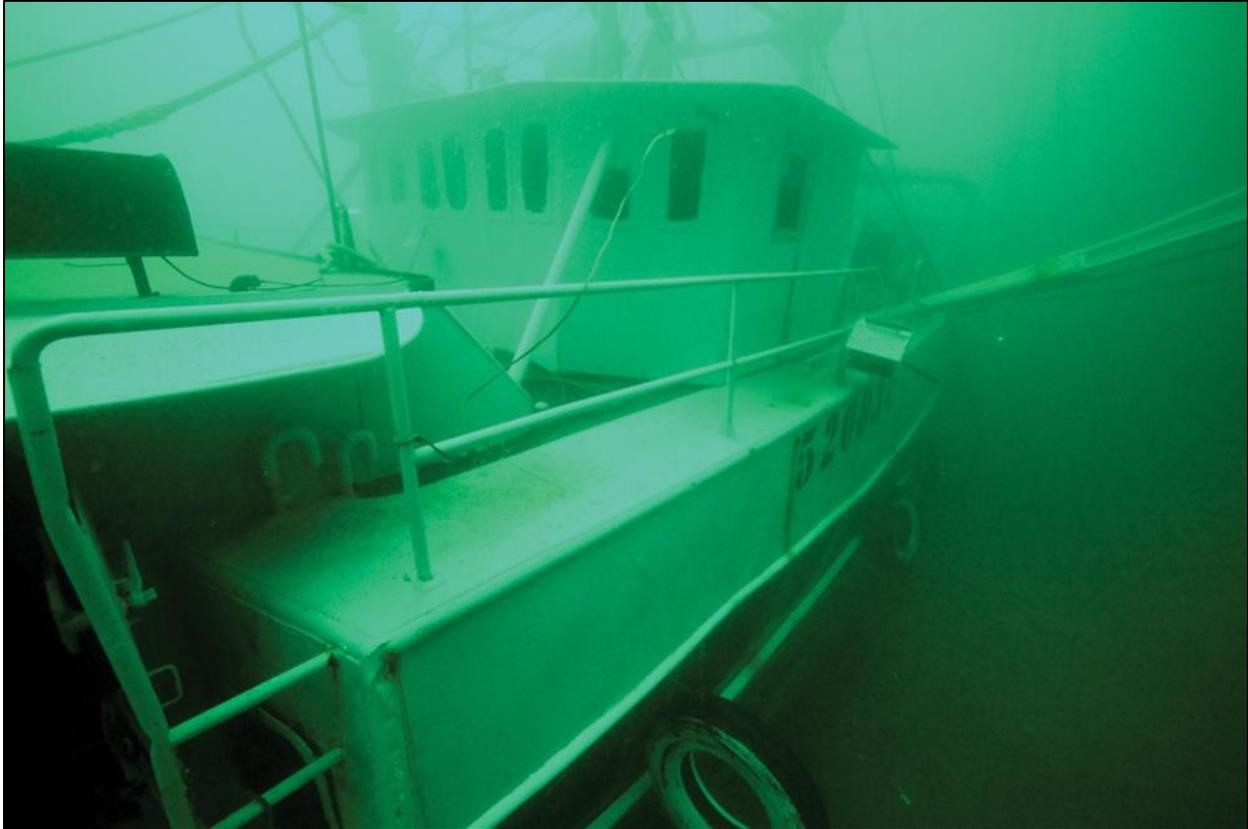
Figure 2. Sunken wreckage of *Lady Mary*, May 2009. (Photo by Bradley Sheard)

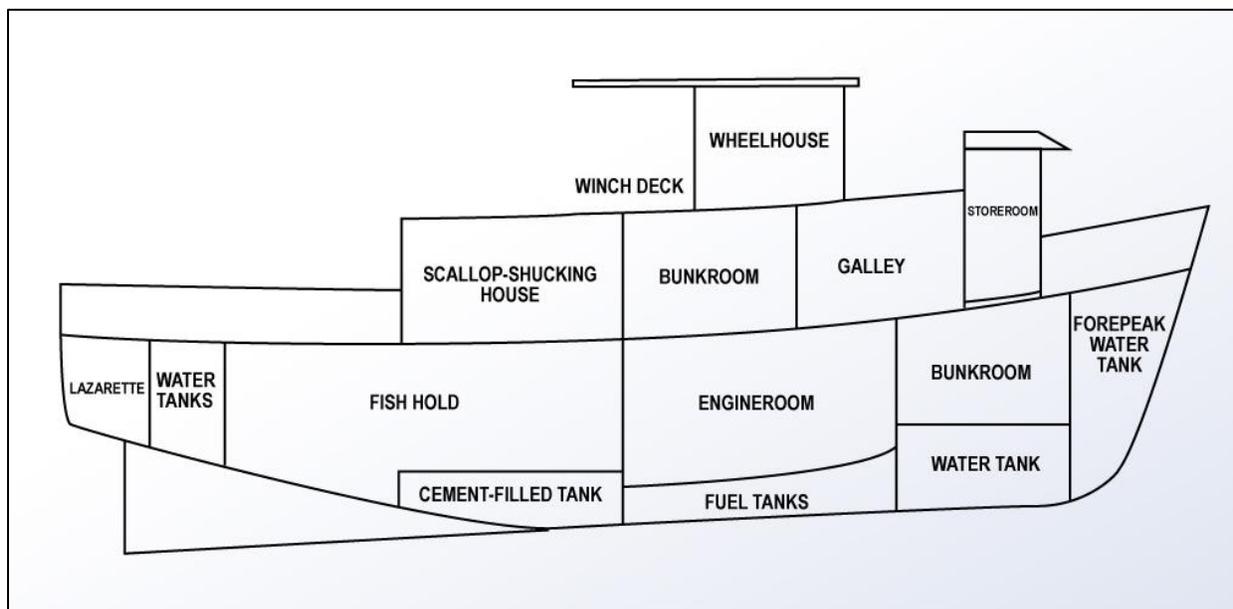
Figure 4. Profile view of *Lady Mary* (drawing based on Coast Guard sketch, not to scale).

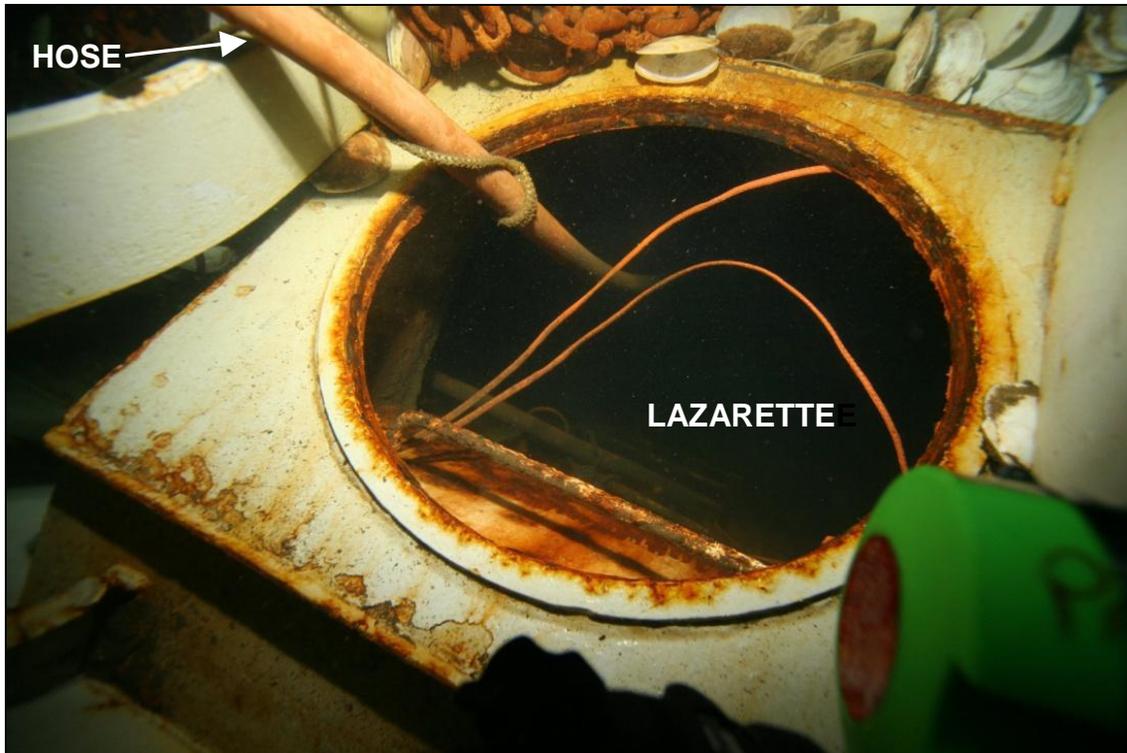
The photographs showed that the lazarette hatch on the main deck was open. A hose that emerged from the lazarette through the open hatch was tied overboard by a rope (figure 6). Although not shown in the photographs, a pump was positioned inside the lazarette, according to both the surviving crewmember and the owners' representative. The survivor told investigators that when it was necessary to dewater the lazarette, a crewmember would remove the hatch cover, enter the lazarette, rig the pump by hand, and empty the space using a hose that discharged over the side. He stated that the lazarette would typically be pumped out three or four times on a 10-day trip, and—in bad weather—they would have to pump it out "about once a day."

Figure 6. Open access hatch to lazarette, showing hose emerging from inside and tied overboard. A vessel's lazarette is its aftermost compartment below its main deck, typically accessed by a deck hatch. (Photo by Paul Whittaker)

Postaccident photographs of the *Lady Mary* wreckage show that the cover to the lazarette access hatch was off, with a hose emerging from the open hatch and tied overboard. According to testimony, the hose was attached to a pump in the lazarette. The survivor did not recall whether the lazarette hatch was open or closed when he went to bed. He said, however, that the crew normally kept the cover closed, as is consistent with safe shipboard practice, unless they were pumping out the lazarette.
