National Transportation Safety Board
Marine Accident Brief
Determination of Probable Cause
Sinking of Fishing Vessel Heritage

Accident no.	DCA-12-LM-007
Vessel	Fishing Vessel <i>Heritage</i>
Accident type	Sinking
Location	Alitak Bay, about 3 miles from Lazy Bay, off southeastern end of Kodiak Island, Alaska
Date	January 25, 2012
Time	0600 Alaska standard time (universal coordinated time – 9 hours)
Injuries	None
Environmental damage	8,000 gallons of diesel fuel on board when the vessel sank
Weather	Northwest winds 43 knots, gusts to about 59 knots Air temperature 1.4° F, sea surface temperature 36.5° F
Waterway characteristics	<i>U.S. Coast Pilot 9</i> describes Lazy Bay as a “good anchorage” and Russian Harbor as “a temporary anchorage in moderate weather, in about 8 fathoms, hard sand bottom. There is but little shelter, and strong tide rips are frequent.”

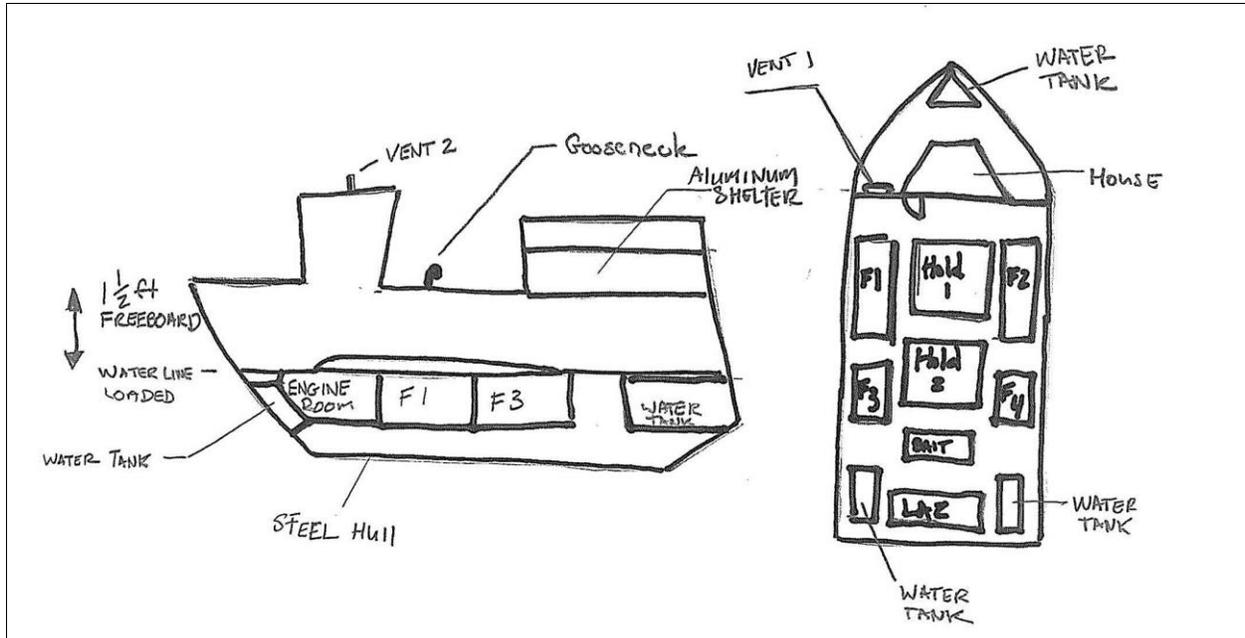
Figure 1. Rendering of the *Heritage* drawn by the master after the accident. No known photos exist of the vessel. Tanks labeled with an F are fuel tanks, and Holds 1 and 2 carried fish.
