# National Transportation Safety Board

## Marine Accident Brief

#### *Fire On Board Passenger Vessel Malaspina*

<b>Accident No.</b>	DCA-12-LM-009
<b>Vessel Name</b>	<i>Malaspina</i>
<b>Accident Type</b>	Fire
<b>Location</b>	Alaska Ship and Drydock (ASD), Ketchikan, Alaska 55°21.3952' N, 131°41.9782' W
<b>Date</b>	February 7, 2012
<b>Time</b>	1155 Alaska standard time (universal coordinated time –9 hours)
<b>Injuries</b>	None
<b>Damage</b>	Est. \$500,000–\$750,000
<b>Environmental damage</b>	None
<b>Weather</b>	Winds light and variable, clear skies, 10-mile visibility Air temperature 45° F
<b>Waterway characteristics</b>	Vessel was out of the water for repairs in ASD's drydock

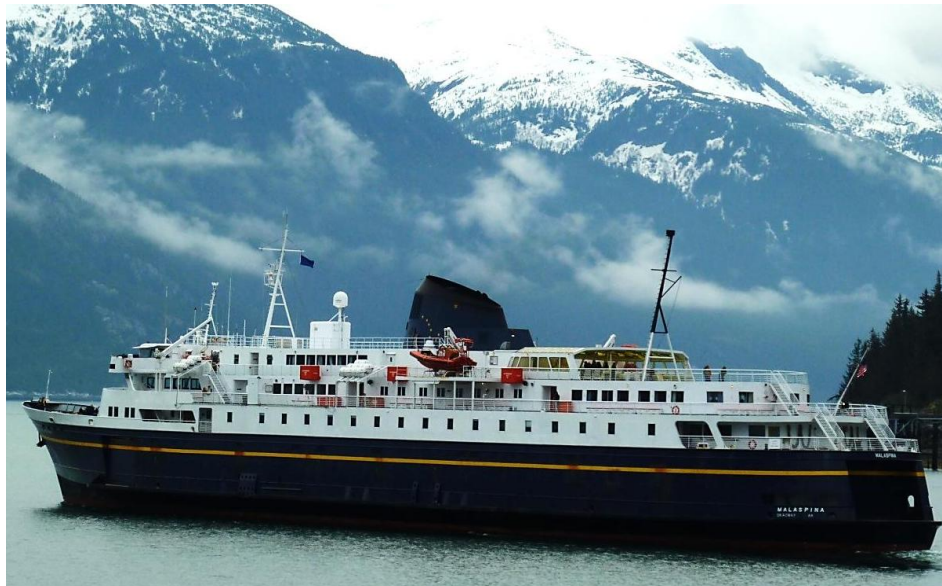
**Figure 1.** The passenger vessel *Malaspina* under way.
